Report on  
Geological Inspection  
Orange Drought Relief Connection  
Orange, NSW

Prepared for  
MWH Australia Pty Ltd

Project 72151.00  
November 2010

## Report on Geological Inspection of Orange Drought Relief Connection Corridors Orange, NSW

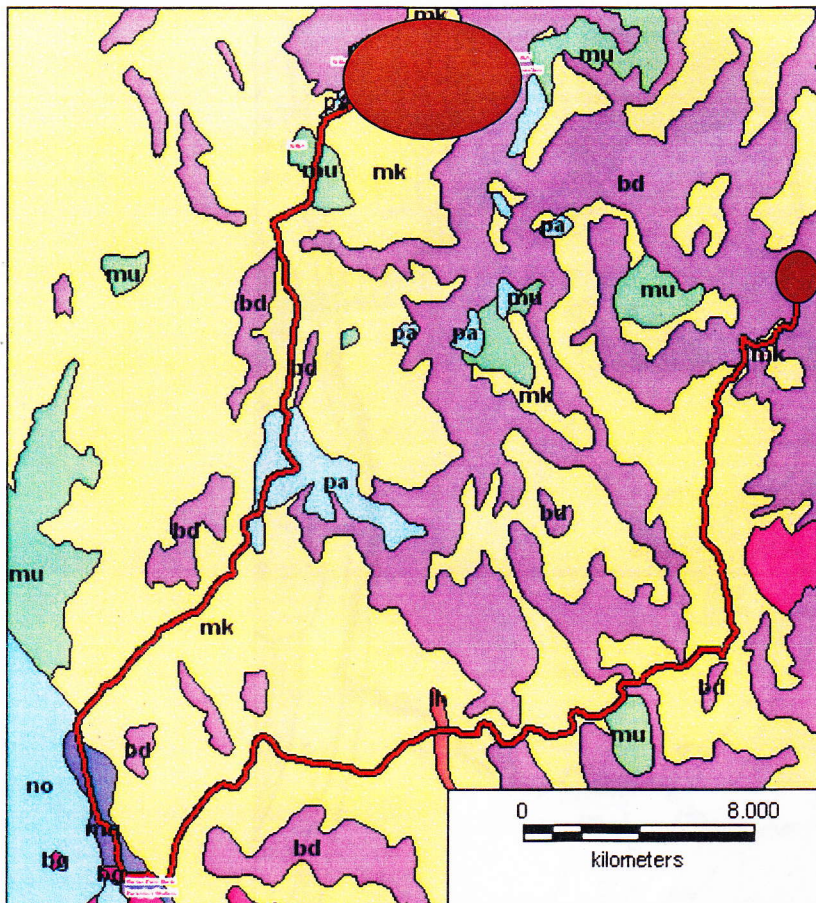
Figure 1: Distribution of mapped soil landscapes

The distributions of the mapped soil landscapes are shown in relation to the investigated pipeline corridors on Figure 1.

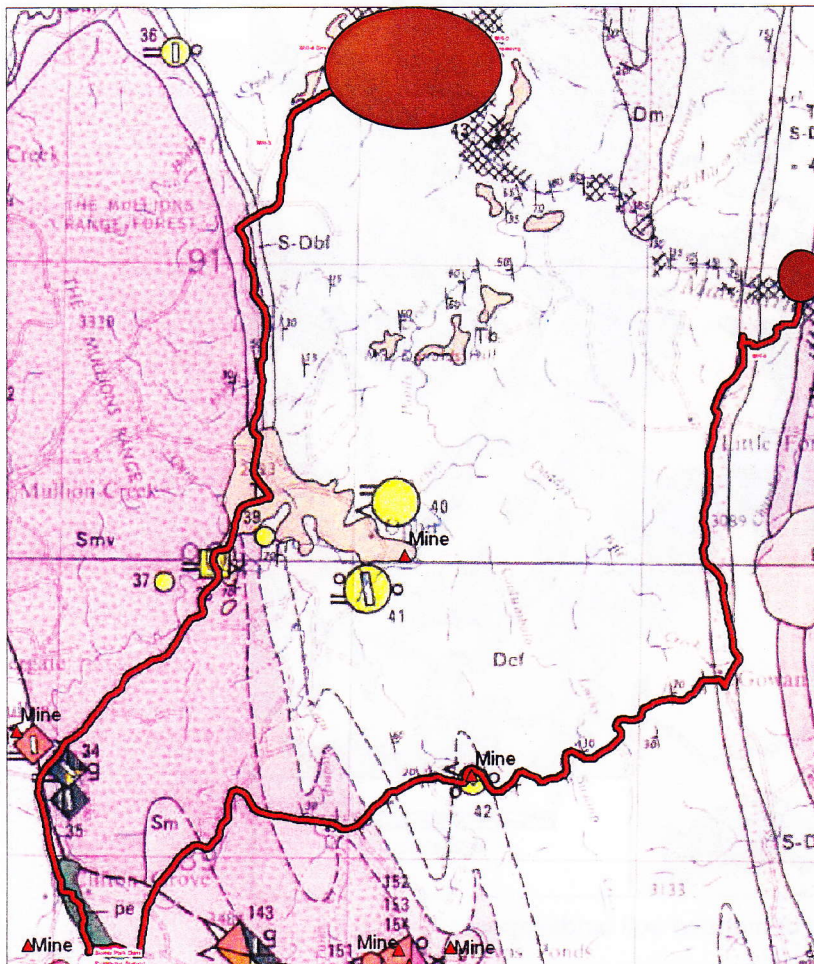
**Figure 2: Mine locations (extract from Bathurst 1:250 000 Metallogenic Map)**

The locations (shown ▲) of previous mining activities recorded on the data base provided by MWH are shown in Figure 2 (following page); an extract of the Bathurst 1:250 000 Metallogenic Map which also shows previous mining locations. The closest previous mining to a corridor (Corridor 2) is the Dead Horse Gully Mine (mine reference No. 42, Figure 2) where the 1:25 000 topographic mapping sheets (refer Map 6, Drawing 7) indicates an “abandoned mine shaft”.

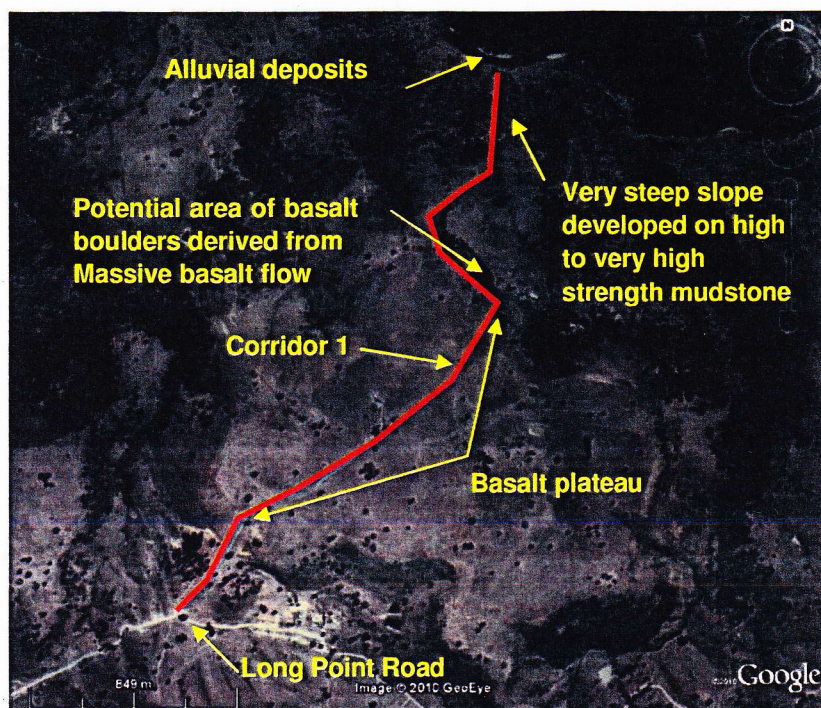
**Figure 3: Inferred conditions of Corridor 1 around MR4 river off-take towards Long Point Road**

It is inferred that the main geological features significant to pipeline installation in this area are:

- Potential for instability of basalt boulders from cliff lines formed about the perimeter of the basalt capped plateau.
- Probable shallow depth to High or Very high strength basalt on the plateau and in foliated mudstone, but with some interbedded sandstone, underlying steep ( $18^{\circ}$  –  $27^{\circ}$ ) to very steep ( $27^{\circ}$  –  $45^{\circ}$ ) slopes below the base of the basalt at approximately RL 600.
- Sand and gravel deposits within the base and banks of the Macquarie River.
