## **BRANDY HILL QUARRY EXPANSION**

Michael Hill  
12 Leumeah Close  
Brandy Hill NSW 2324

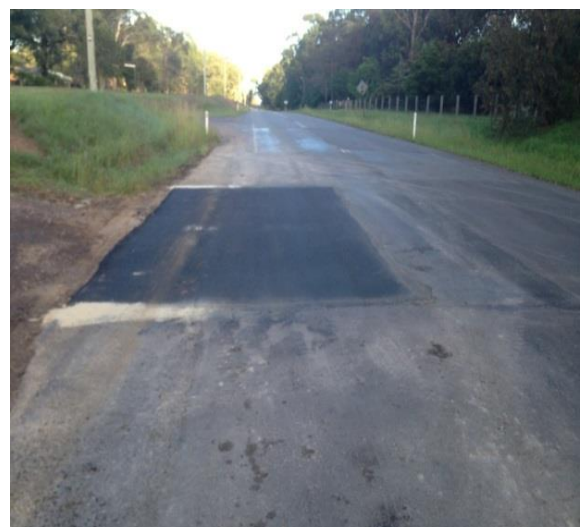
Photo A

In the last 3 weeks a major pot hole developed at the corner of Leumeah Close and Brandy Hill drive. This was a significant hole that measured approx 1 m x 1m and the cars and truck crossed the double line to avoid the hole. This created a very dangerous condition and an area of risk to the safety all road users. Port Stephens Council carried out repairs temporary repairs within two weeks. This repair lasted one day before it was destroyed by the trucks and created an even dangerous situation for cars an traffic coming down Brandy Hill Drive and traffic existing and entering Leumeah close. The pot hole has now been repaired. Photo "A"

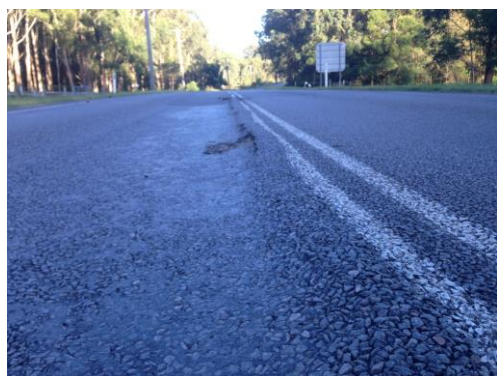
Photo B

There's quite a significant amount of evidence that Brandy Hill drive can't handle the current load of the trucks. These photos, "B, C & D", show the weight of the trucks pushing through the tar and creating large deformations in the road surface. The height of this contour is over 100mm. If a driver did cross over to travel around a cyclist that they could easily lose control.

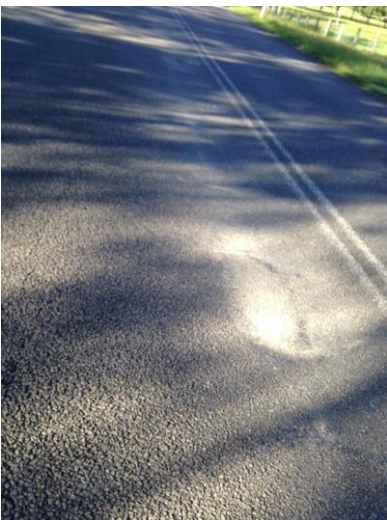
Photo E

The following photos show how the road surface quickly breaks away after rain due to the weight of the trucks pushing through the tar due to cracks in the tar and the sub surface layer being water logged. The ongoing maintenance is just a repair only and despite new sections of road being replaced in the last 12months the new section already shows signs of degradation deformation and pot holes. Photos "E, F & G"

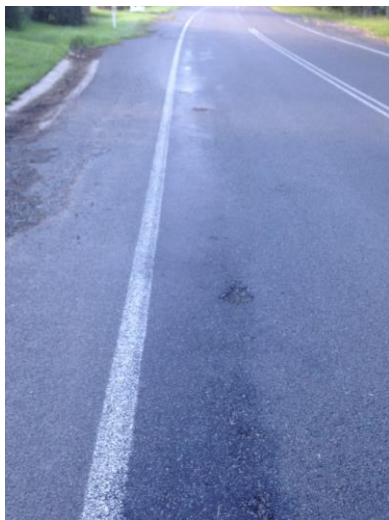
Photo G

Cracks repaired by sealing with tar, have opened up and water is penetrating sub surface and deformation and degradation is occurring at an accelerated rate due to the current traffic. Photos "H, I & G"

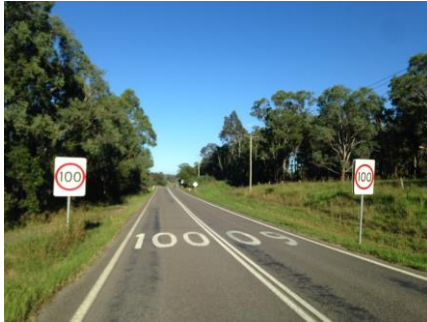
Photo K

The only speed sign on the approach to Brandy Hill Drive from Seaham is when you exit the 60km zone at Seaham. Here it changes to 100km/hr Photo K. The road is 2.7km long from here to Brandy Hill. Cars and trucks can do 100km/hr as they crest the hill, being 150m before the crossroad into the Quarry. This is a high risk collision zone of between cars and trucks crossing over Clarence town Rd. The signs request drivers to take caution and reduce speed. As you approach this intersection the reduce speed sign is obscured by a power pole and the intersection sign. Photos "L & M"

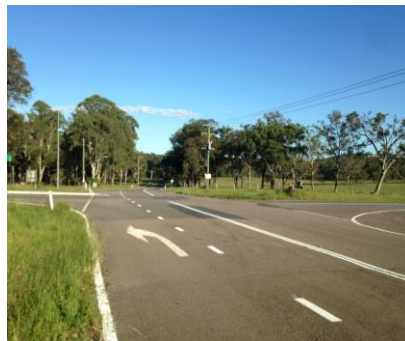
Photo N

This intersection has no street lighting and no turning lane into the quarry for vehicles, trucks coming from Maitland. Photo "N"

(no Street light at Intersection)

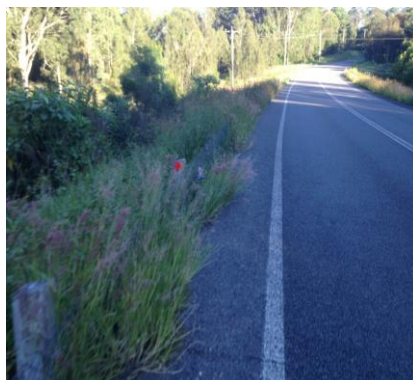
Photos O

Brandy Hill drive is narrow and in many sections has nowhere to walk or cycle as there are no foot paths or the road is not wide enough. The verge in some areas is only 500mm. "Photos O & P" There are two main fenced across filled land and two cuttings that make walking and riding off the road extremely difficult. Photo "Q & R"

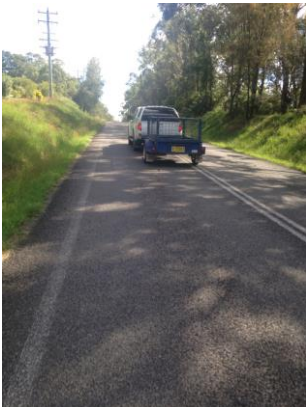
Photo S

The following photo "S, T, U, V & W" were taken on a quite Sunday and in no way shows the danger of wider body truck passing cyclists. On several occasion truck have overtaken me on the crest of the hill. The potential of colliding with on coming traffic is extremley high especially at early morning or latter in the evening when people are coming home from work.

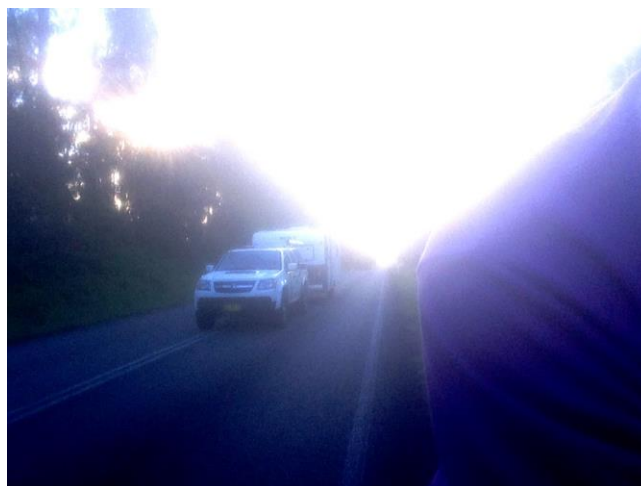
Photo W

Early morning or late in the evening traffic crosses to other side of road up hill
