PCU55391

Submission on the proposed NorthConnex Tunnel

Appendix 1. Assessment of Trees on 2 Trelawney St

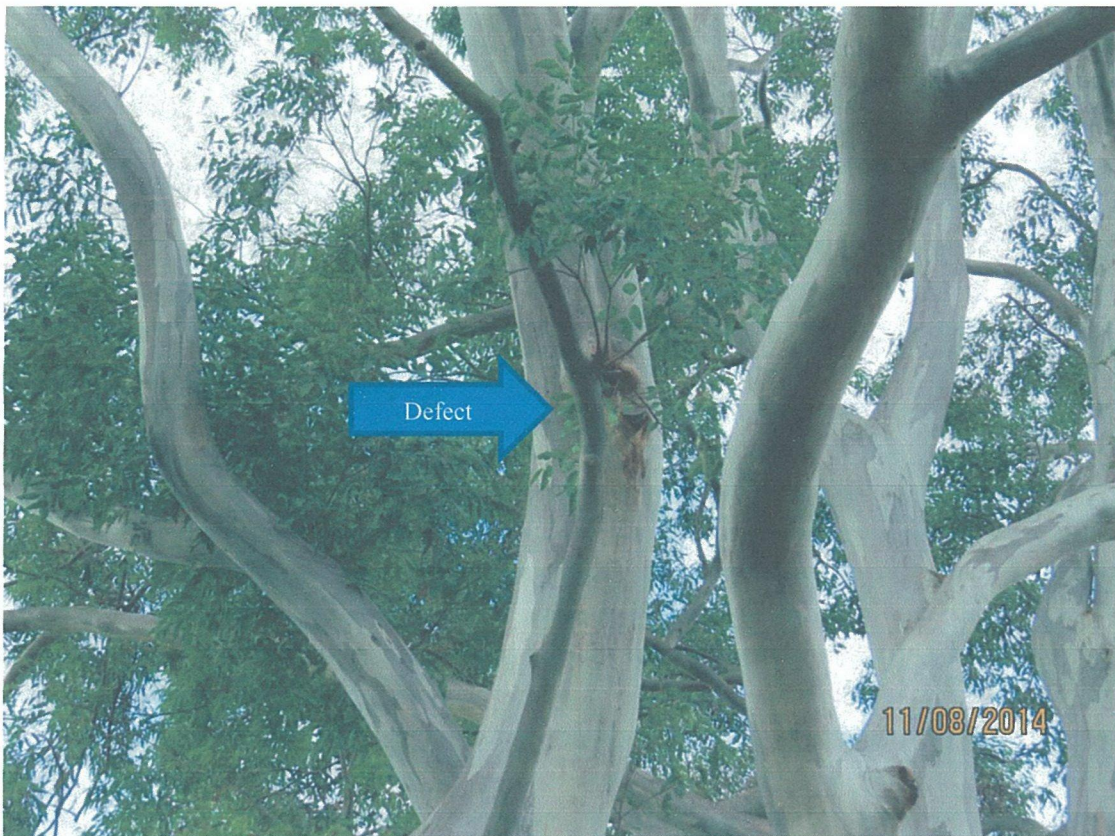
The tree has a minor defect along 1 of its branched and some minor deadwood in the canopy

Photo 2 Tree 1 has a minor defect in 1 of its branches

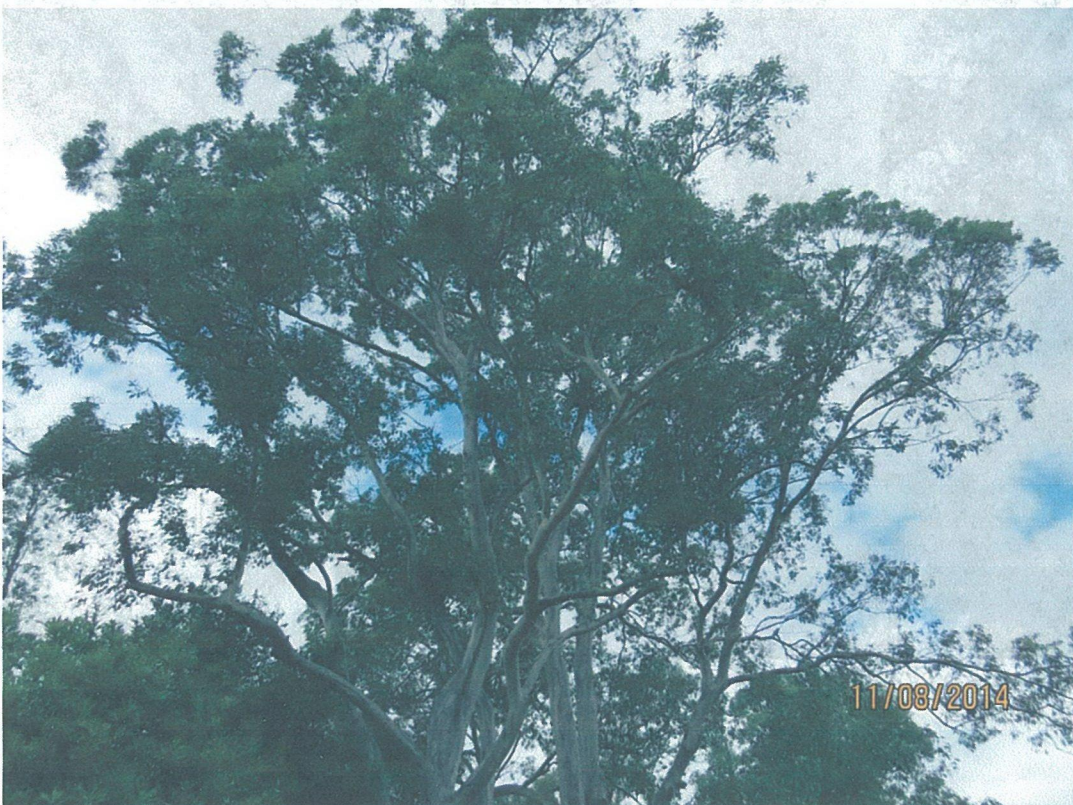
Photo 3 Both trees crown are healthy with no sign of disease or insect damage

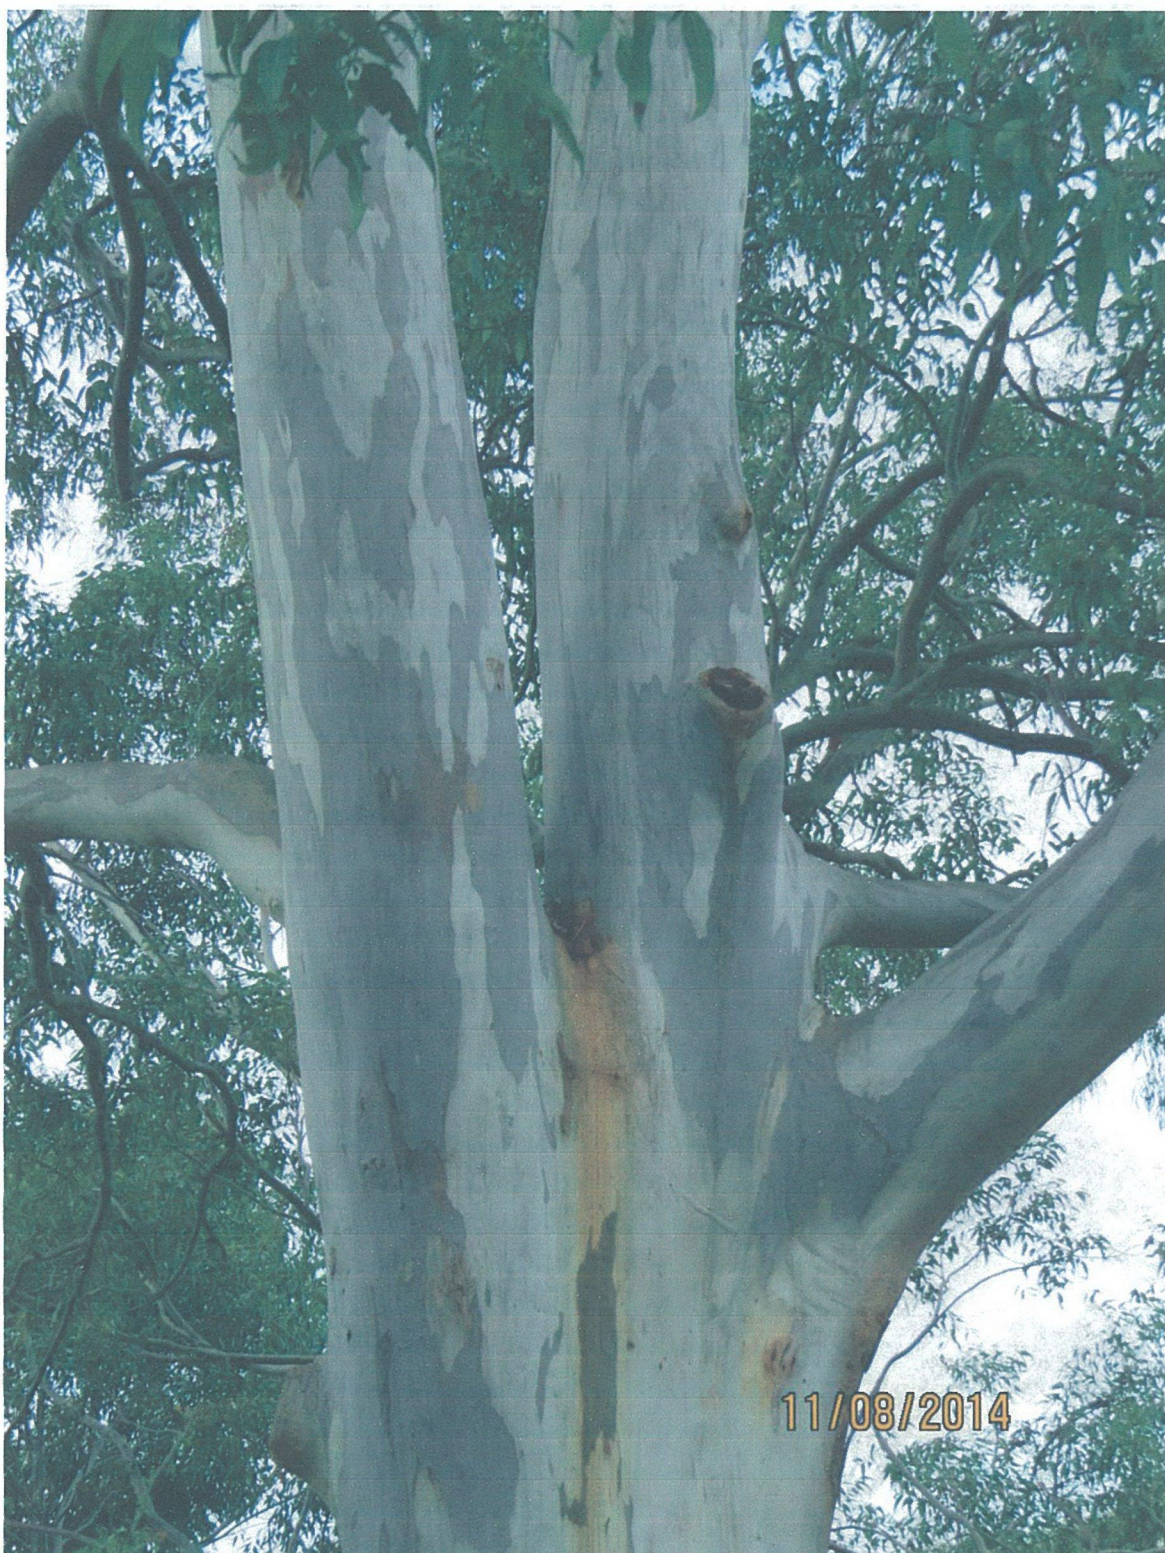
Photo 4 Tree 2 Co Dominant junction is visible sound
