Cranbrook High School

Traffic Management Plan

Roadworks road safety audit (plan-based)

PC-PROJ-0003-01 RW RSA CRANBROOK REV 1

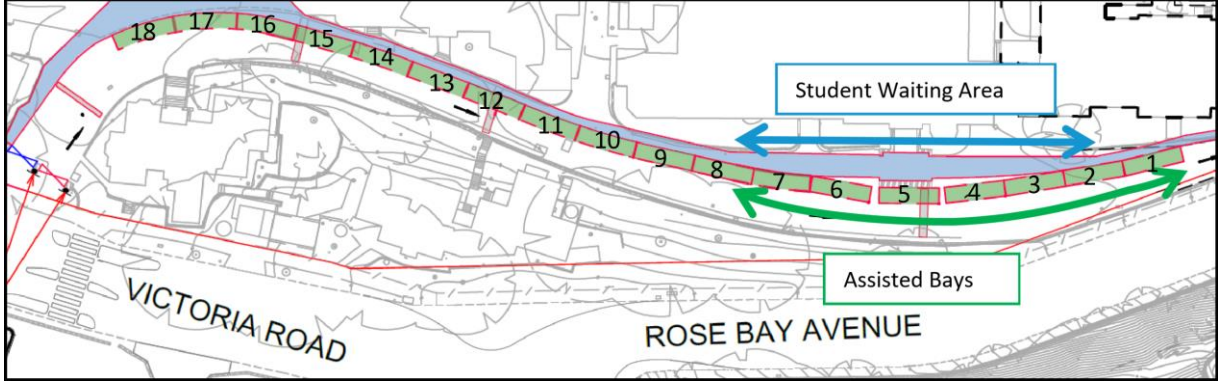
Ref	Location	Road safety audit finding	Priority
1a	General – Safe operation of the drop off and pick up zone.	<p>The drop off/ pick up zone will be positioned in the existing porte cochere stemming off Victoria Road and emerging onto Rose Bay Avenue. An 18-space queuing and pick up line would be established as shown below. The assisted bays would be used mainly by younger students that require assistance when boarding or alighting from vehicles.</p> <p>Much of the success of the assisted drop off/ pick up zone depends on the chain-of-processes involved, the on-site management of students and cars, and the behaviours of the drivers (including queuing behaviour and etiquette). Ideally, under perfect operating conditions during pick up times, vehicles would arrive in bays 1-8 in the designated northbound direction, then load in an efficient manner, and then leave the bays <u>in the same order</u> and proceed to the Rose Bay Avenue gate. This would then allow the vehicles that were originally in bays 9-15 to progress to bays 1-8 and load and leave in the same order. However, in reality the vehicles would not always leave the pick up bays in the same order that they arrived. Similarly, many vehicles would not be ready to leave in the same order if they take longer to load or are required to wait longer. For example, if vehicles 1-7 are loading, but vehicles 4 and 5 are ready to leave well before the others, these drivers may tend to pull out into the circulating lane. This would create additional and unnecessary crash conflicts such as <i>rear-end</i> and <i>side-swipe</i> crashes due to vehicles 4 and 5 pulling out into the circulating lane. There would also be <i>rear-end</i> crash conflicts as vehicle 4 pulls out believing that the circulating lane is free, only to have vehicle 5 pull out at the same time (or even momentarily before).</p> <p>By pulling out of the line before the leading vehicles clear out of the pick up area, it also encourages trailing drivers to pass around the queue to enter those empty spaces. This also creates crash conflicts typical of parking manoeuvres. It would also cause frustration as many drivers would consider this to be “pushing in”, “jumping the queue” etc. Pockets of empty spaces would be more prevalent in the unassisted bays (bays 9-18) as these pick up transactions would be much quicker than the assisted bays.</p>

<p>Above: Extract from the Traffic and Parking Plan showing the designated drop off and pick up bays.</p>	Medium

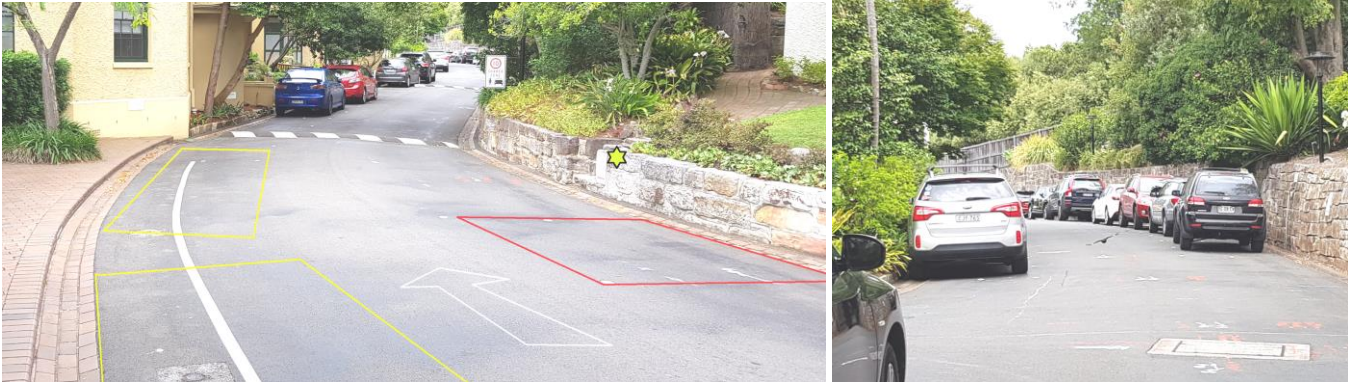
<p>Left: The portion of the porte cochere near the Alumni Building. The yellow polygons are the indicative locations of drop off/ pick up parking bays 17 and 18. If vehicles are stopped in these bays at the same time as a vehicle is parked at the red polygon, there would be very little residual passing clearance between these vehicles (see white arrow). One scenario where this could occur is if a driver is picking up or dropping off a pedestrian at this point, and a trailing driver intends to continue to the assisted bays to pick up younger children. The restricted passing clearance may increase the risk of side-swipe crashes.</p> <p>Right: The portion of the porte cochere downstream of the Kitchen Deliveries loading lane. There would be reduced passing clearance throughout this section due to (i) the proposed kerbed walkway on the western side of the porte cochere which will occupy more driveway width, (ii) vehicles stopped in the drop off/ pick up bays (bays 8 and 9), and (iii) if vehicles are parked/ stopped on the eastern side of the driveway as shown.</p>	Medium

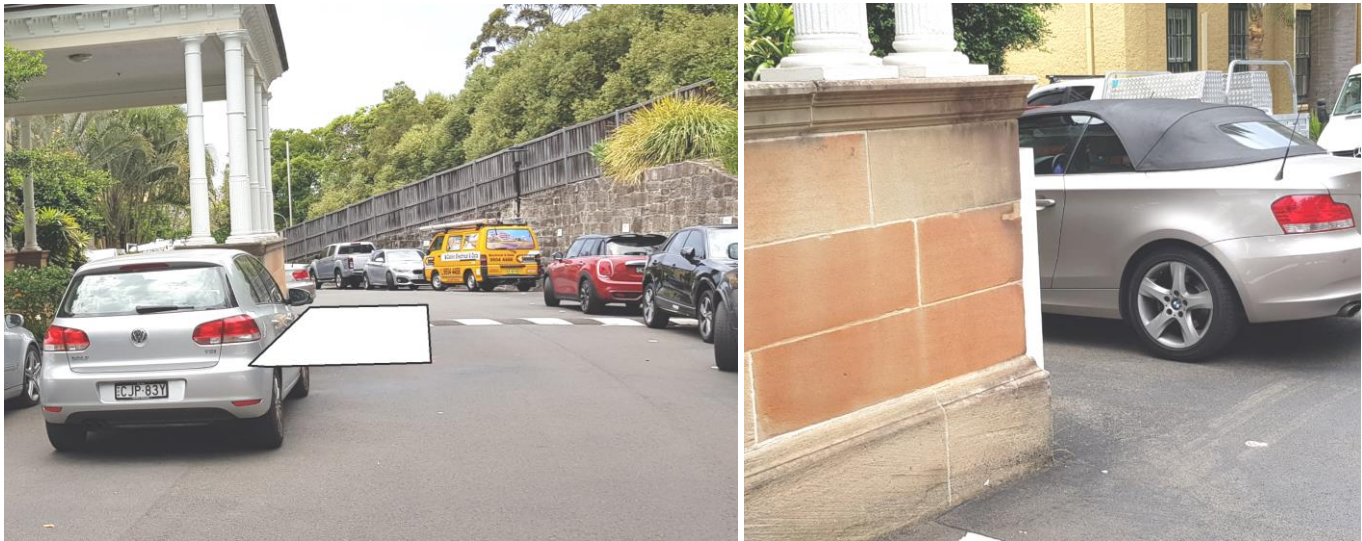
<p>Left: The sheltered entry area to the Mackay Room and Chapel juts out into the porte cochere driveway. The proposed drop off/ pick up bay will extend along the outside of this entry foyer. The white polygon is the approximate position of drop off/ pick up bay 5. As shown, if a vehicle is stopped at this location whilst there are vehicles stopped/ parked along the eastern side of the porte cochere, there would be very little residual driveway width for other vehicles to pass through this gap. This could also lead to side-swipe and nuisance impacts.</p> <p>Right: The audit team also notes that the pre-existing sandstone wall creates a blind corner where pedestrians may emerge suddenly into the path of a vehicle progressing along the drop off/ pick up bays. This could increase the risk of vehicle-pedestrian crashes. Furthermore, this is in the assisted drop off/ pick up area where there would be more likelihood of younger (and hence shorter) students. These children may be at more risk of being concealed by the sandstone wall. The mitigation of this issue through lateral offsets of the vehicle stream has tradeoffs. The greater the offset of the vehicle stream from the wall, the better the sight line and separation to conflicting pedestrians who may suddenly move out into the vehicle stream. However, this would further reduce the passing clearance between the drop-off/pick up vehicles and vehicles parked on the eastern side of the porte cochere. The audit team also notes that unless some lateral offset is provided at the sandstone wall, there may not be sufficient door-opening clearance. This has further safety flow-on effects as pedestrians may be forced to use the driver-side doors rather than the passenger-side doors. Even if doors can be opened with sufficient clearance, there may not be residual offset available for pedestrians to walk around the opened doors.</p>	Medium

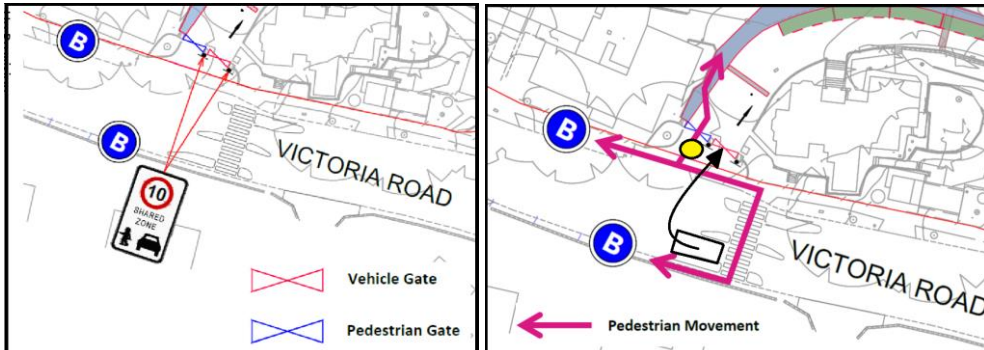
Ref	Location	Road safety audit finding	Priority
3a	Entry gate from Victoria Road.	<p>The <i>Traffic and Parking Plan</i> indicates that the vehicle entry gate would be on the right-hand side of the pedestrian gate if the gate is viewed from the outside looking in. The audit team notes the following concerns:</p> <ul style="list-style-type: none"> Typically, drivers are accustomed to entering on the left-hand side of a given channel due to the left-hand drive rule. The designation of the right-hand channel as the entry path could reduce the legibility of the gate. This could result in driver hesitation, confusion and indecision. Also, pedestrians would be accustomed to seeing oncoming traffic approach on the left-hand side of the driver-viewed channel (the right-hand side of the pedestrian-viewed channel from inside the property). If inbound vehicles are designated to the right-hand gate, this could also be counter-intuitive for pedestrians on the footpath and using the porte cochere driveway. As shown in the right-hand image, one likely pedestrian desire line would be from the internal footpath to the zebra crossing across Victoria Road. As such, these pedestrians would be required to cross the inbound driveway. These pedestrians would be exposed to impacts by inbound vehicles, especially vehicles turning right into the porte cochere. Such right-turning drivers would tend to look to the west to judge gaps in the eastbound traffic stream. In doing so, they may fail to check for pedestrians crossing the inbound gate. This could result in <i>right-turn on pedestrian</i> crashes between the inbound vehicle (black arrow) and pedestrians (yellow dot). The right-hand channel at the entry gate has more pronounced vertical grades and grade changes (see photo on next page). The abrupt changes in grade could result in under-carriage scraping or bottoming out, especially by vehicles with low ground clearance. If entering the right-hand channel at the gate, the driver would have less forward visibility to the driveway conditions ahead. This includes reduced awareness of where the back of queue is located. This could increase the risk of <i>rear-end</i> crashes. It may also lead to right-turning drivers attempting the right turn when there is insufficient downstream clearance within the property. This could therefore increase the risk of queues spilling back <i>through</i> the gate and across the footpath. This could force pedestrians onto the roadway and the back of queue may also be exposed to <i>rear-end</i> crashes if the right-turning vehicle is stranded in the control area of the intersection with no opportunity to pass around the queued vehicles in the road ahead. If the right-hand channel is used, there is more likely to be queue spillback from the westbound lane of Victoria Road back across the zebra crossing. This would be due to westbound right-turners stopping to turn right and being in such close proximity to the zebra crossing. It would also be due to the lack of passing clearance for trailing westbound vehicles as the kerb blister impedes this passing path. <div>

<p>Far left: The <i>Traffic and Parking Plan</i> indicates that the right-hand channel at the entry gate would be used by vehicles and the left-hand channel would be used by pedestrians. Near left: The risk of right-turn on pedestrian crashes at the gate. The inbound right-turning vehicle would tend to look to the west to check for gaps. In doing so, they may fail to see pedestrians crossing the gate and moving to/from the zebra crossing.</p> </div>	Medium

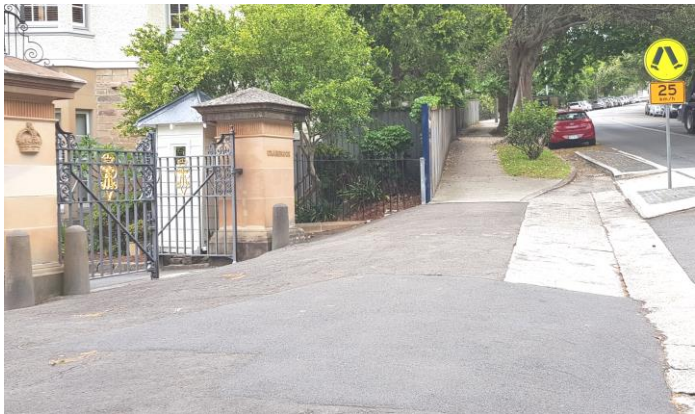
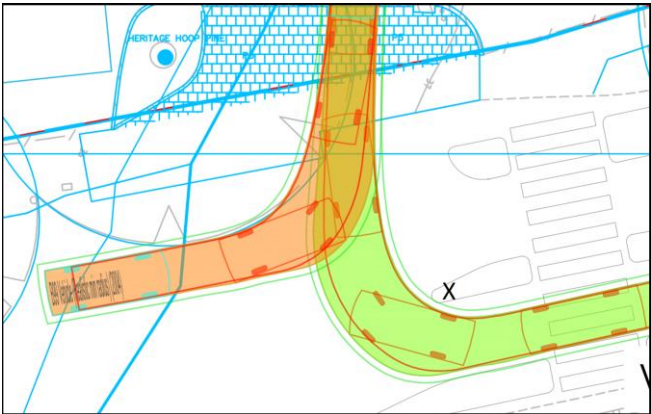
<p>Left: Looking eastbound along Victoria Road at the entry driveway. Note the abrupt change in grade of the right-hand gate (as viewed from the outside) where vehicles may have increased risk of undercarriage scraping and bottoming out. Right: Extract from the swept path model showing how a right-turning vehicle entering the right-hand channel of the entry gate would have marginal clearance from the nose of the median island at "X".</p>	Medium

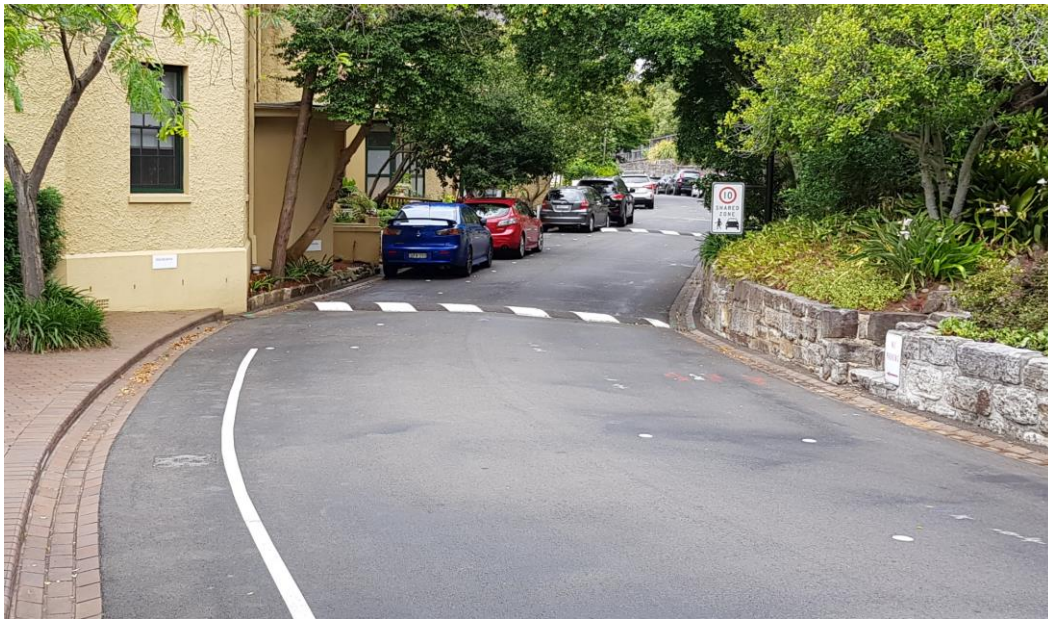
Ref	Location	Road safety audit finding	Priority
4	Visibility along the porte cochere.	<p>Generally, there is a lack of unobstructed line of sight along the 18 proposed drop-off/ pick up bays. This is due to the numerous horizontal curves and sight-obstructing elements adjacent to the road as well as on the road (parked and queued cars). This would restrict the ability of on-site traffic management personnel (the Traffic and Parking Plan states that there will be four staff members on duty to supervise drop off/pick up operations). For example, without a clear line of sight from the assisted pick up spaces, staff members would not be able to judge whether an early arriving driver can wait in place or if they need to leave the system and re-circulate back to the Victoria Road gates. The <i>Traffic and Parking Plan</i> states that early arriving drivers would be directed to leave. However, this would not be necessary if there is a small queue of cars further upstream in the port cochere. Recycling this traffic back to the start point would create unnecessary crash conflicts associated with entering Rose Bay Avenue, negotiating the route back to Victoria Road, making a right-turn at Victoria Road and another right turn into the Victoria Road gate. A clear line of sight would enable more sensible judgement calls to be made.</p> <p>A clear line of sight would also be helpful in safeguarding pedestrians and other vehicles. If problems were detected, the on-site staff could slow down the call-up process, or halt the call-up process altogether.</p> <p>As line of sight is unlikely to be achieved through physical measures, as a result of the pre-existing physical constraints, compensatory measures could be used such as positioning staff members at strategic points and using two-way radios to establish a communication link at least between the head of queue and entry gate. This practice is used extensively in queue-generating traffic control plans across the road network.</p>

<p>Above: An example of an obstructed line of sight along the porte cochere. From this point near the start of the proposed drop off/ pick up zone, there is a lack of clear sight line to the head of queue (bay 1) as well as to the sheltered area at the entry to the Mackay Room and Chapel.</p>	Medium

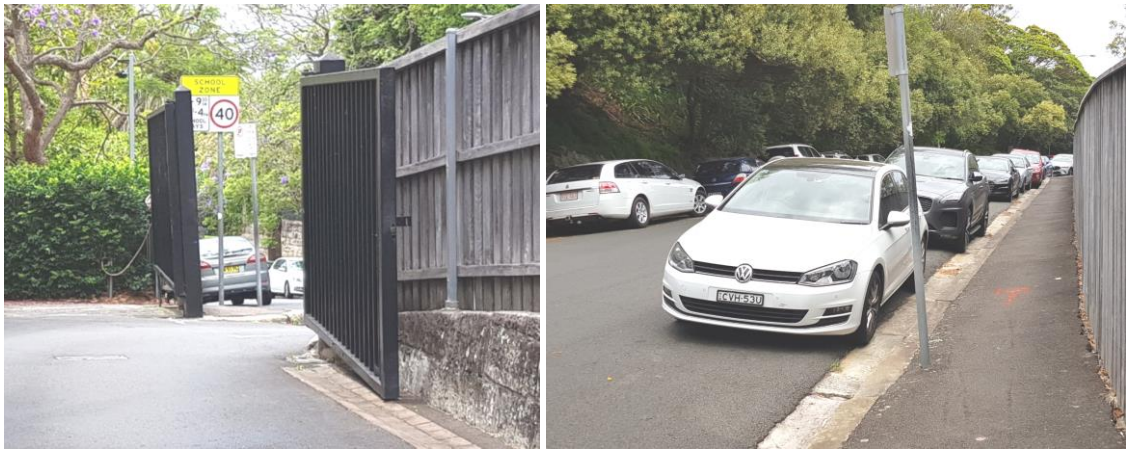
Ref	Location	Road safety audit finding	Priority
5	Safety of the egress gate.	<p>The porte cochere re-emerges onto the external road network at Rose Bay Avenue. Since the porte cochere has a near-parallel alignment with Rose Bay Avenue, this has resulted in a sharp turn in the porte cochere in its immediate approach to Rose Bay Avenue. This has created a number of road safety concerns, as follows:</p> <ul style="list-style-type: none"> ▪ The sharp angle between the porte cochere and Rose Bay Avenue, and the significant elevation difference from Rose Bay Road (higher elevation) and the porte cochere (lower elevation) has required the boundary fence to continue all the way up to the driveway opening (to safeguard pedestrians and prevent fall injuries). This fence therefore restricts driver visibility to pedestrians on the external footpath. This could have corresponding risks of <i>vehicle-pedestrian</i> crashes at the gate. ▪ The egressing vehicle would tend to be aligned at an acute angle to Rose Bay Avenue when stopped to judge gaps. The viewing angle to the eastbound traffic stream is difficult and some vehicles (eg. delivery trucks and utes) may have poor inter-cabin visibility such that the sightline is not even achievable. ▪ Kerbside parking is allowed on the western side of Rose Bay Avenue. As shown in the right-hand image, parked cars would tend to compromise the <i>minimum gap sight distance</i> (MGSD) sight line such that the egressing driver may not be able to detect and select safe gaps to complete the movement. This could result in poor gap selection and consequential <i>cross traffic</i> crashes. ▪ Kerbside parking is also allowed on the eastern side of Rose Bay Avenue. These vehicles restrict the space available for egressing right-turning vehicles. The vehicle would need to perform a 180-degree hard right-turn. Furthermore, they would be required to commence this turn from the extreme left-hand side of the porte cochere channel. There would be risks of <i>side-swipe</i> crashes between right-turning egressing vehicles and parked cars on the eastern side of Rose Bay Avenue. <div data-bbox="519 742 1646 1193">

</div> <p>Left: Looking from the porte cochere channel to the outbound gate where there is limited visibility to pedestrians on the external footpath. Right: The MGSD sight line from the egress driveway is compromised by (i) the poor viewing angle and (ii) parked cars on the western kerbline of Rose Bay Avenue.</p>	Medium
