Gary Blumberg & Associates Pty Ltd

gpb:gpb/07-33/lr775

29 January, 2008

**KIOLOA BEACH HOLIDAY PARK
23 ADDITIONAL SHORT-TERM SITES AND 93 ADDITIONAL CAMP SITES
COASTAL HAZARD ASSESSMENT**

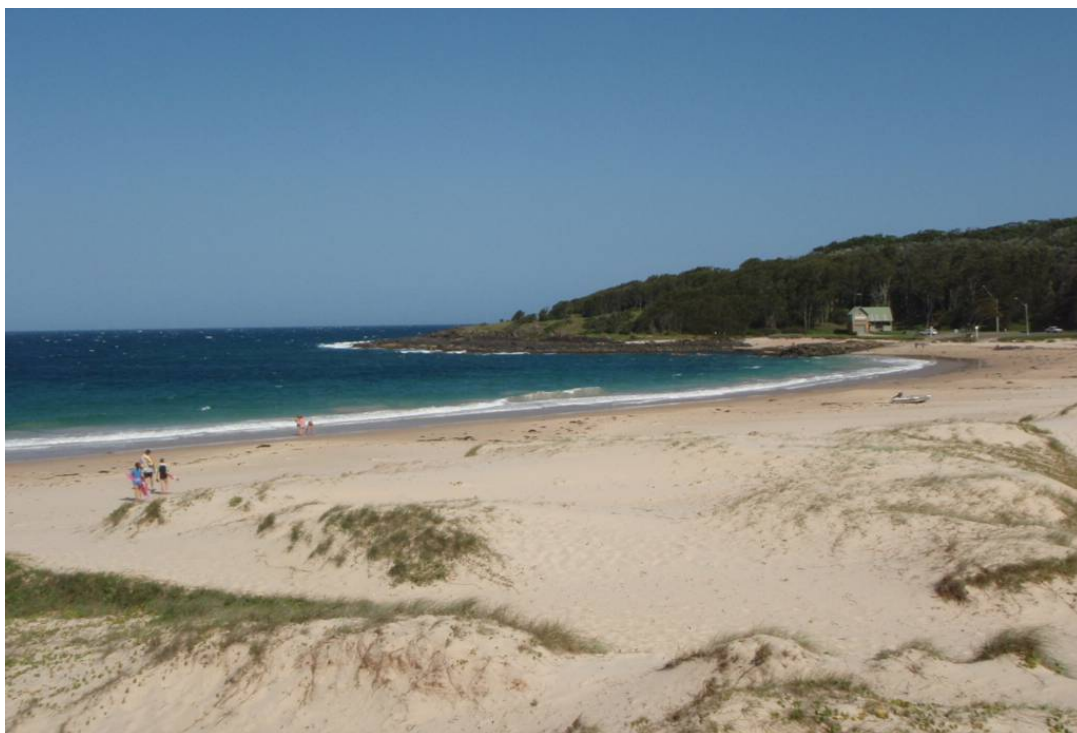
Photo 1 – Kioloa Beach looking south from east end of southern-most accessway. Coastal Patrol facilities shown at O'Hara Head.

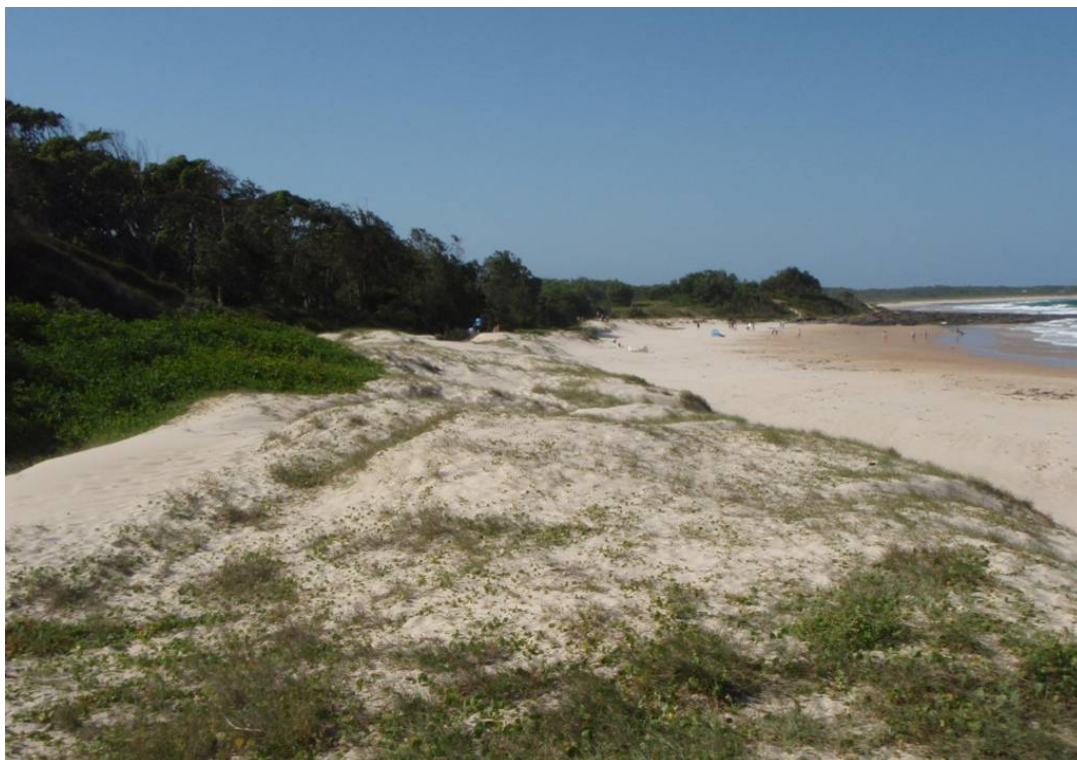
Kioloa Beach appeared in good condition at the time of our inspection. Low tide beach width to the toe of the foredune measured some 50 to 60 m. No residual erosion was evident within the berm, and the well developed foredune (**Photo 2**) showed no damage from the significant storms which affected the NSW coast in late June 2007. Investigations and reports on these storms in and about the Sydney Region cited their recurrence as nominally a 1 in 10 year event. We understand from Mr van Bergen that wave run up from the June storms reached the toe of the foredune, but the feature itself was not impacted. We would expect ESE incident swells to be the critical wave direction for Kioloa Beach, although significant dissipation of wave energy would occur due to refraction, diffraction and wave breaking around the southern headland and island (**Figure 4**).

Photo 2 – Kioloa Beach looking north from southern accessway. Foredune appears healthy and accreting, and hind dune well stabilised with vegetation.

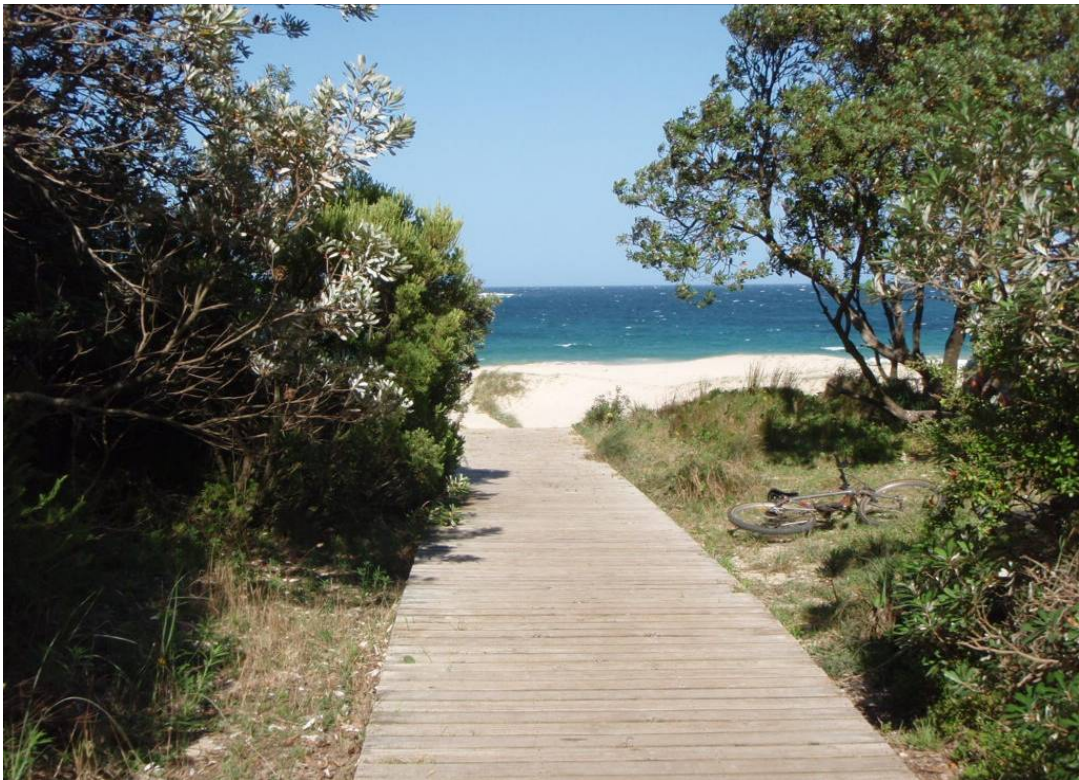
Three boarded pedestrian accessways cross the dune (**Photos 3** to **5**), all of which we understand are well used.

Photo 3 – View along boardwalk at southern-most accessway.

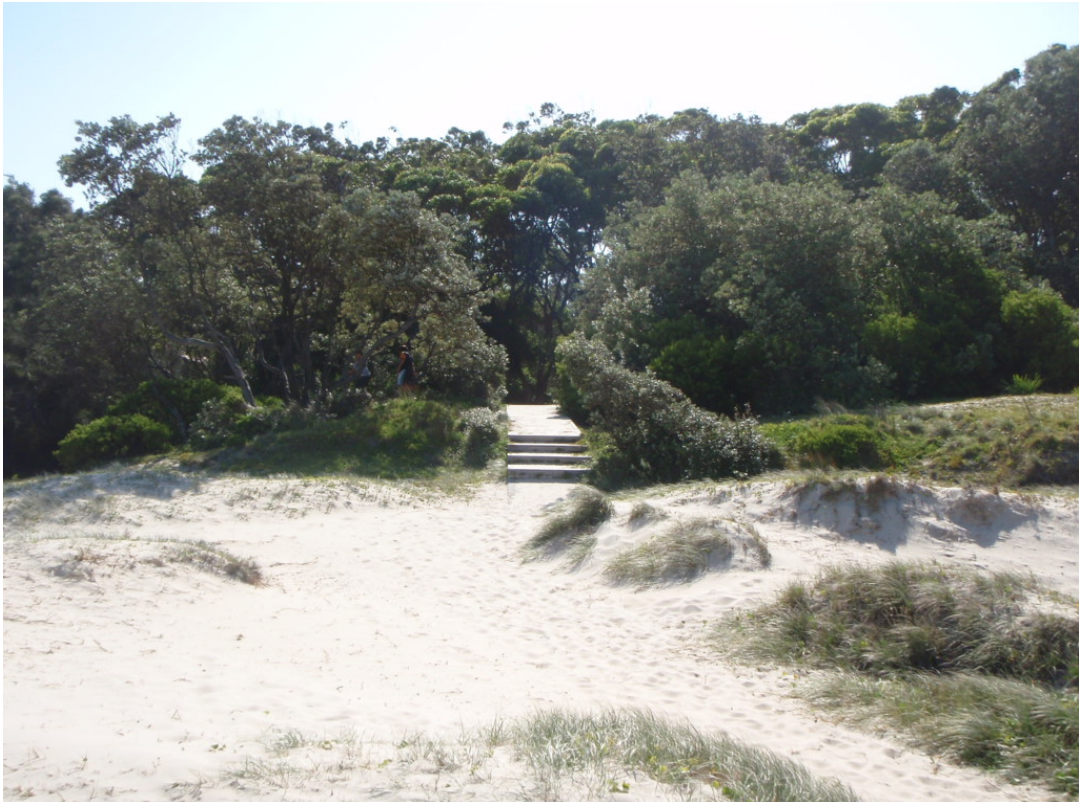
Photo 4 – Boardwalk and steps at southern-most accessway.

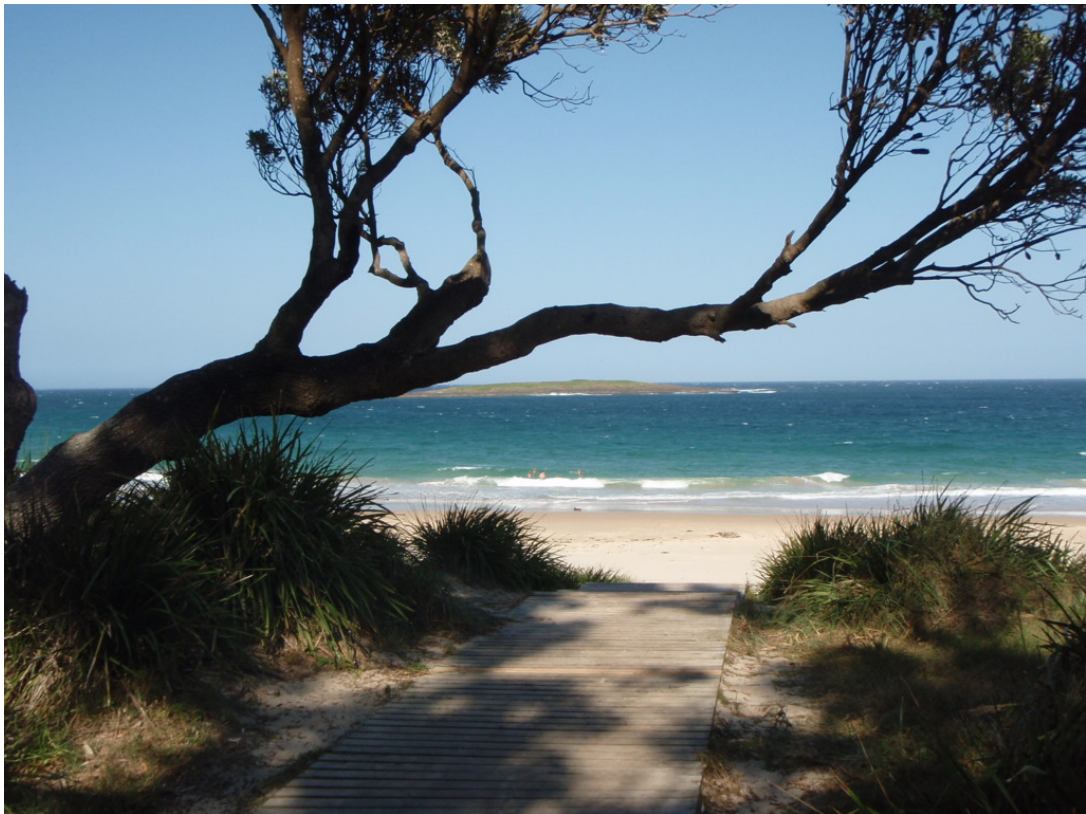
Photo 5 – View along a central accessway. Belowla Island 800 m offshore.

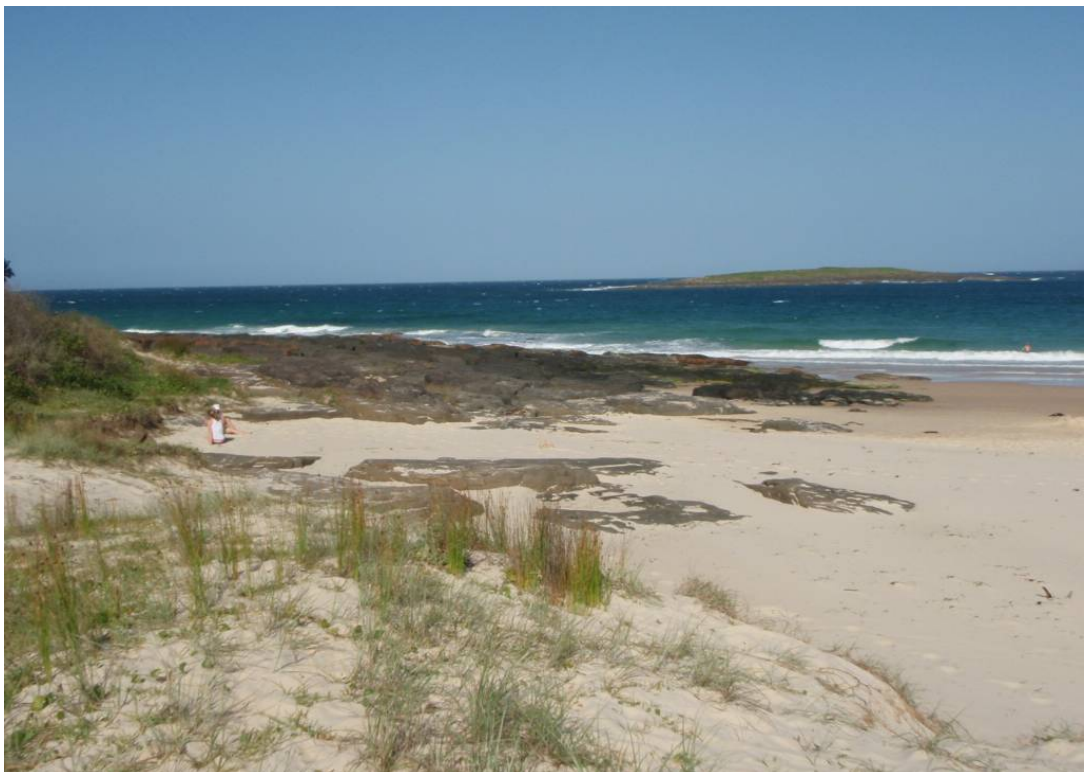
Photo 6 – Basalt outcrop at Butlers Point, and Belowla Island.

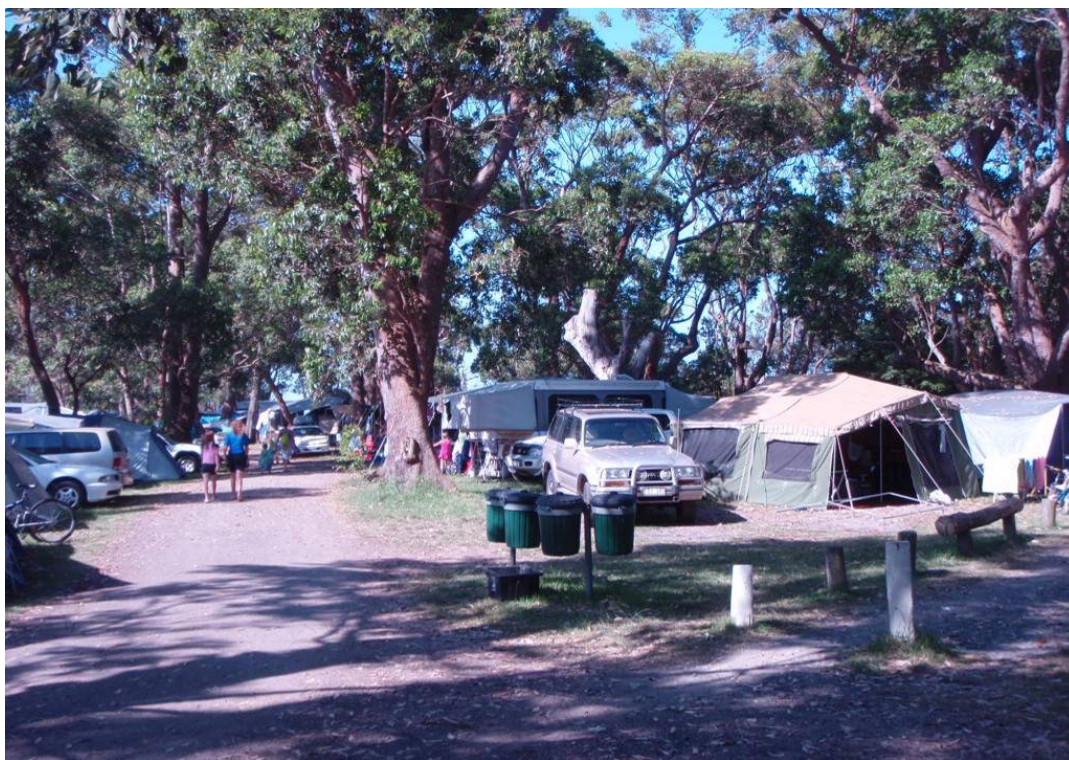
Photo 7 – Typical layout of camping sites on east side of Holiday Park.

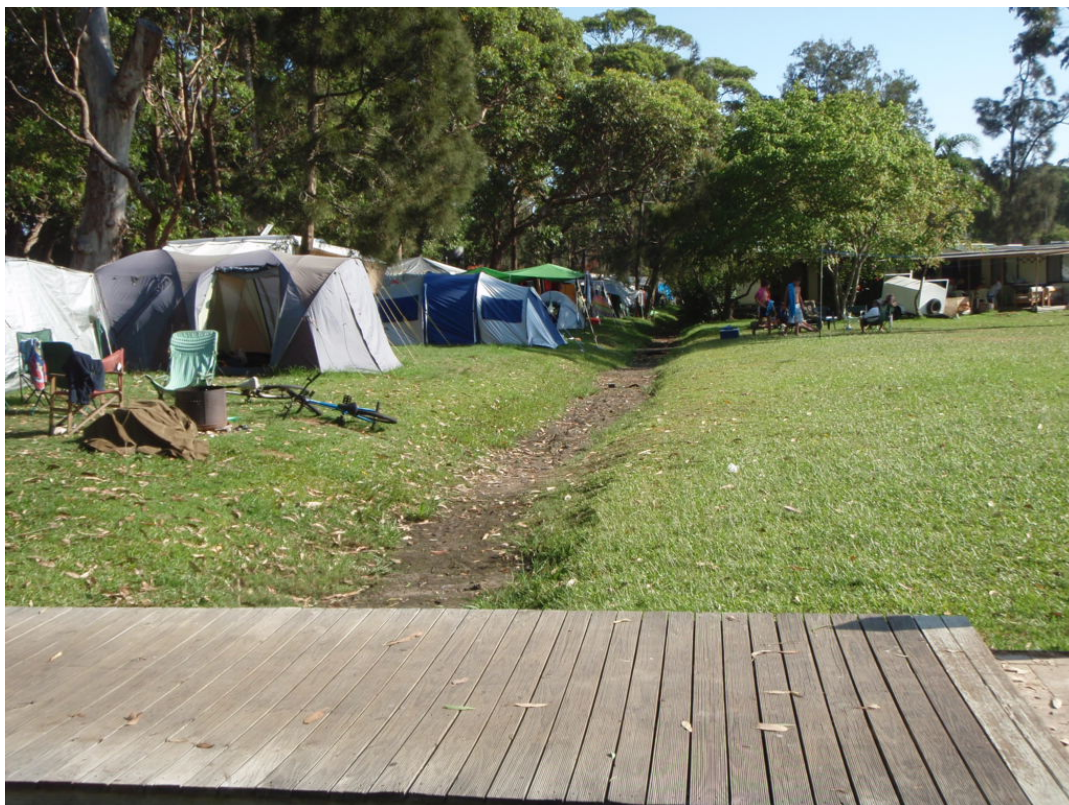
The Holiday Park is drained via a gully located on the western edge of the camping sites. This gully drains north-south into a small dam (**Figure 1, Photos 8 and 9**). The dam then drains to a larger creek, the catchment of which extends to the west side of Murramarang Road. The host creek widens below this dam, turning southwards within the dune complex before spilling across the southern end of Kioloa Beach. This creek entrance would be mostly closed, only breaking-out after

Photo 8 – Drainage gully flows north to south along west edge of camping sites.

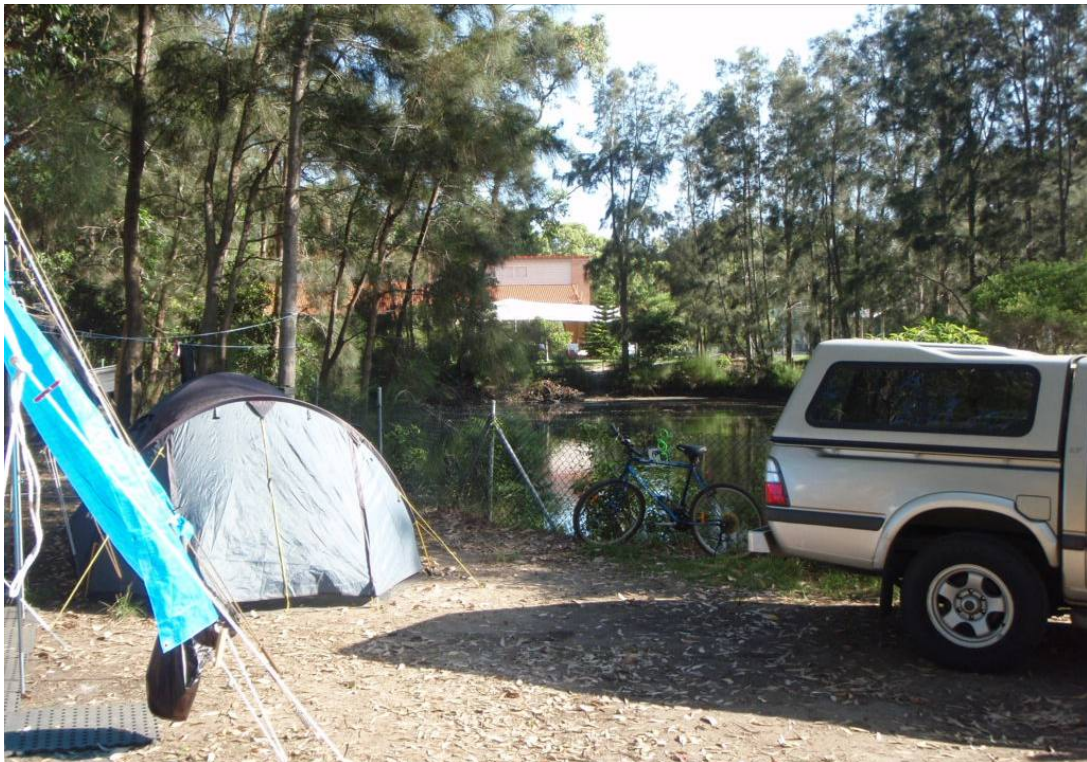
Photo 9 – Drainage gully connects to this small dam, which overflows to the creek at the south end of Kioloa Beach.

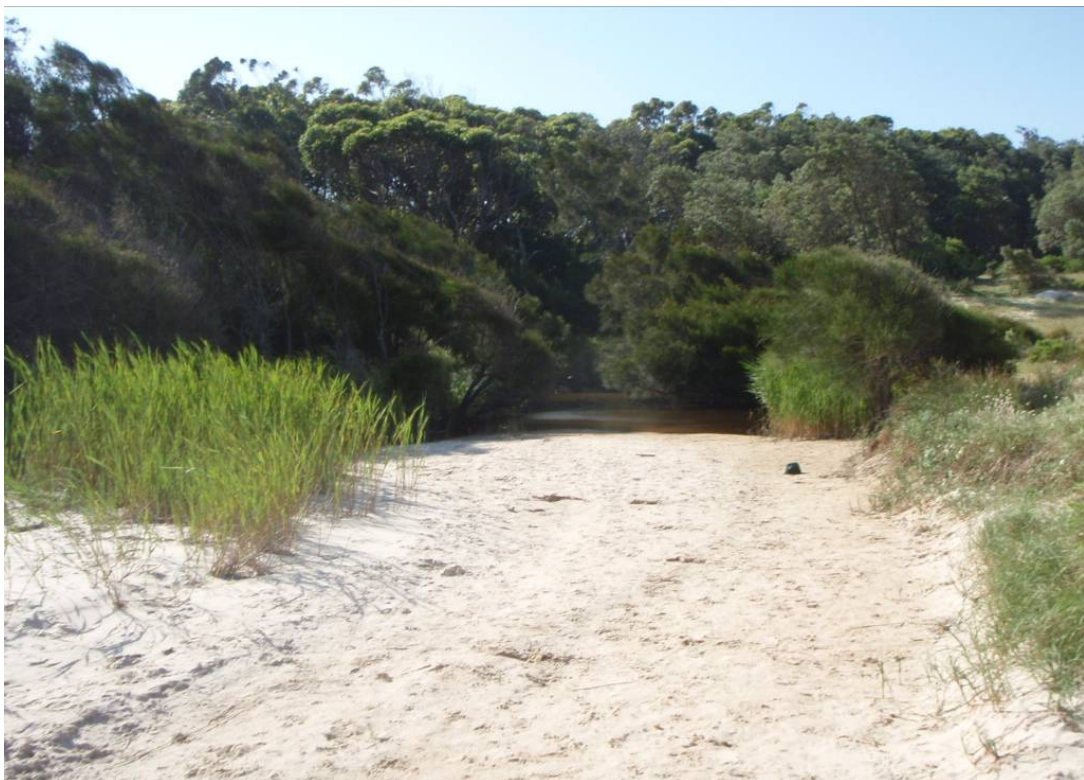
Photo 10 – Closed entrance to creek at southern end of Kioloa Beach.

sufficient rainfall (**Photo 10**). The topography of the park site and adjoining dune ensures that drainage onto Kioloa Beach is confined to this single creek outlet. Butlers Creek drains to the beach on the north side of Butlers Point, however there would appear to be minimal drainage from the Holiday Park to this system (*note contours in Figure 1*).

During our site inspection we observed the blocked entrance to the southern creek (**Photo 10**). Based on our understanding of typical back-beach creek pondage behaviour and our appraisal of back-beach levels at Kioloa, we estimate the water level in the closed off creek entrance at approximately RL 1.0, or some 2 m below the existing water level in the small dam.

A break-out of the creek outlet would concentrate erosion of the berm, however any influence on erosion behaviour would be localised (*say within 50 m of the outlet*). While this may locally contribute to the erosion hazard, the magnitude of the impact would be such as to have no bearing on park infrastructure which is well removed from the SE corner of the site (**Figure 4**).

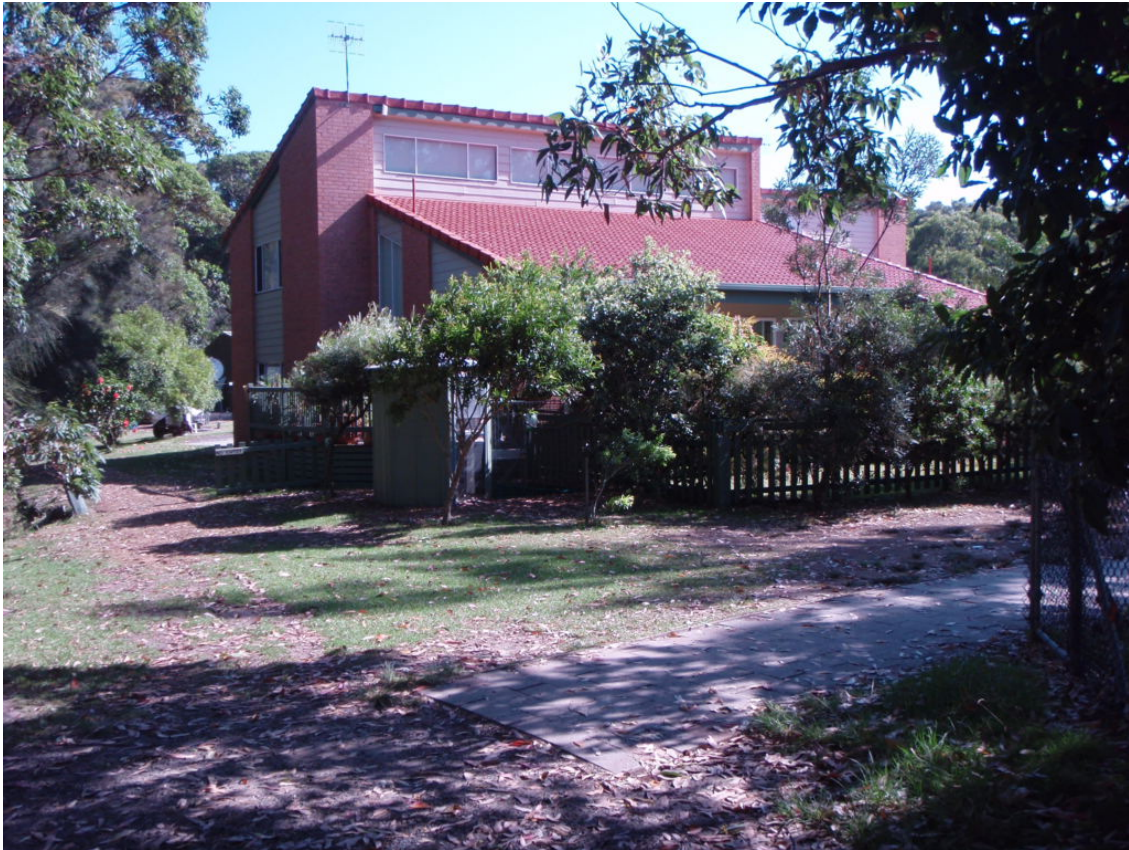
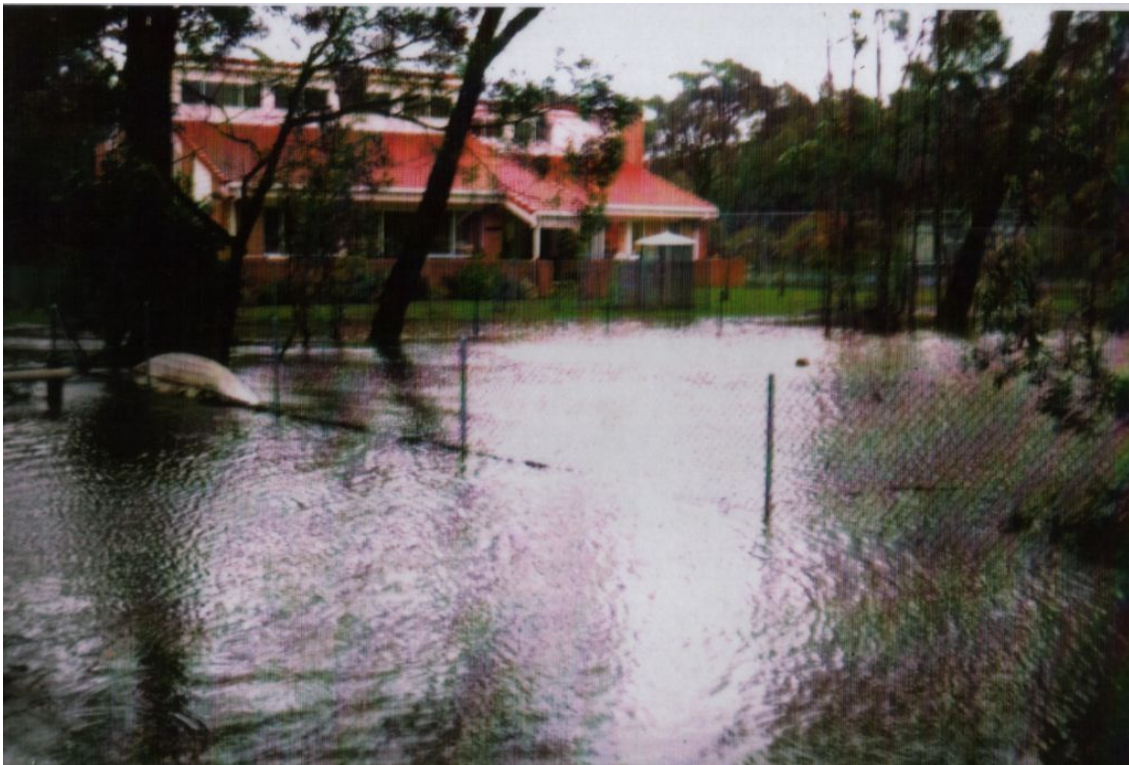
PHOTOS C-1

We understand that localised flooding of the Holiday Park occurred in October 1999 as a result of the stormwater system in Murramarang Road overflowing onto the site. From diary records prepared by Mr van Bergen, 195 mm of rain fell over the weekend prior to Monday 25 October 1999. Later on that Monday, at about 3.00 pm, approximately 100 mm of rain fell in one hour. Localised flooding occurred from 4.00 pm, and by 8.00 pm the majority of the flooding had passed. Photos taken during this event, together with a copy of Mr van Bergen's diary entry and his appraisal of the extent of localised flooding, are included in **Appendix B**. GBA understands that 100 mm of rain falling in one hour would constitute a rainfall intensity more extreme than a 1 in 100 year event in Sydney (CPAA, 1991). Whilst we have no information for the Kioloa area, a comparable recurrence could be expected. An appraisal of the contribution of elevated coastal water levels to flood egress from the park is made in **Section 6.2**.
