ARMIDALE REGIONAL LANDFILL

Environmental Assessment

**Geological report on proposed Armidale Dumaresq
Council landfill site, with emphasis on investigation of
a possible geological fault**

February, 2006

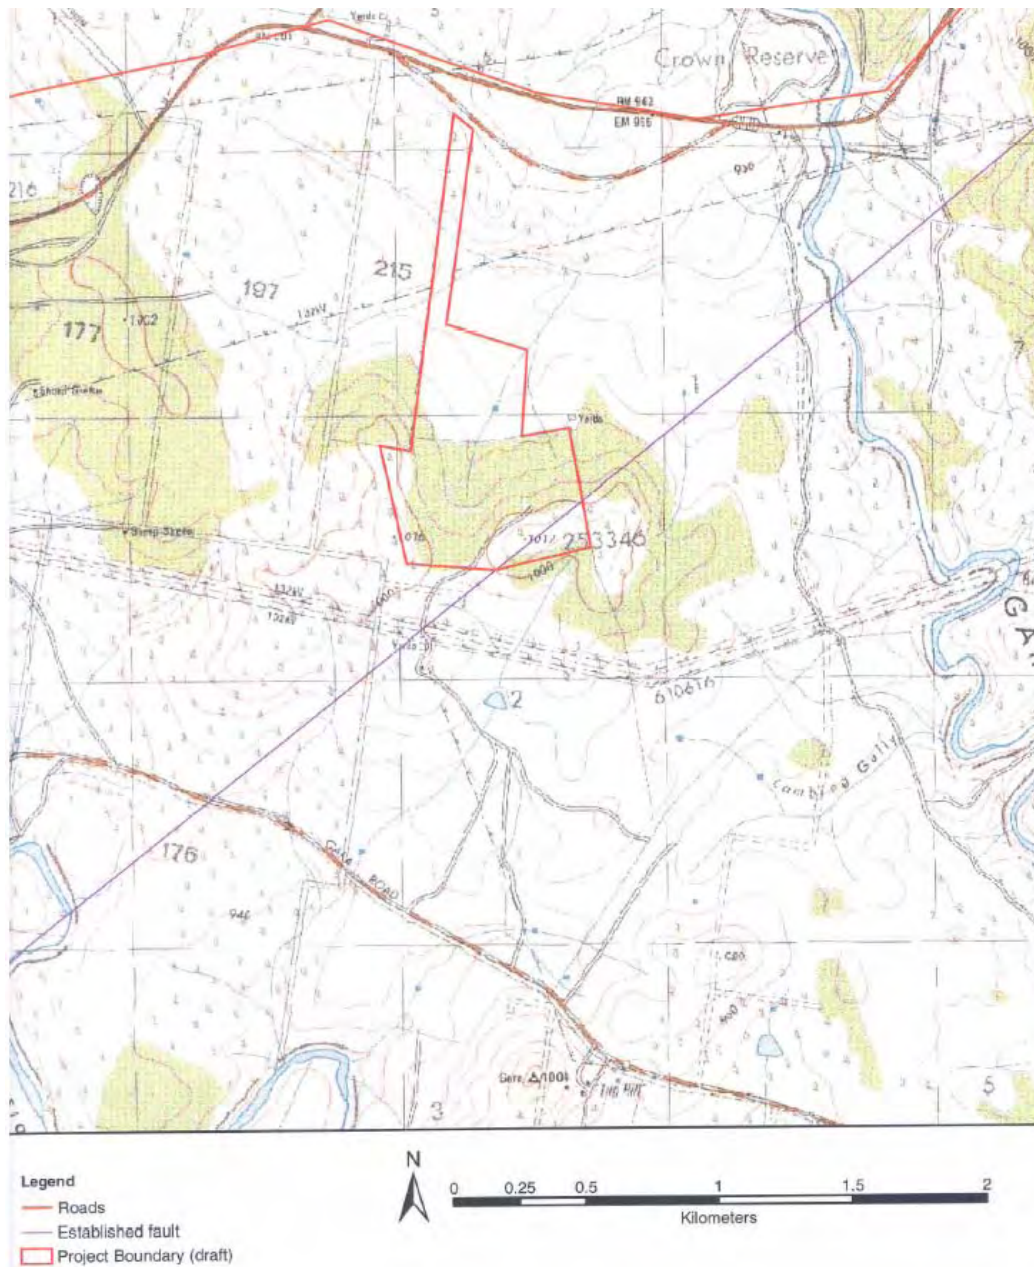
Figure 1: Portion of the Hillgrove 1:25 000 topographic map with the position of the proposed landfill site indicated by the red boundary. The projected trace of the fault indicated on the Dorrigo-Coffs Harbour 1:250 000 geological map is shown by the purple diagonal line. The term “established fault” in the legend was added by EA Systems. The term does not conform to that on the geological map which has the fault designated as “position approximate”. The road towards the northern margin of the map is the Waterfall Way.

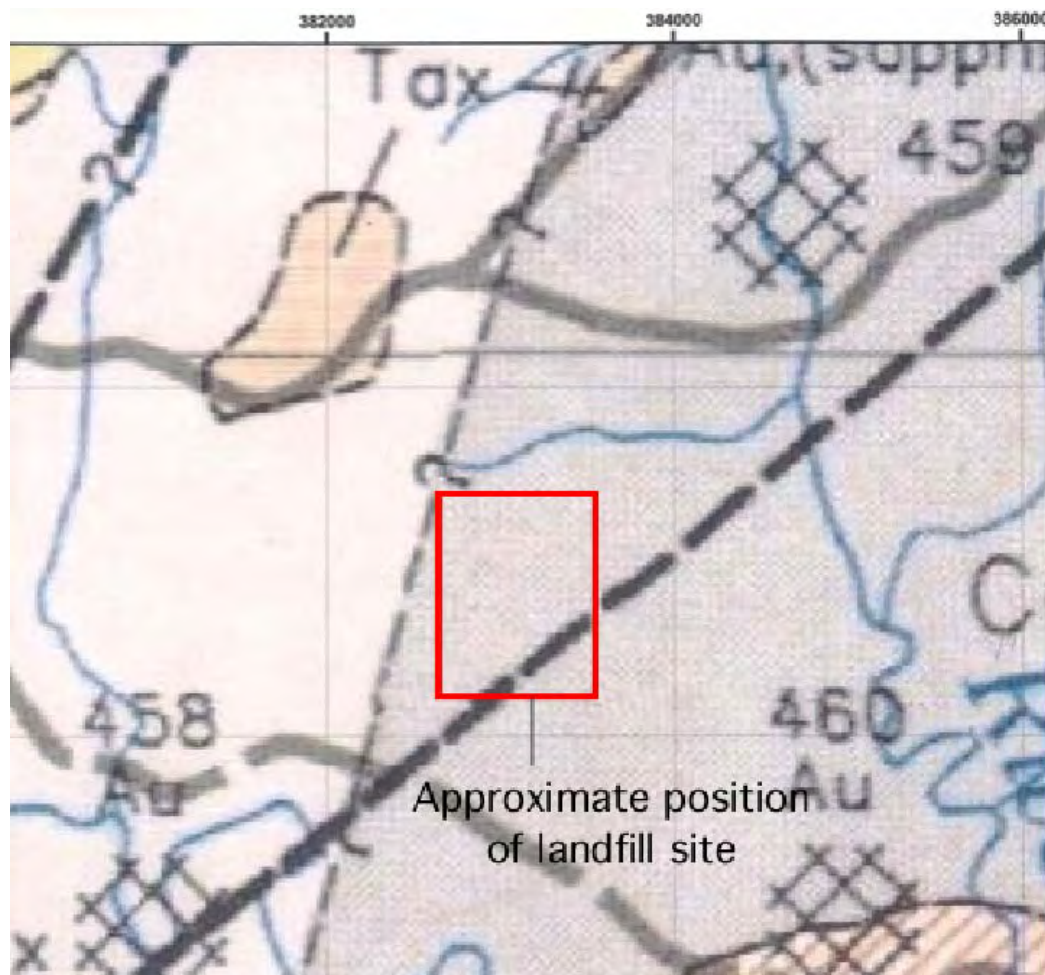
Figure 2: Portion of the Dorrig-Coffs Harbour geological map (Gilligan et al., 1992), with the approximate position of the landfill site superimposed. The fault symbol (dashed diagonal line) designates “position approximate” on the published map. The pale mauve shading is designated as Girrakool Beds on the geological map.

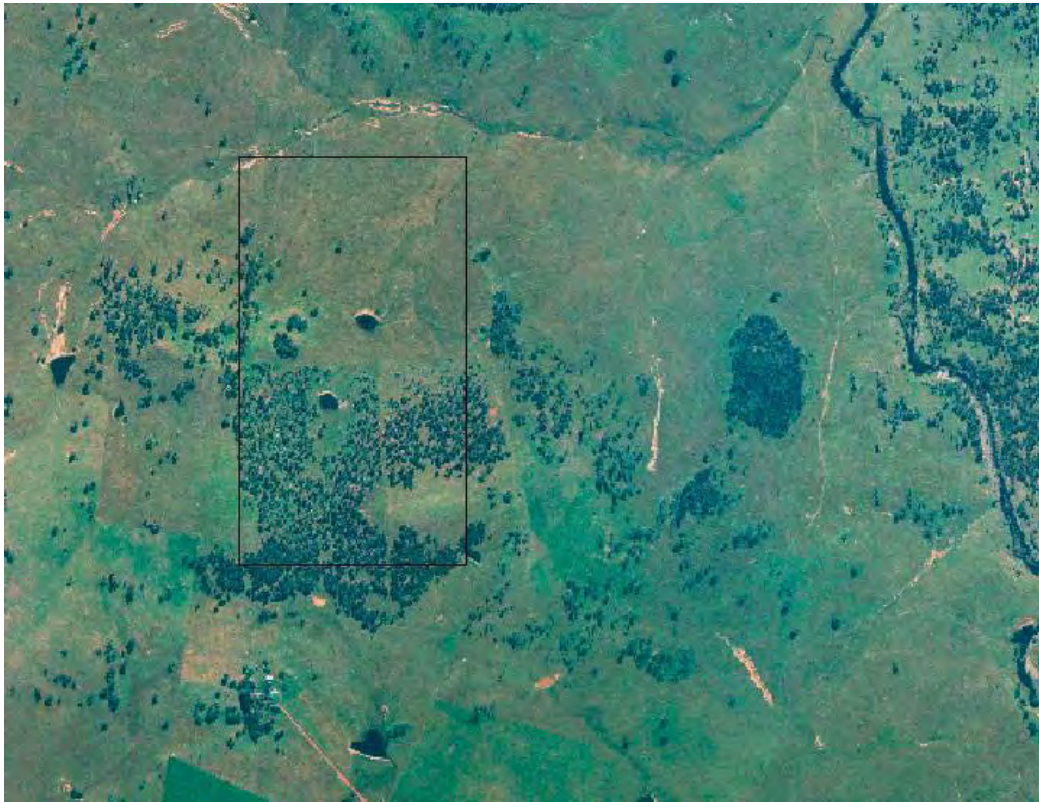
- a) air photo interpretation: no linears or other features are indicated in the topography to suggest the presence of a fault in the projected position (Fig. 3).

Figure 3: Aerial photograph of the landfill site and immediate surrounding area. The projected fault trace has been omitted, but it trends approximately northeast across the image from near the southwest corner to the northeast corner. The landfill site occupies much of the wooded area just left of centre. The image is approximately 2 km east-west. It is relevant to note that there is no topographic expression or photo-linear corresponding to the projected position of the fault.

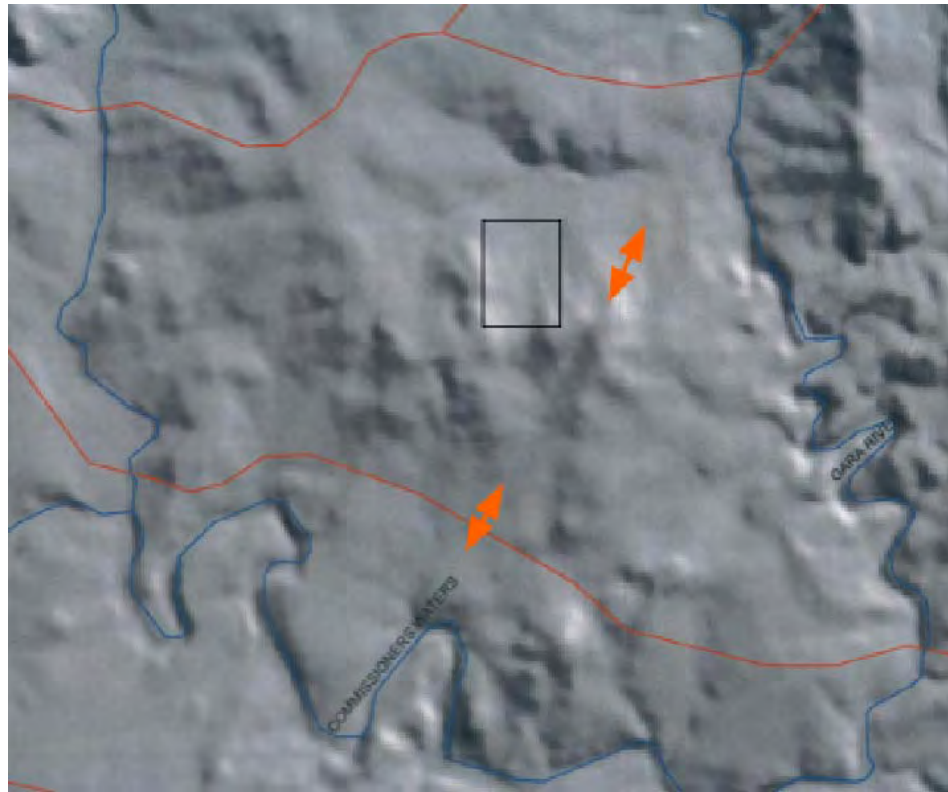
- b) Landsat TM: same result.
- c) Digital terrain model (DTM): There are no linears in the projected position or strike (050°) of the fault, although there is a single weak linear just southeast of the landfill site with a strike of 025° (Fig. 4).

Figure 4: Portion of the digital terrain model supplied by the Geological Survey of NSW, covering the area of the landfill site (shown approximately by the rectangle) and surrounds. A single weak linear (indicated by arrows) is evident to the southeast of the site, but has a strike of $\sim 025^\circ$, whereas the projected fault has a strike of $\sim 050^\circ$.

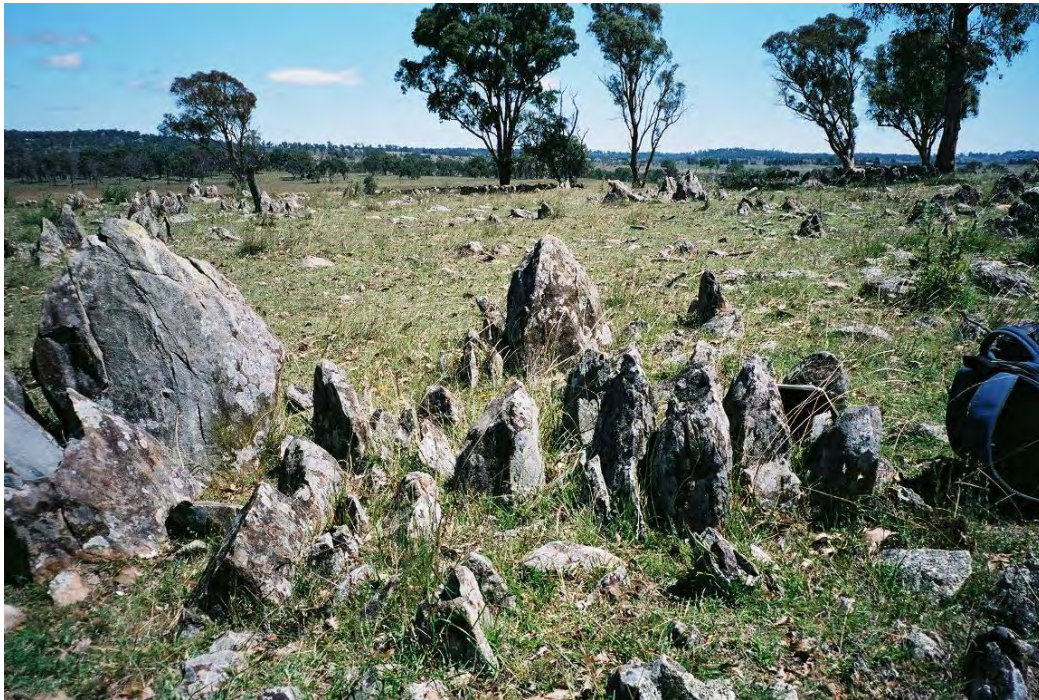
Figure 6: Weakly cleaved greywacke at grid reference 381682mE, 6617358mN. Strike of cleavage is 010°-015°M.

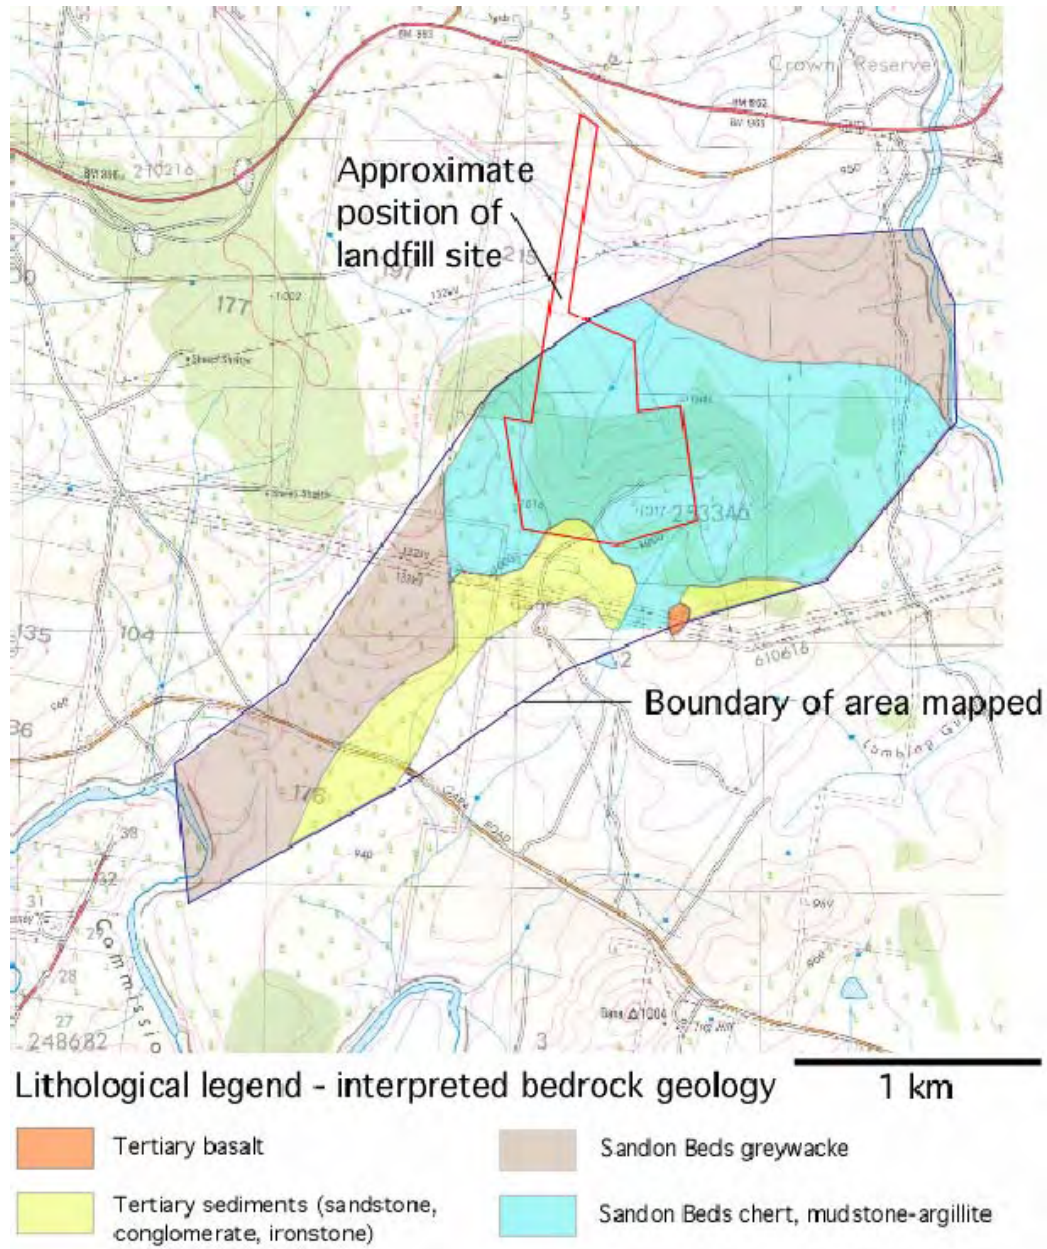
{conglomerate} and sandstone, along with a few masses of ferruginous cemented transported regolith (Figs 7, 9). These sedimentary materials appear to form only a thin, discontinuous veneer (up to a few metres thick) resting unconformably on the Sandon Beds. They probably represent remnants of former fluvial deposits. Closely associated with the Tertiary sediments about 0.5 km east of the Crisp homestead, there is a small (50-100 m diameter) mass of Tertiary basalt (Fig. 7), perhaps representing an erosional remnant of a lava flow or small intrusion.

Figure 7: Bedrock geology (rock types) interpreted from reconnaissance mapping, including the area of the landfill site.

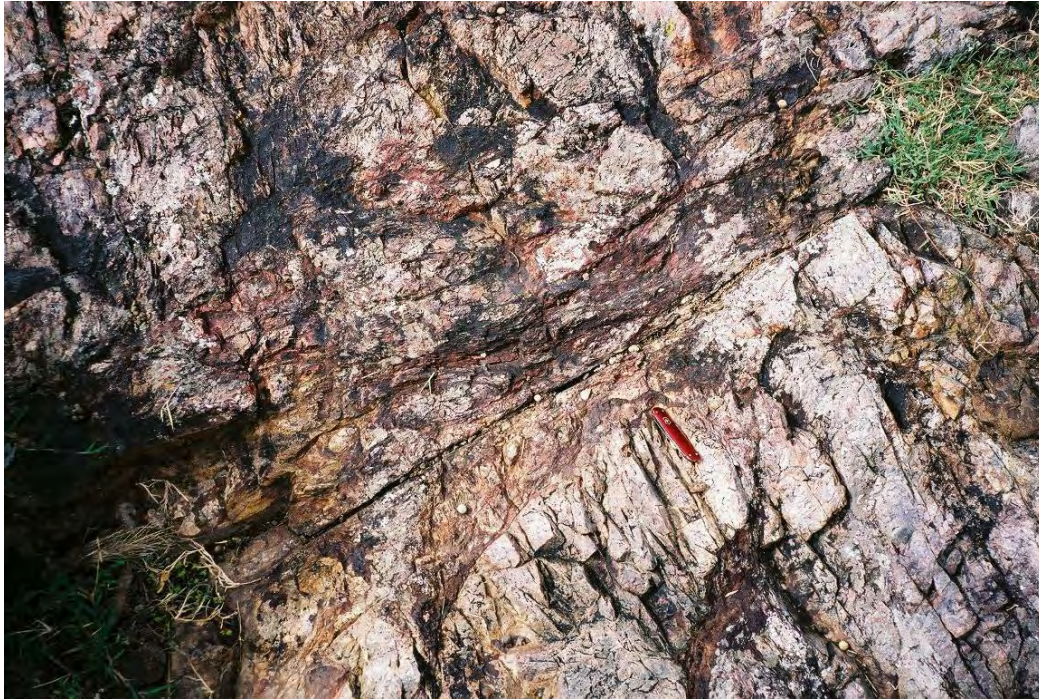
Figure 8: Fractured chert, with associated sheared zone in cherty mudstone (centre) at grid reference 383750mE, 6618650mN. Strike of foliation is 060°M.

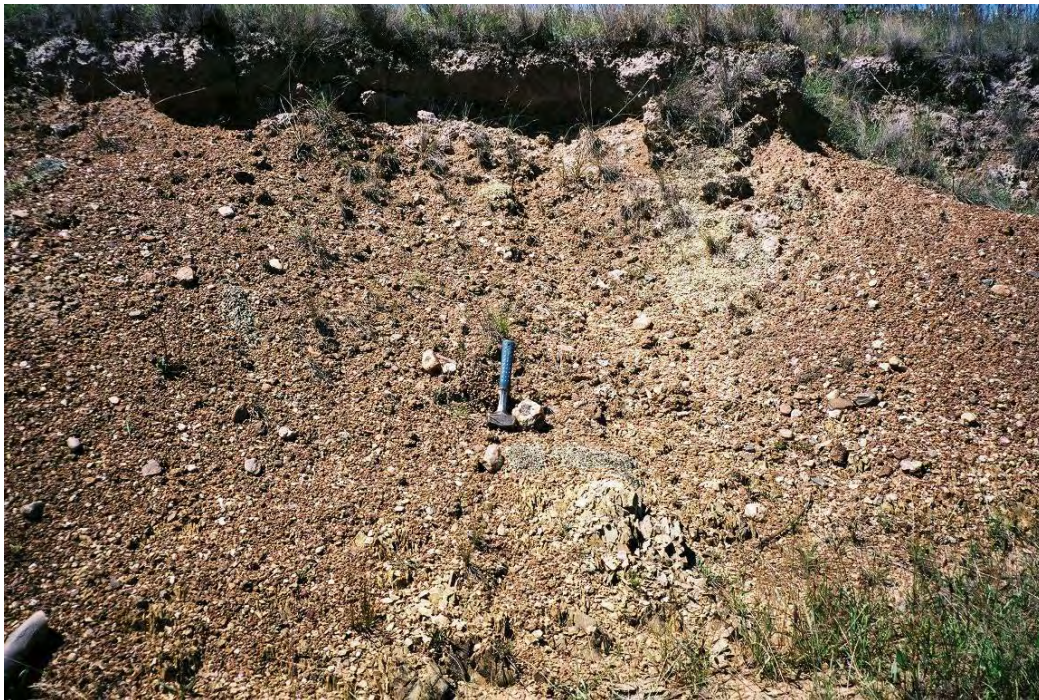
Figure 9: Cleaved greywacke-siltstone (bottom of image) overlain by transported Tertiary gravel and ironstone regolith at grid reference 382206mE, 6617524mN. Strike of foliation in bedrock is 020°M.

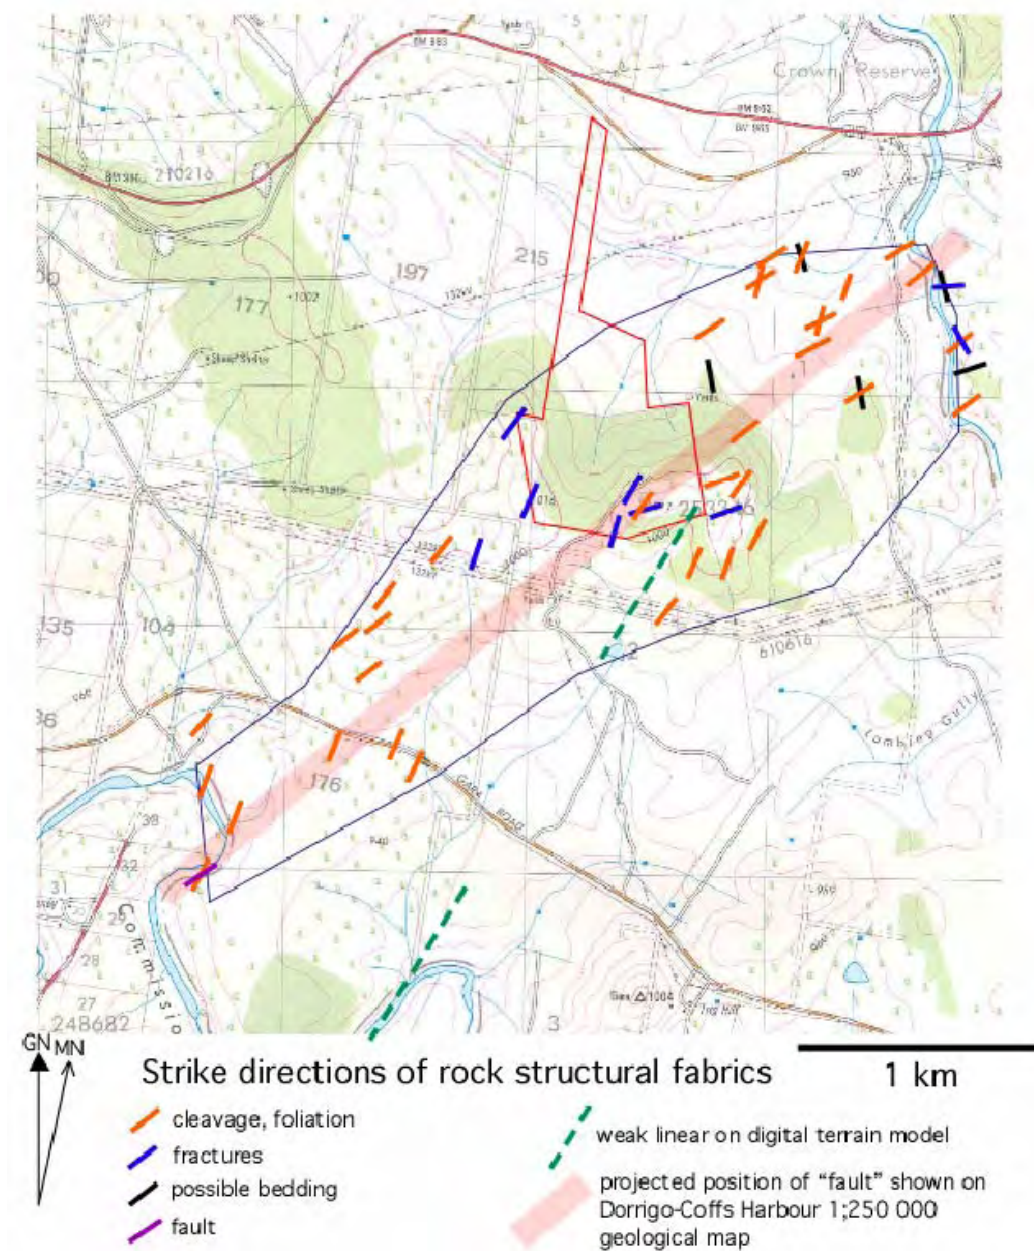
Figure 11: Strike directions of rock structural fabrics (cleavage, foliation, fractures, bedding, fault) in the area mapped (blue boundary). Also displayed are the weak linear from the digital terrain model (see Fig. 4), the projected position of the "fault" shown on the Dorrigo-Coffs Harbour 1:250 000 geological map and the approximate position of the landfill site (red boundary).
