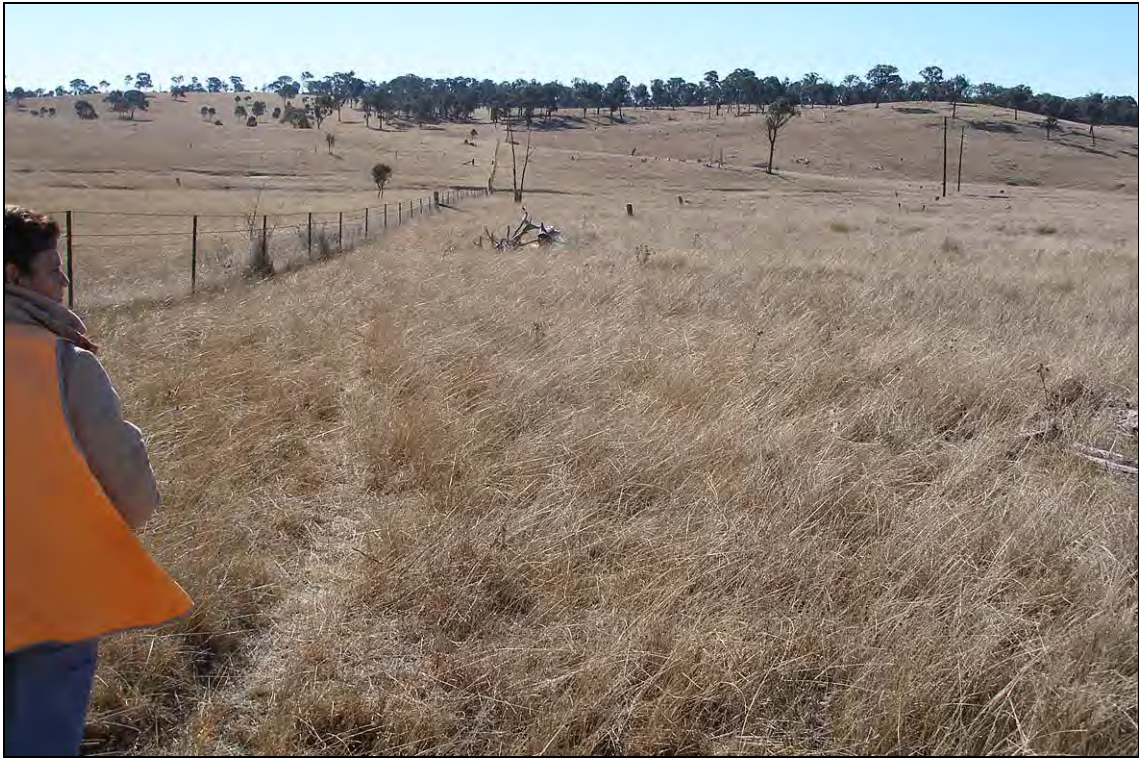
Figure 10 – Looking northwards along the road corridor from the southern end.

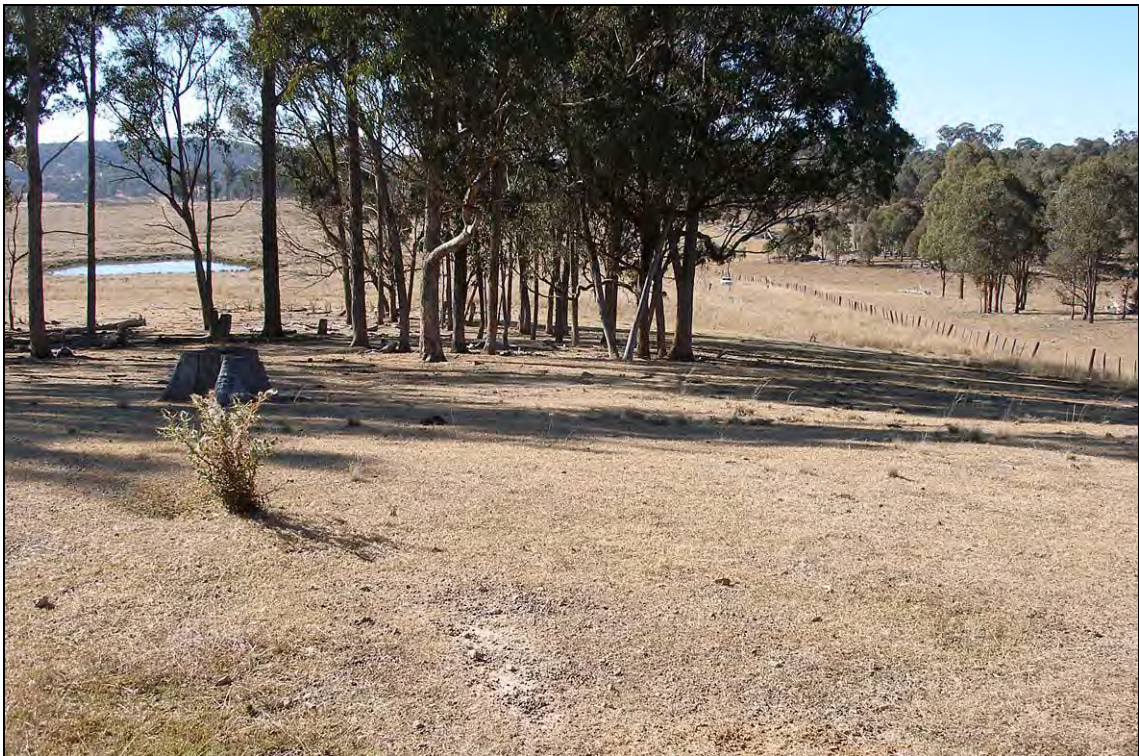
Figure 11 – Looking eastwards across the centre of the landfill site from the western boundary on "Edington".
