**PHOTOGRAPHIC PLATE No. 6**: Existing path entry into SEPP 26 Rainforest

PROJECT NO:	4898	DRAWING TITLE:	EXHIBIT PA06: RAINFOREST BOARDWALK - SHEET 2			
	DA NO.:	-	DRAWING TILE:				
	DESIGNED BY:	DAT	· PROJECT:	LOT 4 DP 615261 & LOT 1 DP 374315			
	DRAWN BY:	PH		OCEAN DRIVE, LAKE CATHIE			
	CHECKED BY:	DAT	CLIENT:	SEAWIDE PTY LTD & MILLAND PTY LTD	DRAWING NO:	SHEET:	REVISIO
	DATE CREATED:	JULY 2010			14898_Exhibit_6_PA_Rainforest_Walk_Sh2.psd	1	А

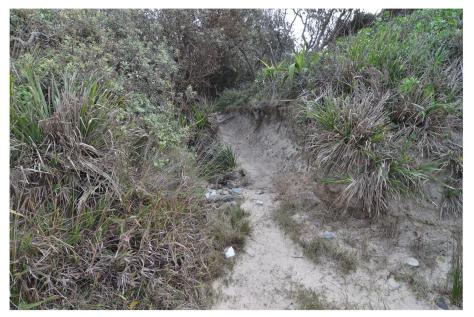
PHOTOGRAPHIC PLATE No. 1: Path access at beach. Some minor bank stabalisation required using Treemax Recover™ or equivalent and planting in accordance with Vegetation Management Plan (VMP)

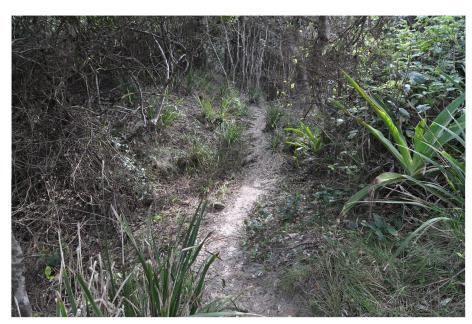
PHOTOGRAPHIC PLATE No. 2: Access path across gully. Boardwalk to board and chain accessway will transition at base of photo

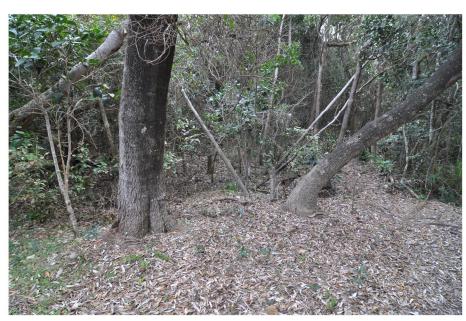
PHOTOGRAPHIC PLATE No. 3: Existing eroded minor gully to be rehabilitated - refer to Vegetation Management Plan (VMP)
