© King & Campbell Pty Ltd				14898_Exhibit_6_PA_Rainforest_Walk_Sh2.psd	1	A

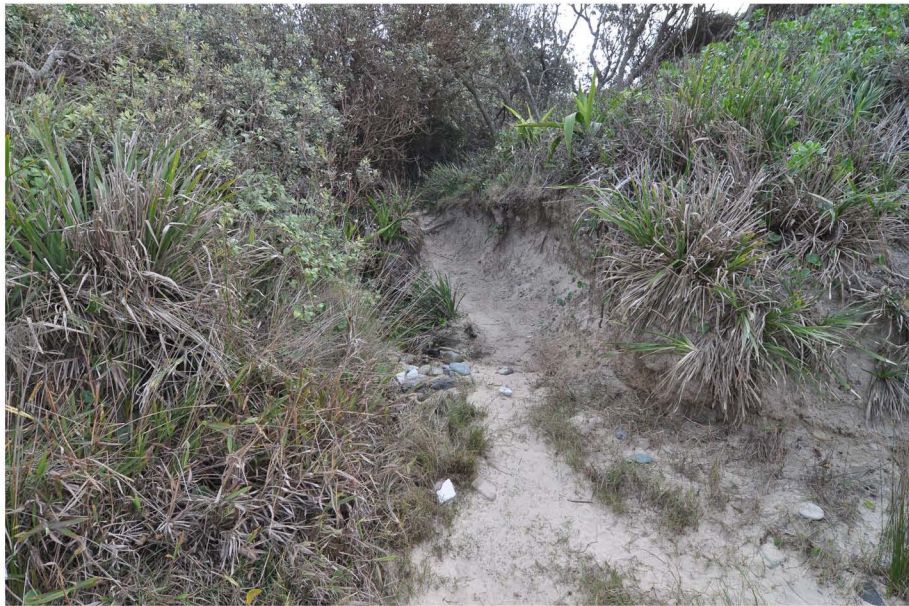
PHOTOGRAPHIC PLATE No. 1: Path access at beach. Some minor bank stabilisation required using Treemax Recover™ or equivalent and planting in accordance with Vegetation Management Plan (VMP)

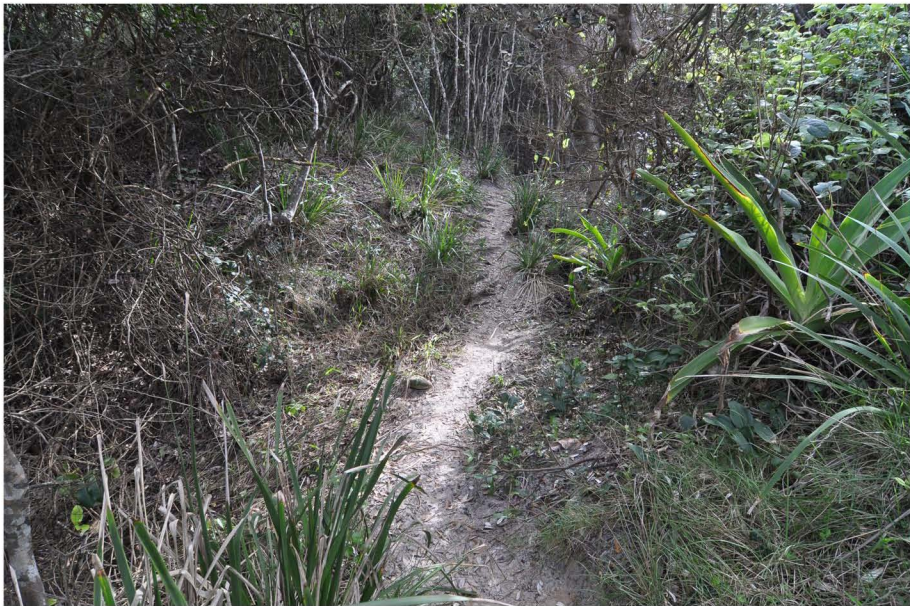
PHOTOGRAPHIC PLATE No. 2: Access path across gully. Boardwalk to board and chain accessway will transition at base of photo

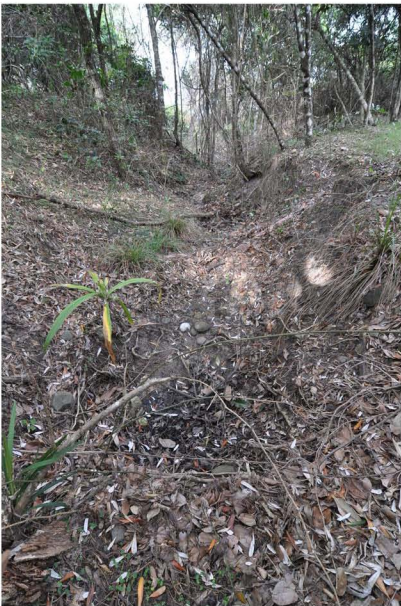
PHOTOGRAPHIC PLATE No. 3: Existing eroded minor gully to be rehabilitated - refer to Vegetation Management Plan (VMP)

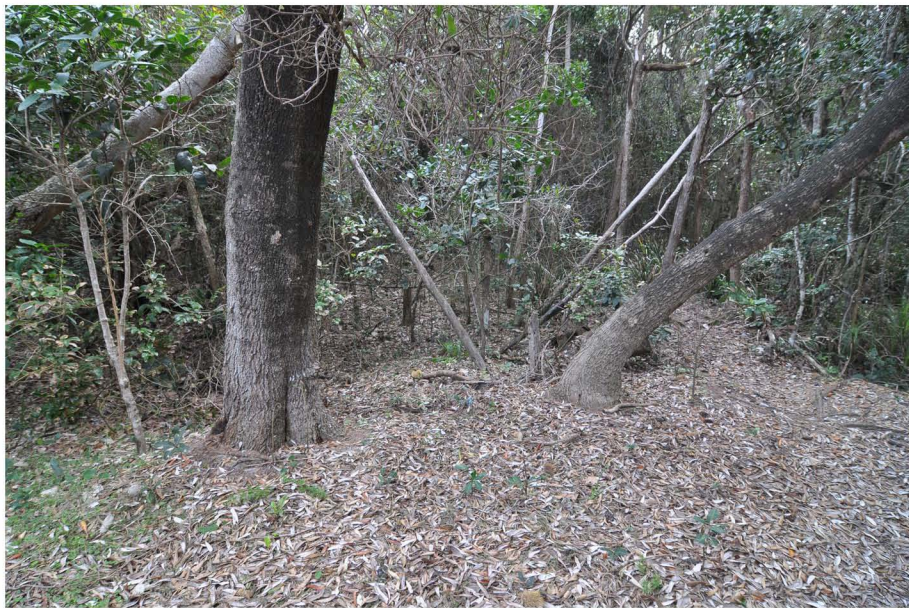
PHOTOGRAPHIC PLATE No. 4: Boardwalk to be aligned carefully between these two trees

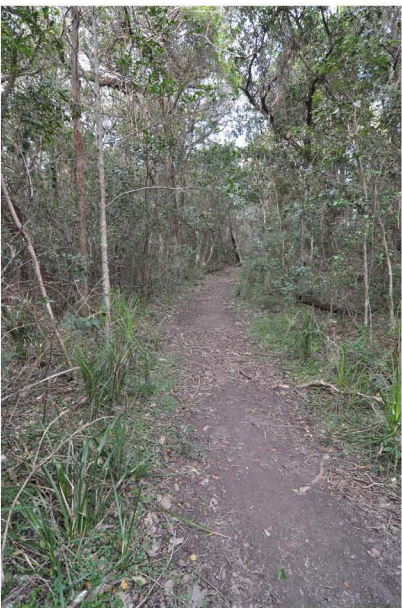
PHOTOGRAPHIC PLATE No. 5: Typical character and width of existing path access. The boardwalk is to be aligned along the path

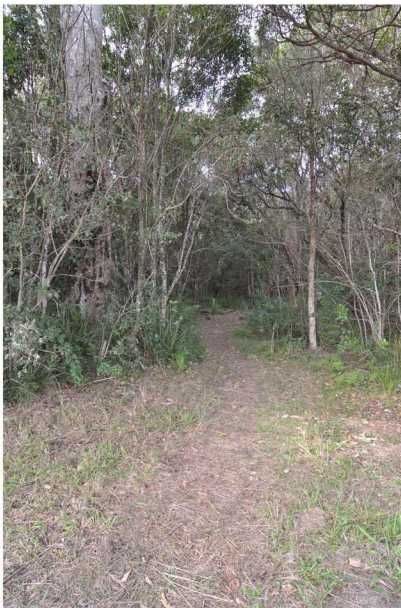
PHOTOGRAPHIC PLATE No. 6: Existing path entry into SEPP 26 Rainforest
