# **Pacific Highway Upgrade Nambucca Heads to Urunga Operational Phase**

## **Threatened Flora Monitoring Annual Report Year 4 – 2020/21**

Transport for NSW | 09 February 2021 | Final Report

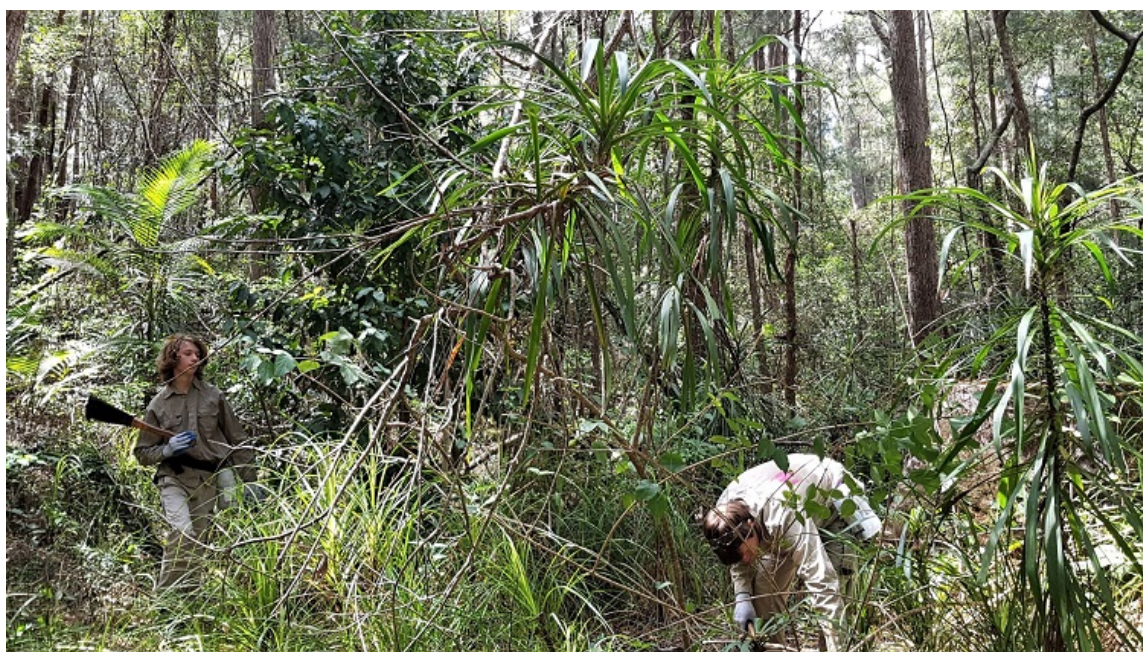
Figure 4: Bush regeneration team cutting and painting Lantana. Large translocated Rusty Plum in background.

The first weed treatment at TA1 was performed on 25<sup>th</sup> November 2020 by New Earth Regeneration (three personnel). Treatment involved hand removal and cut and paint of Lantana plants (Figure 4) and targeted spot-spraying of Broad-leaved Paspalum (Figure 5) in the vicinity of the Rusty Plum translocations and enhancement plantings.

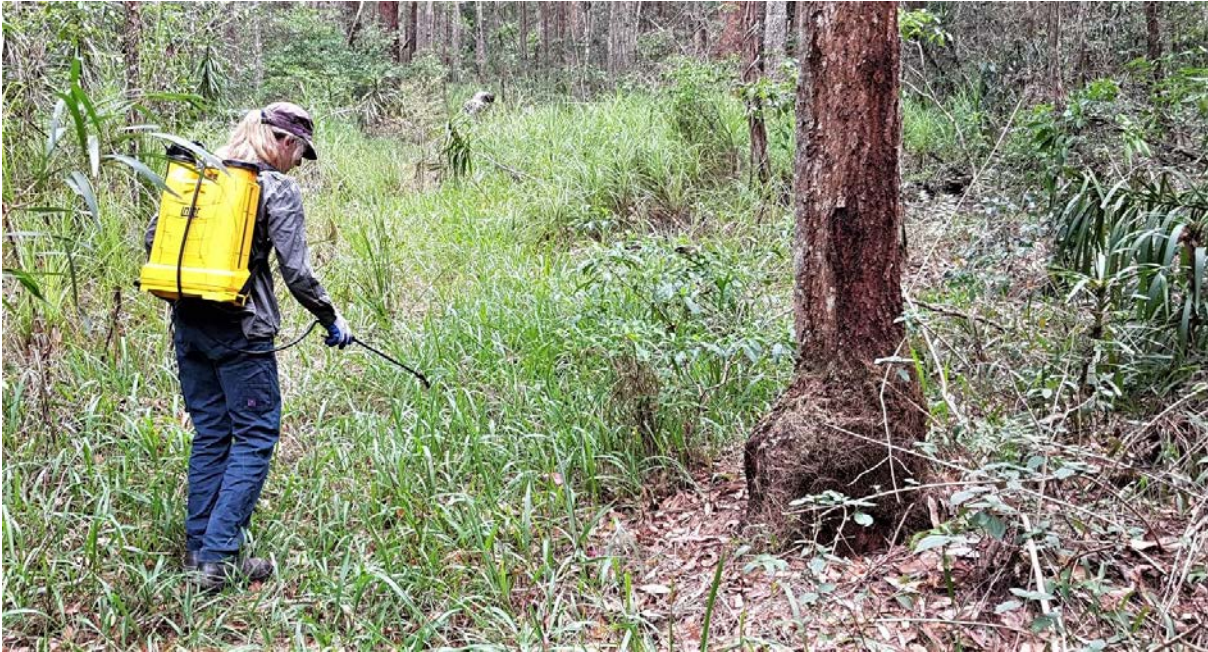
Figure 5: Spot-spraying of Broad-leaved Paspalum in TA1.

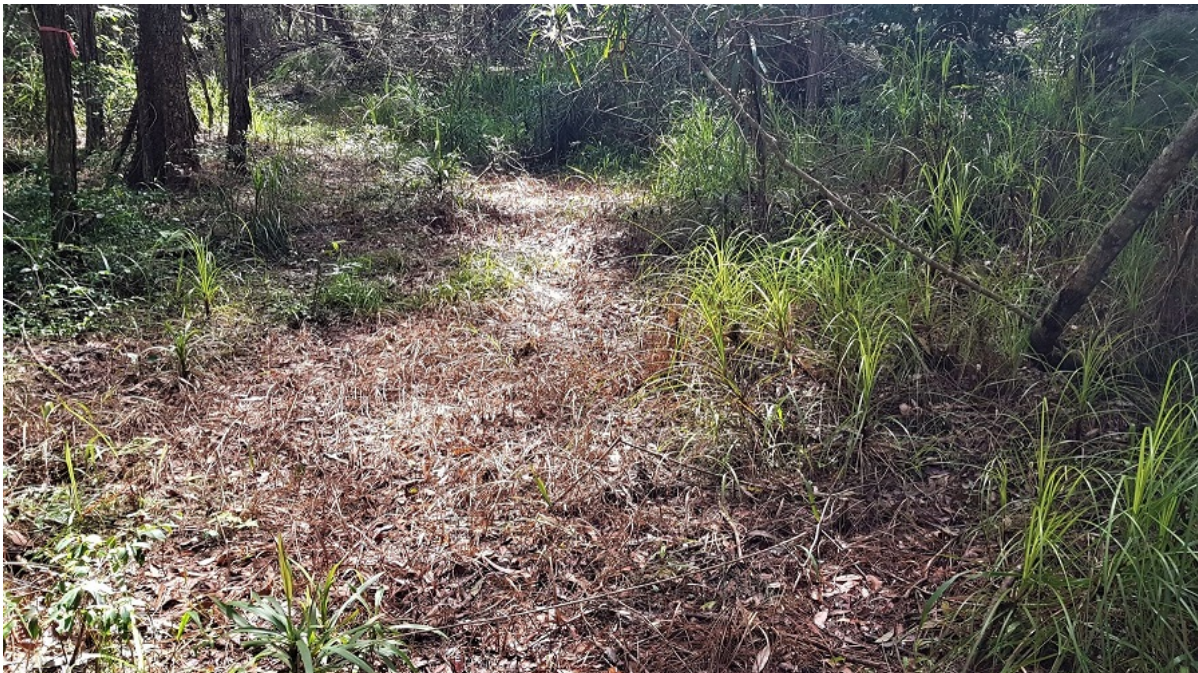
An inspection of the treatment area on 3<sup>rd</sup> January 2021 revealed significant reduction in weed cover and minimal impact upon native recruitment into the site (Figure 6).

Figure 6: Post-treatment image taken 3<sup>rd</sup> Jan 2021 of area treated for Broad-leaved Paspalum 25<sup>th</sup> Nov 2020.

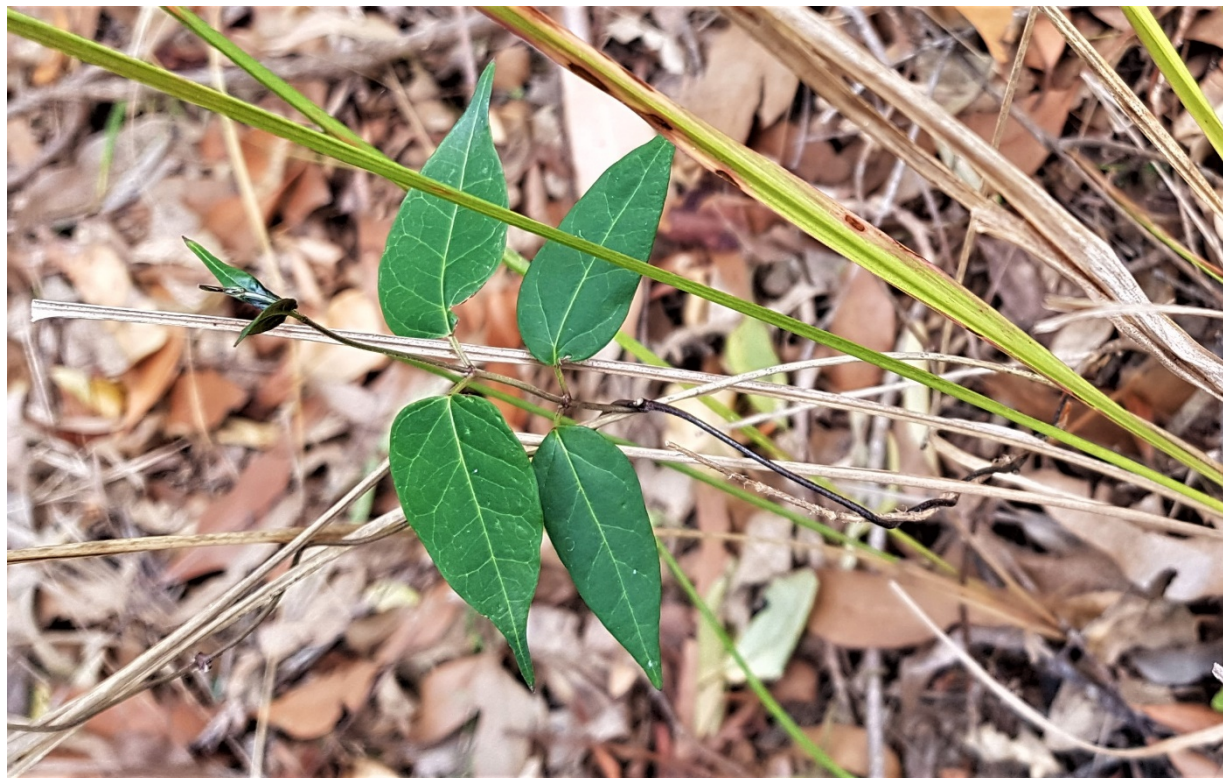
Appendix 1 provides full details of the results of the NH2U Year 4 monitoring of *in situ* Slender Marsdenia. Of the five *in situ* Slender Marsdenia plants being monitored, one (ML119) has now been recorded as died back for four consecutive years. Of the remaining sites, the plants near Martells Road (2010-1 and 2010-3) supported healthy plants, with a condition class of 3. Plants at site UTW3 remained in only fair condition, whilst plants at site UTW4 (Figure 9), had declined in condition.

Figure 9: *In situ* Slender Marsdenia UTW4 in Jan 2021.

Slender Marsdenia currently meets 2 of 3 performance indicators for *in situ* flora. There was a decline in condition of some plants resulting in a median condition class of 2. This is probably a result of the past three seasons of hot dry weather having a significant impact, in particular, on the plants UTW3 and UTW4, which occur on a much drier site than is typical for Slender Marsdenia.

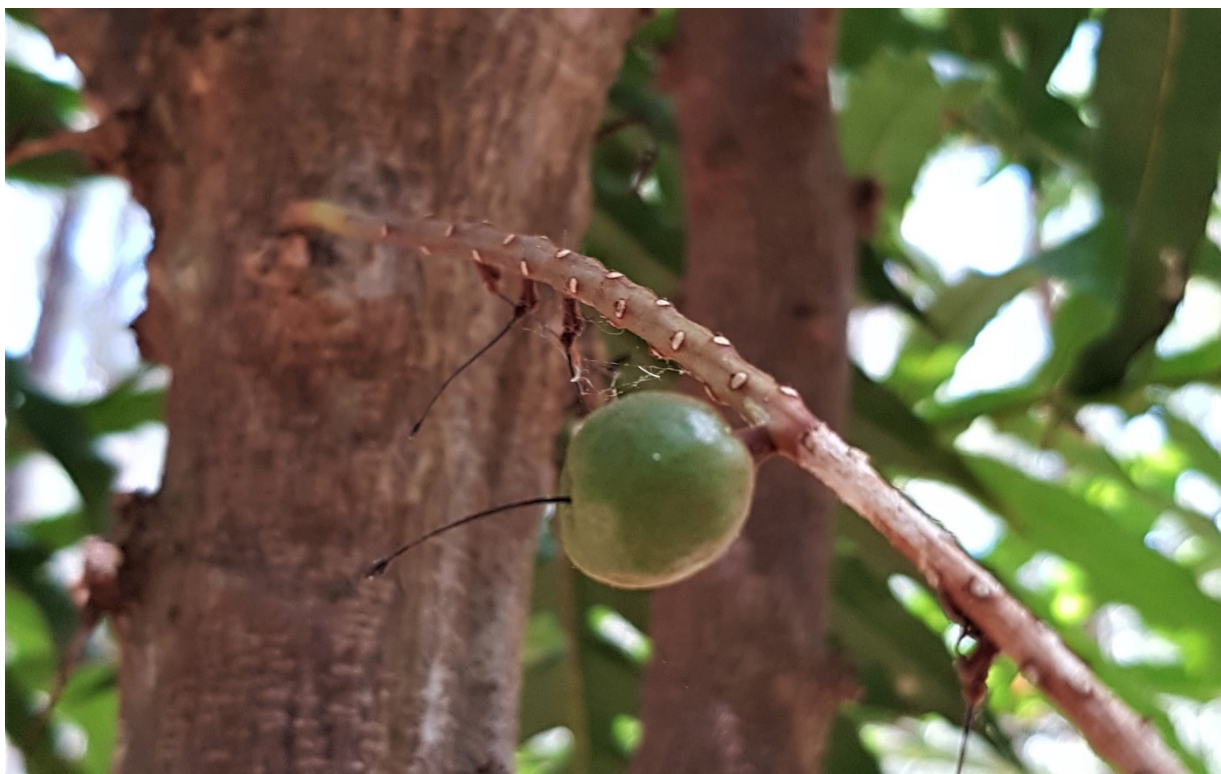
A single Red Bopple Nut tree was transplanted to Sector H in TA1. The tree was recorded in excellent condition during the current survey. Flowering had occurred, with several developing fruits observed (Figure 11).

Figure 11: One of several immature fruits observed on Red Bopple Nut transplant in TA1 Nov 2021

The single translocated Red Bopple Nut tree is in excellent condition, flowering and sparse fruiting occurring in spring 2020. It is expected that this specimen will meet ongoing performance criteria.
