**INVINCIBLE SOUTHERN EXTENSION PROJECT - BLASTING
IMPACT ASSESSMENT**

REPORT NO. UM-1606-150916

**Thomas Lewandowski
15th September 2016**

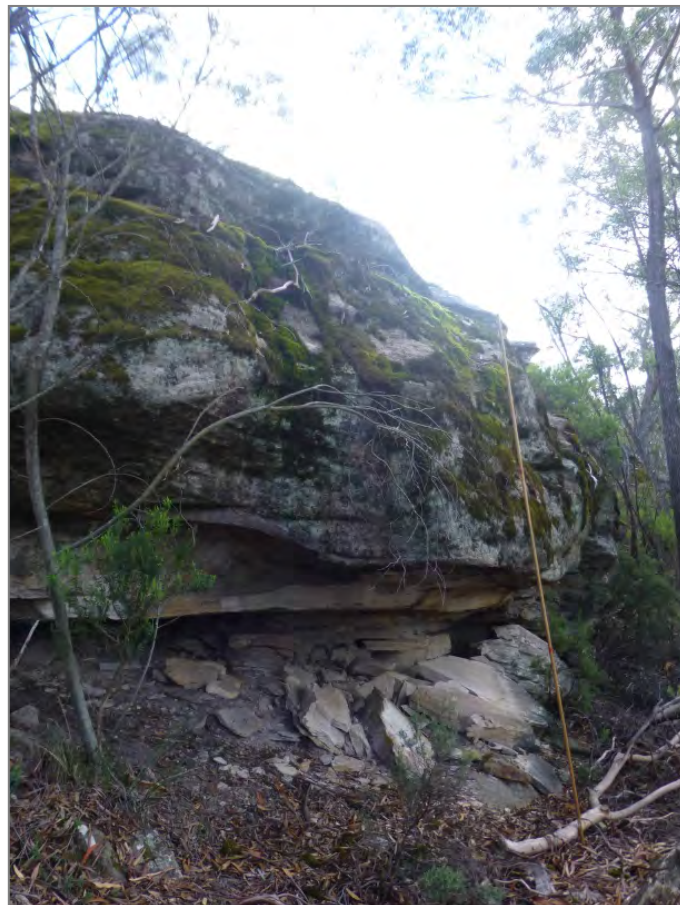
Figure 2A - Recessive Band

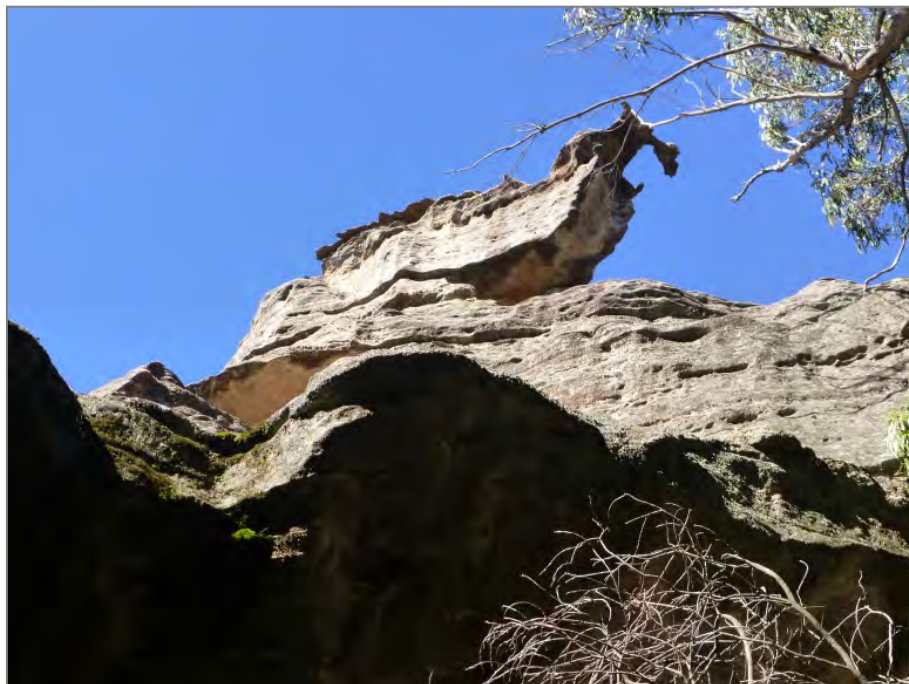
Figure 2D - Top Feature

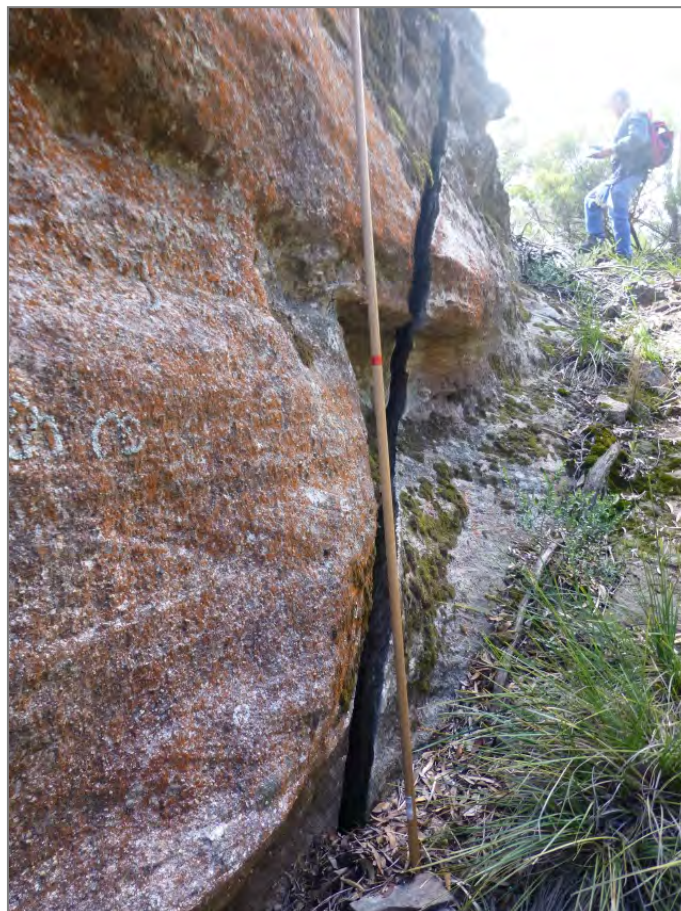
The man-induced cracks, such as those due to surface subsidence, usually exhibit a certain pattern, such as a number of parallel cracks or a semi-circular pattern due to, for example, the sliding motion of the slope.

Overall, see Lewandowski (1996), it should be noted that one-off crack occurrences within a pagoda structure do not have any significant influence on the overall stability of the structure. Also, it is concluded that due to the limited number of these cracks the impact of blasting should not have a significant effect, nor provide any additional risks (besides the ongoing natural erosion factors), to the pagodas when exposed to controlled blasting from the adjacent mine.

Figure 2E - Major Crack – 8 cm wide

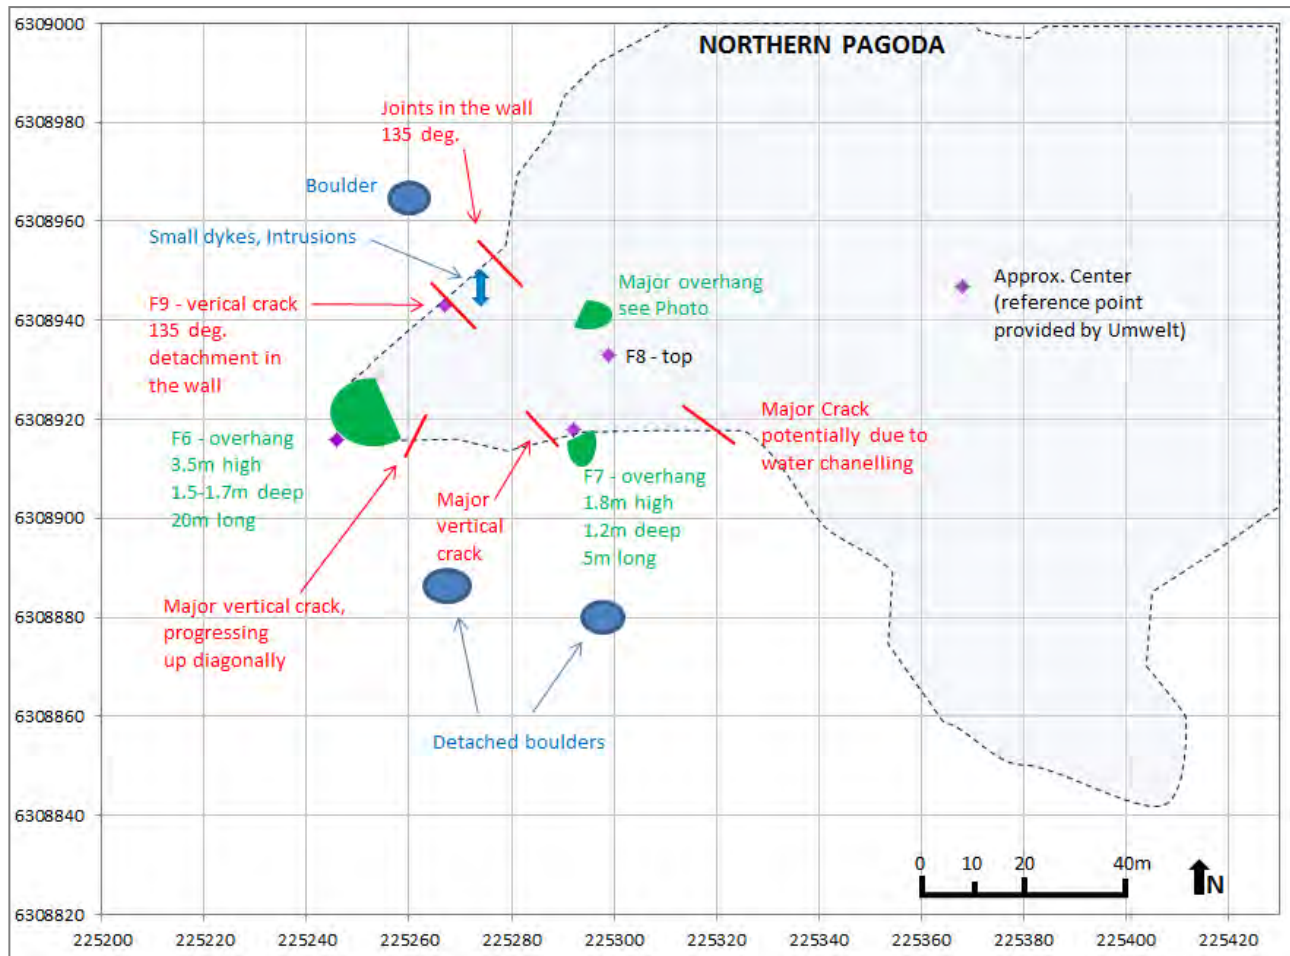
Overall, it has been concluded that due to the limited number of cracks / defects the impact of blasting should not have a significant effect, nor provide any additional risks (besides the ongoing natural erosion factors), to the pagodas when exposed to controlled blasting from the adjacent mine.

The assessed section of the Northern Pagodas formation appears to be structurally sound with a limited number of defects identified (as specified above).

Figure 5 – Survey of the Northern Pagoda

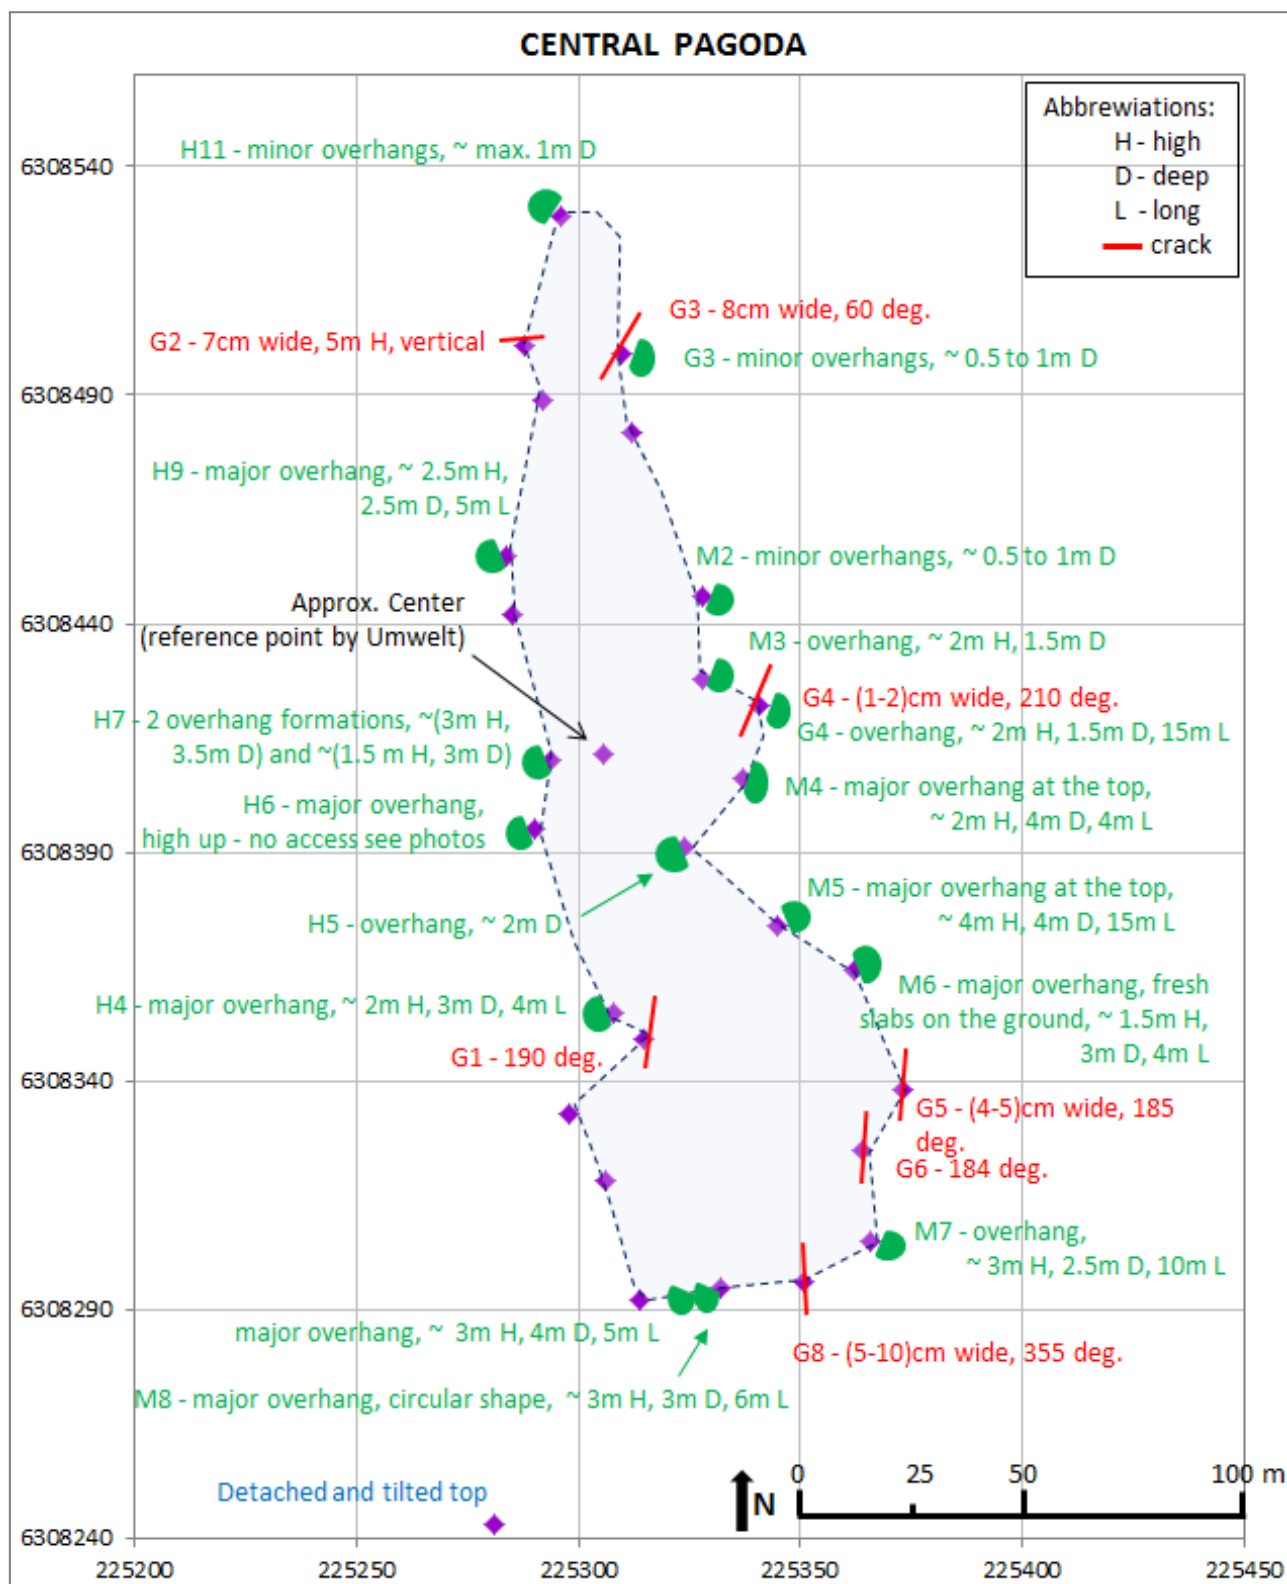
The assessed Central Pagodas formation appears to be structurally sound with a limited number of defects identified (as specified above).

Figure 6 – Survey of the Central Pagoda

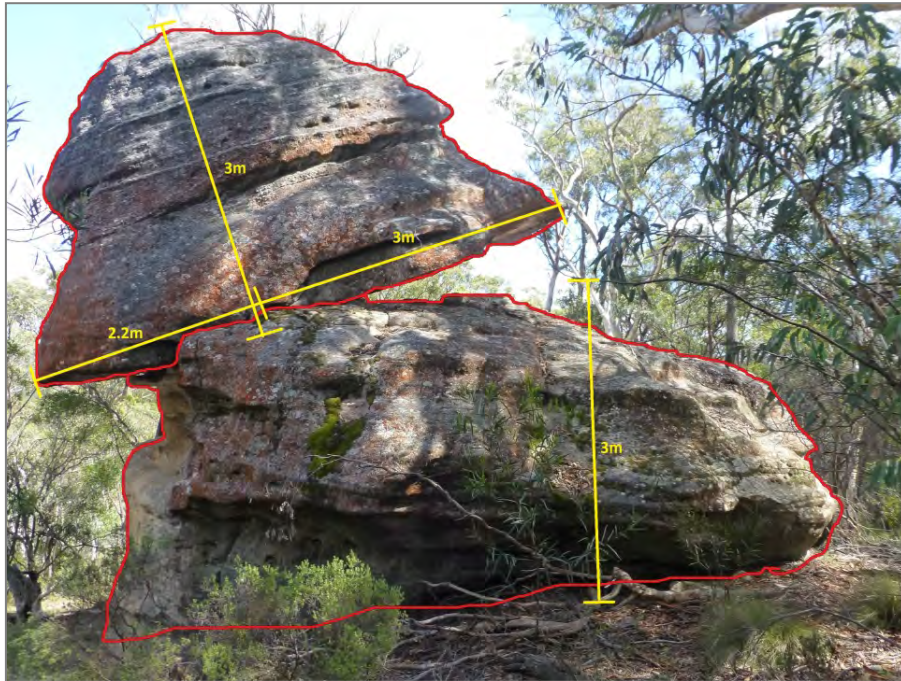
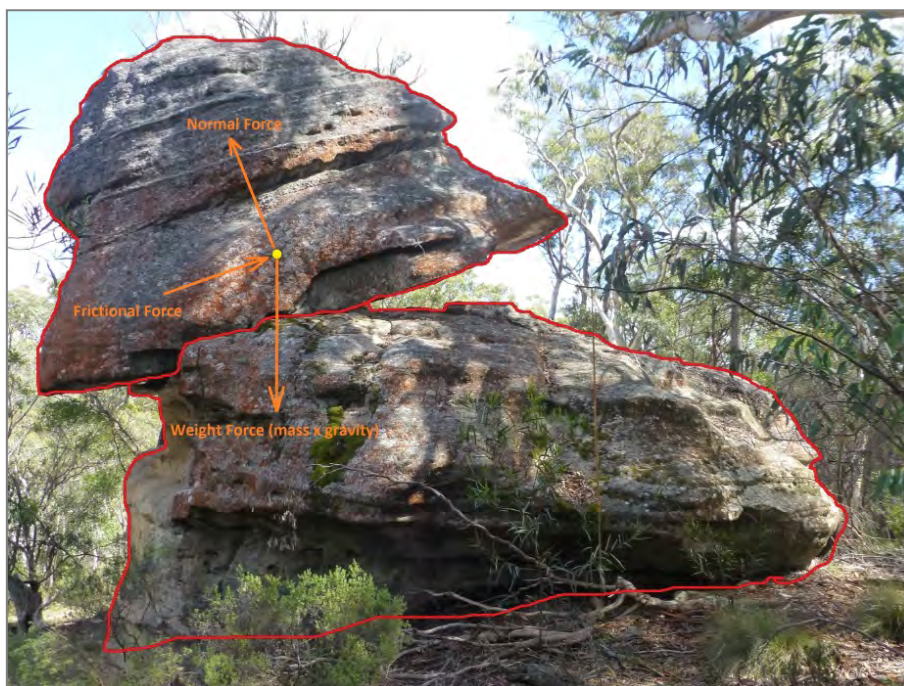
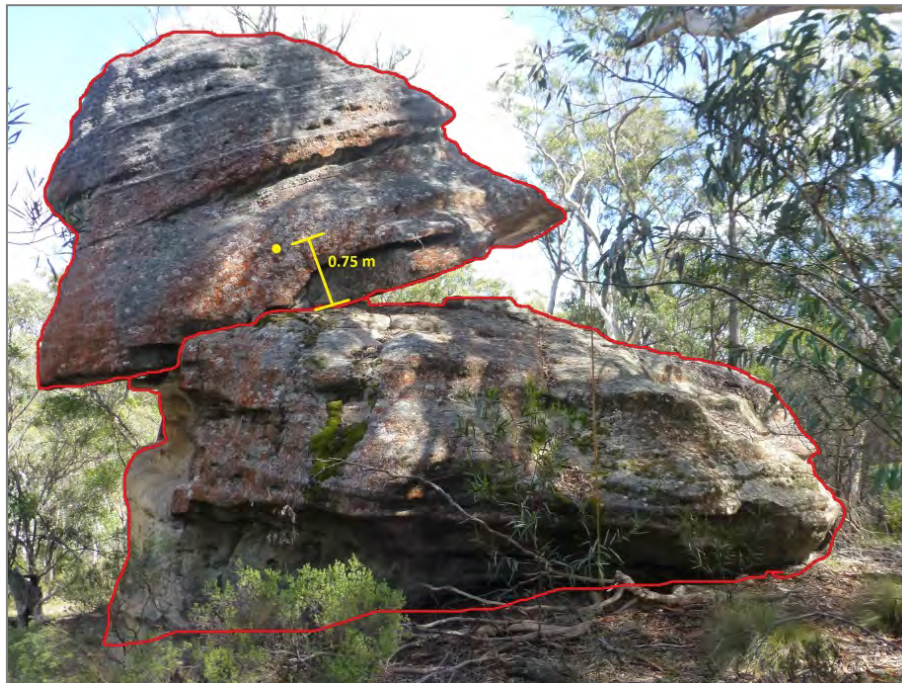
Taking into consideration blasting impacts such as those generated by 25 mm/s or even 50 mm/s, the induced displacement is no higher than 1 to 2 mm (i.e. dynamic displacement). Therefore, the detached cone will not be sufficiently displaced to shift the cone to be in the danger zone (i.e. to be on the edge of the base), that it can tilt over.

In addition, the analysis assumes the “worst case scenario” that during the moment of actual vibration the resistance force is almost minimal and all induced displacement by the vibration forces is transferred directly to the detached cone. In reality however this is not the case.

Figure 7A – Degraded Pagoda

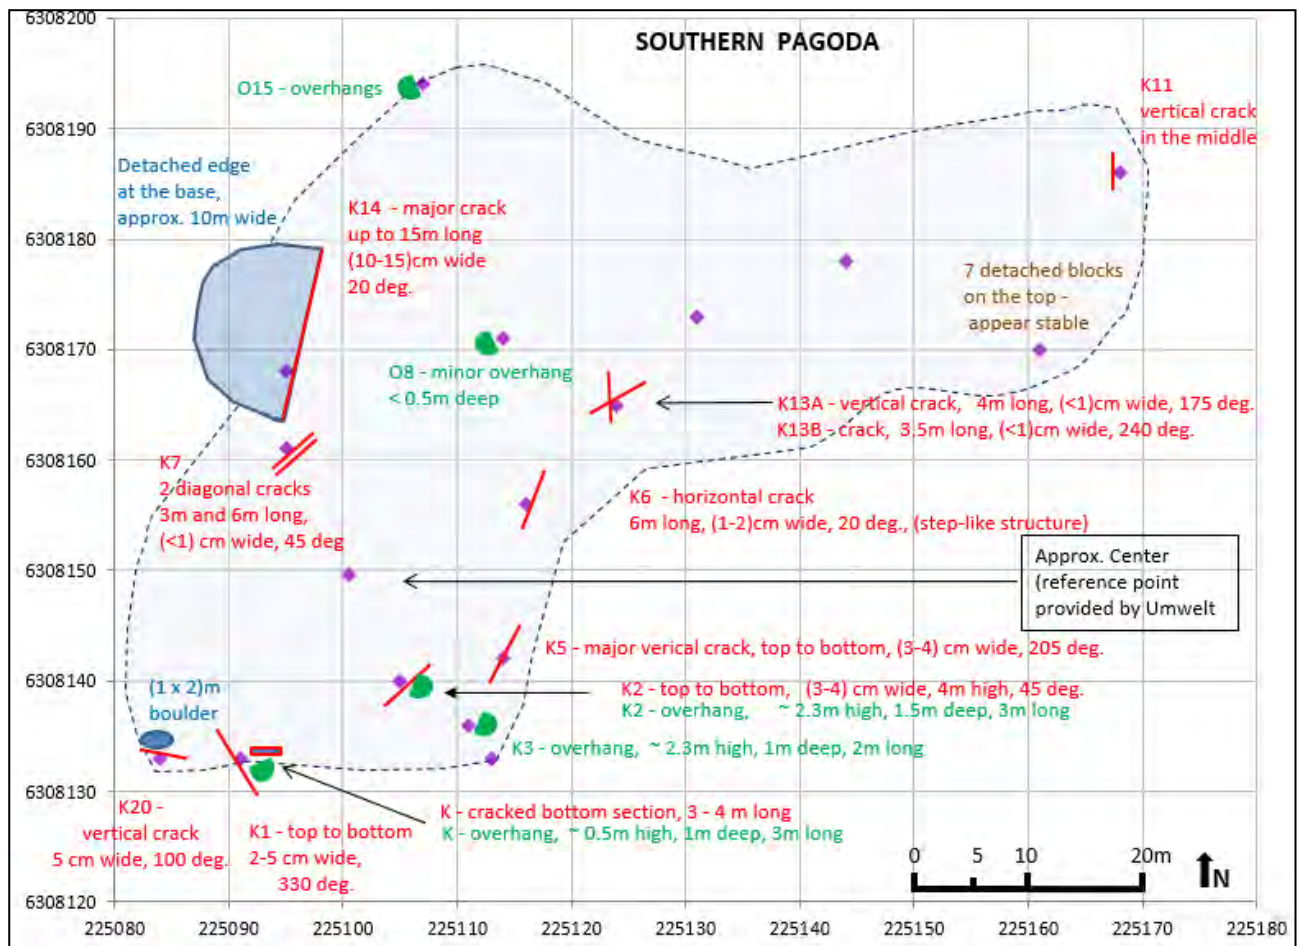
The inspection identified two sections with some defects / damage. This included the south-west corner with a detached boulder on top and a cracked corner section. There is also a detached ledge on the western side with a major crack splitting it from the pagoda section. The detached ledge appears to be displaced by localised ground instability. It is unlikely that this was caused by underground subsidence, but more likely by a localised issue.

The extent of the damage in both cases appears to be limited. The damage does not seem to be recent and does not appear to be continuing. The other sectors appear structurally sound.

Figure 8 – Survey of the Southern Pagoda

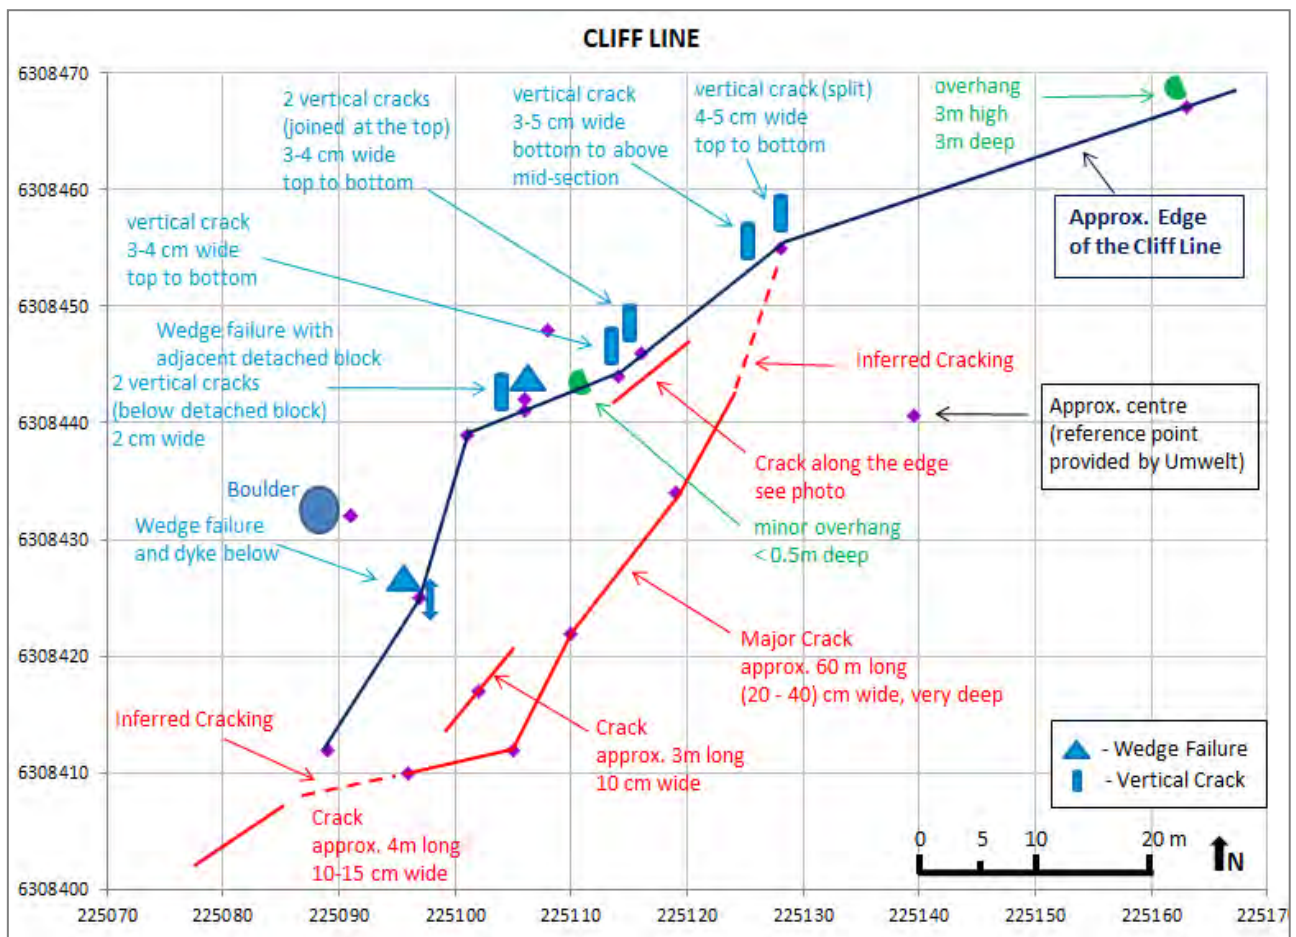
In summary, the structure is described as a major vertical wall of 8 – 14 m high. One section of the Cliff Line appears to be heavily damaged by inferred surface subsidence from previous underground operations. The extent of the damage for the affected area is classified as significant, showing signs of slope sliding. The damage occurred at some time in the past and does not appear to be actively continuing. The remaining section appears structurally sound.

Figure 9B – Survey of the Cliff Line

This includes periodic vibration monitoring of the Sandstone Pagodas and Cliff Line, including crack behaviour monitoring and surveys of the area, in particular of the damaged section of the Cliff Line (caused by inferred surface subsidence) which will be required when blasting is within a 500 metre radius of these sites.
