**Re: Royal Rehabilitation Centre, Sydney –
Issue with retention of Tree 43.**

As discussed with you recently in May this year, there is some confusion as to whether a large *Eucalyptus saligna* [Sydney Blue Gum] ("the tree") located near the southeast corner of the grounds of the Royal Rehabilitation Centre ("the site") is to be retained or removed. The tree is identified as Tree 43 in a report prepared by Urban Forestry Australia in October 2007 ("the 2007 report").

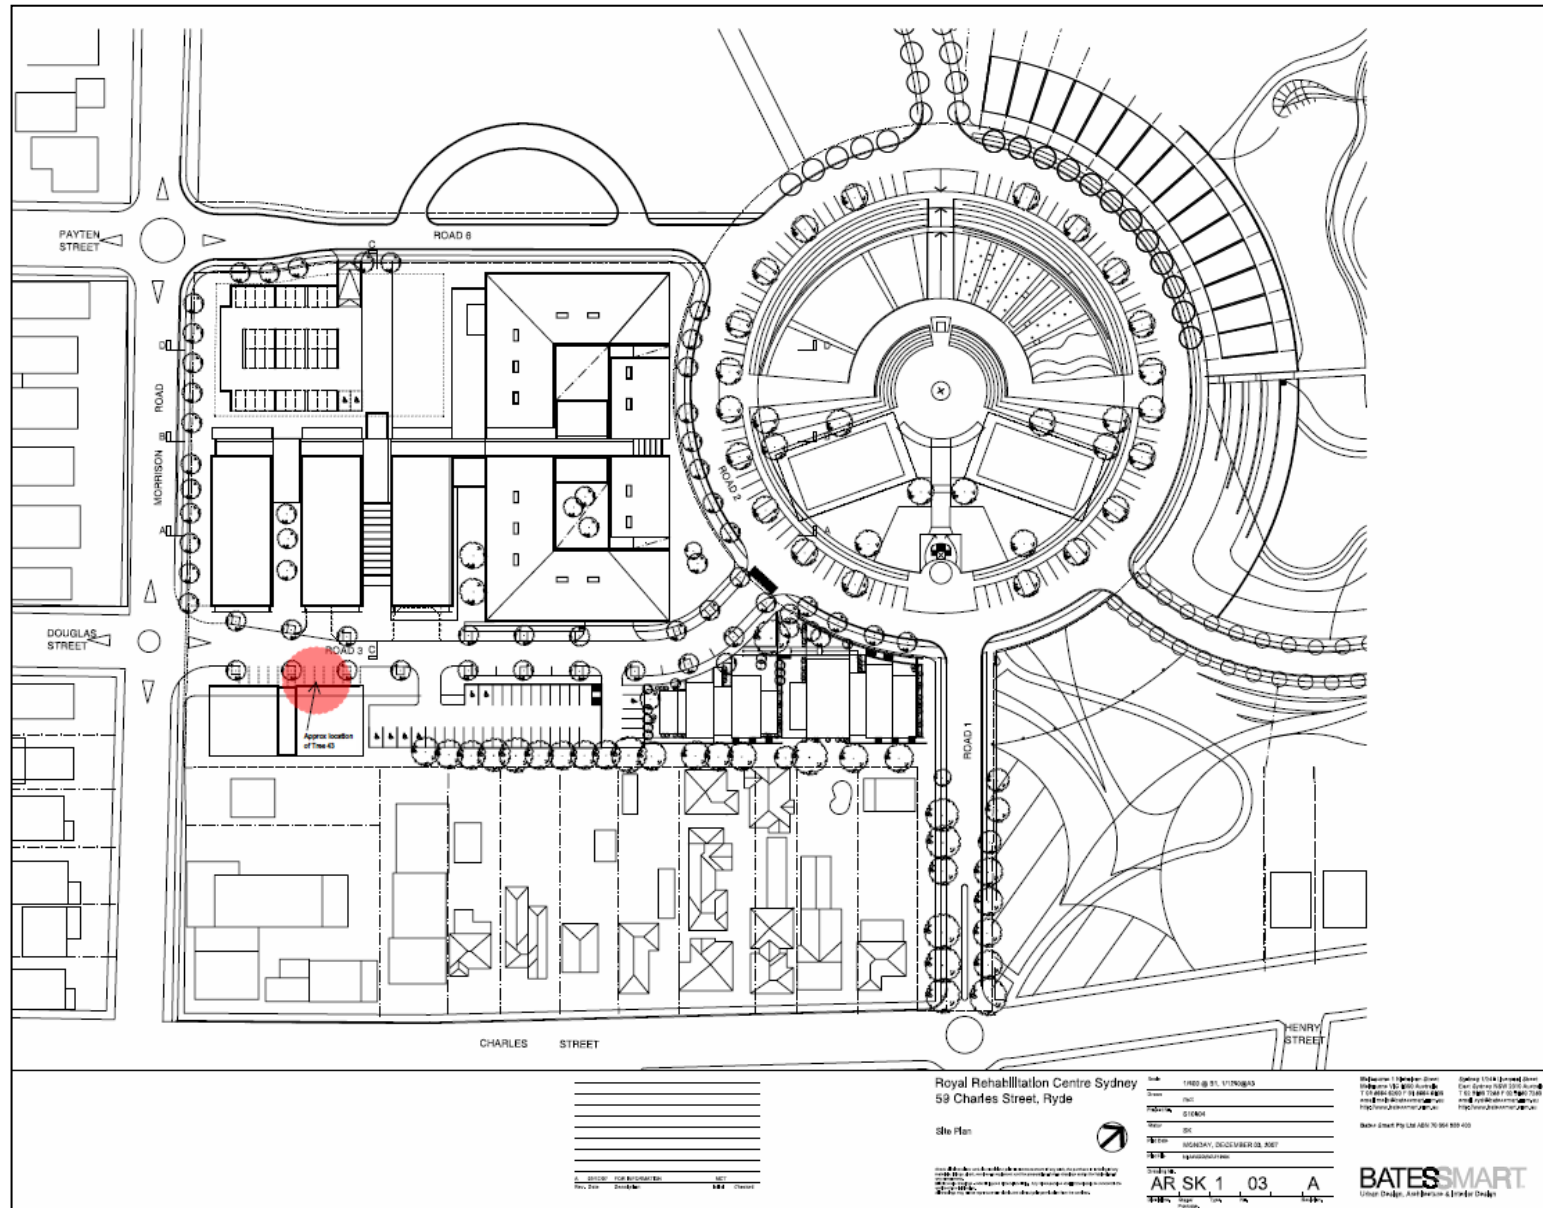
Copy of Site Plan
AR SK 1 03 A dated 03 December 2007
by Bates Smart.
Marked up by C. Mackenzie. This copy not to scale

I did note however, that the tree was not retained on a Bates Smart plan (Site Plan December 2007) and the parking spaces and buildings would require its removal in any event. The civil plans by Meinhardt, emailed to me today 2, August 2013, which are stamped Section 75W modification documents, also shows the same building, parking spaces and new Road 3 (copies attached).

Note:
TREE IS NOT SHOWN TO BE
RETAINED ON PLAN
Red circle and arrow identifies
approximate location of tree.

Subsequently, I recommend the tree is removed so that the development of the site can continue.
