16 June 2015

Project No: 1321-15

Re: Global Switch east – Stage 2 – BCA review

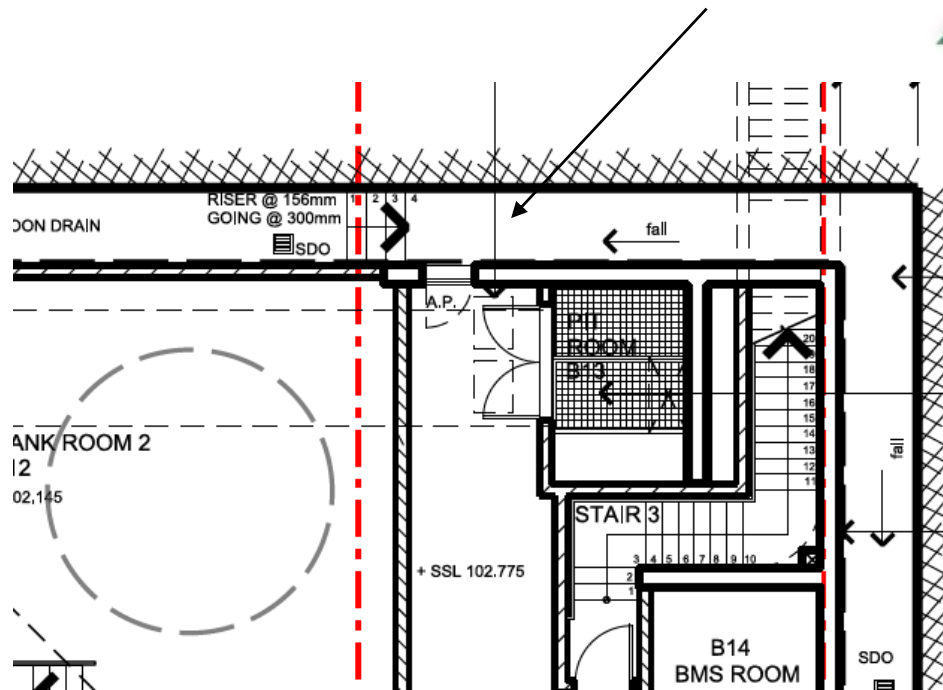
1. The design indicates access panel's within the basement that are hinged in nature not fixed. This would result in the plenum spaces being considered accessible from a BCA point of view. As such services would be required within these spaces, such as exit signage, emergency lighting etc. In addition travel distances would either need to be compliant or addressed via a performance based solution (noting it is circa 100-m between exits in the plenum on the eastern side.
