Project 85696.00
10 February 2017
C.001.Rev0
JAM

**Geotechnical Response to TfNSW Conditions
Commercial Tower
1 Denison Street, North Sydney**

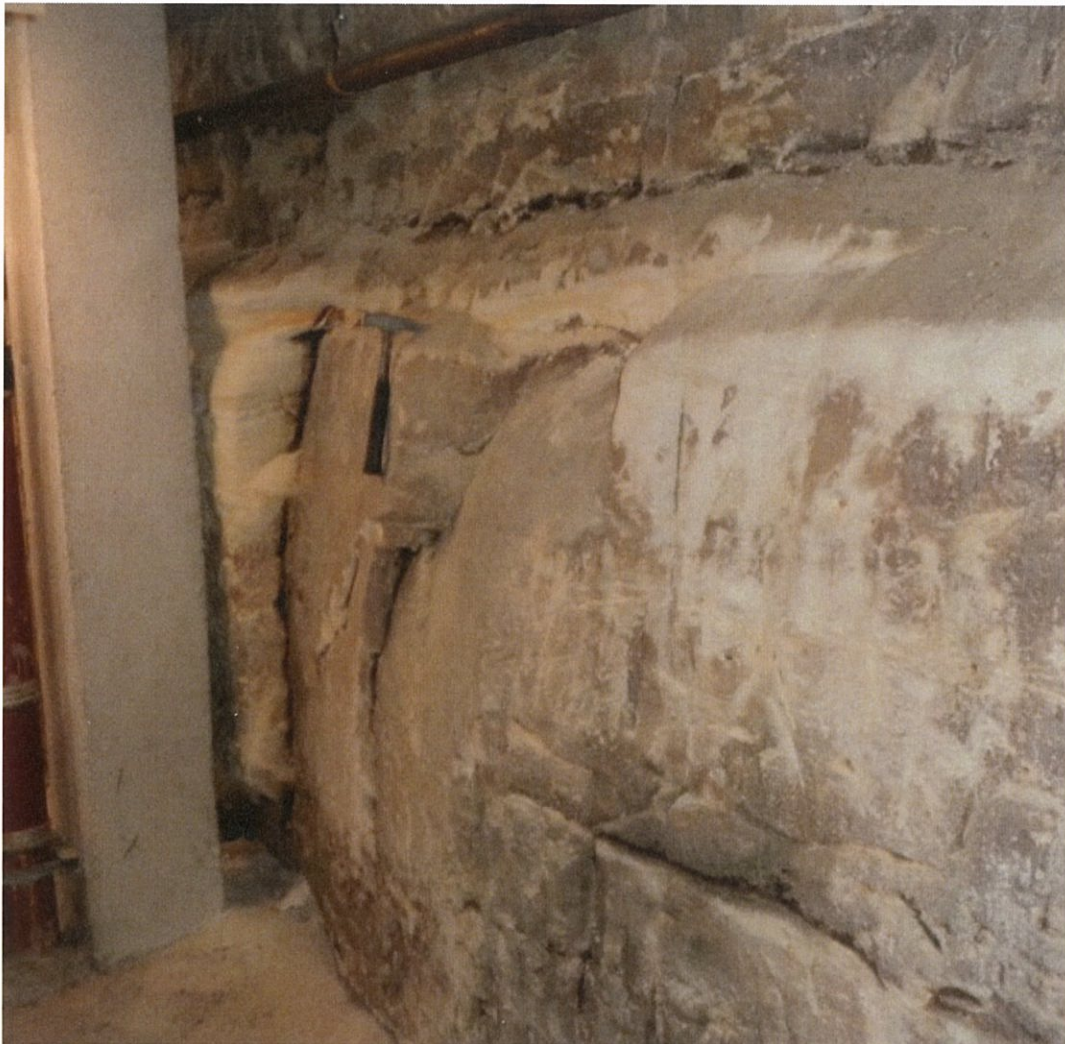
weathered, very low and low strength sandstone to a depth of between 1 m and 3 m, underlain by medium and high strength, essentially unbroken sandstone. Traces of north-south trending vertical joints (Set 1 joints, see Photo 1 below) were noted in the east-west trending walls, typically at more than 5 m spacing.

Photo 1: Intersection of north-south trending joints with the western basement wall.

Minor block failure was noted in the north-south oriented walls where the north-south trending sub-vertical joints intercepted the face. Accumulation of fines at the toe of the walls indicated pronounced salt weathering. The inspected faces, on basement levels four and seven were generally considered stable with the minor instabilities at the joint/face intersections and salt weathering. The rock exposed on the northern wall of the existing basement beneath the site, which is beneath the Beau Monde building was similar to the thickly bedded sandstone exposed in the Beau Monde basements.

The western wall comprised mainly medium to high strength sandstone with north-south trending sub-vertical joints intercepting the face (Photo 1 above). The slabs formed by these joints were locally fragmented and typically detached from the wall.

Medium and high strength sandstone is considered self-supporting, unless affected by adversely oriented discontinuities. The existing exposed rock faces within and on the adjacent site are considered stable, except the minor salt erosion and the slab/block fall at the joint/face intersections.

The slabs/blocks formed at these intersections are typically less than 200 m thick. Once the joint surface is about 300 mm behind the rock face, the risk of slab/block detachment appears to reduce significantly. The detachment of the small slab/block has an insignificant effect on the overall stability of the rock face.

Should other adversely oriented discontinuities be encountered during the excavation, the face instabilities formed by these discontinuities will be stabilised by appropriate methods, such as rock bolts/anchors, shotcrete or similar.
