Re: Proposed approach to patching of Martin Road from the Australian Native Landscapes site entrance to the entrance to Boral's Badgerys Creek Quarry and Brick Making Facility

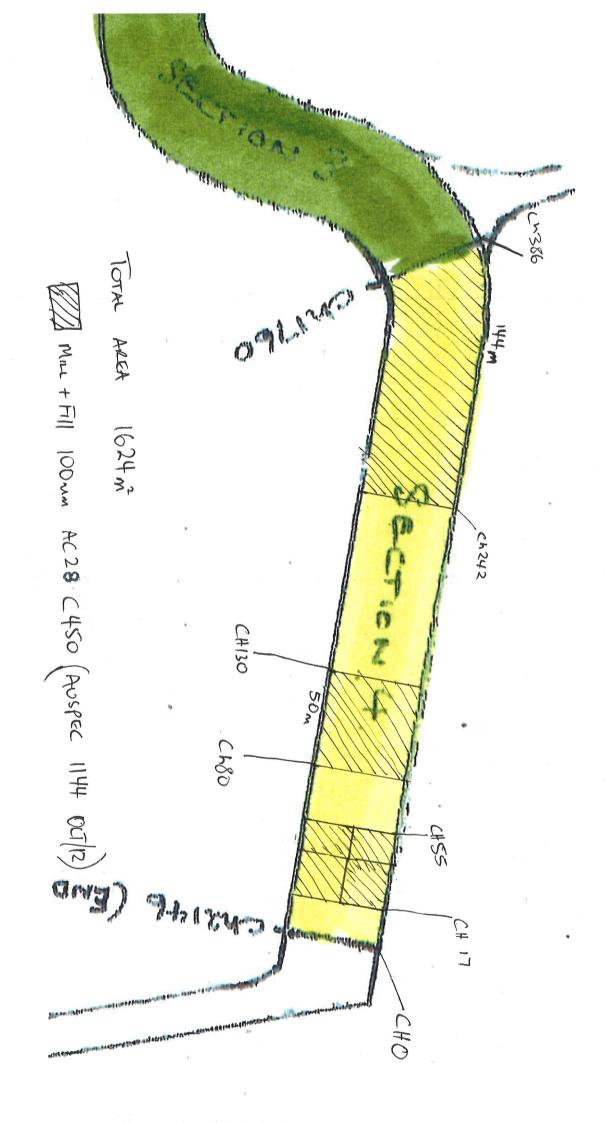
LCC and Boral met on site on 15 March 2013 and agreed in principle to both the extent of repairs (see attached figure) that are required as well as the specifications of this repair work.

For ease of reference, the interface between Boral's concrete driveway and the asphalt surface at the end of Martin Road is defined as Chainage 0 (CH0) with increasing chainage references towards Chainage 386, opposite the entrance to ANL.

Boral is committed to the repair of the full width of Martin Road (approximately 7m from shoulder) in the following areas:

- CH17 CH55 ($38m \times 7m = 266m^2$);
- CH80 CH130 (50m x $7m = 350m^2$)
- $CH242 CH386 (144m \times 7m = 1008m^2)$

The approach to the repair works that were agreed with LCC were to mill the areas to be repaired to a depth of 100mm and to fill these areas with 100mm of asphalt (AC28 C450 – AUSPEC 1144 Oct/12).
