RUSSELL VALE COLLIERY - MG6 CORRIMAL FAULT INSPECTION

Memo: MG6 Panel

WOLLONGONG COAL RUSSELL VALE COLLIERY

GEOLOGICAL REPORT ON THE CORRIMAL FAULT

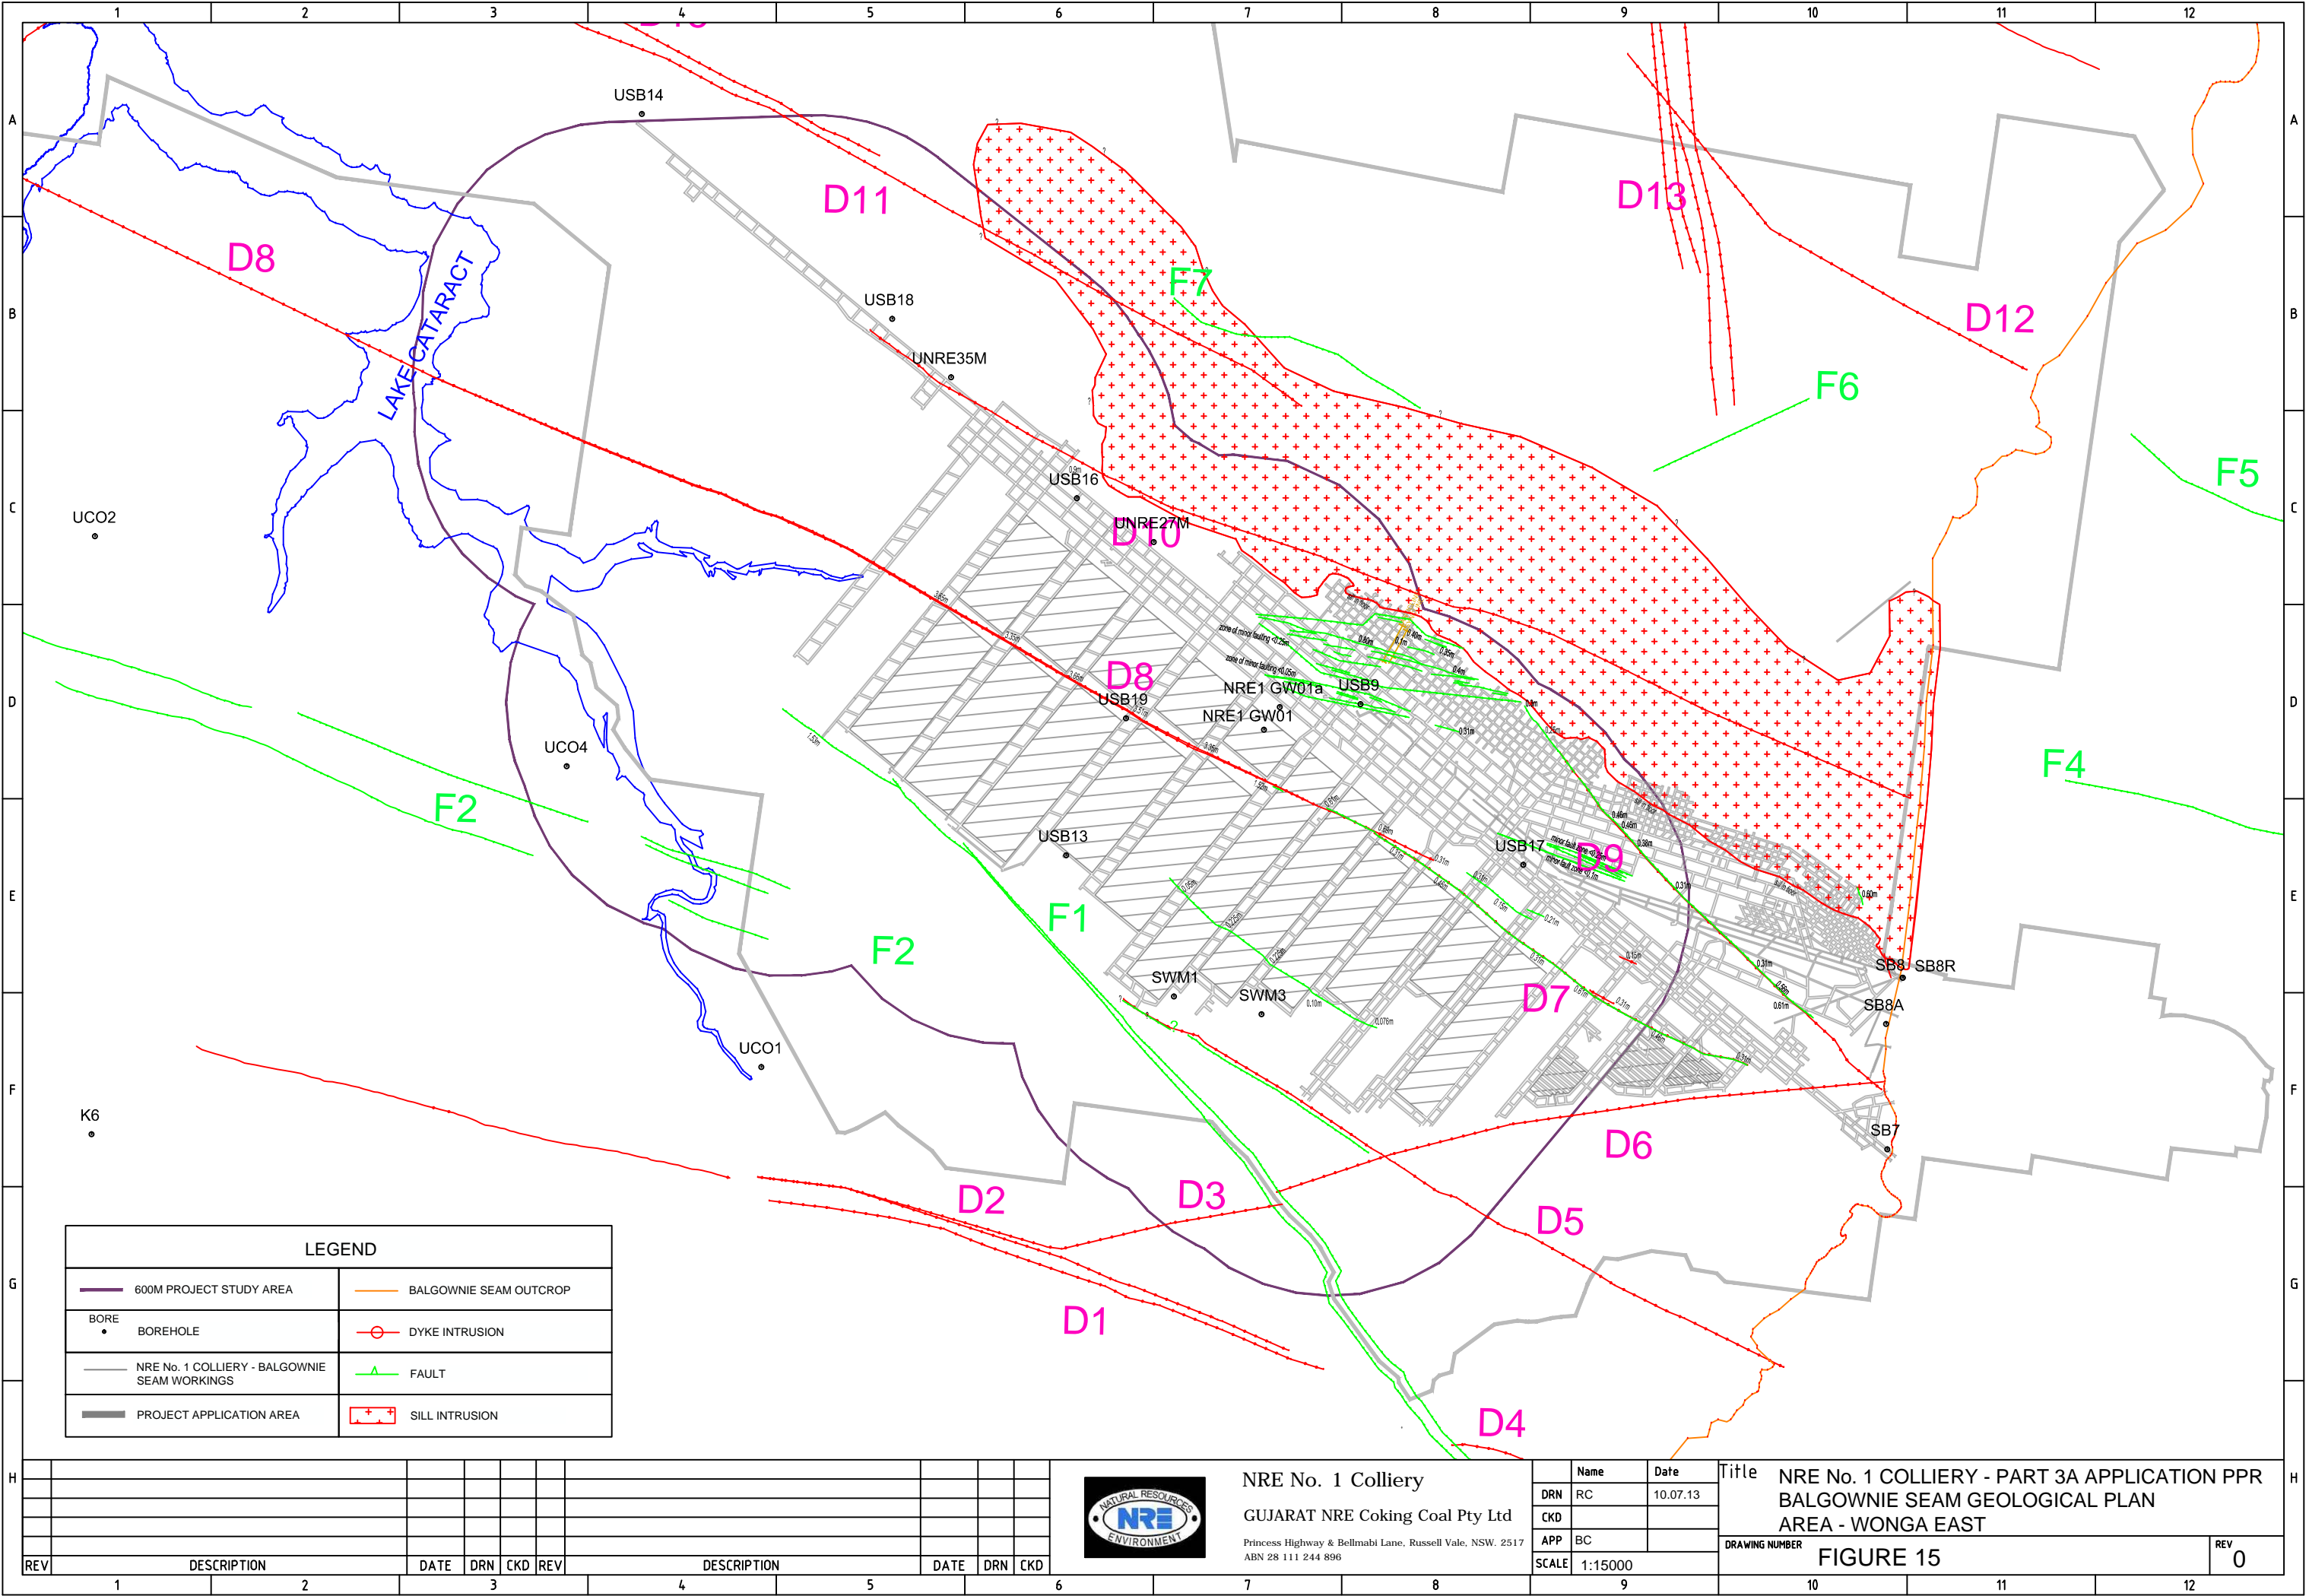
Fault F1 in the Bulli Seam (Corrimal Fault) was intersected in a heading of gate road driveage and had a displacement of 1.53m and was offset 7.0m to the north from the fault position in the Bulli seam.

Fault F3 in the Bulli seam was associated with dyke D5. Intersected in an overdrive heading the fault and dyke still appear together in a very similar location to the location in the Bulli Seam. This gives weight to the fault being formed during injection of the dyke as the fault has no offset to its position in the Bulli seam.

Dyke D5 was intersected by an overdrive heading. No indication of thickness or strike length is known from the Balgownie Seam workings.

Dyke D6 was intersected in initial Balgownie Seam workings. No indication of dyke thickness has been sighted. Dyke strike direction is the same as the dyke intersected in the overlying Bulli Seam workings.

Dyke D7 was intersected in many roadways and varied in thickness from about 0.31m to 0.61m and from the Balgownie mine plan appears to be a soft clay dyke. Thickness on this dyke from the Bulli Seam workings indicated 1.5m to 1.6m. Strike length and direction are similar to the Bulli Seam dyke position.

Dyke D8, prominent in the Bulli Seam workings, is also prominent in the Balgownie Seam workings. The dyke varies from about 0.31m thick where first intersected to 3.65m at its last measured intersection. In a similar location in the overlying Bulli Seam to its last measured thickness in the Balgownie Seam the dyke was 3.7m thick. The dyke is hard and as it thickened the Balgownie seam longwall was recovered and reinstalled on a new install heading avoiding mining through the dyke.

Dyke D9 was intersected by numerous roadways. Dyke thickness has a maximum of 0.56m and dies out to the west-nor-west as it does in the Bulli Seam where it has a thickness of 0.9m.

Dyke D10 was intersected over several roadways and measured at 0.9m thick. Its thickness in the Bulli seam at a similar location was estimated at 3.1m.

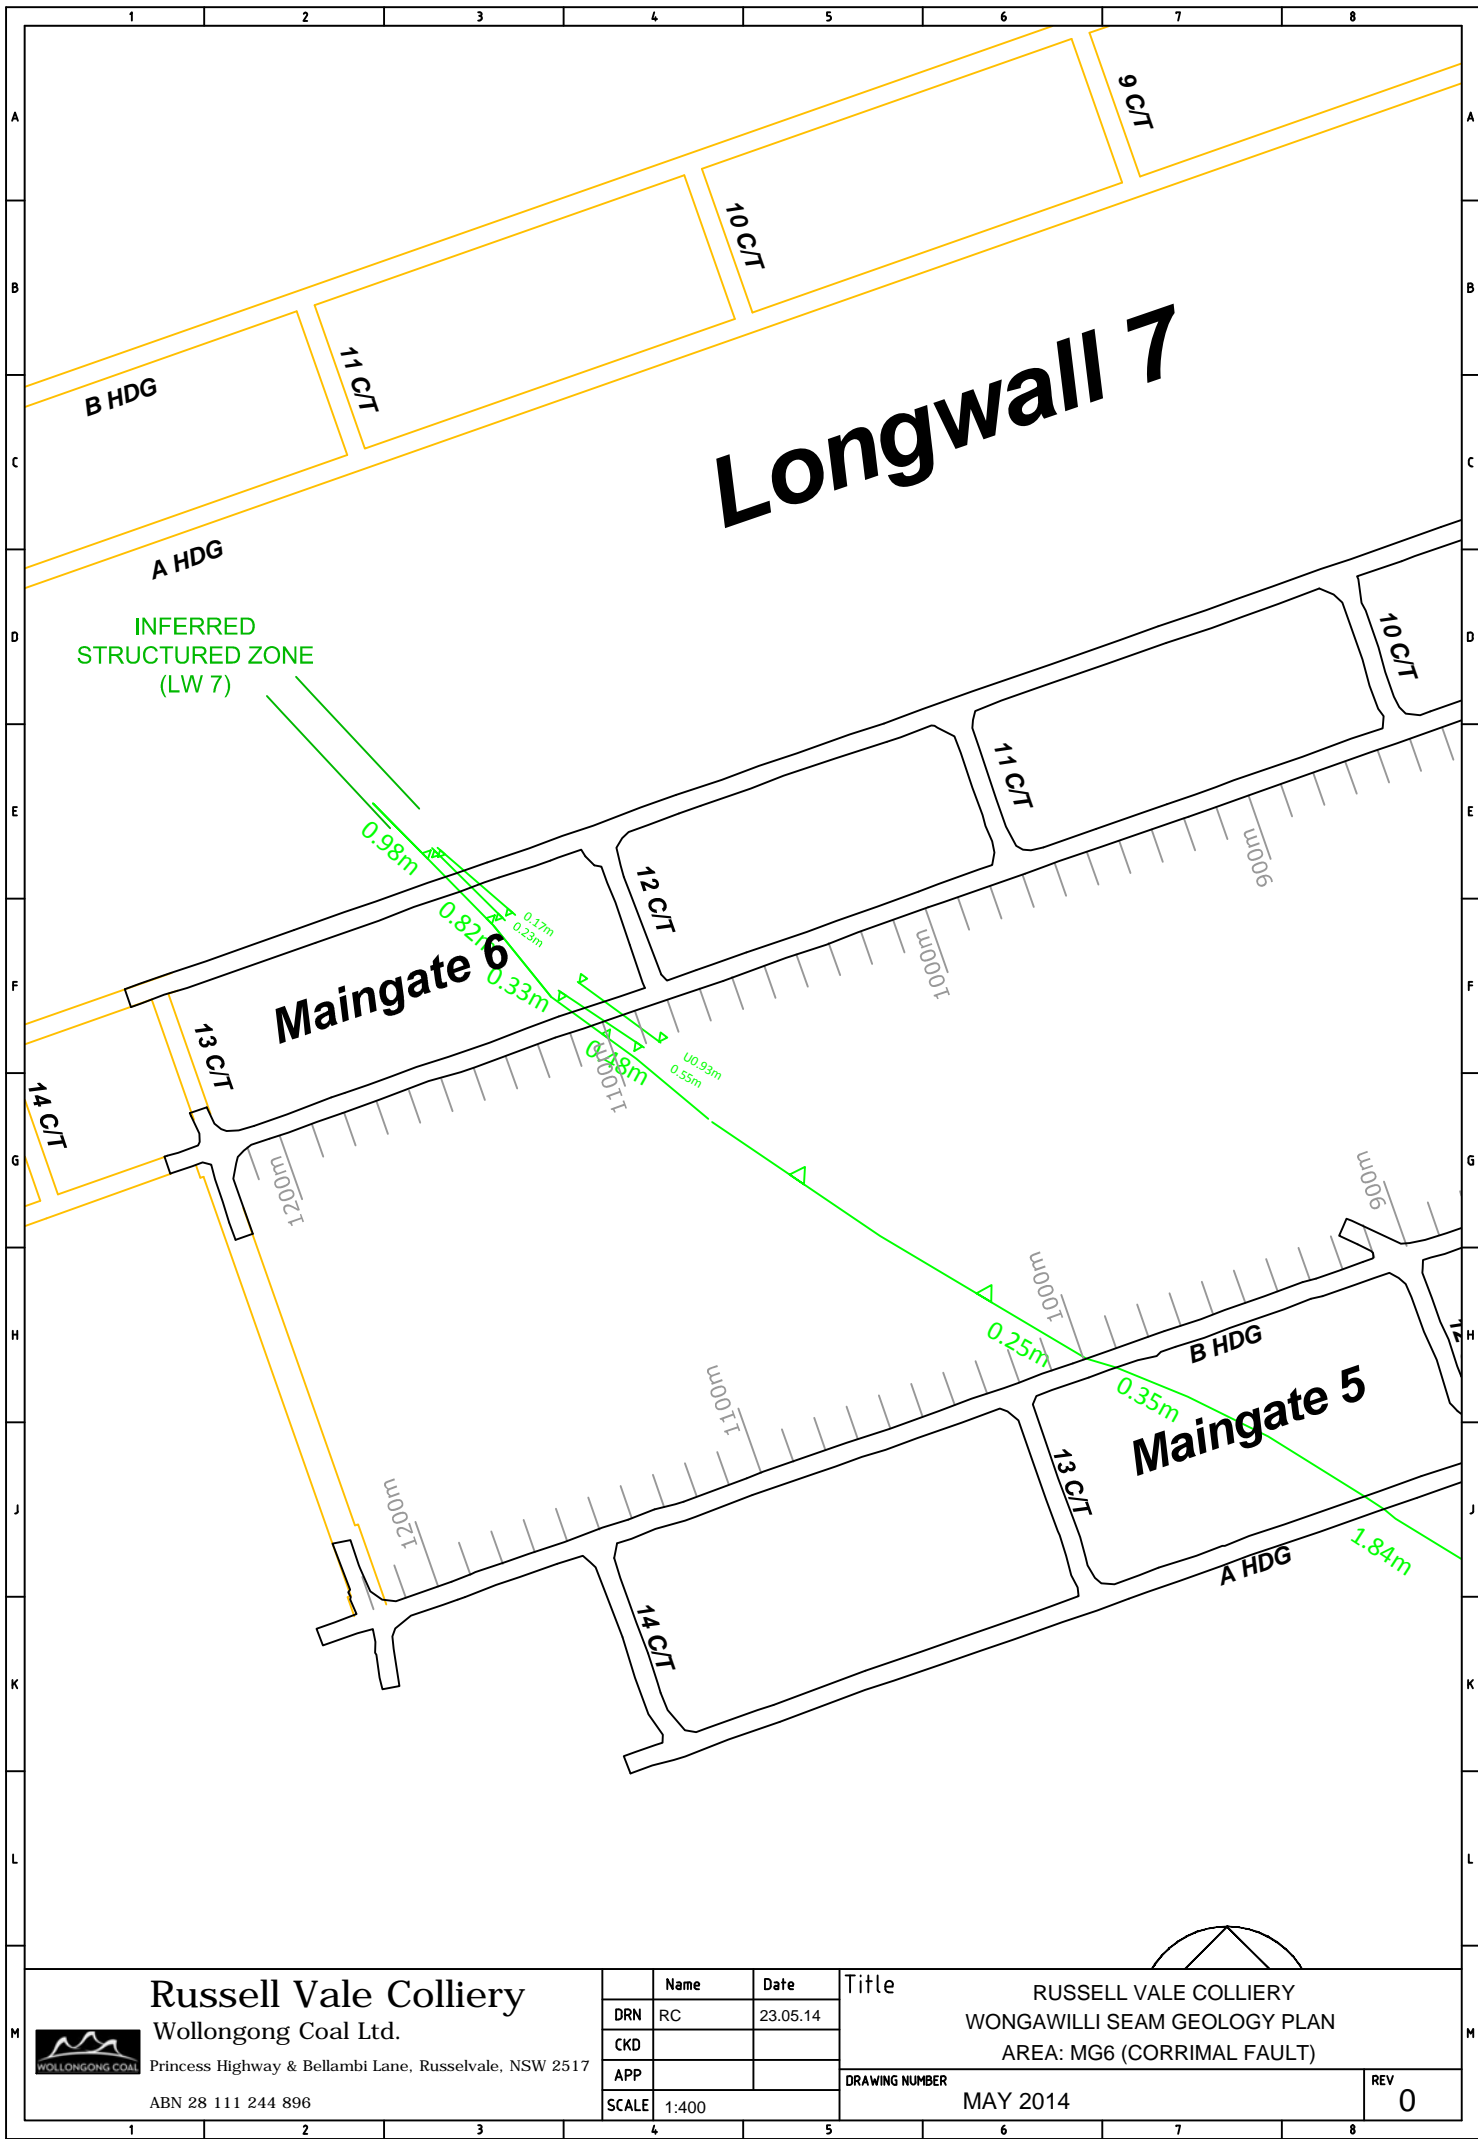
Title
RUSSELL VALE COLLIERY
WONGAWILLI SEAM GEOLOGY PLAN
AREA: MG6 (CORRIMAL FAULT)

- As experienced in MG6 A HGD, a structured zone consisting of three (3) distinct faults has been identified approximately 40m inbye of B12 intersection. The structured zone is summarized as the following geological features:

Fault 1 – A normal fault located 38m on the RHR inbye of B12 intersection. Measured displacement was 0.17m down-throw with an observed hade of 70 degrees towards the south-west.

Fault 2 – A normal fault located 40m on the RHR inbye B12 intersection. Measured displacement was 0.23m down-throw with an observed hade of 60 degrees towards the south-west.

Fault 3 – A normal fault located 44m on the RHR inbye B12 intersection. Measured displacement was 0.82m up-throw with an observed hade of 70 degrees towards the north-east. Note – these characteristics are consistent with the projection of the Corrimal Fault through adjacent panels.

- A series of sub-parallel ‘cutters’ are associated with the faults. No significant displacement was noted on these minor structures. This zone of minor structures associated with the structured zone has caused significant 2.5m cavity in the roof (base of Wongawilli Sandstone) & slumping to approximately 1.0m on the right hand side rib looking inbye.
- No noticeable water-make was noted on the structure to date. No excessive corrosion was noted on any support hardware indicating that water-make had occurred outside the time of inspection.

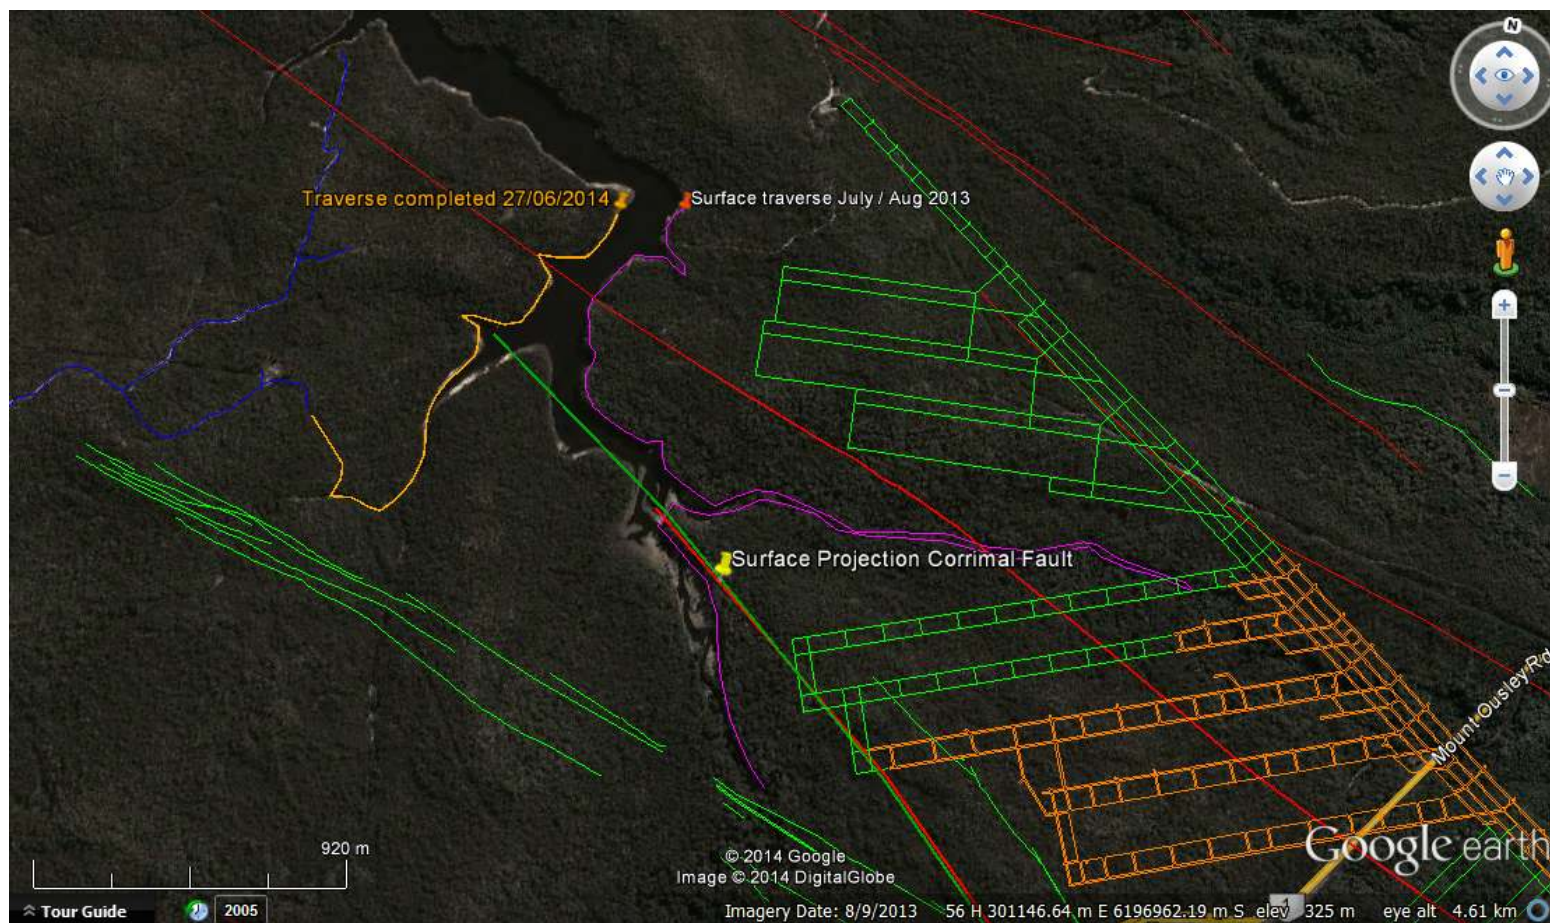
Figure 1 Surface traverse paths and projected geological structures

No surface expression of the Corrimal Fault has been found during the ground profiling traverses. Dominant over the plateaux and ridges on both sides of the Cataract Reservoir is the Hawkesbury Sandstone forming prominent cliff lines in most areas inspected. Prominent jointing within the Hawkesbury Sandstone is generally striking 055⁰ to the northeast / southwest with a less prominent conjugate set at 155⁰ to the southeast / northwest. These joint directions tend to control many of the prominent topographic features particularly the cliff lines within the Hawkesbury Sandstone which are commonly formed by block failure along the prominent 055⁰ joint direction as shown in Figure 2. The Corrimal Fault projects at approximately 125⁰ to the southeast / northwest. Minor jointing with a similar strike was measured within the proximity of the projected strike of the fault on the western edge of the Cataract Reservoir but no evidence of movement along this jointing was found.

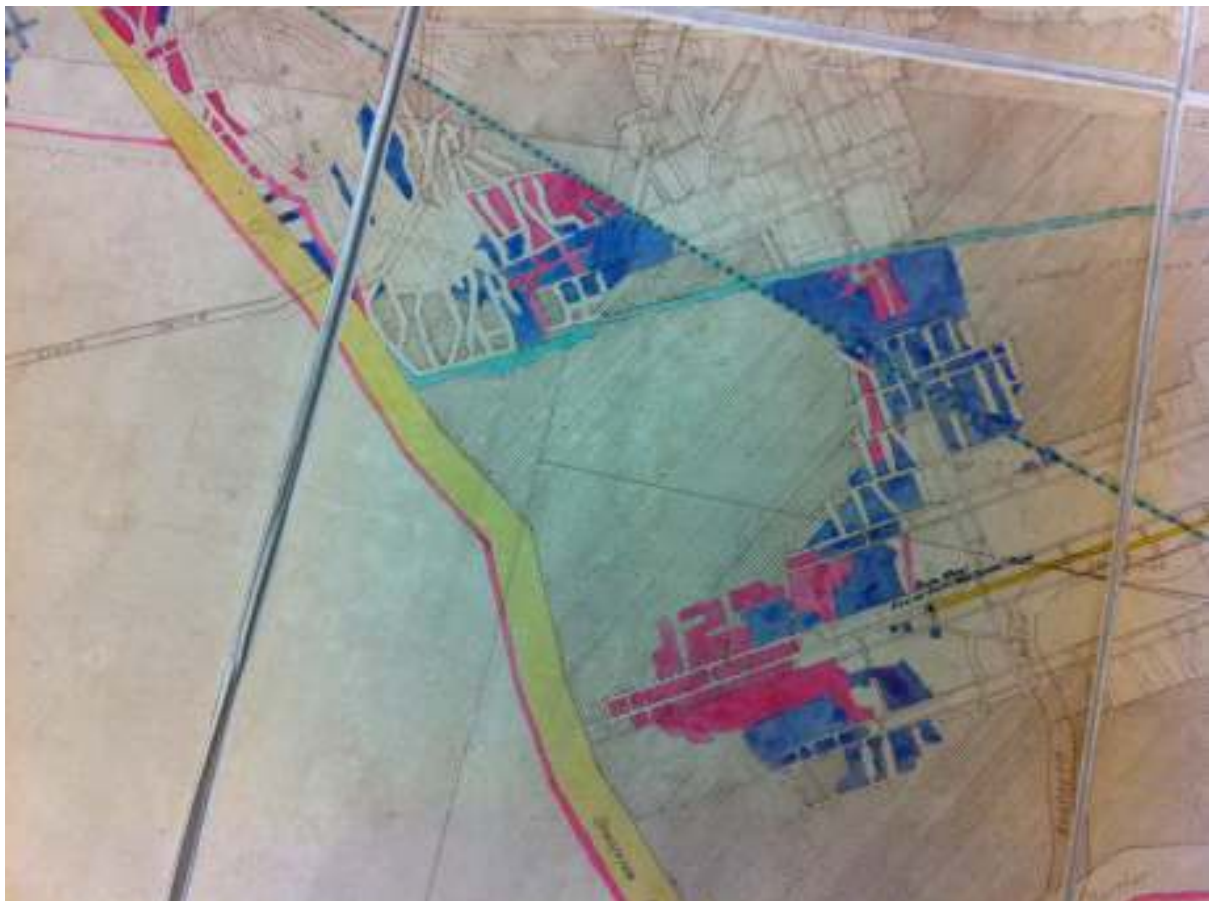
Figure 4 Corrimal Fault near outcrop

Within the Bulli Seam mine workings the Corrimal Fault occurs from outcrop and extends approximately 3000m to the northwest (bearing 320 degrees) before dying out within the mine workings. Maximum recorded displacement has been measured at 28.7m with a fault width of approximately 20m. There are no records or documentation indicating moisture ingress being associated with the fault.
