REVISED REPORT

> ON GEOTECHNICAL ASSESSMENT

FOR PROPOSED MULTI-STOREY DEVELOPMENT

AT 1, 1A & 5 AVON ROAD AND 4 & 8 BEECHWORTH ROAD, PYMBLE, NSW

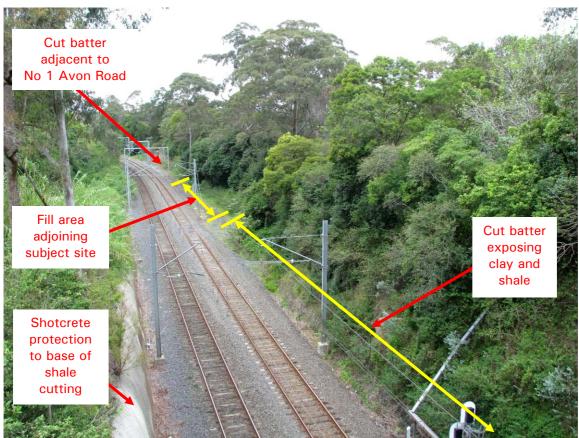
PHOTOGRAPH 1: View to south-east from Beechworth Road bridge along North Shore Railway line.

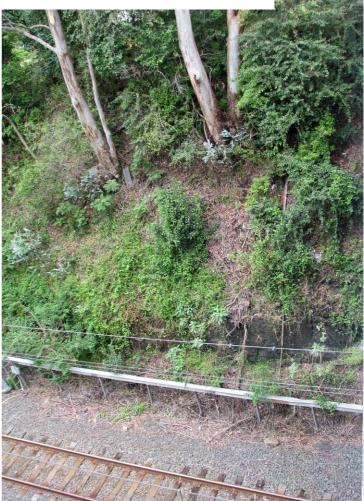
PHOTOGRAPH 2: View of cut batter on south-eastern side of Beechworth Road bridge, showing shale exposed at base of cutting.

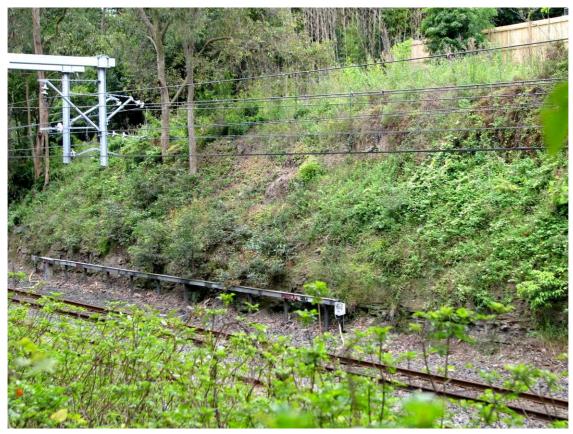
PHOTOGRAPH 3: View of shale exposed in North Shore Railway line cutting on northeastern side, adjacent to No 1 Avon Road.

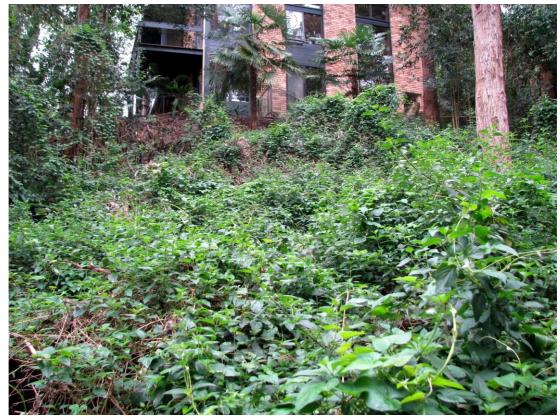
PHOTOGRAPH 4: Possible fill batter adjoining No 10A Beechworth Road.

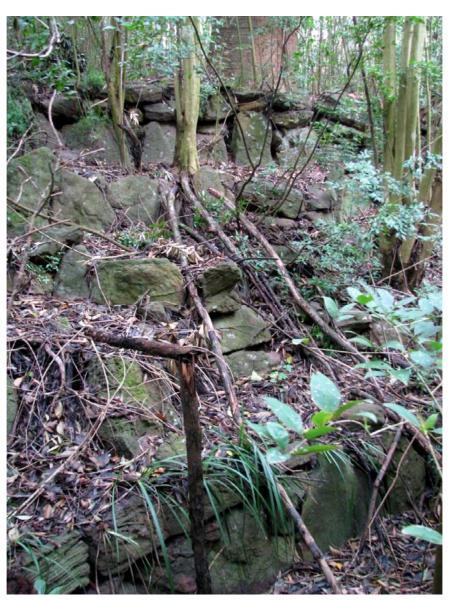
PHOTOGRAPH 5: view of terraced garden walls at north-eastern corner of the disused tennis court on No 1 Avon Road.
