Arboricultural Impact Assessment & Tree Protection Plan

Sydney Fish Market – Site Accommodation
Glebe NSW 2037

Version 2

January 2022

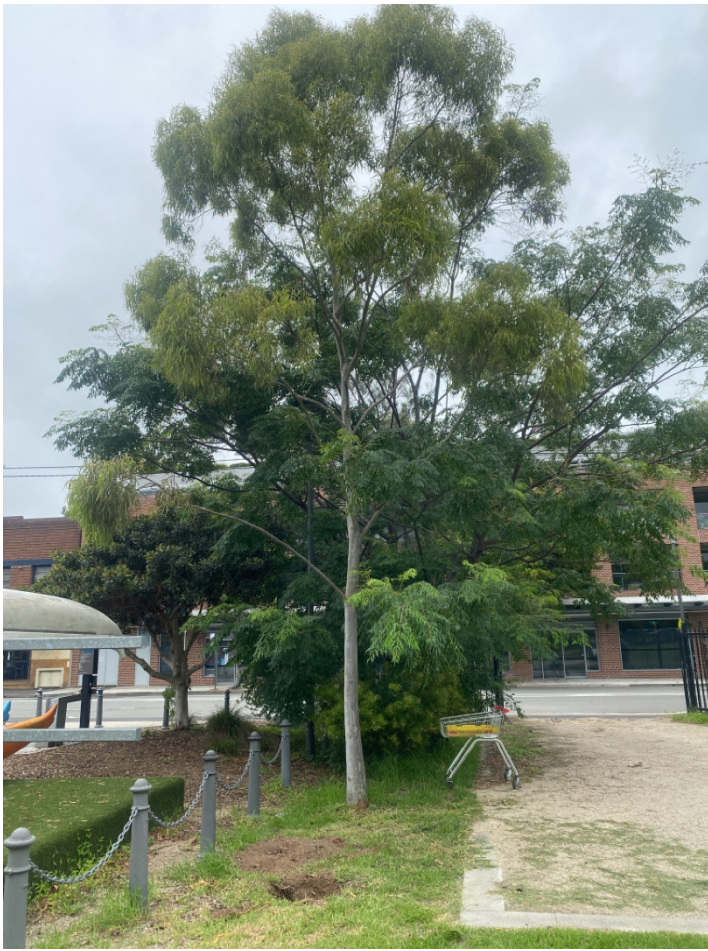
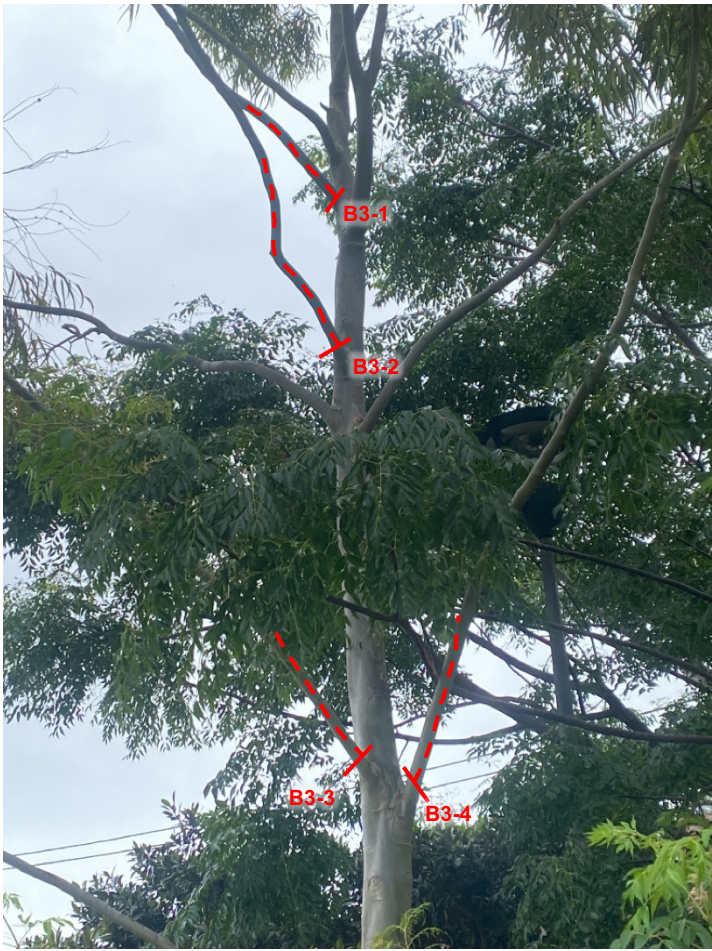
- The Subject Tree is situated on the eastern side of the proposed site accommodation structure.
- The Subject Tree is a multi-trunk specimen.
- The Subject Tree is in good health and condition.
- 4x first-order lateral branches (4x 40mmØ) extend in a northerly direction and is in conflict with the location of the proposed site accommodation structure.

Image I: Subject Tree id. 3

Image II: Subject Tree id. 3 indicative pruning locations

- 4x first-order lateral branches (4x 40mm), as shown in **Image II**, are recommended for removal.

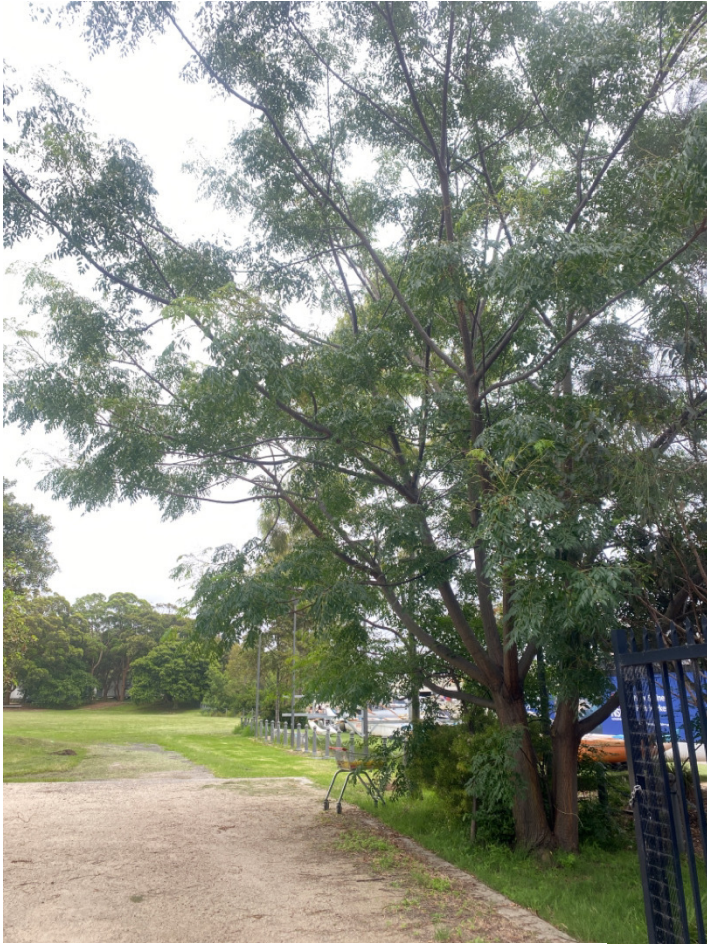
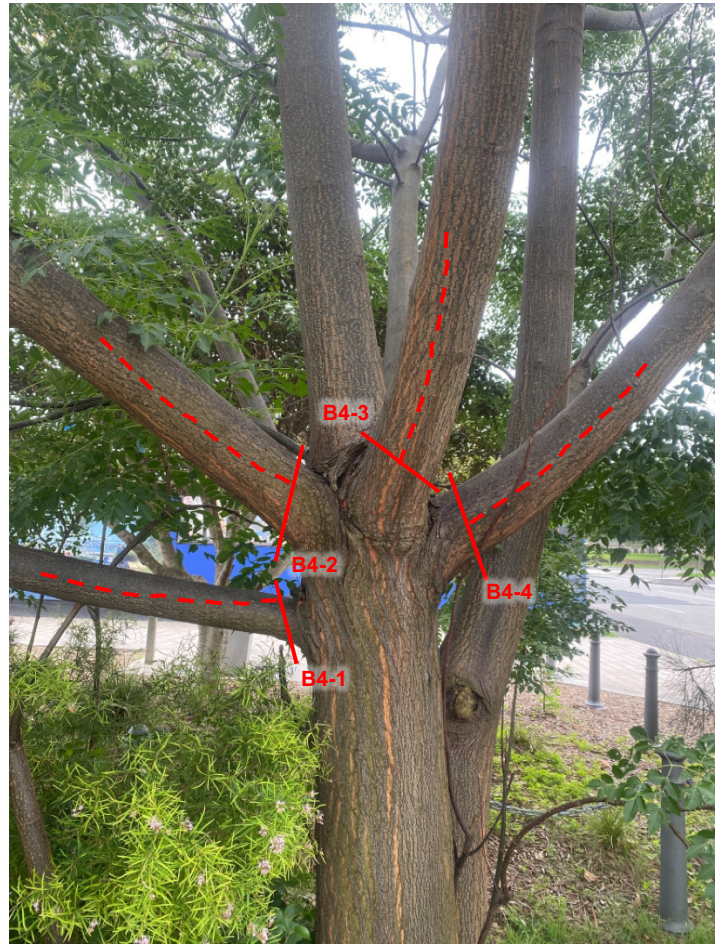
- The Subject Tree is situated on the eastern side of the proposed site accommodation structure.
- The Subject Tree is a single trunk specimen.
- The Subject Tree is in good health and condition.
- 4x first-order lateral branches (3x 150mmØ and 1x 100mmØ) extend in a northerly direction and is in conflict with the location of the proposed site accommodation structure and plant/vehicle access route.

Image III: Subject Tree id. 4

Image IV: Subject Tree id. 4 indicative pruning locations

- 4x first-order lateral branches (3x 150mmØ and 1x 100mmØ), as shown in **Image IV**, are recommended for removal.

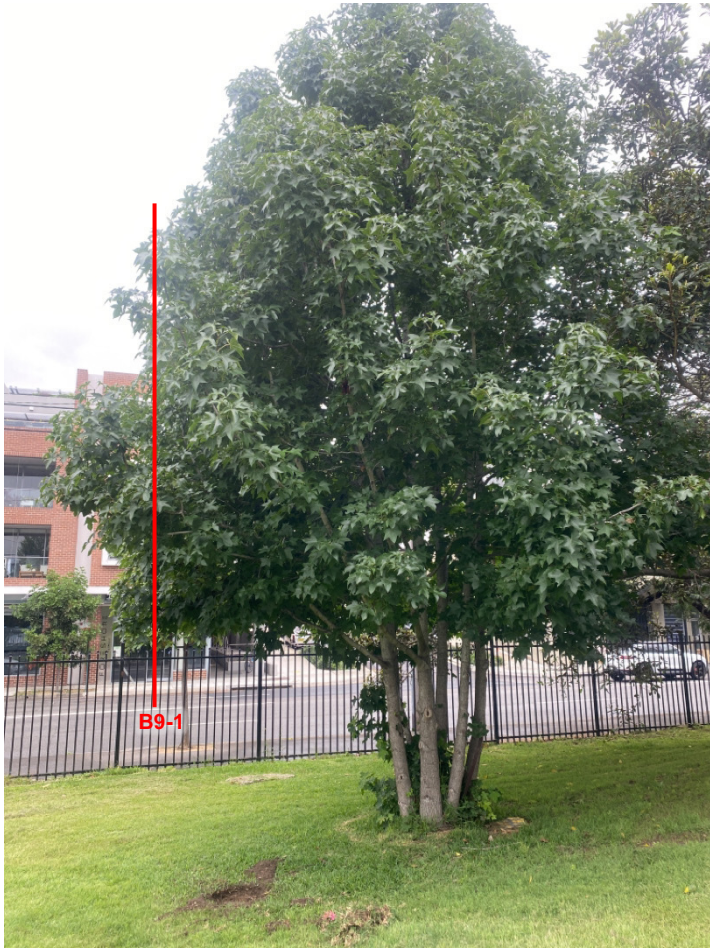
- The Subject Tree is situated on the western side of the proposed site accommodation structure.
- The subject tree appears to be epicormic stump regrowth.
- The subject tree is in good health and condition.
- Terminal foliage of multiple 3rd and 4th order branches extend in an easterly direction and are in conflict with the location of the proposed site accommodation structure.

Image V: Subject Tree **id. 9** indicative terminal foliage pruning locations

- Terminal foliage pruning of conflicting 3rd and 4th order branches, as shown in **Image V**, are recommended for removal.

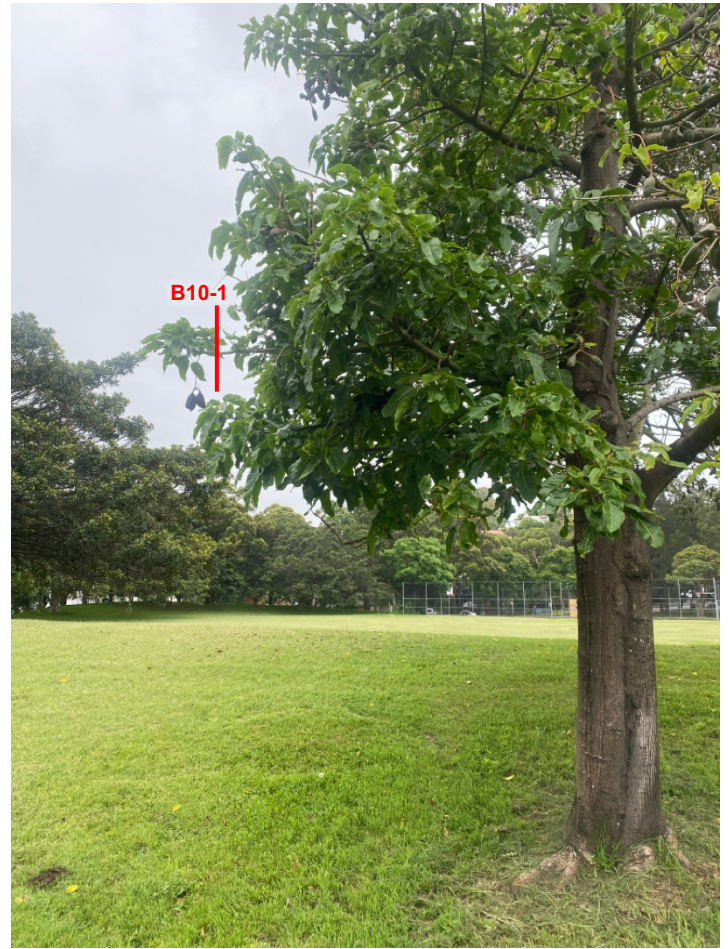
- The Subject Tree is situated on the western side of the proposed site accommodation structure.
- The Subject Tree is a single trunk specimen.
- The Subject Tree is in good health and condition.
- Terminal foliage of a 3rd order branch extends in an easterly direction and is in conflict with the location of the proposed site accommodation structure.

Image VI: Subject Tree **id. 10** indicative terminal foliage pruning location

- Terminal foliage pruning of conflicting 3rd order branch, as shown in **Image VI**, is recommended for removal.

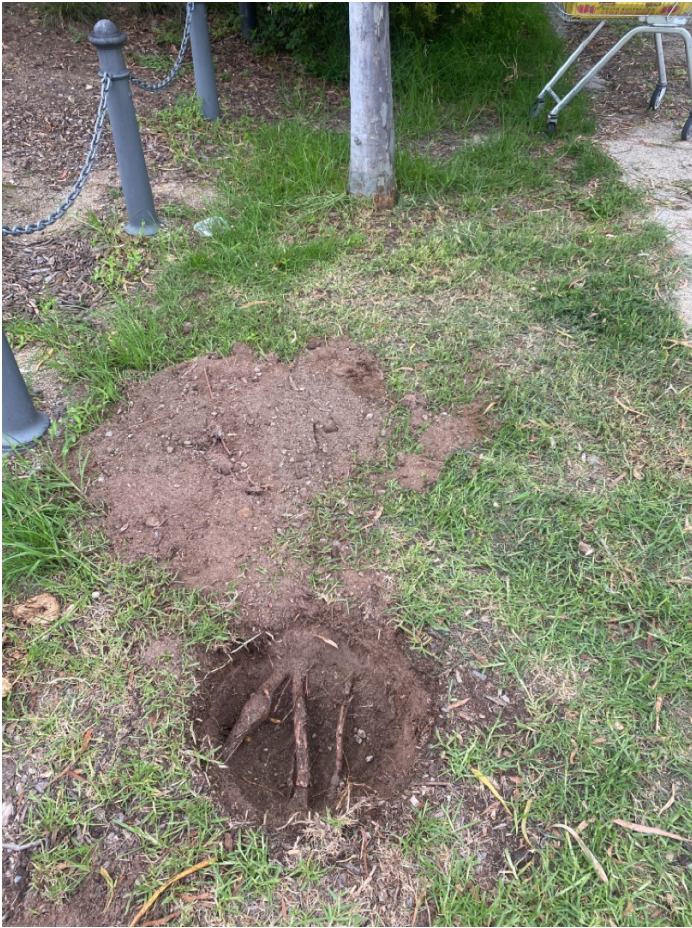
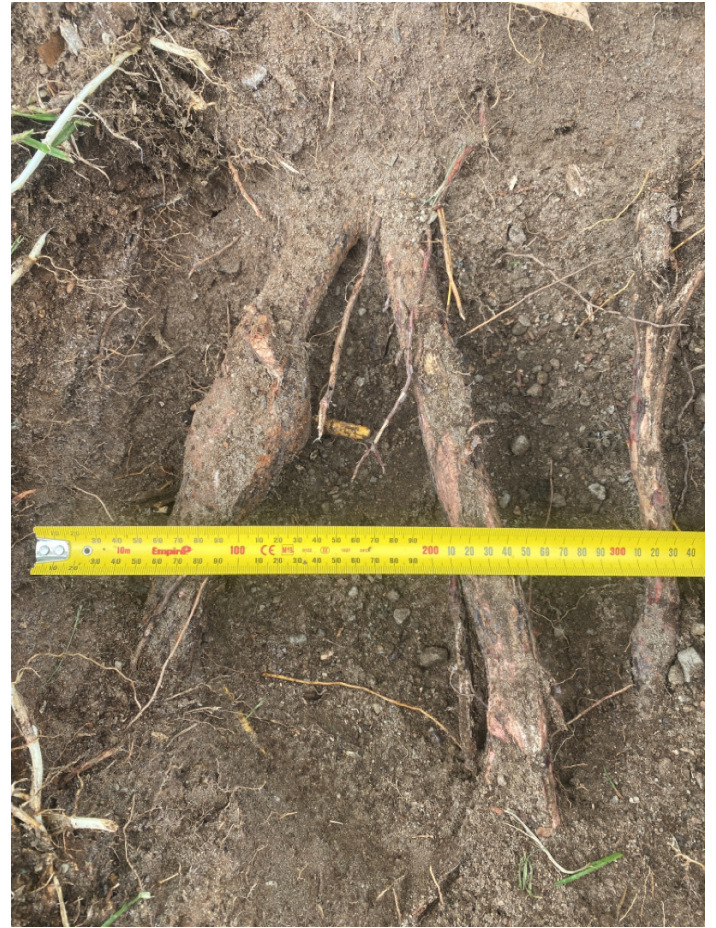
Localised excavation 600mmØ was undertaken at the proposed location of the closest screw pile footing (as determined onsite by Multiplex engineer) using non-destructive methods (hand digging) to expose root material which will require severance. NDE was abandoned at a depth of 250mm in order to prevent damage to root material encountered. The following root material was exposed during the NDE:

Image I: Subject Tree id. 3 in relation to NDE

Image II: Subject Tree id. 3 NDE

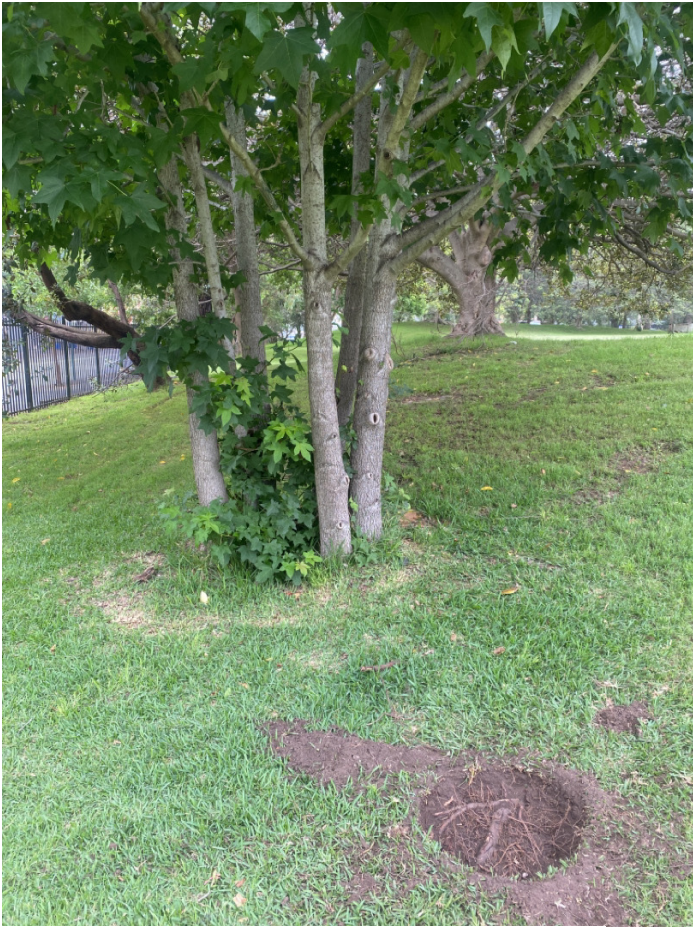
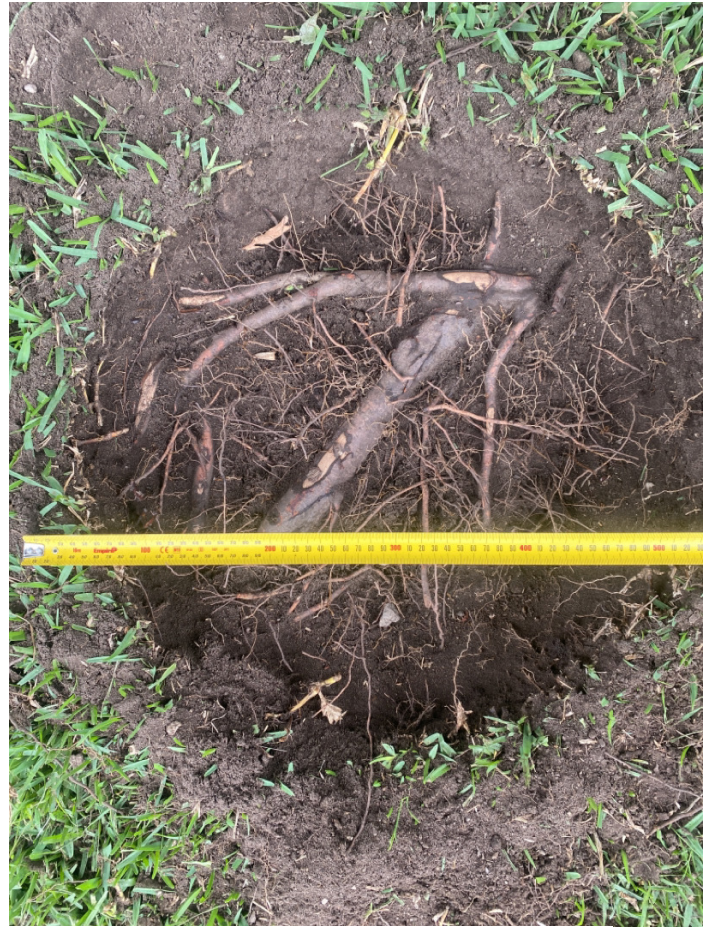
Image III: Subject Tree id. 9 in relation to NDE

Image IV: Subject Tree id. 9 NDE

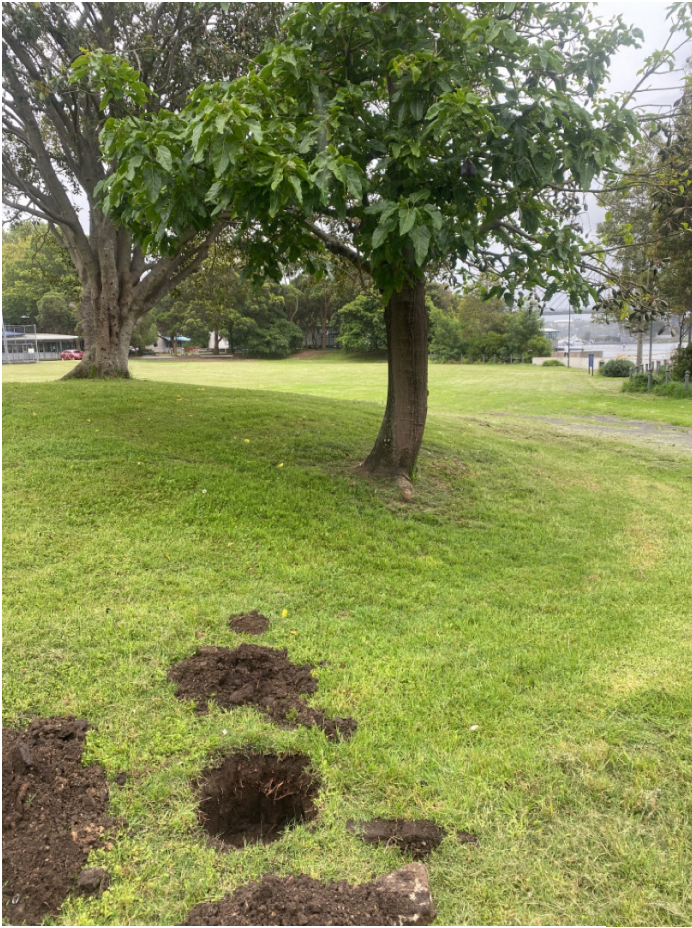
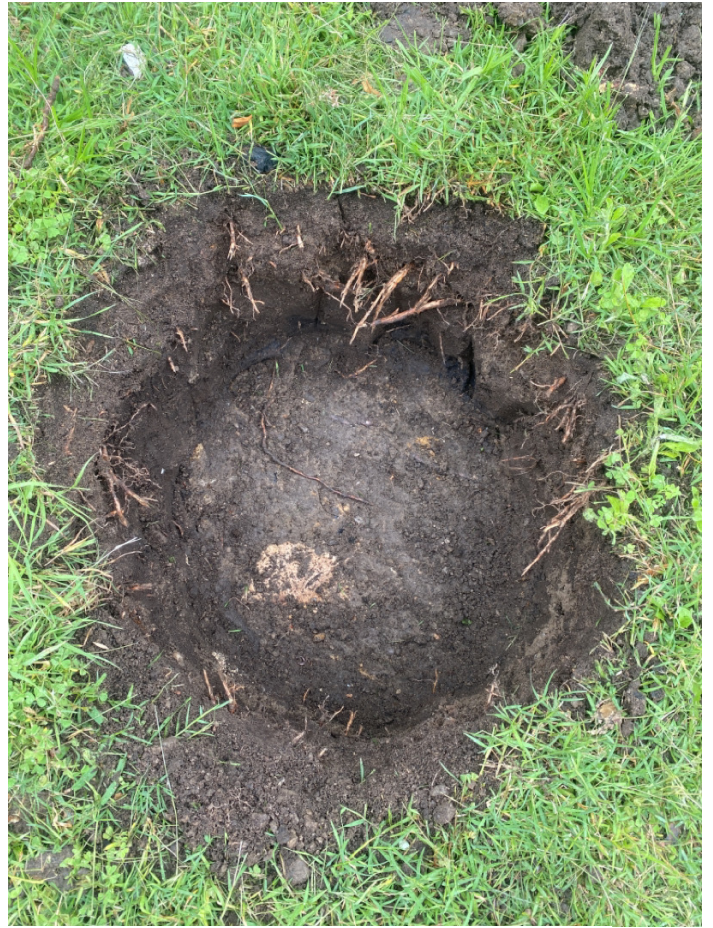
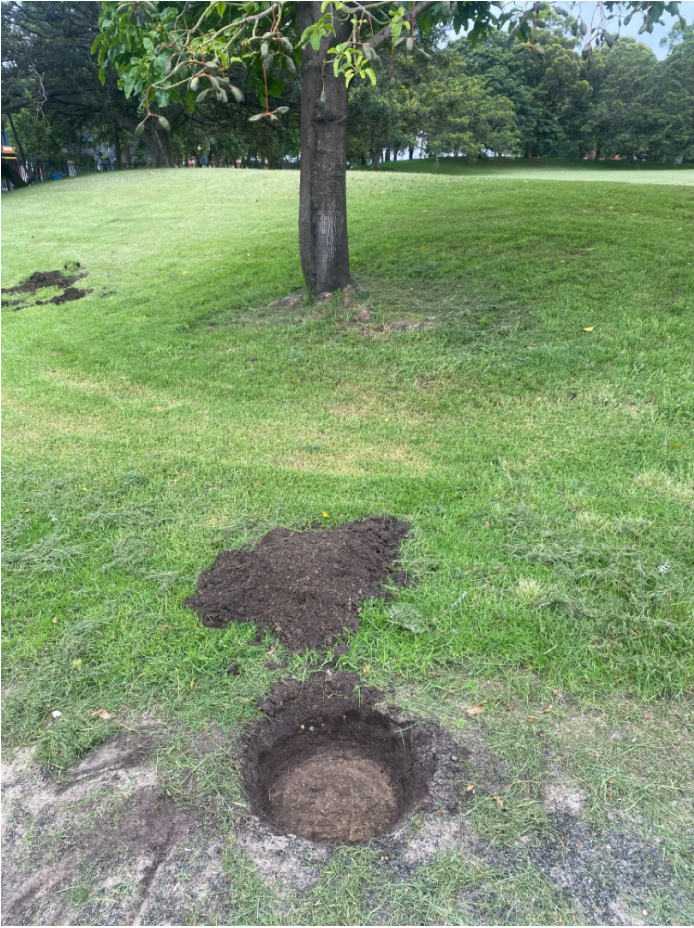
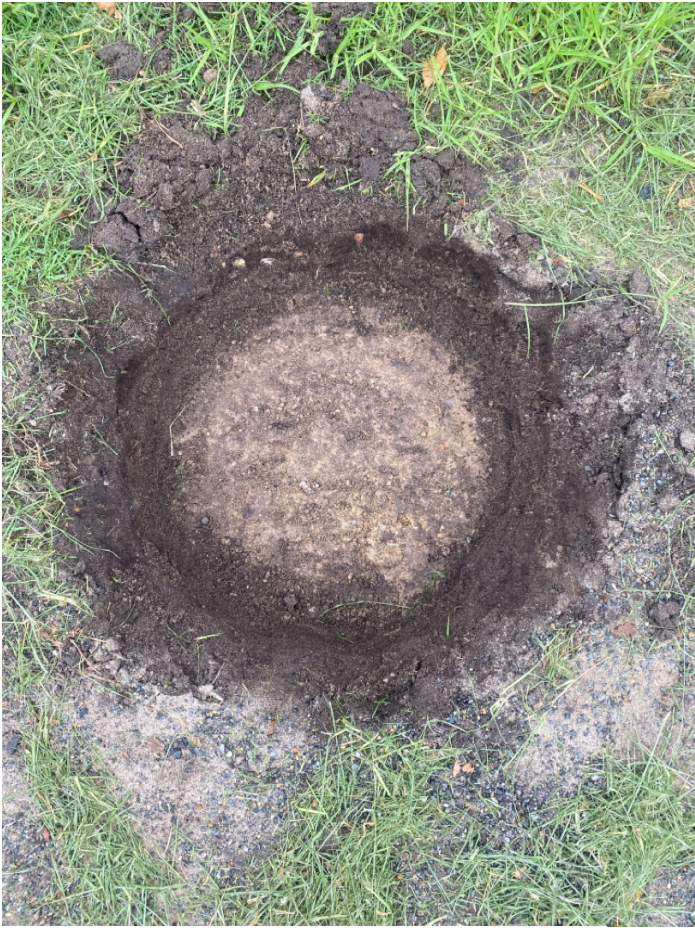
The loss of the identified root material of Subject Trees **id. 3, 9 & 10** to facilitate installation of the proposed site accommodation is approximately 1% of total TPZ area is unlikely to have a significant impact on the subject tree's ability to store carbohydrates, use stored carbohydrates in times of stress and is unlikely to have a significant impact on the health, condition or stability of the tree long term.

Image V: Subject Tree **id. 10** in relation to NDE (south)

Image VI: Subject Tree **id. 10** NDE (south)

Image VII: Subject Tree id. 10 in relation to NDE (east)

Image VIII: Subject Tree id. 10 NDE (east)

- Where additional root material (other than root material identified within this report) is required to be severed, additional assessment by an AQF 5 arborist should be undertaken.
- All exposed root material should be clean cut using secateurs, hand saw or similar.
