# Construction Impact Assessment and Management Plan

Kincoppal School, Rose Bay.

**Prepared For:** Terry Mahady.

**Dated:** April, 2020.

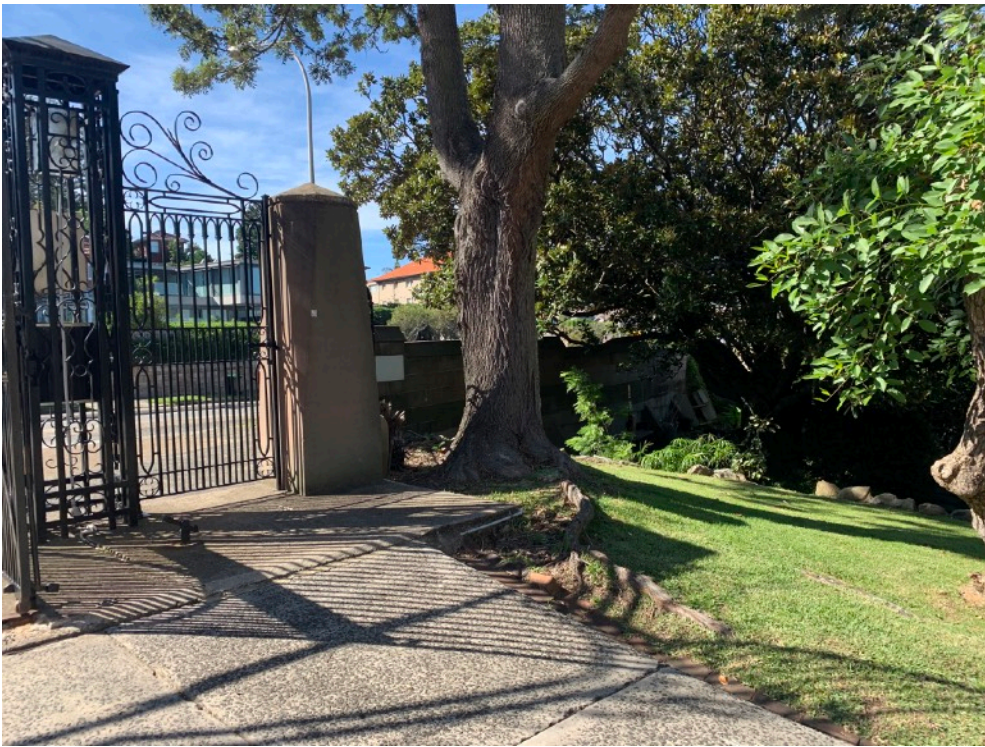
6.3 Tree 2 is a semi mature to early mature *Grevillea robusta*, or Silky Oak. This tree has been planted directly adjacent to the front entrance of the school. The tree has been planted too high in the soil profile and has exposed structural roots. Several of these sit above the soil surface with visible surface decay noted. The tree's canopy has grown to a height of over 12m and is supported on a co dominate trunk that forks at approximately 2.8m above ground level. The tree appears to have had a number of upper canopy limbs fail.

7.1 The proposed works recommend the removal of a number of trees that are located outside the CIZ. The first of these is the *Grevillea robusta*, or Silky Oak tree at the front entrance. The tree is a semi mature example of the species that has a poorly structured basal root plate. This will have developed following it being planted too high in the soil profile. Surface erosion may have also contributed to this. The result is that the tree has a structural root network that is shallow rooted and partially exposed. This and the visible surface decay noted (See **Figure 1**) have compromised the tree's structural integrity.

7.2 The *G. robusta* species is better suited for riverside gullies and wet forests. This location is high in the local topography and set within an area providing limited access to appropriate soil moisture and nutrient requirements. The tree will continue to struggle to form a well structured canopy and will be prone to both canopy and total basal failure.

**Figure 1** Shows the poor basal development of the Silky Oak documented as Tree 2.

7.3 The foliage and fruit of *G. robusta* also contain hydrogen cyanide and is know to be responsible for contact dermatitis. [https://en.wikipedia.org/wiki/Grevillea\\_robusta](https://en.wikipedia.org/wiki/Grevillea_robusta). The location of the tree, adjacent to the front entrance increases exposure to a larger target, it is of limited amenity and Low Value. Recommended for removal irrespective of the proposed development.

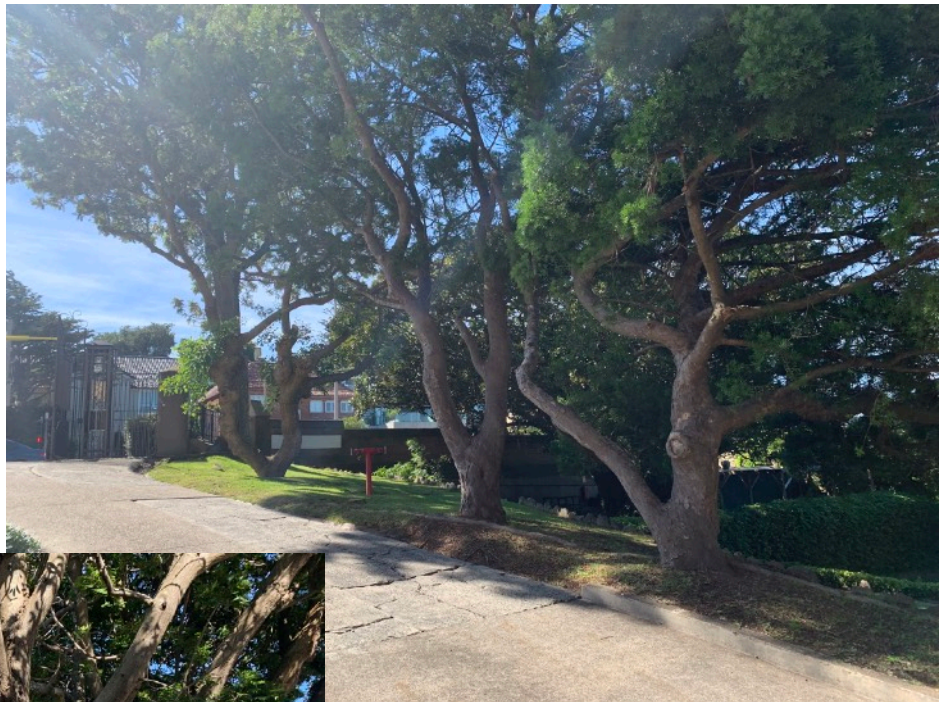
6.4 Tree 3 is a well established *Erythrina x sykesii*, or Coral tree. This tree has grown to a height of approximately 8m and is supported on a co dominate trunk that forks at 40cm above ground level. The tree is on Woollahra Council's noxious and exempt tree species list and can be removed without seeking formal approval.

6.5 Trees 4, 5 and 6 are all semi mature *Podocarpus elatus* or Plum Pines. These are a well suited native tree species that have established here. The largest of these (Tree 6) is supported on a trunk of over 90cm in diameter and all can be described as mature examples of this native tree species. All are required for removal to allow for the proposed.

**Figure 2** Shows the Podocarpus and Coral trees documented as Trees 3, 4 and 5.

7.4 The adjacent *E. sykesii*, or Coral tree is an exempt tree species under Woollahra Councils Tree Preservation Legislation and can be removed without seeking formal approval. The tree is however a well structured example of the species and is a cultivar that is less vigorous.

7.5 Trees 4, 5 and 6 are well established examples of their species located on the upper edge of the boundary wall. The proposed works will require their removal. The arboricultural amenity of these should be considered and replacement trees installed to maintain this over time.

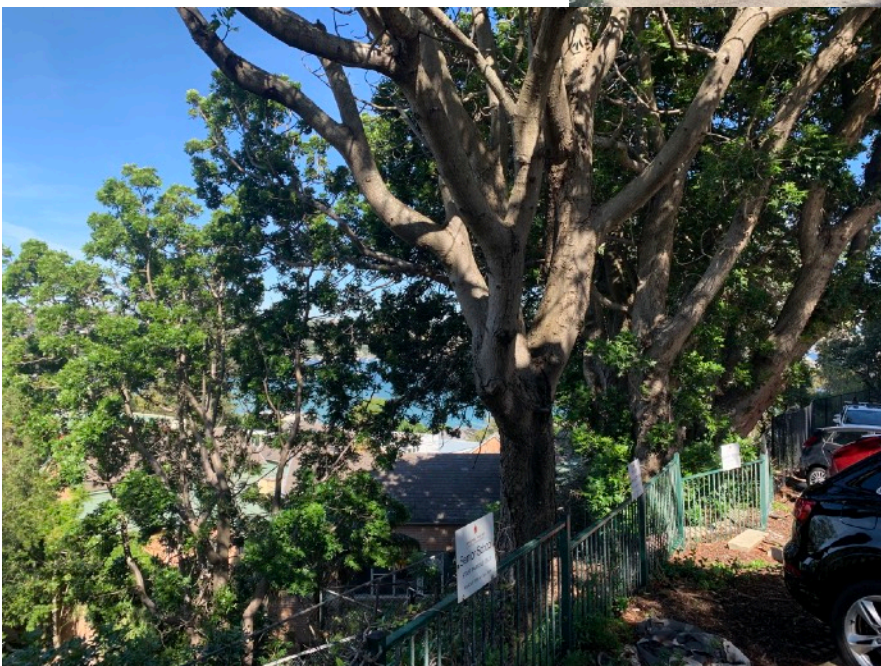
6.10 Trees 11,12 and 13 are all *Harpephyllum caffrum* species. All are well established and mature examples of this exotic tree species. Tree 12 is the largest and will likely have been the first planted. All have grown to over 10m and remain a fraction of their biological potential. All are within 1.5m of the sandstone retaining wall that supports this elevated parking area. Moderate significance but required for removal.

7.7 Trees 11,12 and 13 are the largest trees recommended for removal. As noted, these are all *Harpephyllum caffrum*. This is an exotic tree species and they remain a fraction of their full biological potential and will continue to grow beyond the size suitable for this location. This has affected the historic sandstone boundary and retaining wall and will force it out further in time.

7.8 Tree 12 has developed with a partially included base. This is a structural fault that can lead to the failure of the sub dominant leader. This is a large diameter portion of the tree and will impact on a neighbouring residence. All trees have been considered as being of Moderate value and are required for removal to allow for the proposed development.

**Figure 3** Shows the African Plum trees documented as Trees 11,12 and 13 required for removal.

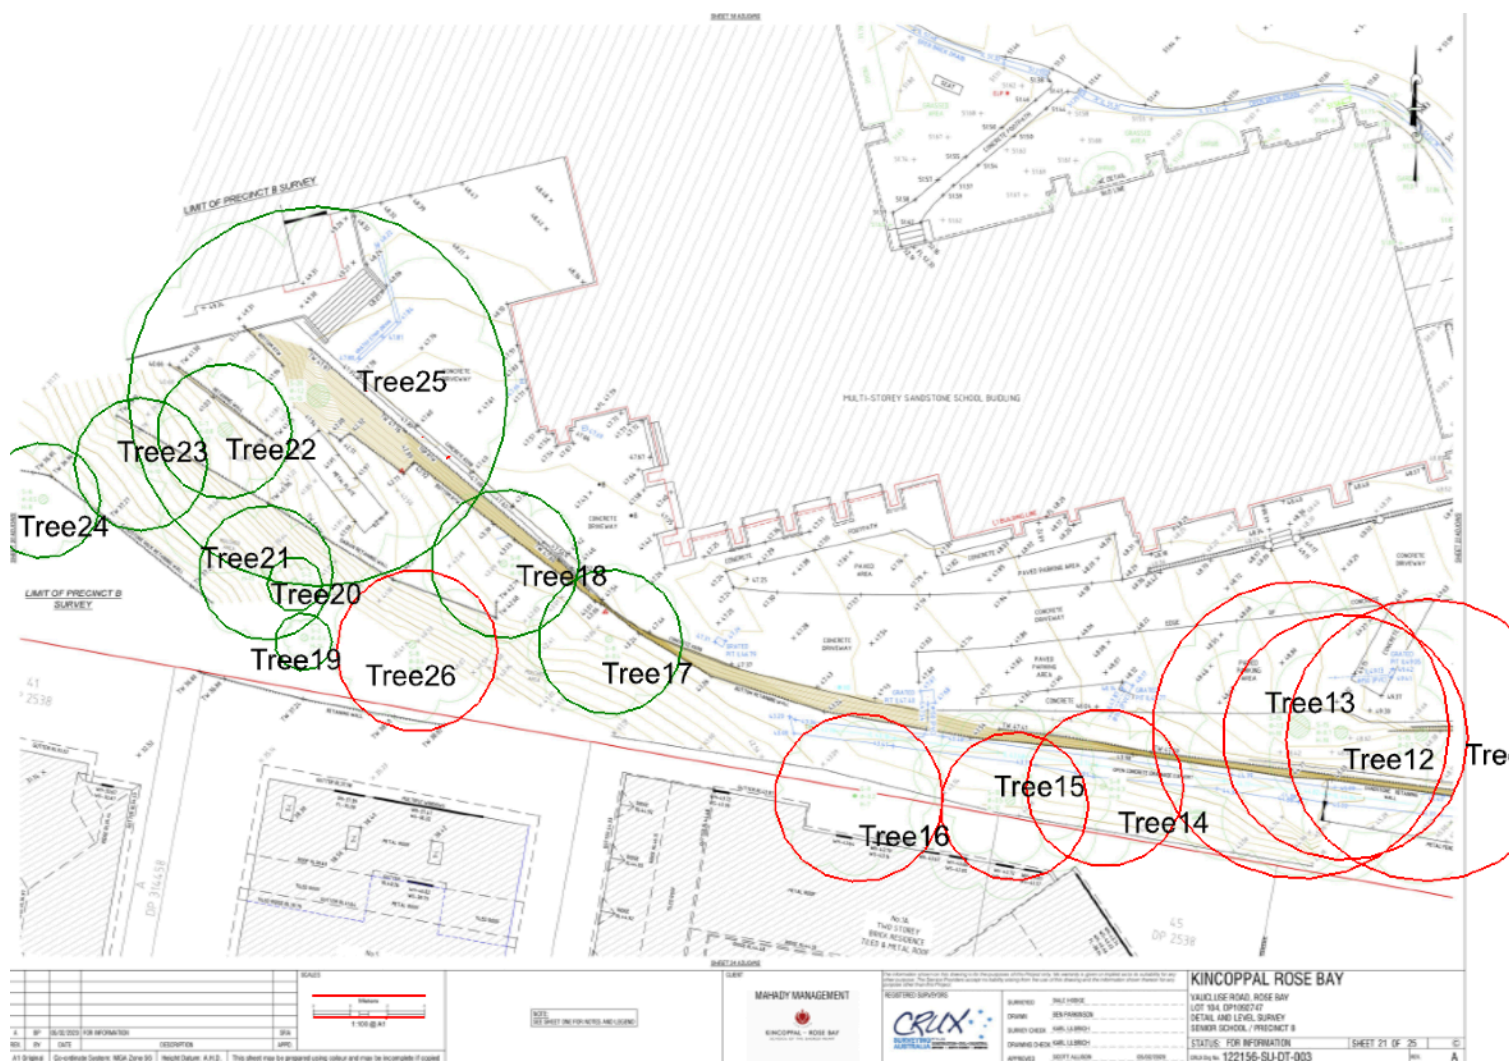
**Figure 5** Shows the locations of the documented trees in relation to existing driveway.

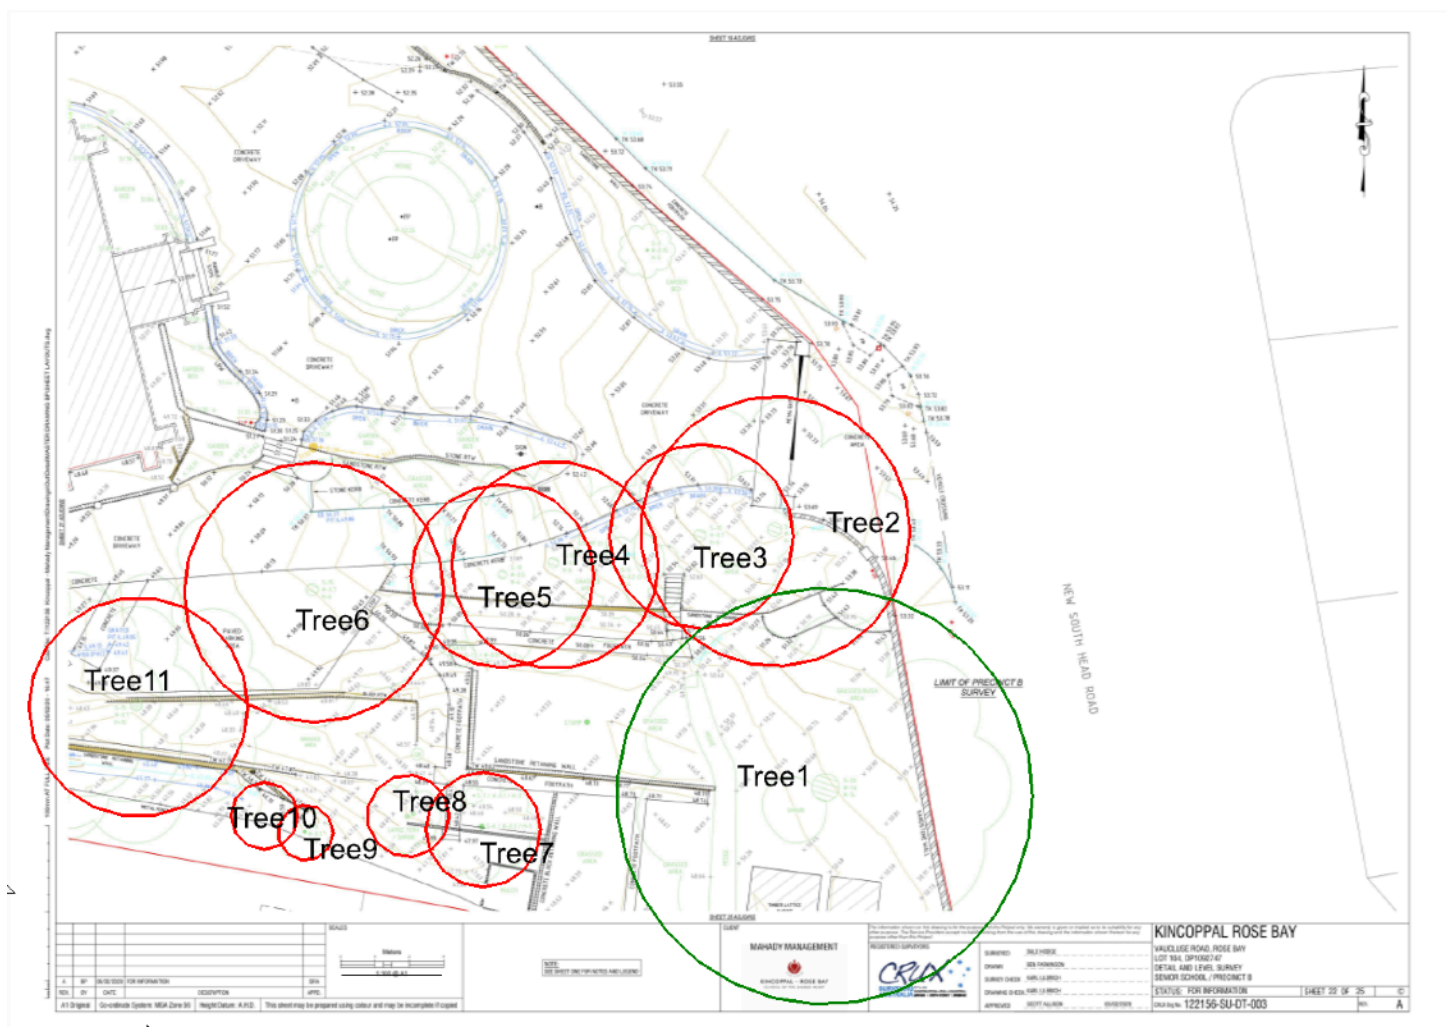
**Figure 6** Shows the remainder of the trees documented in relation to the existing structures and topography.
