ARBORICULTURAL IMPACT ASSESSMENT

**Sydney Olympic Park
new high school
7-9 Burroway Road, Wentworth Point**

Prepared for: CADENCE AUSTRALIA

27th August 2021
Revision F

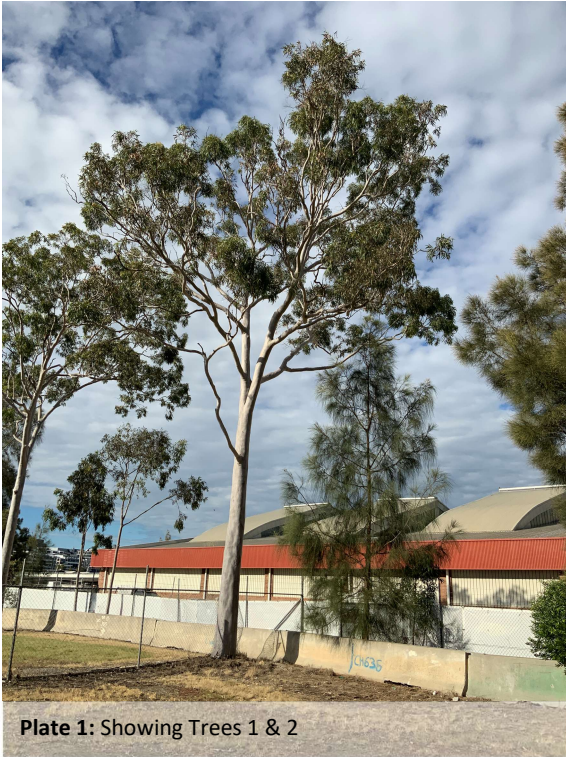
Plate 1: Showing Trees 1 & 2

Tree 1 is a mature *Corymbia maculata* (Spotted Gum) which is located in the southern area of the site. The tree is of good health and structural condition. Tree 1 is of moderate Landscape Significance and has been allocated a Retention Value of *Consider for Retention*.

Trees/Tree Groups 2, 4, 5, 7-12, 20 and 22-26 are groups of young, semi-mature and mature *Casuarina glauca* (Swamp She Oak) which are located across the site. The trees are of low Landscape Significance and have been allocated a Retention Value of *Consider for Removal*.

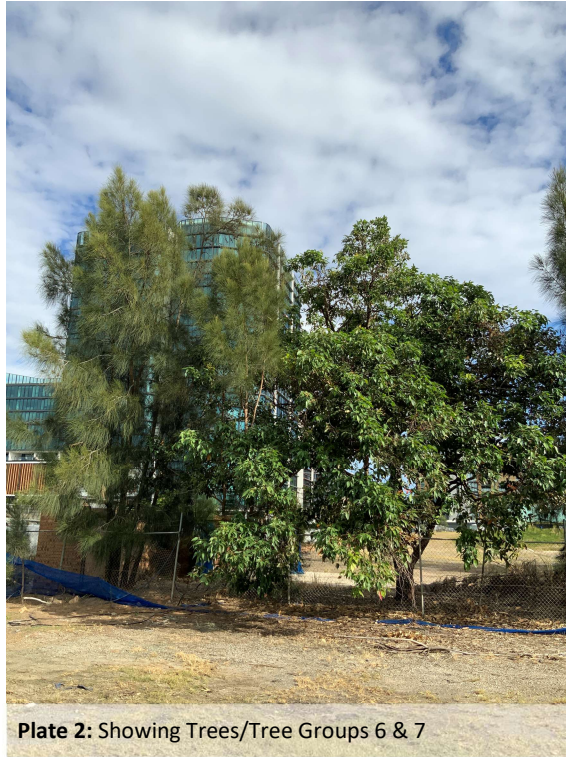
Plate 2: Showing Trees/Tree Groups 6 & 7

Tree 6 is a mature *Eucalyptus robusta* (Swamp Mahogany) which is located in the southern area of the site. The tree is of good health and structural condition. Tree 6 is of moderate Landscape Significance and has been allocated a Retention Value of *Consider for Retention*.

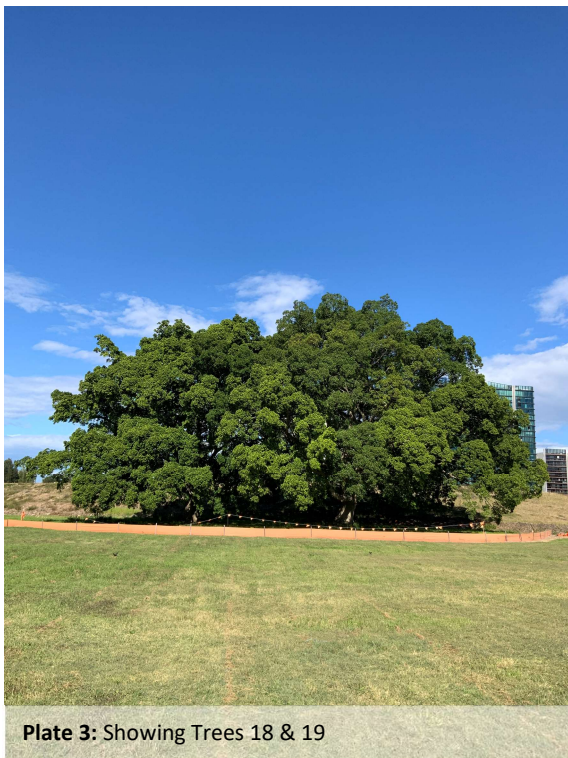
Plate 3: Showing Trees 18 & 19

Trees 18 and 19 are mature *Ficus microcarpa* var. 'Hillii' (Hills Weeping Fig) located in the northern area of the site. The trees are of high Landscape Significance and have been allocated a Retention Value of *Priority for Retention*.

3.2.11 The supplied plans show no works are proposed with the TPZ areas of Trees 18 and 19.
