# Safe Useful Life Expectancy tree report

Proposed new clinical building

Blacktown Hospital Blacktown Road, Blacktown

Date: 15 August 2012 Prepared for: Health Infrastructure Prepared by: Abel Ecology

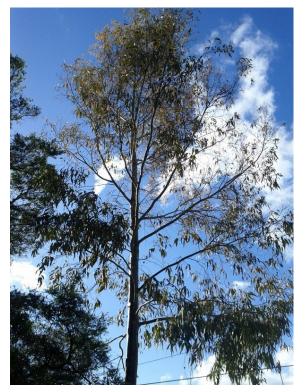
Tree 9

Tree no.	Tree name	Problem
9	Corymbia maculata	On inspection this tree appeared to be in very poor heath and had significant die-back in it's canopy. If the canopy continues to diminish it will result in the death of this tree.

Iree no.	Species	Age class	Height (m)	d.b.h. (cm)	Rac	lius	Vitality	Condition	SULE	Comments
6	Corymbia maculata	SM	8	29	N S E W	2 2 2 2	F	F	3A	thinning canopy, dw, ep
7	Corymbia maculata	SM	9	30	N S E W	2 2 2 2	G	G	1A/ 2A	localised ep, dw due to shading
8	Corymbia maculata	SM	8	30	N S E W	2.5 2 2 2	G	G	1A/ 2A	dw due to shading
9	Corymbia maculata	SM	8	26	N S E W	3 2 2 3	Ρ	Ρ	4A	ep, dw, TW at base of tree, large scale canopy dieback
