Flora and Fauna Assessment including Arborist Report

Flora and fauna assessment report

Kempsey District Hospital

Document No: 1123-REP-23-ISS-6

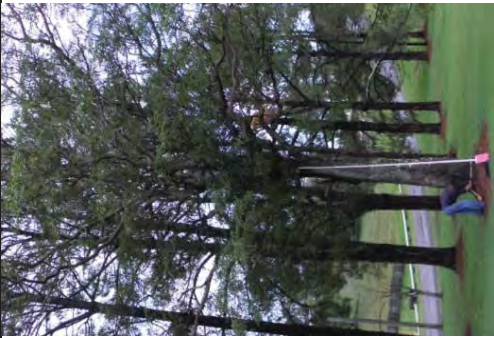
Tree no.	Species	Age class	Height (m)	Diam. At base (cm)	d.b.h. (cm)	Radius	Vitality	Condition	TPZ Full/reduced (m)	SRZ (m)	SULE	Comments
TR 2	Brush Box Lophostemon conferus	M	12	101	81	N S E W 4 5 4 10	E	E	9.72/ 6.68	3.32	1A

<p>Retain. Tree protection fence required. No encroachment by trench for High voltage power line.</p>

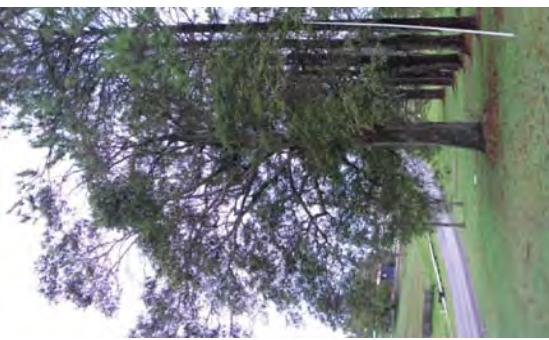
Tree no.	Species	Age class	Height (m)	Diam. At base (cm)	d.b.h. (cm)	Radius	Vitality	Condition	TPZ Full/reduced (m)	SRZ (m)	SULE	Comments
TR 3	Brush Box Lophostemon conferus	M	10	107	87	N S E W 5 3 3 3	E	E	10.44/ 7.17	3.4	1A

<p>Tree protection fence required Clearance distance variable to encroachment by excavation for sewer access chamber excavation. New sewer pipe by underboring Adjacent filling for batter. Isolate by means of works corridor fencing</p>
TR 6	Camphor Laurel Cinnamomum camphora

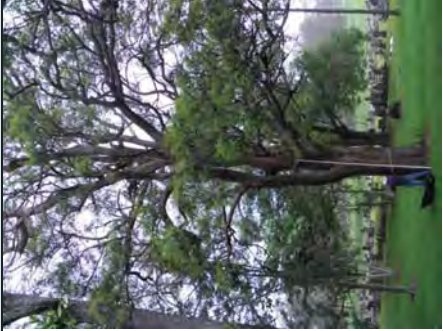
Tree no.	Species	Age class	Height (m)	Diam. At base (cm)	d.b.h. (cm)	Radius	Vitality	Condition	TPZ Full/ reduced (m)	SRZ (m)	SULE	Comments
TR 16	Tallowood <i>Eucalyptus microcorys</i>	M	18	150	102	N 14.5 S 10 E 8 W 8	G	E	12.24/ 8.41	3.63	1A

<p>Tree protection fence required Isolate by means of works corridor fencing CD, DW, dw. Minimum 8.41m clearance distance upslope side</p>

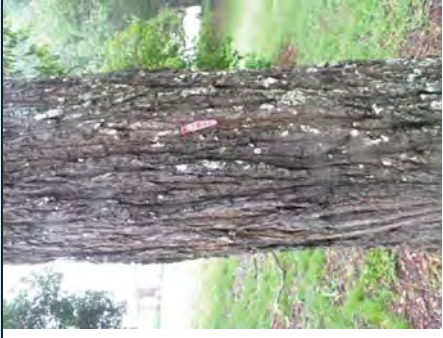
Tree no.	Species	Age class	Height (m)	Diam. At base (cm)	d.b.h. (cm)	Radius	Vitality	Condition	TPZ Full/reduced (m)	SRZ (m)	SULE	Comments
TR 17	Ironbark <i>Eucalyptus</i> sp.	M	18	98	77	N S E W 13 8 8 8	E	E	9.24/ 6.35	3.28	1A

<p>Tree protection fence required Minimum 6.35m clearance distance upslope side</p>
TR 18	<i>Gordonia axillaris</i> . Exotic shrub related to <i>Camellias</i> .					N S E W 4

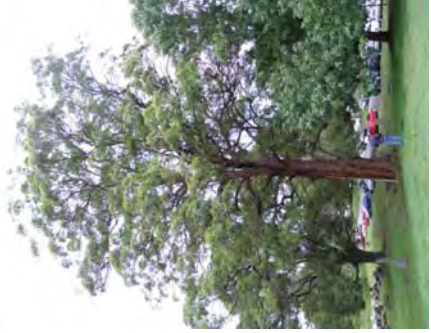
Tree no.	Species	Age class	Height (m)	Diam. At base (cm)	d.b.h. (cm)	Radius	Vitality	Condition	TPZ Full/ reduced (m)	SRZ (m)	SULE	Comments
TR 29	Tallowwood <i>Eucalyptus microcorys</i>	M	20	188	154	N 14 S 16 E 15.5 W 13.5	E	E	15.00/ 10.31	3.63	1A

<p>Tree protection fence required all around Minimum 10.0m clearance distance upslope side</p>

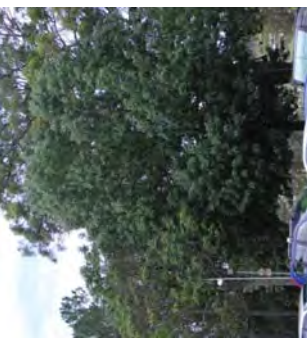
Tree no.	Species	Age class	Height (m)	Diam. At base (cm)	d.b.h. (cm)	Radius	Vitality	Condition	TPZ Full/reduced (m)	SRZ (m)	SULE	Comments
TR 30	Liquid Amber <i>Liquidambar sp.</i>	M	12	68	59	N 9.5 S 7.3 E 9 W 10.2	E	E	7.08/ 4.86	2.81	1A

<p>Tree protection fence required Minimum 4.86m clearance distance upslope side</p>

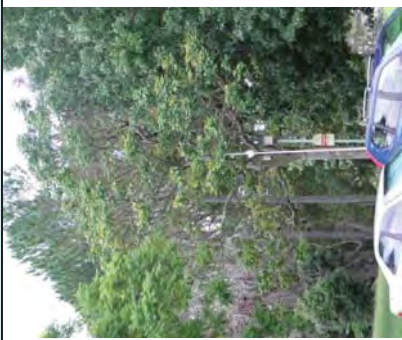
Tree no.	Species	Age class	Height (m)	Diam. At base (cm)	d.b.h. (cm)	Radius	Vitality	Condition	TPZ Full/ reduced (m)	SRZ (m)	SULE	Comments
TR 31	<i>Spathodea campanulata</i> EXOTIC ORNAMENTAL TREE FROM AFRICA	M	9	56	42	N S E W 4.5 4.5 6 7.2	F	F	5.04/ 3.46	2.59	2D

<p>Tree protection fence required 3.46m toward stormwater trench and 5.04m downslope. Dw, ep</p>

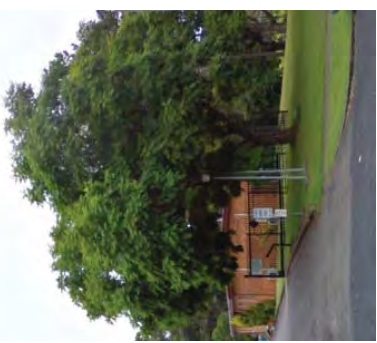
Tree no.	Species	Age class	Height (m)	Diam. At base (cm)	d.b.h. (cm)	Radius	Vitality	Condition	TPZ Full/reduced (m)	SRZ (m)	SULE	Comments
TR 32	Jacaranda Jacaranda mimosifolia	M	5	35	35	N 4 S 3 E 3 W 3	E	E	2.5	2	1A

<p>Provide tree protection fence if trenches are dug near this tree</p>
TR 33	Crepe Myrtle shrub. Exotic ornamental shrub					N S E W

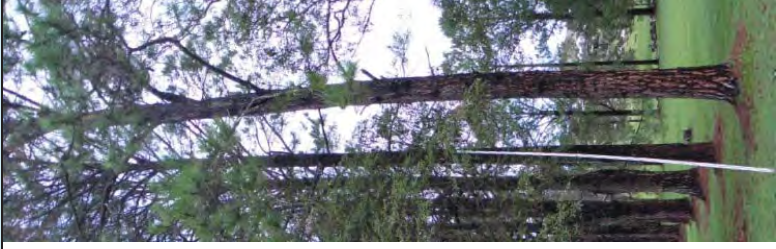
Tree no.	Species	Age class	Height (m)	Diam. At base (cm)	d.b.h. (cm)	Radius	Vitality	Condition	TPZ Full/reduced (m)	SRZ (m)	SULE	Comments
PINE 60	Radiata Pine	M	18	73	56	N 3 S 3 E 3 W 7	G	G	6.72/ 4.62	2.9	2B

<p>Tree protection fence required Clearance distance 2.9m</p>

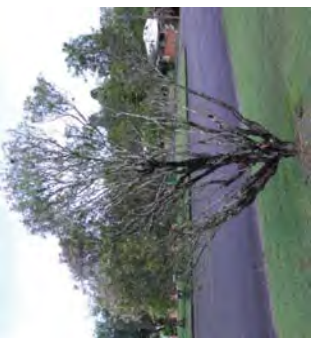
Tree no.	Species	Age class	Height (m)	Diam. At base (cm)	d.b.h. (cm)	Radius	Vitality	Condition	TPZ Full/reduced (m)	SRZ (m)	SULE	Comments
TR 61	<i>Callistemon viminalis</i> Native shrub	M	4	10	NA	N S E W 2	P	P	NA	NA	4D

Shrub. Recommend removal
T 62	Jacaranda Jacaranda mimosifolia	SM	4	10	NA	N S E W 2	F	F	2	2	4D

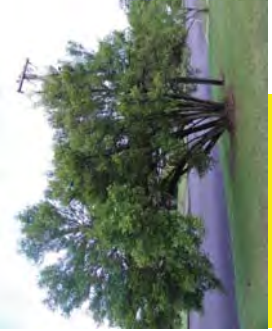
Tree no.	Species	Age class	Height (m)	Diam. At base (cm)	d.b.h. (cm)	Radius	Vitality	Condition	TPZ Full/reduced (m)	SRZ (m)	SULE	Comments
T 63	Cheese Tree <i>Glochidion ferdinandi</i> Shrub form	M	4	NA	NA	N S E W 5	G	G	NA	NA	1B

Recommend removal for flight path
T 64	<i>Callistemon viminalis</i>	M	5	15	NA	N S E W 2	F	G	NA	NA	3D

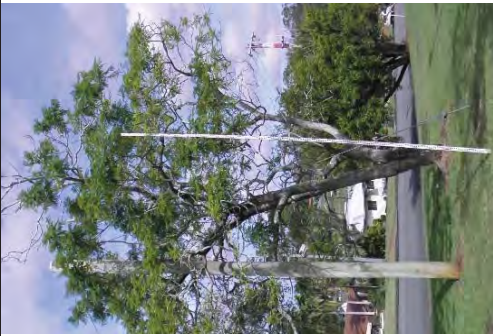
Tree no.	Species	Age class	Height (m)	Diam. At base (cm)	d.b.h. (cm)	Radius	Vitality	Condition	TPZ Full/reduced (m)	SRZ (m)	SULE	Comments
T 65	Jacaranda Jacaranda mimosifolia	M	6	20	50	N S E W 5	F	F	6.00/ 4.12	NA	2D

<p>Recommend removal for flight path. DW, dw, CD, CB, TL, TW</p>

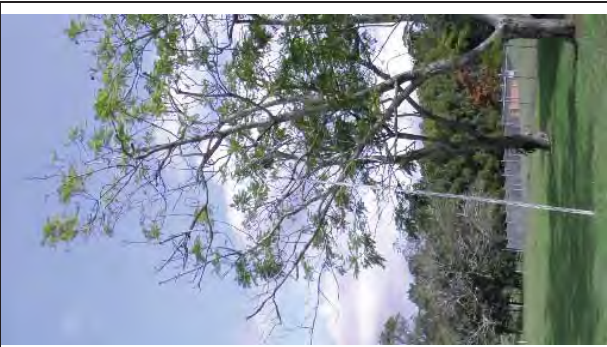
Tree no.	Species	Age class	Height (m)	Diam. At base (cm)	d.b.h. (cm)	Radius	Vitality	Condition	TPZ Full/reduced (m)	SRZ (m)	SULE	Comments
T 66	Jacaranda Jacaranda mimosifolia	W	7	29	29	N S E W 4.5	F	F	3.48/ 2.39	NA	3D

<p>Recommend removal for flight path</p>

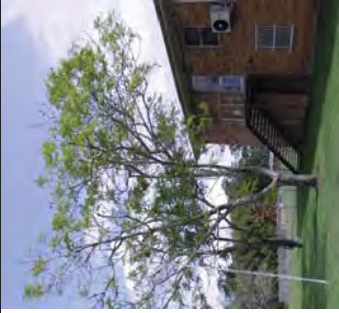
Tree no.	Species	Age class	Height (m)	Diam. At base (cm)	d.b.h. (cm)	Radius	Vitality	Condition	TPZ Full/reduced (m)	SRZ (m)	SULE	Comments
T 67	Jacaranda Jacaranda mimosifolia	M	8	NA	34	N S E W 5.4	G	F	4.08/ 2.8	NA	1B

Remove for construction
T 69	Jacaranda Jacaranda mimosifolia	M	6	25	24	N S E W 2	P	P	2.88/ 2.00	NA	4A

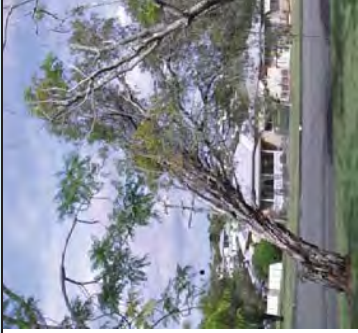
Tree no.	Species	Age class	Height (m)	Diam. At base (cm)	d.b.h. (cm)	Radius	Vitality	Condition	TPZ Full/reduced (m)	SRZ (m)	SULE	Comments
T 70	<i>Callistemon viminalis</i>	M	5	NA	20	N S E W	F	P	NA	NA	4C

Recommend removal. CB, TL, dw, TW
T 71	<i>Jacaranda Jacaranda mimosifolia</i>	M	6	NA	24	N S E W 3.8	F	F	2.88/ 2.00	NA	2D

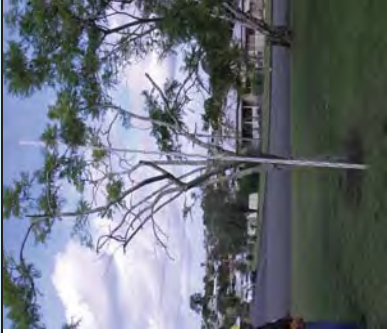
Tree no.	Species	Age class	Height (m)	Diam. At base (cm)	d.b.h. (cm)	Radius	Vitality	Condition	TPZ Full/ reduced (m)	SRZ (m)	SULE	Comments
72	Jacaranda Jacaranda mimosifolia	SM	6	NA	17	N S E W 3	P	P	2.04/ 2.00	NA	4A

Dying. Recommend removal.
T 73	Jacaranda Jacaranda mimosifolia	SM	5	NA	26	N S E W 1.8	P	P	3.12/ 2.14	NA	4A

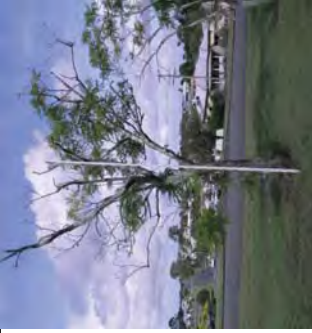
Dying. Recommend removal.

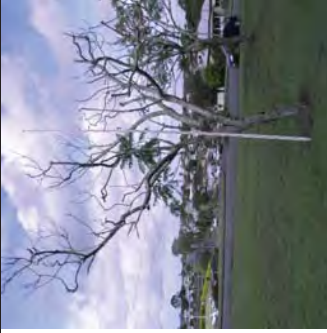
Tree no.	Species	Age class	Height (m)	Diam. At base (cm)	d.b.h. (cm)	Radius	Vitality	Condition	TPZ Full/reduced (m)	SRZ (m)	SULE	Comments
T 74	Jacaranda Jacaranda mimosifolia	SM	5	NA	20	N S E W 1	P	P	2.4/ 2.00	NA	4A

Dying, Recommend removal
T 75	Jacaranda Jacaranda mimosifolia	M	6	35	30	N S E W 4.3	G	G	3.6/ 2.47	NA	1B

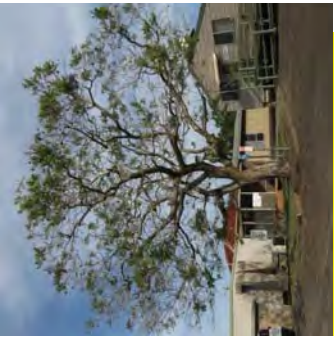
Tree no.	Species	Age class	Height (m)	Diam. At base (cm)	d.b.h. (cm)	Radius	Vitality	Condition	TPZ Full/reduced (m)	SRZ (m)	SULE	Comments
T81	Jacaranda Jacaranda mimosifolia	M	7	70	70	N S E W	5 5 4 5	G	8.40/ 5.77	2.85	1A	Flush cut branch at 1.2 m. Previously lopped. TW, dw.

REMOVE for car parking and ambulance access

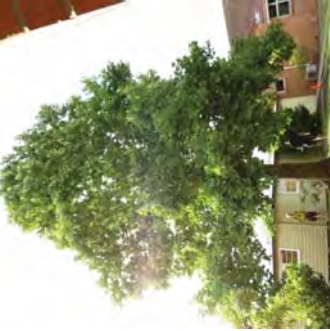
Tree no.	Species	Age class	Height (m)	Diam. At base (cm)	d.b.h. (cm)	Radius	Vitality	Condition	TPZ Full/reduced (m)	SRZ (m)	SULE	Comments
T82	Liquid Amber <i>Liquidambar sp.</i>	M	18	110	55	N S E W 5 4 5 6	E	E	6.6/ 4.53	3.44	1A	Lower branches trimmed. Flush cut. Multiple trunks at 8 m

Proposed to retain with tree protection
F100	Fig tree <i>Ficus rubiginosa</i>	M	7	90	64	N S E W 5 5 5 5	P	P	7.68/ 5.28	3.17	4A

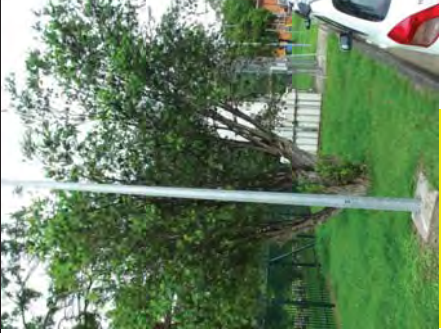
Tree no.	Species	Age class	Height (m)	Diam. At base (cm)	d.b.h. (cm)	Radius	Vitality	Condition	TPZ Full/reduced (m)	SRZ (m)	SULE	Comments
TR 105	Callistemon Shrub	M

Remove for car park
T 106	Shrub	M	5	25	NA	1.5

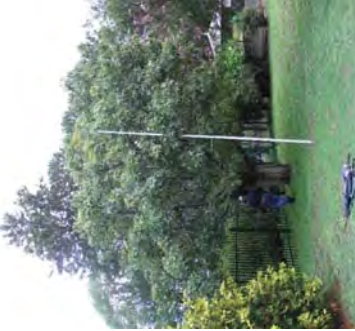
Tree no.	Species	Age class	Height (m)	Diam. At base (cm)	d.b.h. (cm)	Radius	Vitality	Condition	TPZ Full/reduced (m)	SRZ (m)	SULE	Comments
T 107	Illawarra Flame Tree <i>Brachychiton acerifolius</i>	SM	6	65	62	N S E W	E	E	7.44/ 5.11	2.76	1A

<p>CD, TW. Available clearance distance 2.5m north, 5m south, inadequate for tree survival. Provide whatever protection space is available and accept a moderate risk to the tree. Branch pruning may be required.</p>

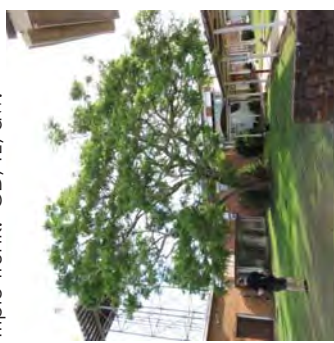
Tree no.	Species	Age class	Height (m)	Diam. At base (cm)	d.b.h. (cm)	Radius	Vitality	Condition	TPZ Full/reduced (m)	SRZ (m)	SULE	Comments
T 108	Jacaranda Jacaranda mimosifolia	M	11	70	35 40 30 (105)	N S E W		G	12.6/ 8.66	2.85	1A	<div>

<p>Triple trunk. CD, TL, dw. Proposed to REMOVE for building</p> </div>

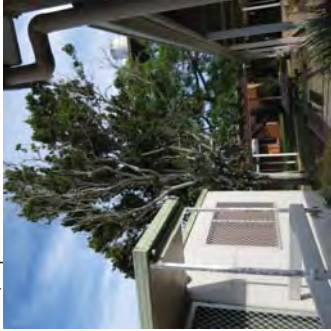
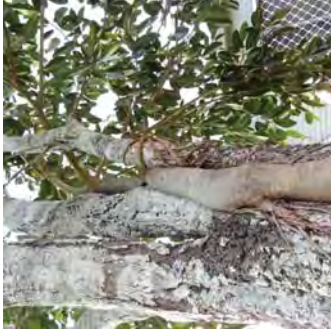
Tree no.	Species	Age class	Height (m)	Diam. At base (cm)	d.b.h. (cm)	Radius	Vitality	Condition	TPZ Full/reduced (m)	SRZ (m)	SULE	Comments
T 109	Firewheel Tree <i>Stenocarpus sinuatus</i>	M	10	60	45	N S E W 2 3 3 4	F	F	5.4/ 3.71	2.67	1B	Juvenile Rusty Fig <i>Ficus rubiginosa</i> on tree. DW, ep.

Proposed to REMOVE for building

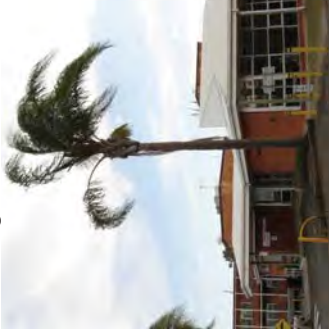
Tree no.	Species	Age class	Height (m)	Diam. At base (cm)	d.b.h. (cm)	Radius	Vitality	Condition	TPZ Full/reduced (m)	SRZ (m)	SULE	Comments
TR 110	Bangalow Palm <i>Archontophoenix cunninghamiana</i>	M	10	65	35	N S E W 4 4 4 4	G	G	5/5	5	2C	Elevated garden

Proposed to REMOVE for building. Suitable to relocate.
TR 111	Bangalow Palm <i>Archontophoenix cunninghamiana</i>	M	10	60	30	N S E W 2 2 2 2	G	G	3/3	3	2C	Elevated garden

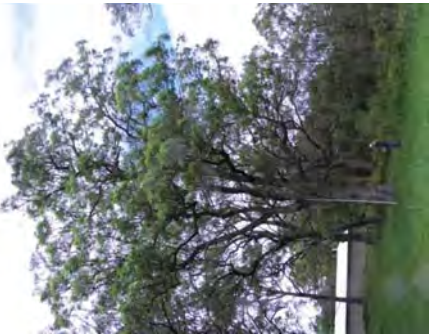
Tree no.	Species	Age class	Height (m)	Diam. At base (cm)	d.b.h. (cm)	Radius	Vitality	Condition	TPZ Full/ reduced (m)	SRZ (m)	SULE	Comments
TR 120	Stringybark <i>Eucalyptus umbra</i>	M	18	123	100	N 11.2 S 7.3 E 6.9 W 10	E	E	12.00/ 8.24	3.61	1A

<p>Tree protection fence required 8.24m clearance distance from trench. CD, DW, dw</p>

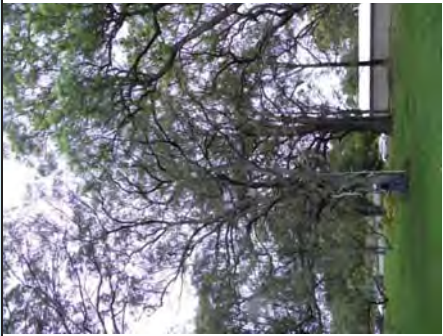
Tree no.	Species	Age class	Height (m)	Diam. At base (cm)	d.b.h. (cm)	Radius	Vitality	Condition	TPZ Full/ reduced (m)	SRZ (m)	SULE	Comments
TR 121	Stringybark <i>Eucalyptus umbra</i>	M	15	112	104	N 13.5 S 9 E 11 W 8.3	F	G	12.48/ 8.57	3.47	2D

<p>Tree protection fence required 8.57m clearance distance from trench.</p>

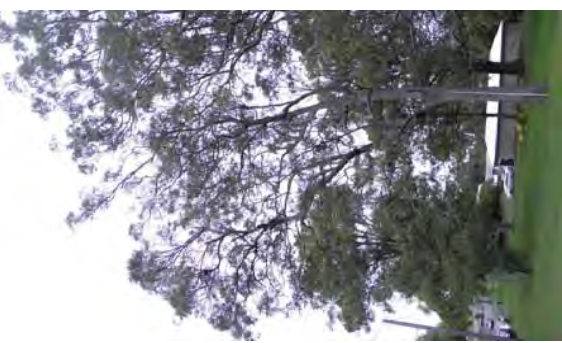
Tree no.	Species	Age class	Height (m)	Diam. At base (cm)	d.b.h. (cm)	Radius	Vitality	Condition	TPZ Full/reduced (m)	SRZ (m)	SULE	Comments
TR 124	Bloodwood <i>Corymbia intermedia</i>	M	18	109	82	N 12 S 11 E 11.5 W 2.7	G	F	9.84/ 6.76	3.43	1B

Remove for car park CL, dw

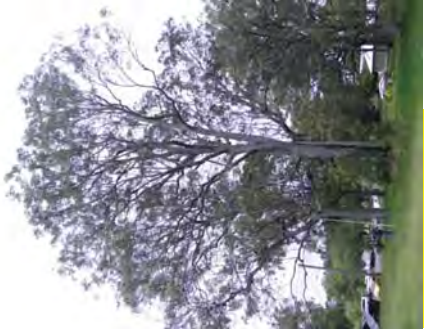
Tree no.	Species	Age class	Height (m)	Diam. At base (cm)	d.b.h. (cm)	Radius	Vitality	Condition	TPZ Full/reduced (m)	SRZ (m)	SULE	Comments
TR 125	Bloodwood <i>Corymbia intermedia</i>	M	20	134	113	N 15 S 13.7 E 11.5 W 9.5	E	E	13.56/9.3 2	3.63	1A

Remove for car park CD, dw

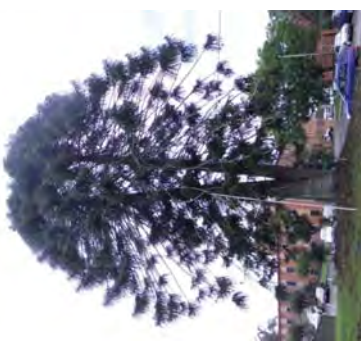
Tree no.	Species	Age class	Height (m)	Diam. At base (cm)	d.b.h. (cm)	Radius	Vitality	Condition	TPZ Full/reduced (m)	SRZ (m)	SULE	Comments
TR 126	Bunya Pine	M	12	127	110	N S E W 6.5 6.5 6.5 6.5	E	F	13.2/ 9.07	3.63	4C

CD, CB, Remove for car park

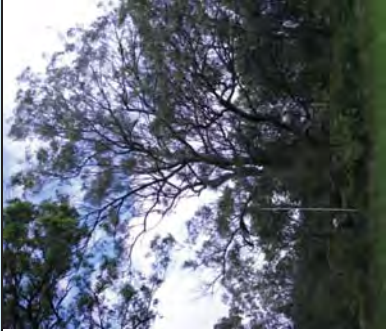
Tree no.	Species	Age class	Height (m)	Diam. At base (cm)	d.b.h. (cm)	Radius	Vitality	Condition	TPZ Full/reduced (m)	SRZ (m)	SULE	Comments
TR 131	Stringybark <i>Eucalyptus umbra</i>	M	10	72	75	N S E W 9 2 6 3	F	F	9.00/ 6.18	2.88	1A

<p>Tree protection fence required 6.18m clearance distance from trench. Tree on right. CB. TL.</p>

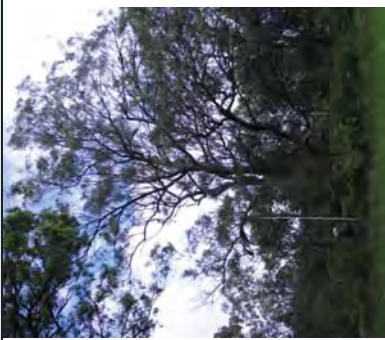
Tree no.	Species	Age class	Height (m)	Diam. At base (cm)	d.b.h. (cm)	Radius	Vitality	Condition	TPZ Full/reduced (m)	SRZ (m)	SULE	Comments
TR 132	Stringybark <i>Eucalyptus umbra</i> .	M	15	67	57	N 8 S 7 E 7.7 W 7	G	G	6.84/ 4.7	2.8	1A

<p>Tree on left. Tree protection fence required 4.7m clearance distance from trench.</p>
None	Kentia Palm (?)	M	3	15	15		E	E			1A

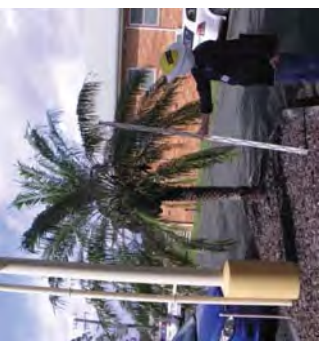
Tree no.	Species	Age class	Height (m)	Diam. At base (cm)	d.b.h. (cm)	Radius	Vitality	Condition	TPZ Full/ reduced (m)	SRZ (m)	SULE	Comments
None	Kentia Palm (?)	M	3	15	15		E	E			1A

SUITABLE TO RELOCATE

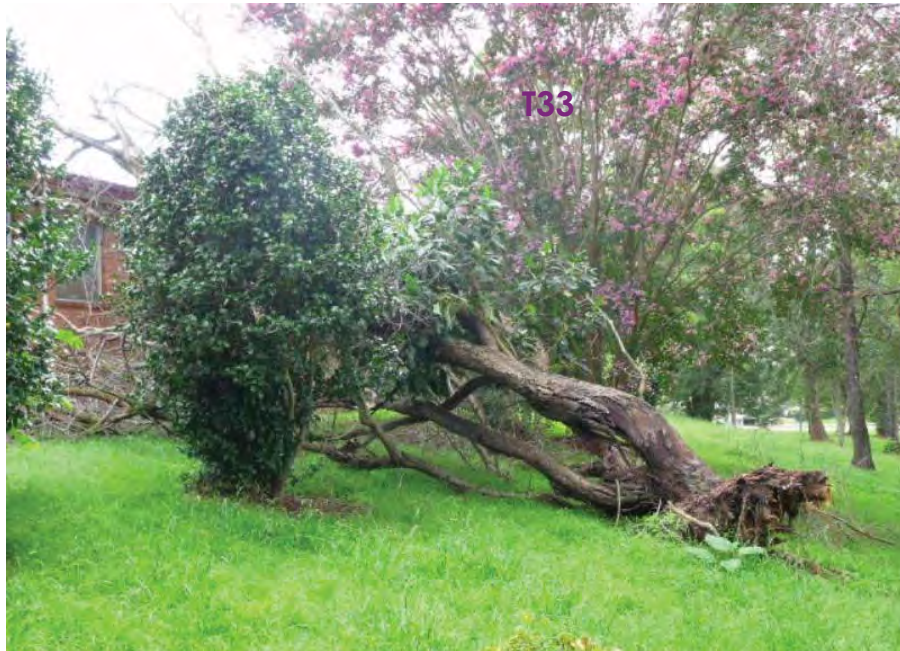
Figure 9. Fallen vegetation near Tree T33 may be cleared for the stormwater trench

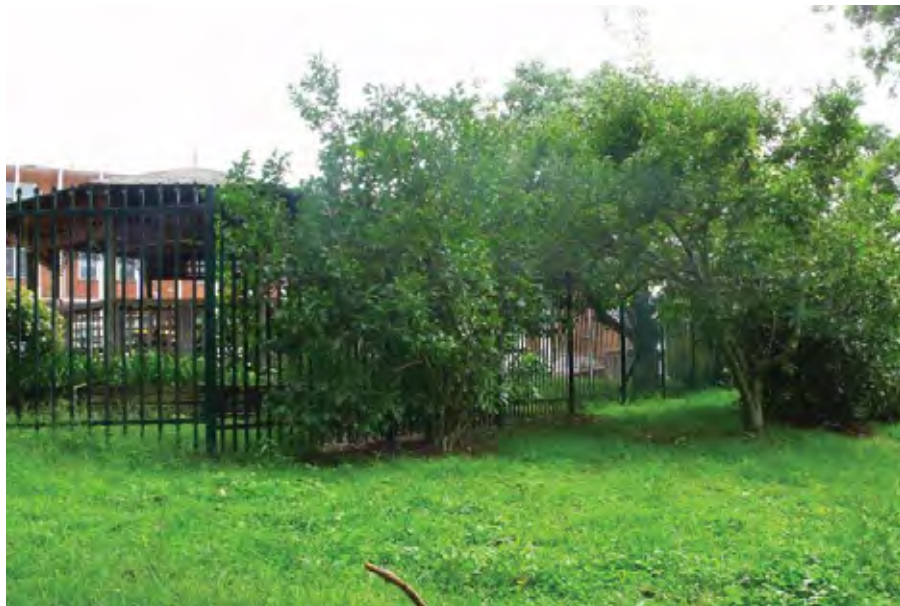
Figure 10. Vegetation near Tree T33 may be cleared for stormwater trench if required
