Tree Report

Wahroonga Adventist School
Fox Valley Road Wahroonga

For Stanton Dahl Architects Pty Ltd

March 2013

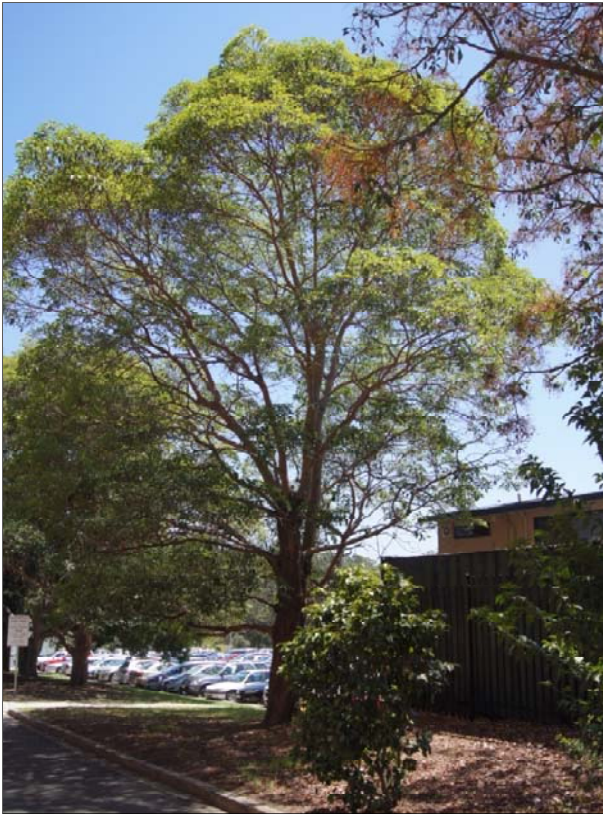
Tree 1 *Lophostemon confertus* (Brushbox), Tree 2 *Brachychiton acerifolius* (Illawarra Flame Tree) and Tree 3 *Jacaranda mimosifolia* (Jacaranda) are located in the accessway and would be retained with setbacks of approximately 7m from the proposed building.

Plate 1: Tree 1 *Lophostemon confertus* (Brushbox)

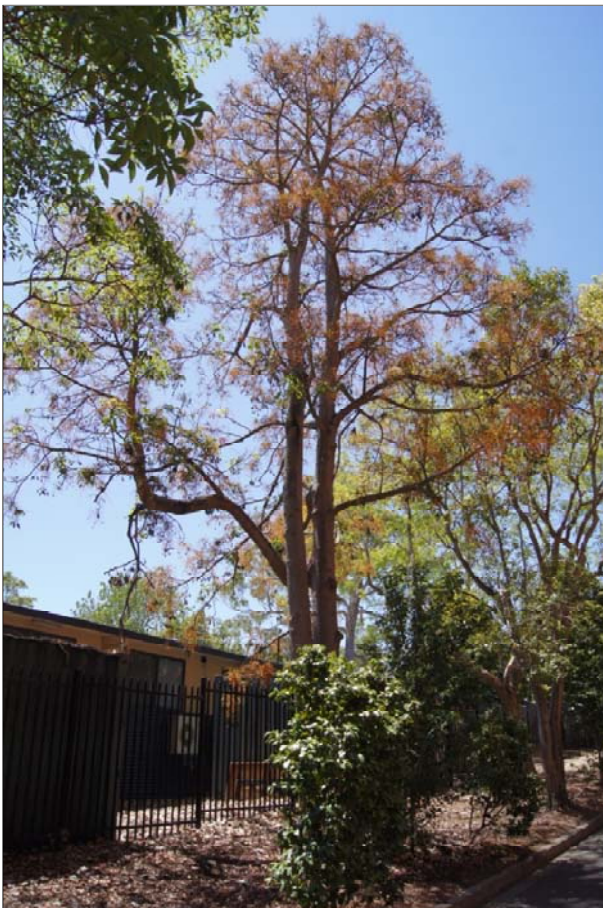
Plate 2: Tree 2 *Brachychiton acerifolius* (Illawarra Flame Tree)

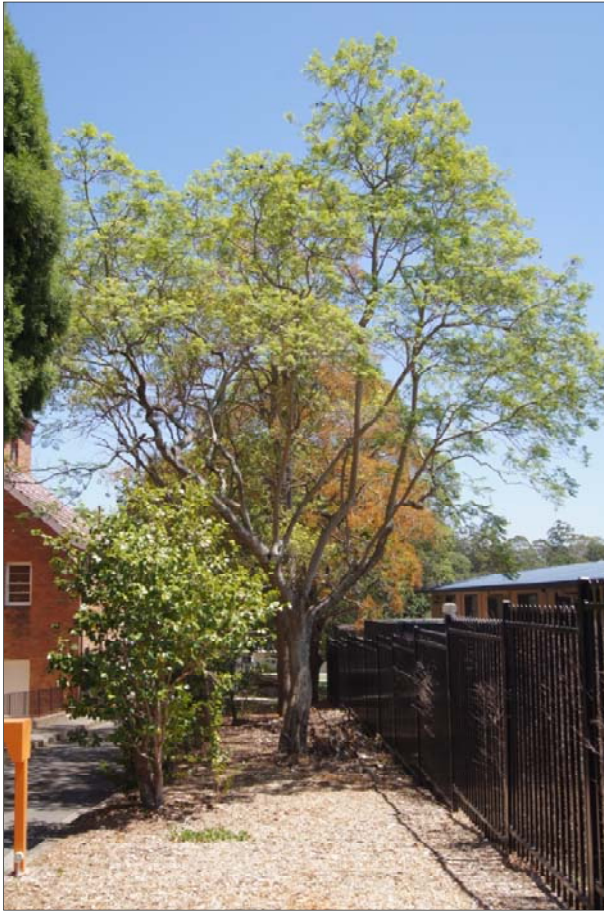
Plate 3: Tree 3 *Jacaranda mimosifolia* (Jacaranda)

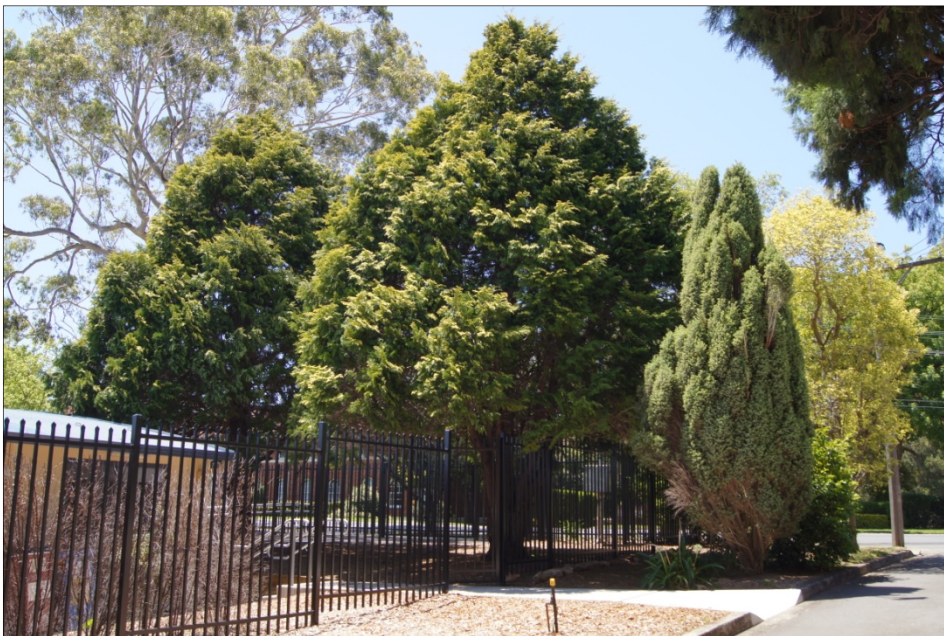
Tree 4 *Juniperus chinensis* (Chinese Juniper) is a poor specimen with a one-sided crown.

Trees 6 and 7 *Chamaecyparis obtusa* (Hinoki False Cypress) are located between the existing footpaths. These are a pair of conifers prominent in the street corner of the site. They are in good health and condition but are proposed to be removed in order to open up the corner as part of the school entry.

Plate 4: Trees 6 and 7 *Chamaecyparis obtusa* (Hinoki False Cypress); Tree 4 *Juniperus chinensis* (Chinese Juniper) to the right

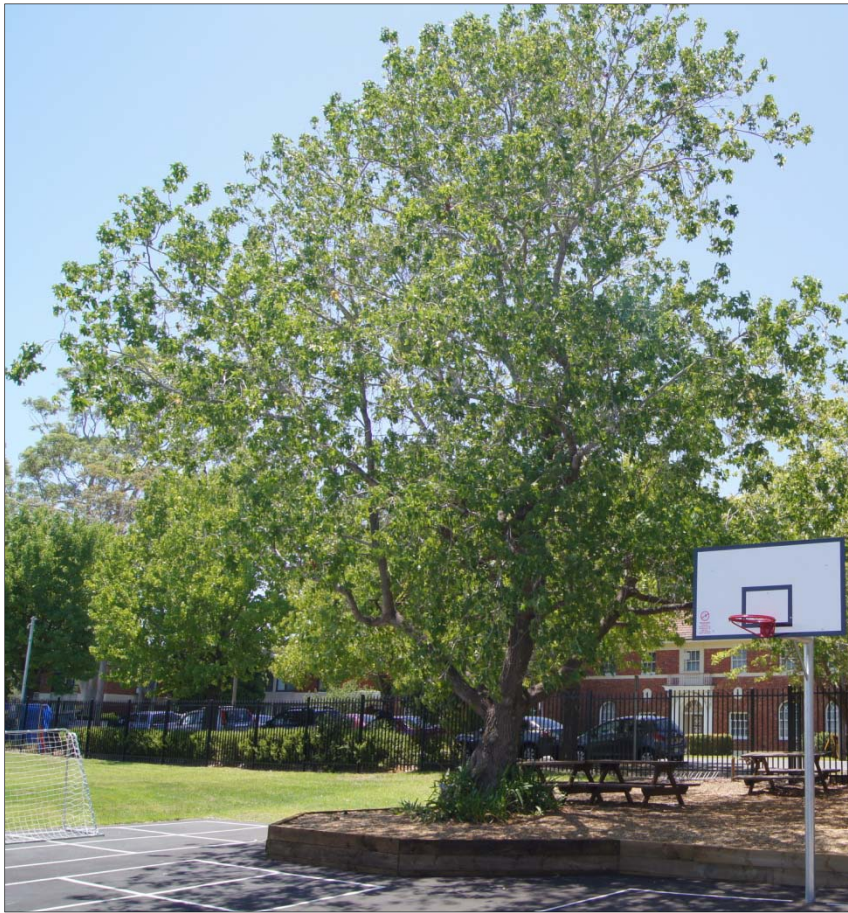
Tree 10 *Liquidambar styraciflua* (Liquidambar) is a large specimen and prominent in the landscape near the street frontage. It is approximately at the height below which the species becomes exempt from the provisions of the Ku-Ring-Gai Council Tree Preservation Order.

Plate 5: Tree 10 *Liquidambar styraciflua* (Liquidambar)

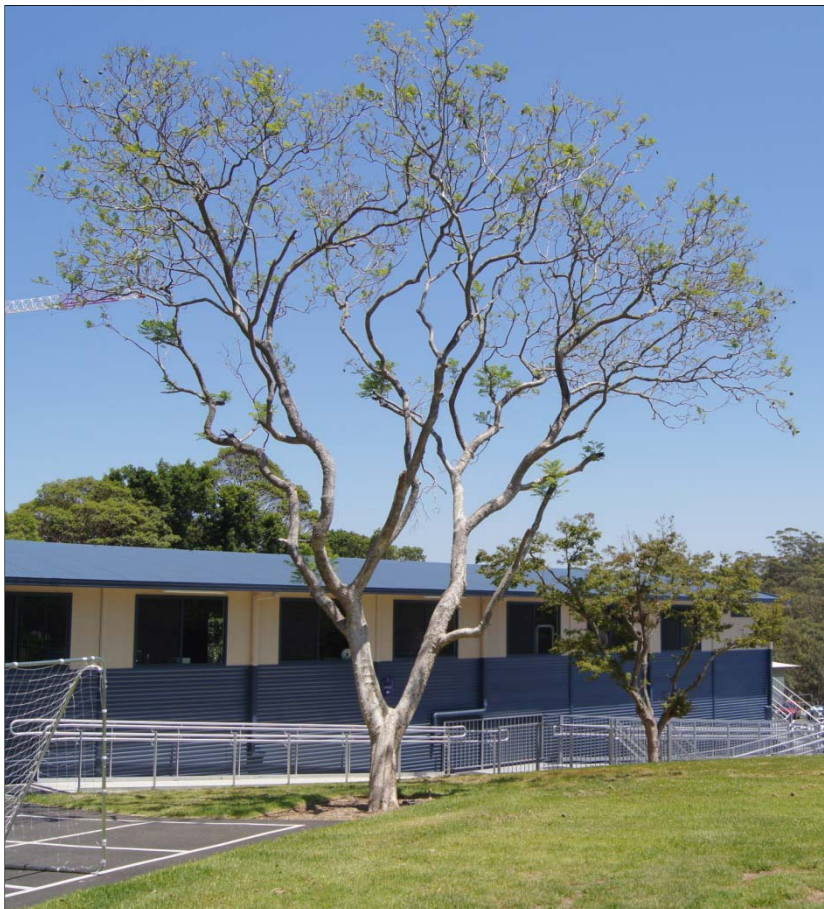
Tree 12 *Acer palmatum* (Japanese Maple) is sparse and stressed.

Tree 11 *Jacaranda mimosifolia* (Jacaranda) is a fair specimen but is not significant in the landscape and is not worthy of the changes to the design which its retention would require.

Plate 6: Tree 11 *Jacaranda mimosifolia* (Jacaranda); Tree 12 *Acer palmatum* (Japanese Maple) to the rear

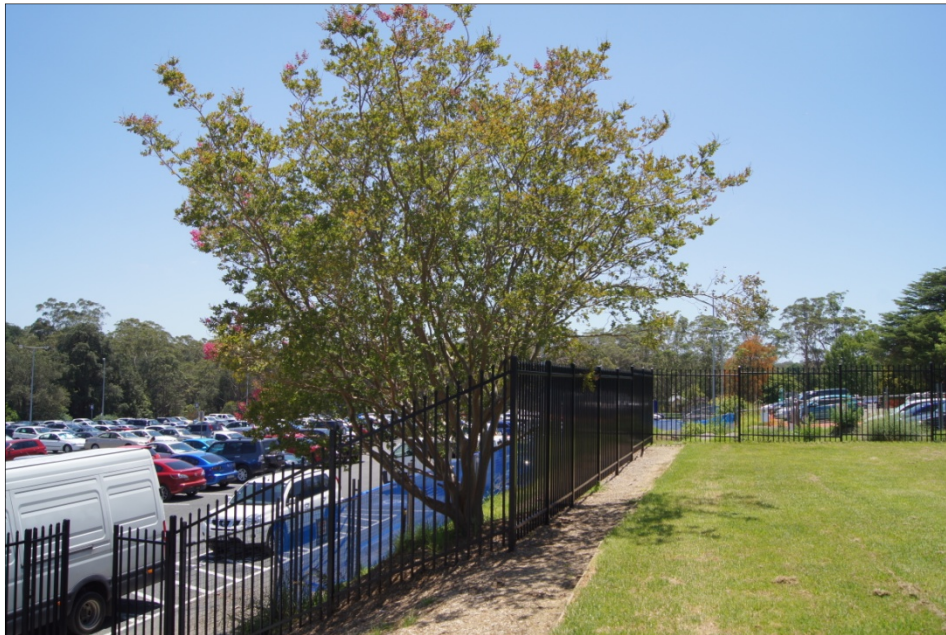
Tree 14 *Lagerstroemia indica* (Crepe Myrtle) is a fair specimen but not of great landscape value.

Plate 7: Tree 14 *Lagerstroemia indica* (Crepe Myrtle)

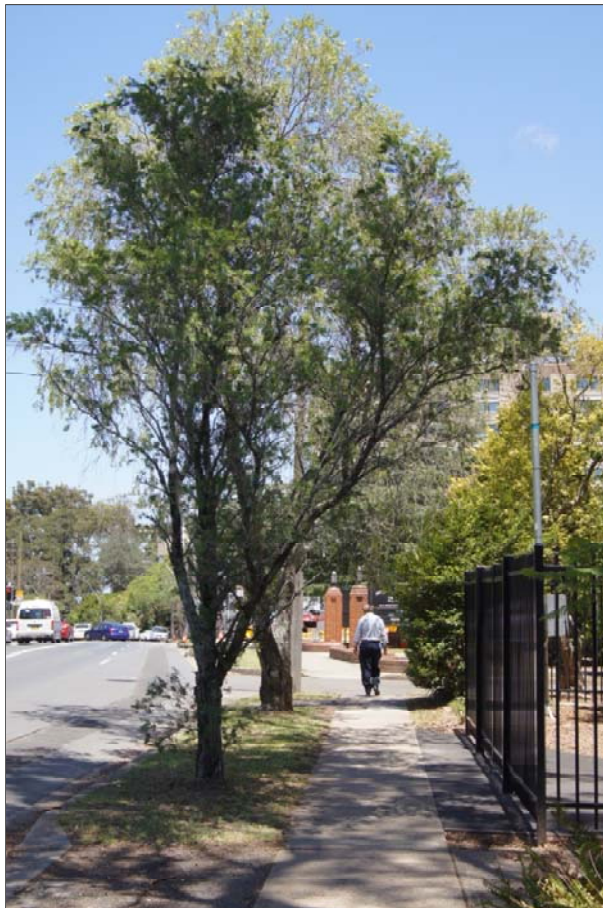
Trees 15 and 16 *Callistemon viminalis* (Weeping Bottlebrush) are street trees in poor health and condition and would be removed.

Plate 8: Trees 15 and 16
Callistemon viminalis
(Weeping Bottlebrush)

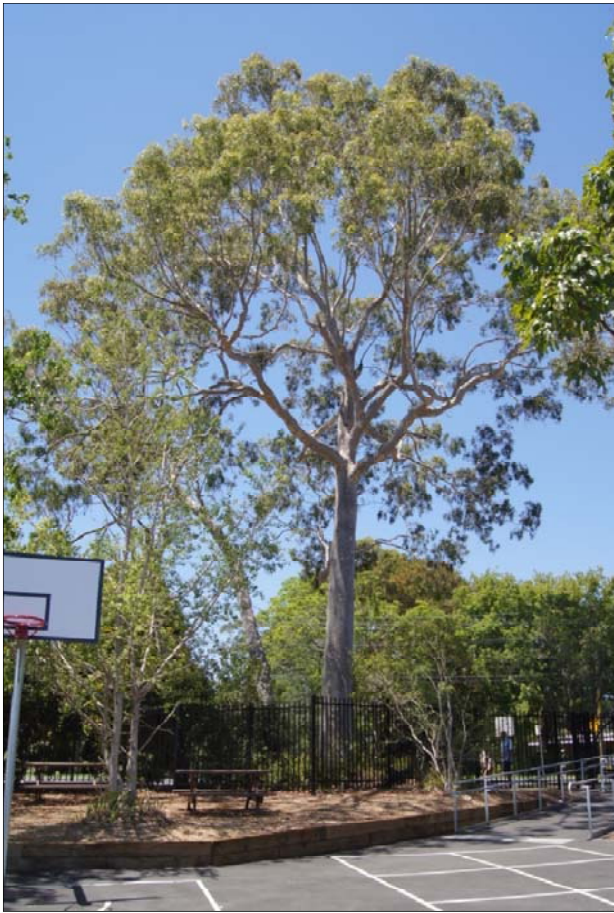
A group of *Corymbia citriodora* (Lemon Scented Gum) is located in the south of the site near the street frontage: Trees 17, 18 and 19. Tree 17 is a large mature specimen in good health and condition and is prominent in the landscape. Trees 18 and 19 are poor specimens which have been suppressed and deformed under the crown of Tree 17.

To the west of Tree 17 is a newly constructed timber retaining wall and a bitumen sealed footpath and play area. It is understood that minimal or no root loss occurred during construction and as long as the proposed footpath does not encroach further into the theoretical tree protection zone of Tree 17 (ie 11m radius from the trunk) there would be no additional impact on the tree.

Tree 9 *Ginkgo biloba* (Maidenhair Tree) is a small specimen in declining health.

Plate 9: Trees 17, 18 and 19
Corymbia citriodora (Lemon
Scented Gum); Tree 9 *Ginkgo
biloba* (Maidenhair Tree) to
the front

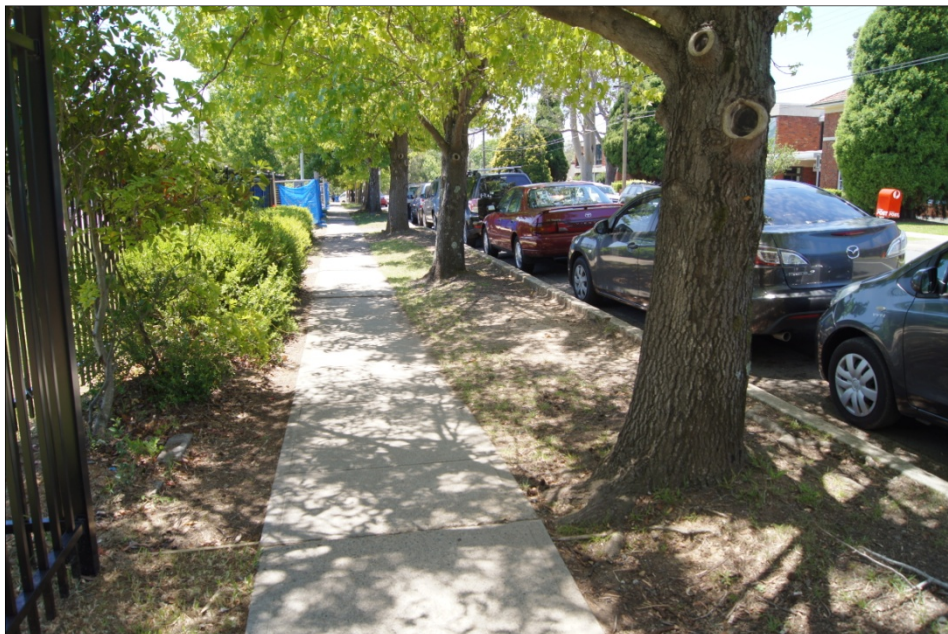
The row of *Lophostemon confertus* (Brushbox) street trees comprises Trees 20, 21, 22, 23, 24, 25, 26, 28, 29 and 34. These are in good health and in fair condition, although their root systems are causing footpath damage. The setbacks between the trees and the buildings are approximately 12m, sufficient to avoid disturbance of the root systems and the trees would be unaffected. The design and materials of steps and play area would need to be considered where these are in proximity to trees.

Plate 10: Trees 20 to 23
Liquidambar styraciflua
(Liquidambar)

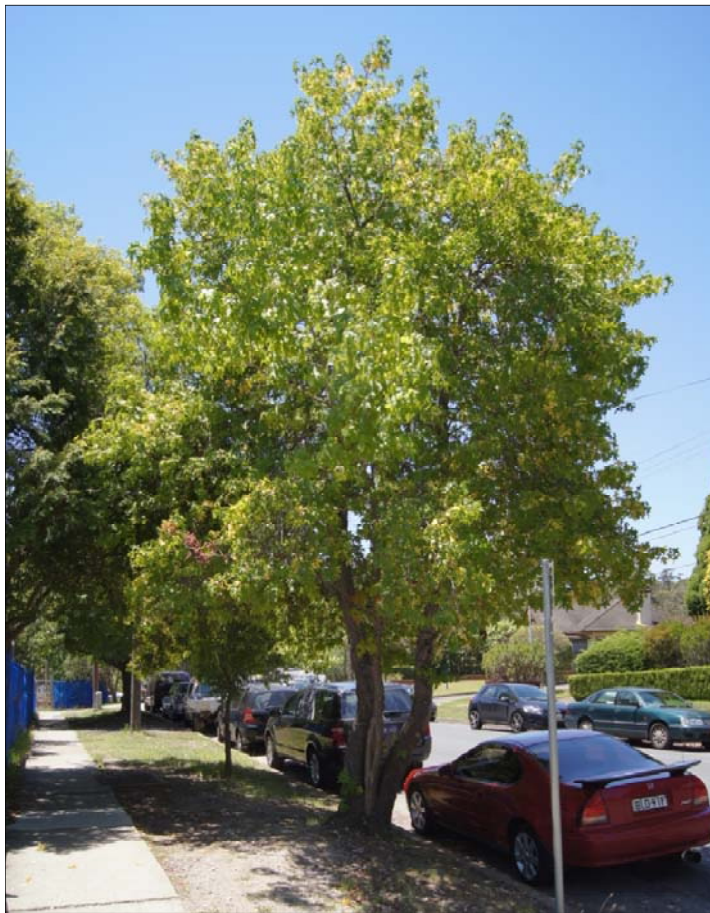
Plate 11: Tree 29 *Liquidambar styraciflua* (Liquidambar)

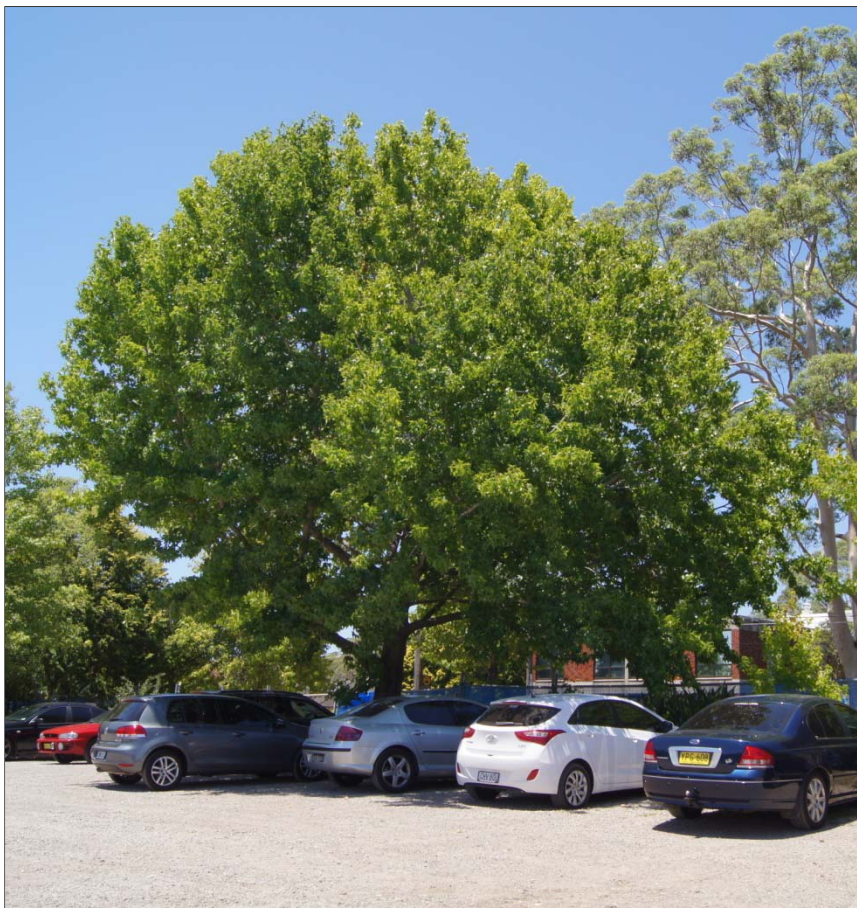
Tree 27 *Liquidambar styraciflua* (Liquidambar) is a large and prominent specimen in good health and in fair structural condition. The chief adverse factor is the coverage of the root zone by a compacted fill for the carpark surface: this replaces the formerly existing soft soil garden. The fill is likely to cause rapid decline and death of major roots. The species is exempt from the Ku-Ring-Gai Council Tree Preservation Order if less than 12m in height and this is an indication that the species is considered to be a nuisance. Tree 27 is over 12m in height and is this subject to the Tree Preservation Order. The School would currently prefer to obtain approval for its removal and intends to re-evaluate whether or not to remove it when the Junior School stage proceeds in the future.

Plate 12: Tree 27 *Liquidambar styraciflua* (Liquidambar)

However to enable a future decision to be made at the Junior School development stage the continued health of the tree should be ensured. The fill should be carefully removed to a radius of 6m from the trunk without causing injury to roots and the former soil surface covered with a 75mm depth of composted mulch. This area should be fenced to form a tree protection zone.

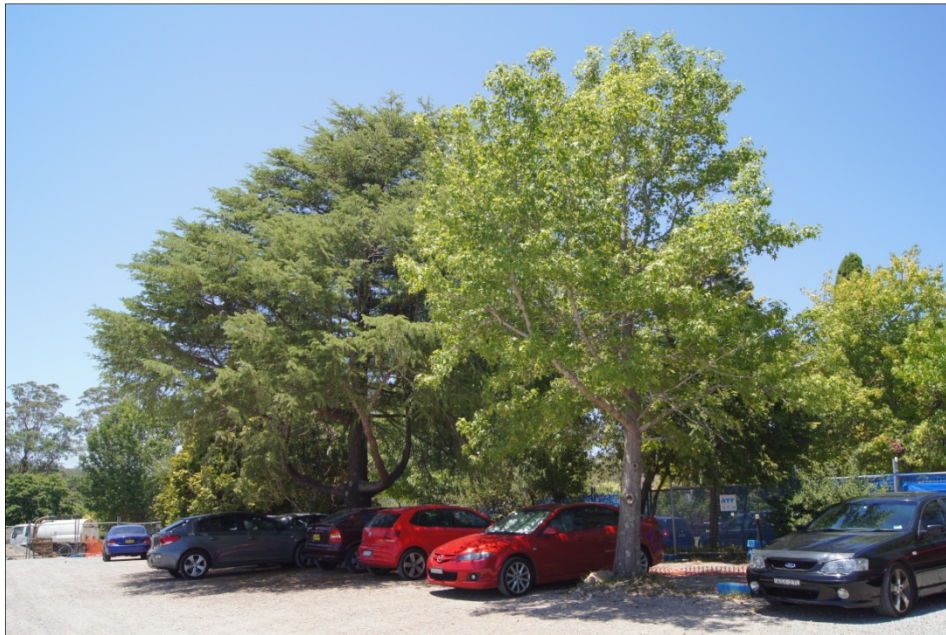
Tree 30 *Liquidambar styraciflua* (Liquidambar) is a small specimen of minor landscape value.

Tree 33 *Cedrus deodara* (Himalayan Cedar) is a mature and prominent specimen in good health but with large lower branches which detract from the typically pyramidal form of the species. The root system is covered by carpark fill which is likely to cause significant injury to the root system. The tree would be located near the edge of the proposed access road and is proposed for removal.

Plate 13: Tree 30 *Liquidambar styraciflua* (Liquidambar) right and Tree 33 *Cedrus deodara* (Himalayan Cedar) left

To ensure the retention of the tree until the Junior School stage proceeds, the fill should be carefully removed to a radius of 8m from the trunk without causing injury to roots and the former soil surface covered with a 75mm depth of composted mulch. This area should be fenced to form a tree protection zone.

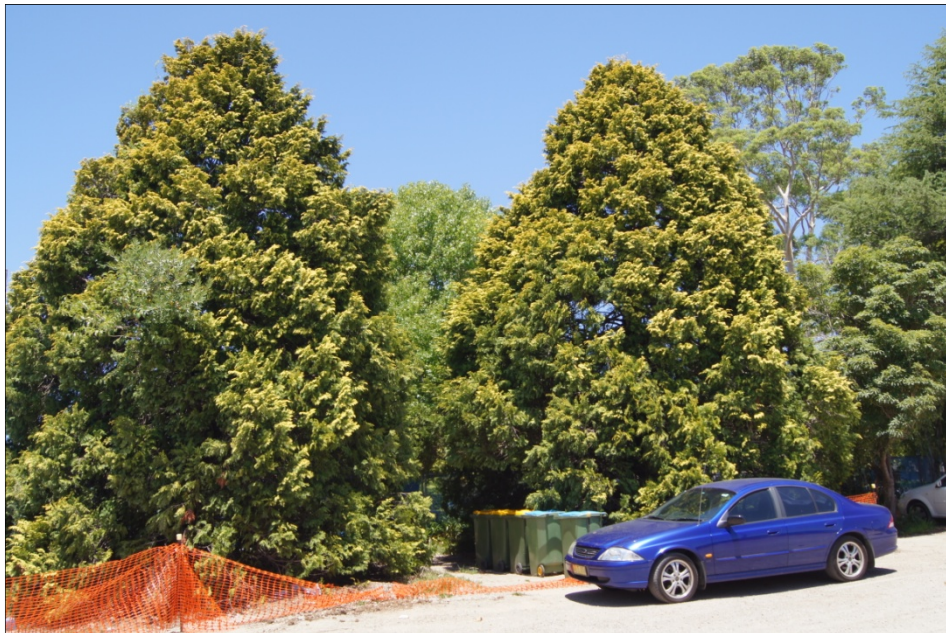
Tree 37 *Chamaecyparis obtusa* (Hinoki False Cypress) is one of a pair to the northeast of the proposed access road. It would be clear of any likely excavation disturbance, but would need to be fenced to a radius of 6m from the trunk except where access is required for construction of the road. Any carpark fill within this radius should be removed and the tree protection zone covered with a 75mm depth of composted mulch.

Tree 36 *Chamaecyparis obtusa* (Hinoki False Cypress) is one of a well-grown pair but would be within the proposed access road and is proposed for removal.

Plate 14: Trees 36 and 37 *Chamaecyparis obtusa* (Hinoki False Cypress)

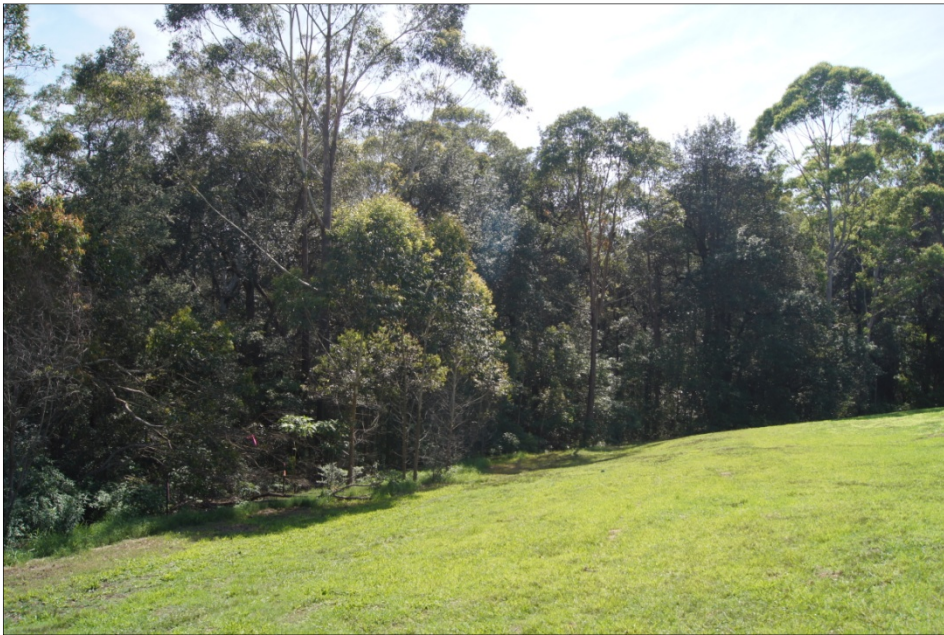
However it is noted that a significant depth of fill has been deposited in the past and the toe of this fill area extends to within a few metres of the closest trees, including major specimens as noted in the table. The trees appear in good vigour and it is evident that the fill deposited in the past has not adversely affected their health.

Plate 15: western edge of playing field site between Pegs 3 and 4 showing proximity of trees to existing fill

To make an assessment as to likely impact, the depth and composition of the existing fill including its permeability, the hydrology of the fill and the slope, the location of the trees in relation to the retaining walls and the disposition of the root systems would be required. This information will be provided as the project proceeds. It is acknowledged that continuity of the forest in good health is paramount and the design of the playing field will be amended as required to avoid any impact.

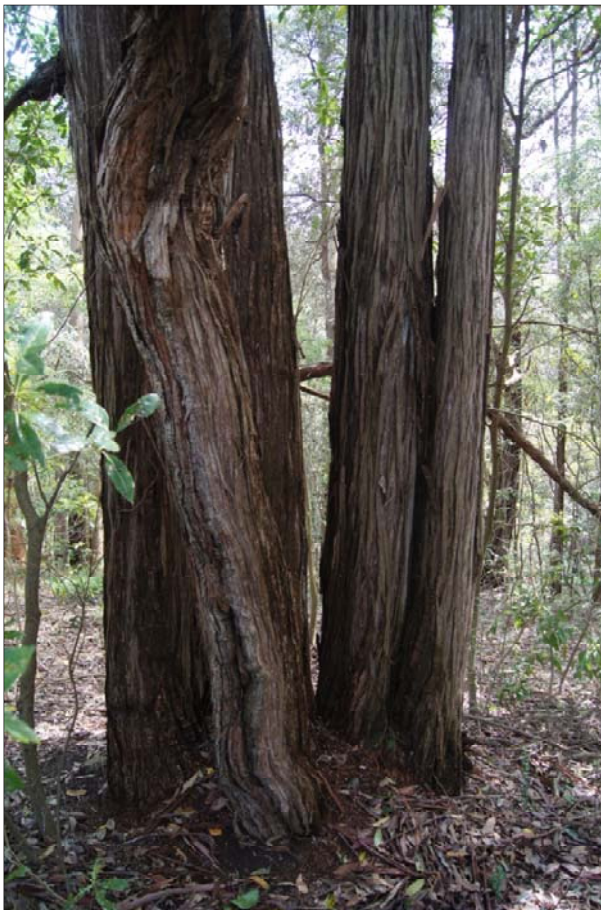
Plate 16: multi-stemmed mature specimen of *Syncarpia glomulifera* (Turpentine) near edge of fill bank
