Arboricultural Impact Assessment

One Sydney Harbour
Barangaroo South
Development Application
Finalisation

Project No 5029/D/2016/A

One Sydney Harbour – Temporary drainage - Barangaroo South: Stage 1B

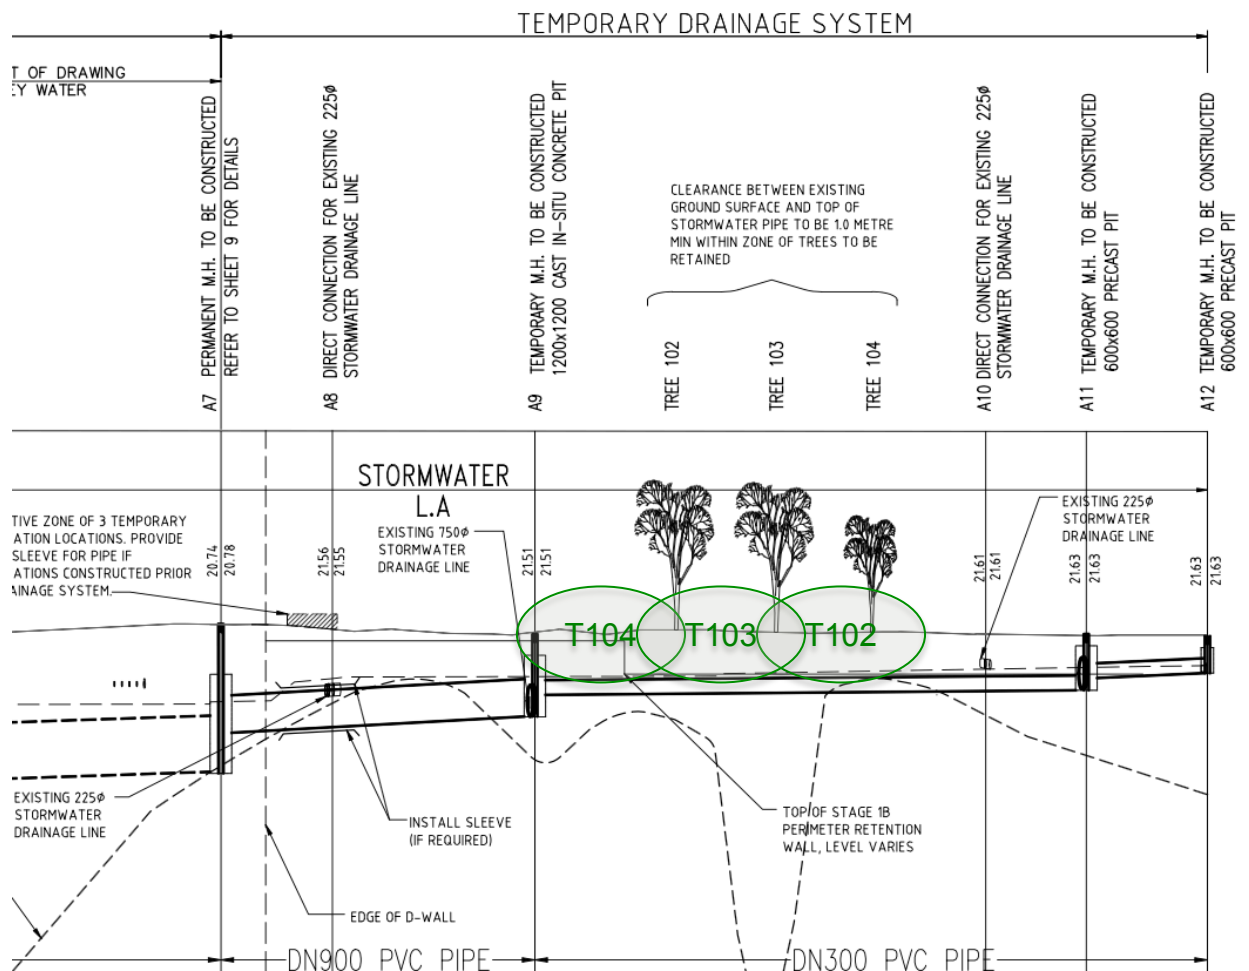
Image 1: Enlarged section of plan of proposed works from Appendix A

Assessment of these plans in relation to tree protections requirements finds that the proposed temporary 300mm diameter pipeline Line A. (L .A) as noted on the attached plan, has works being perform with directional drilling at one metre below soil surface and entry and exits pits are 5 metres and outside most of the tree protection zones.

The structural root zones of Trees 102, 103 and 104 are 2.9, 2.8 and 2.7 respectively. There may be sinker roots deeper, however, works will be outside the theoretical Structural Root Zones and below most roots.

At these distances it is highly unlikely that any large roots will be encountered and if they are they will be outside the area of most structural roots.

If it is possible to install the pipe so the top of the pipe is one metre below the existing street level, and pits - at ground level – are no closer than 5 metres from the trees, then retention of the trees is possible.

Should any large (10cm or greater) roots be found or tree health or stability become evident your project arborist must be consulted immediately.
