Martins Creek Project Code 10475 Pavement Condition Survey Assessment

Martins Creek, Vacy, Paterson & Largs

NEW14P-0135-AB 30 April 2015

RE: MARTINS CREEK PROJECT – CODE 10475 PAVEMENT CONDITION SURVEY ASSESSMENT

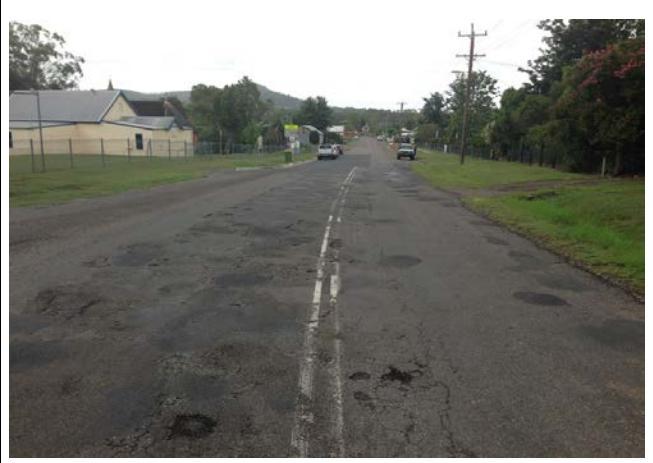
PHOTO 1 - Ch. 700m Looking back north towards Vacy. Road pavement in poor condition. Extensive defects, expedient repairs and repeated failures through pavement in both lanes.

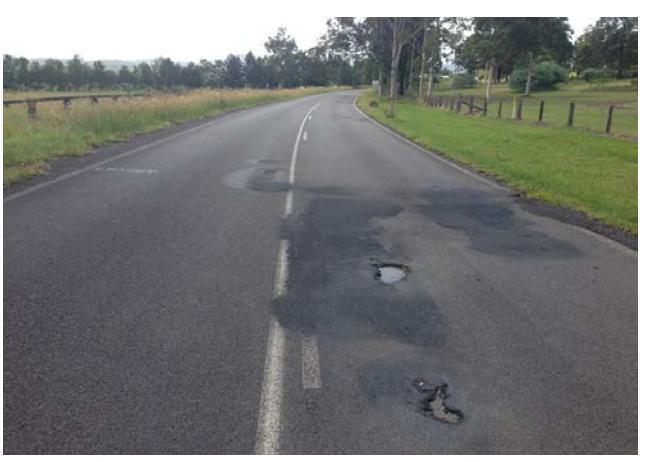
PHOTO 3 - Ch. 1,690m Expedient patching, areas with repeated surface stripping of asphalt, deformation shoving in outer wheel path.

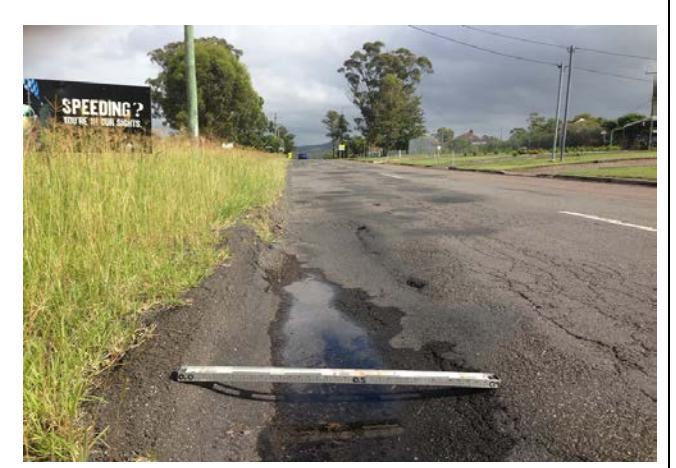
PHOTO 2 - Ch. 970m Looking back north towards Vacy. Deep rutting and shoving along road edge, crocodile cracking and expedient atching visible.

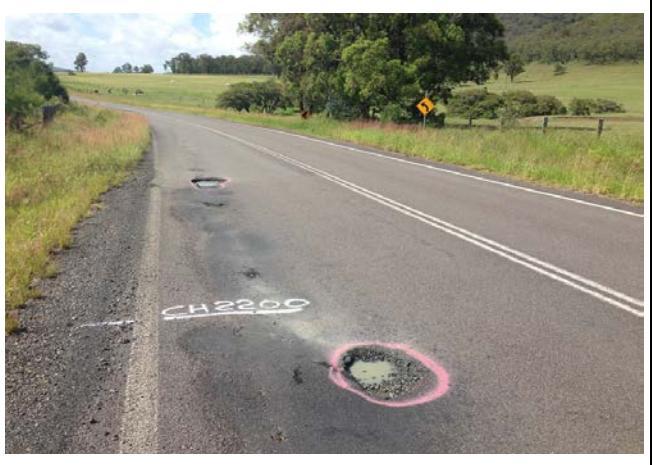
PHOTO 4 - Ch. 2,200m Potholes, with depressions, surface stripping and expedient patching in outer wheel path.

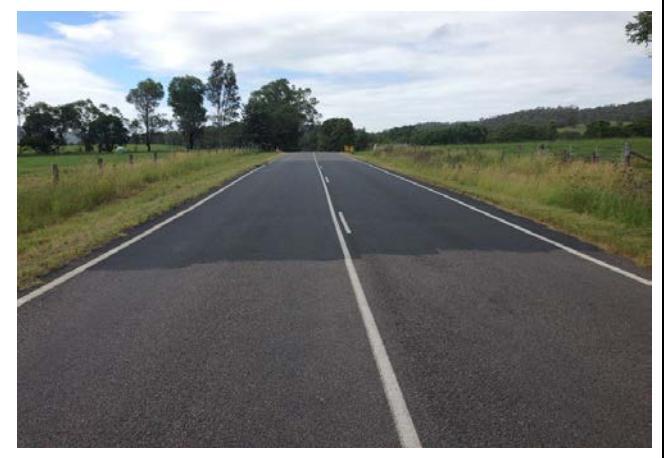
PHOTO 6 - Ch. 4,680m Road pavement generally in good condition. Full width patch visible.

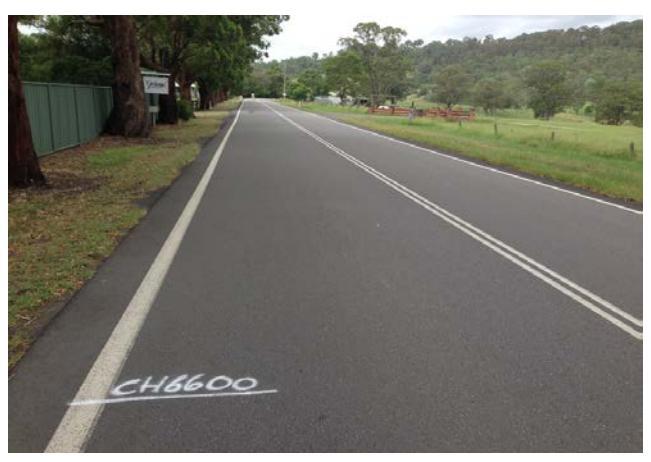
PHOTO 8 - Ch. 6,600m Road pavement in good condition.

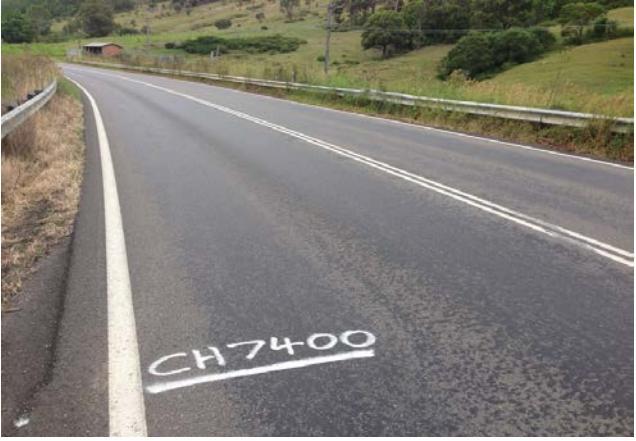
<u>PHOTO 9 - Ch. 7,400m</u> Road pavement in generally good condition. Surface flushing visible inner and outer whell paths in both lanes.

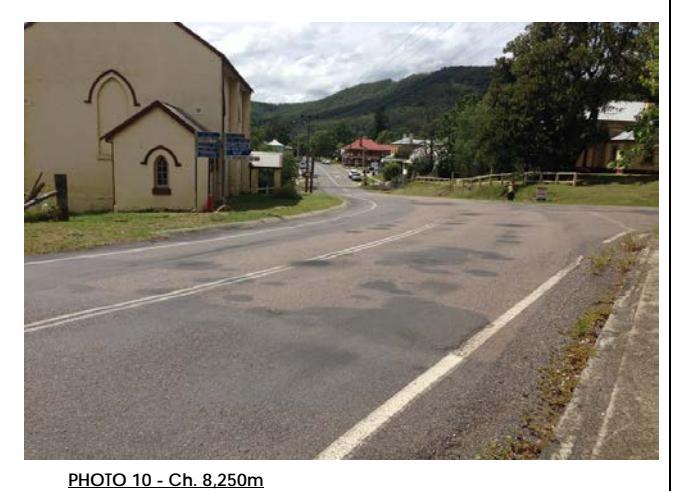
On approach into township of Paterson. Road pavement in poor condition. Extensive defects, expedient repairs in both lanes. Church Street to RHS similar poor pavement condition.

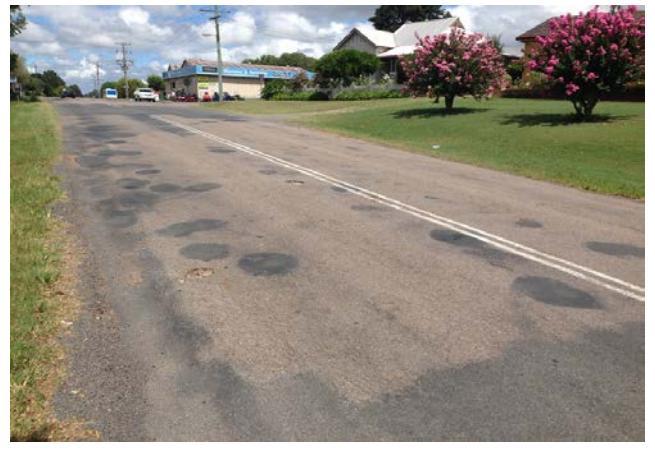
PHOTO 12 - Ch. 9,030m Road pavement in poor condition. Extensive defects, expedient repairs and repeated failures through pavement in both lanes.

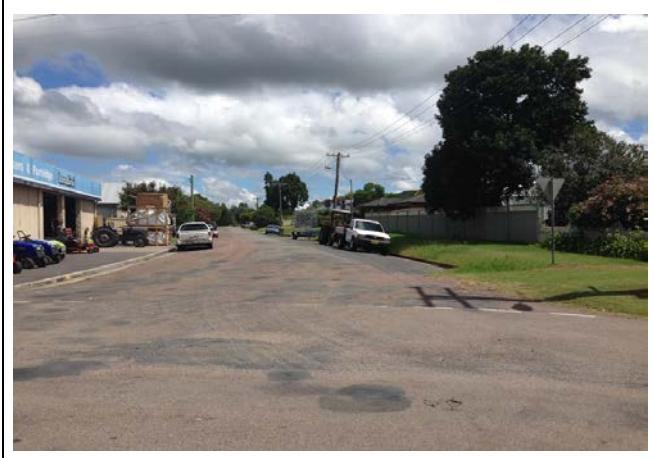
PHOTO 13 - Ch. 9,090m

Road pavement in poor condition. Extensive defects, expedient repairs and repeated failures through pavement in both lanes. Sloane Street to RHS similar poor pavement condition.

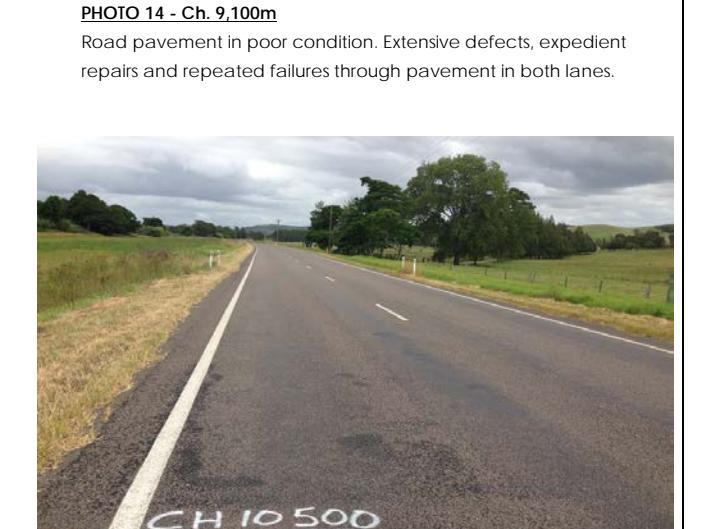
PHOTO 16 - Ch. 10,500m Road pavement in generally good condition. Minor surface flushing and surface ravelling associated with general traffic use.

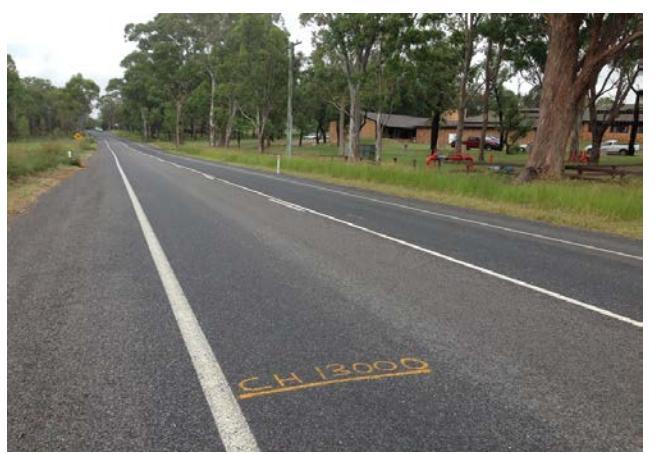
PHOTO 17 - Ch. 13,000m Road pavement in generally good condition. Minor surface flushing and surface ravelling associated with general traffic use.

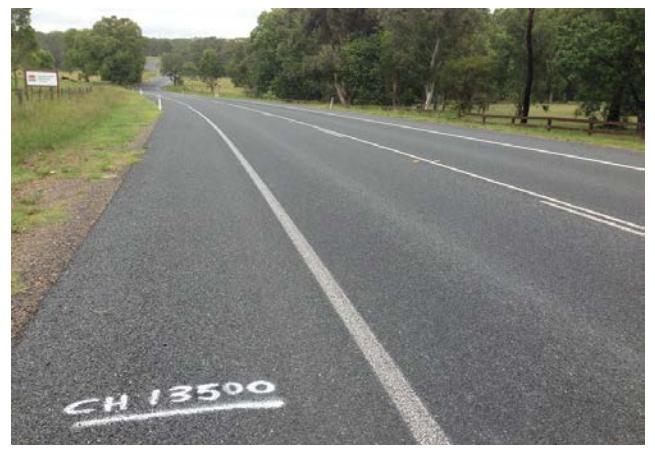
PHOTO 18 - Ch. 13,500m Road pavement in generally good condition. Minor surface flushing and surface ravelling associated with general traffic use.

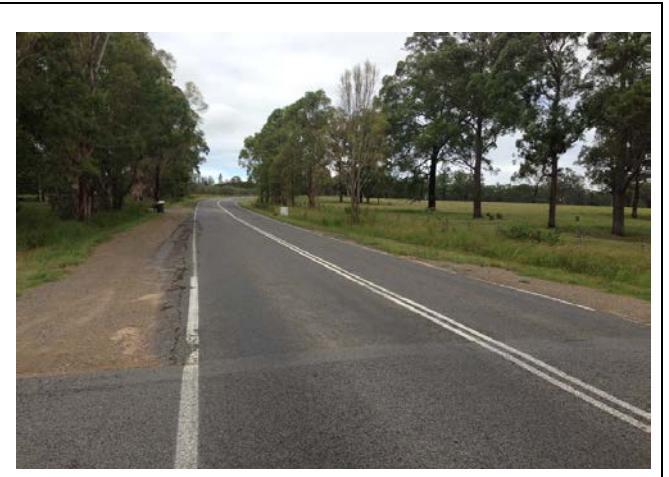
<u>PHOTO 20 - Ch. 14,810m</u> Change in pavement surface seal. Edge break, crocodile cracking, and expedient patching along road shoulders.

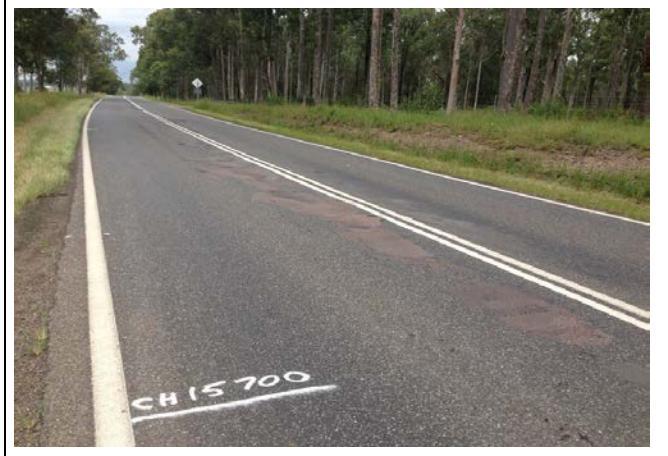
<u>PHOTO 21 - Ch. 15,700m</u> Surface ravelling along both sides of road centreline, with intermittant expedient patching.

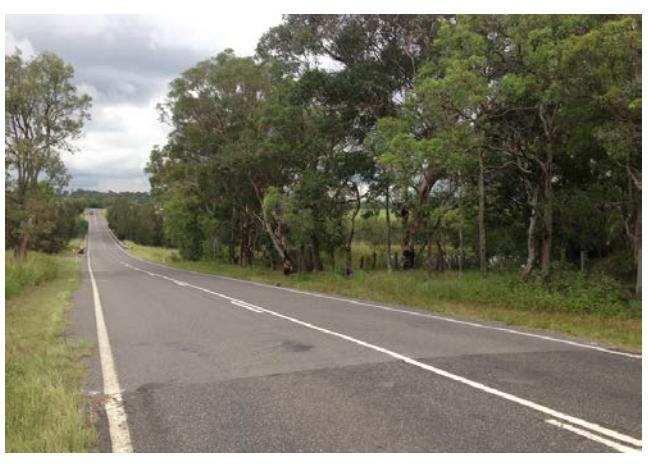
PHOTO 22 - Ch. 16,140m Road pavement in generally good condition. Minor surface flushing and surface ravelling associated with general traffic use.

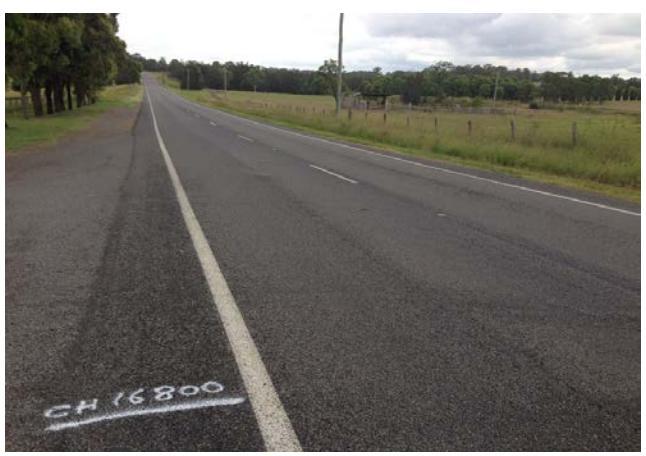
PHOTO 23 - Ch. 16,800m Road pavement in generally good condition. Minor surface ravelling and block cracking visible.

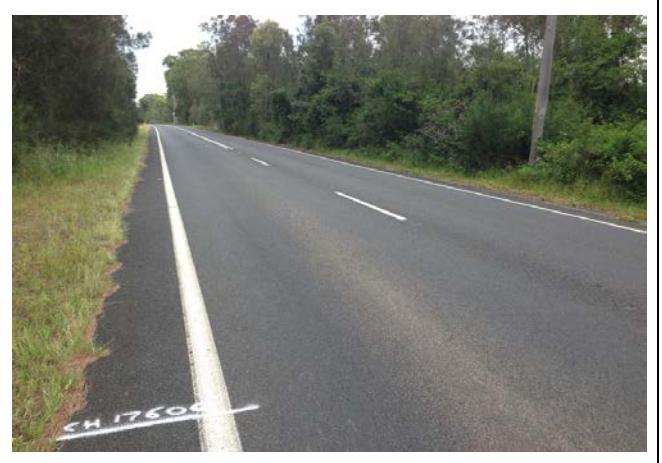
PHOTO 24 - Ch. 17,600m Road pavement in generally good condition. Minor surface flushing and surface ravelling associated with general traffic use.

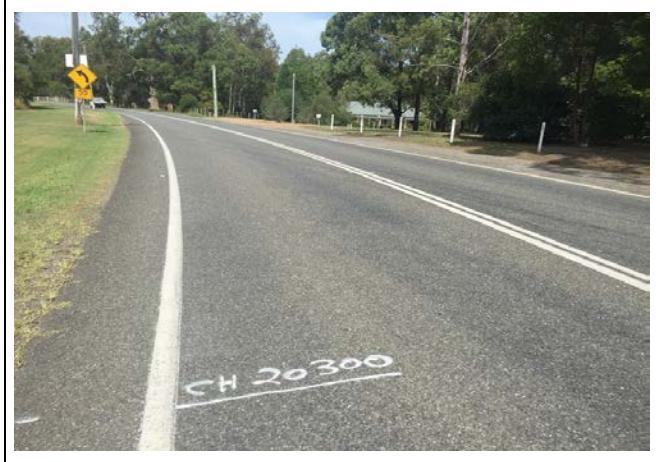
Road pavement in generally good condition. Minor surface flushing and surface ravelling associated with general traffic use.

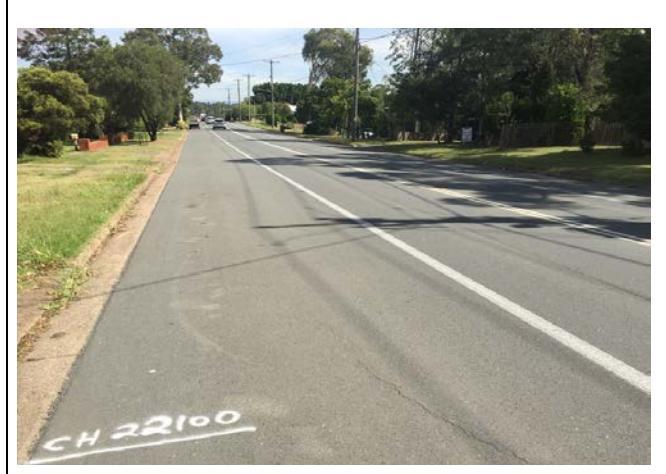
PHOTO 29 - Ch. 22,100m Road pavement in generally good condition. Some longitudinal cracking visible in pavement surface

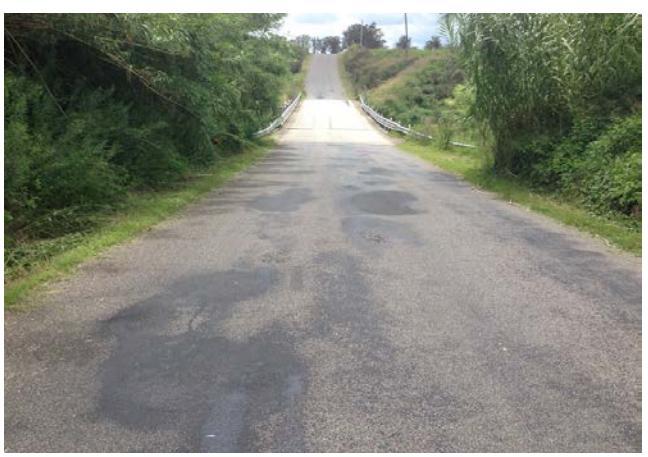
PHOTO 1 - Ch. 340m

Road pavement in poor condition. Extensive defects, expedient patches and failures through pavement in both lanes on approach downhill approach to bridge.

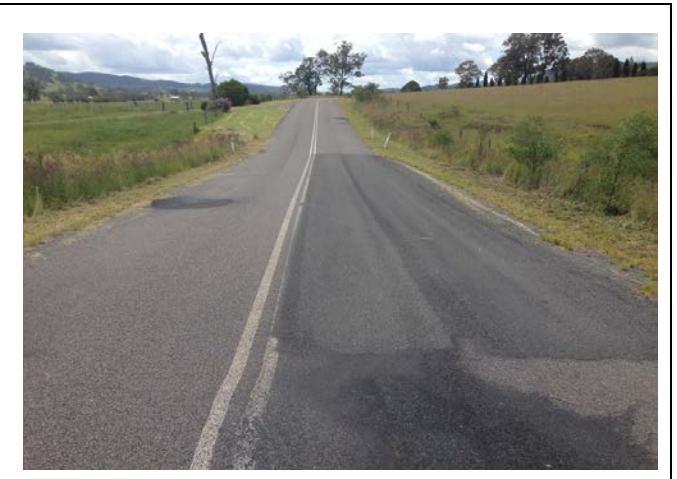
PHOTO 2 - Ch. 1,370m Full lane width remedial patch. With some expedient patches adjoining and on other side of road.

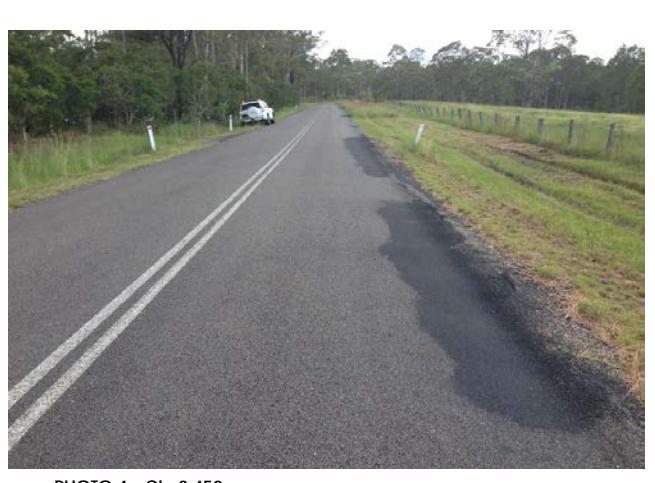
PHOTO 4 - Ch. 3,450m Road pavement in generally good condition. Deformation shoving, surface poishing and expedient patching in outer wheel path.

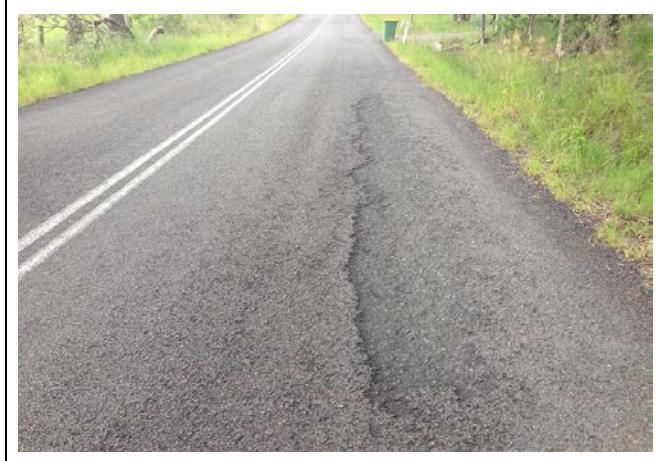
PHOTO 5 - Ch. 4,140m Surface ravelling of pavement surface in outer wheel path.

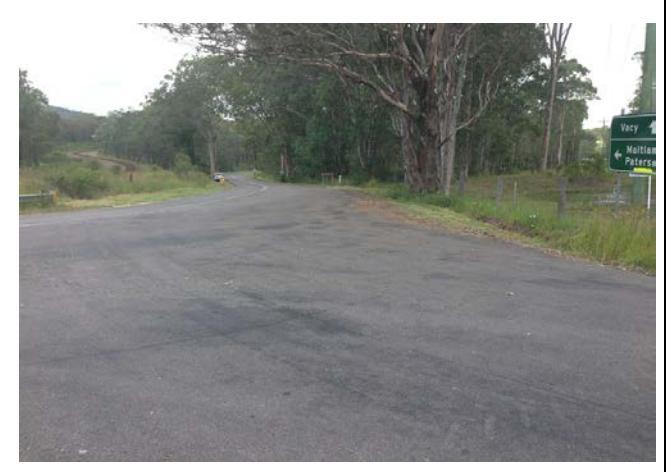
PHOTO 6 - Ch. 4,240m Intersection with Dungog Road. Surface ravelling, surface polishing and expedient patching across intersection associated with turning vehicles.

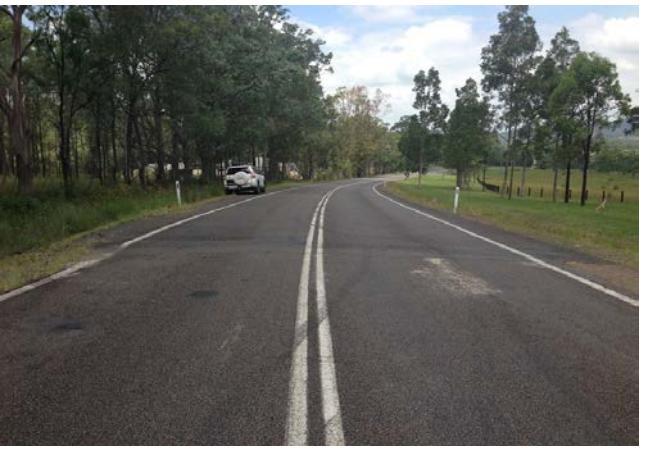
PHOTO 3 - Ch. 1,180m Change in road surface seal. Minor deformation shoving, depression and crocodile cracking at pavement interface.

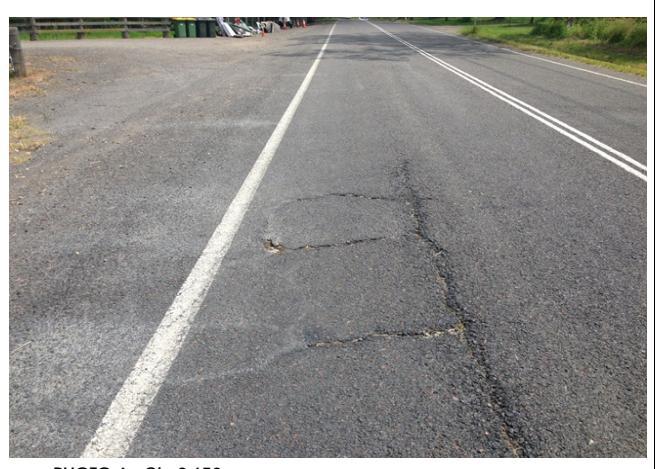
PHOTO 4 - Ch. 2,650m Deep block cracking, loss of seal, near entry into rural property on LHS.

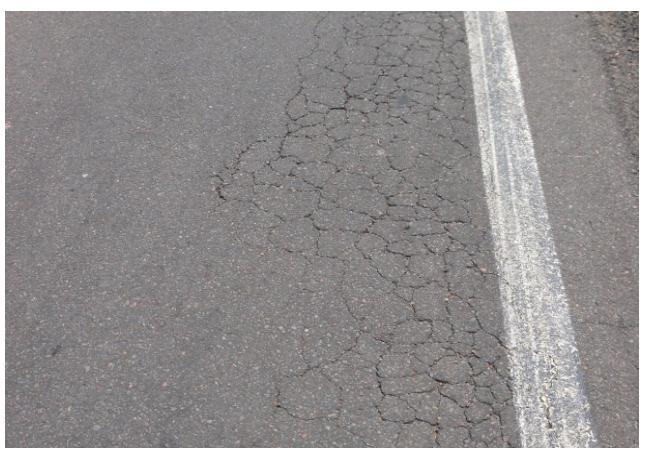
PHOTO 5 - Ch. 3,115m Crocodile cracking in outer wheel path of area previously repaired with remedial patch.

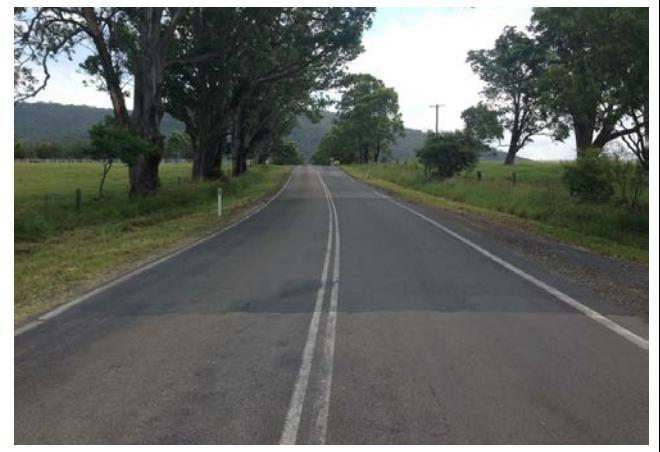
<u>PHOTO 6 - Ch. 3,130m</u> Remedial patch, full road width.

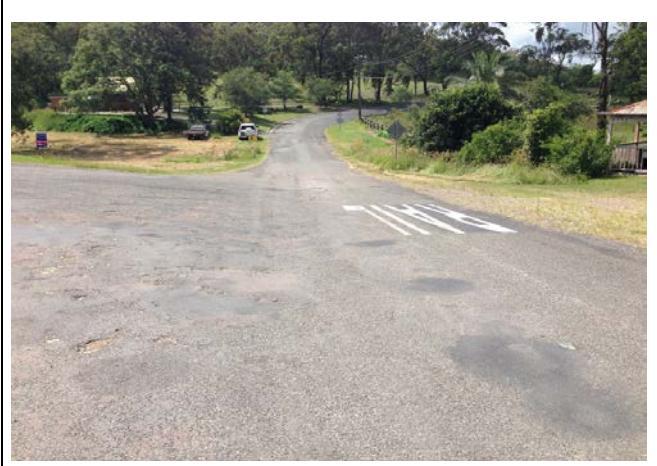
PHOTO 1 - Ch. 710m

Road pavement in poor condition. Extensive defects, expedient patch repairs and repeated failures in both lanes. Douglas Street to LHS similar poor pavement condition.

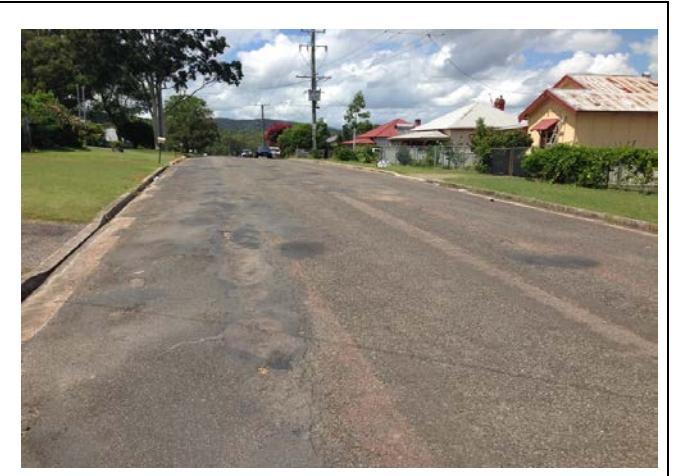
<u>PHOTO 2 - Ch. 1,130m</u> Road pavement in poor condition. Extensive defects, expedient patch repairs and repeated failures in both lanes.

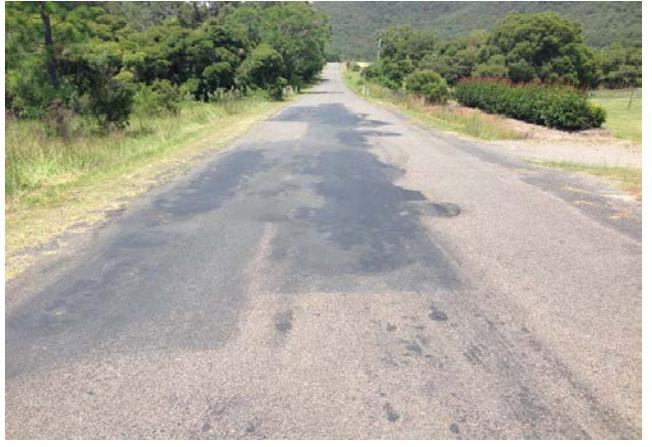
PHOTO 3 - Ch. 4,720m

Road pavement in poor condition. Extensive defects, expedient patch repairs and repeated failures in both lanes.

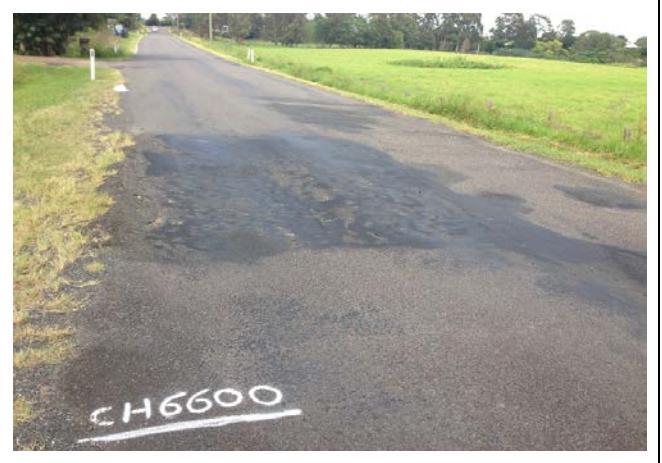
PHOTO 4 - Ch. 6,600m Road pavement in poor condition. Extensive defects, expedient patch repairs and repeated failures in both lanes.

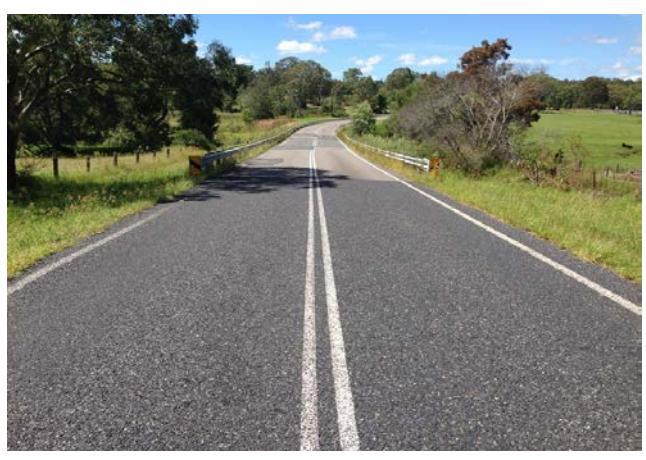
PHOTO 1 - Ch. 2,180m Road pavement in generally condition on approach to embankment. Full width patching visible within embankment.

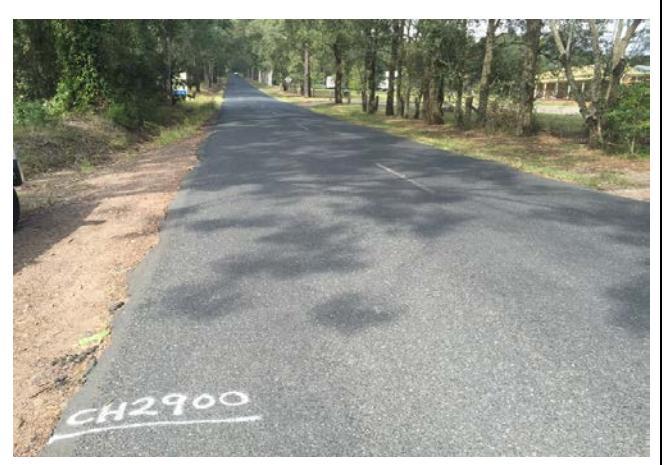
<u>PHOTO 2 - Ch. 2,900m</u> Road pavement in generally good condition. Minor edge break both sides along edges of pavement.

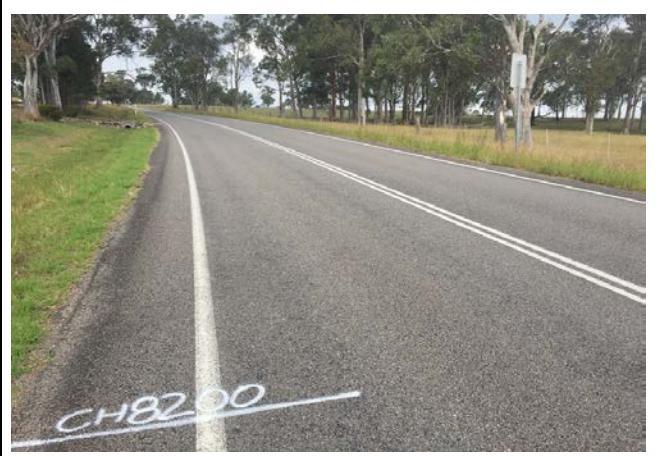
PHOTO 5 - Ch. 8,200m Road pavement in generally good condition. Minor surface flushing and ravelling associated with general traffic use.

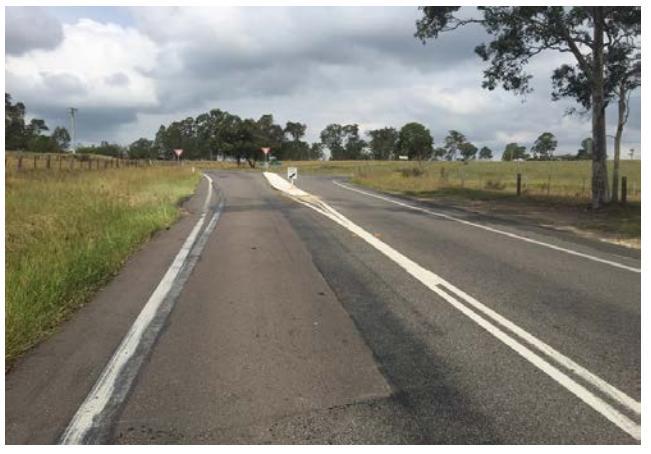
PHOTO 6 - Ch. 8,350m Approach to Clarencetown Road intersection. Remedial patches, surface flushing and some edge break and edge drop visible.
