Project No: F23/USYD/15 Report No: F23/USYD/AIA/C

ARBORICULTURAL IMPACT ASSESSMENT TREE PROTECTION SPECIFICATION

F23 Administration Building University of Sydney

11th April 2016 Revision C

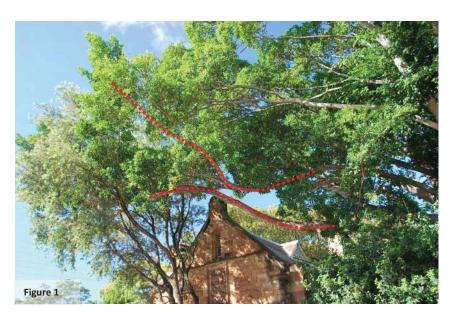
Tree 499 - Ficus microcarpa var. hillii (Hill's Weeping Fig)

Orientation of Branch	Height of Branch above Grade	Order of Branch	Branch Diameter	Comments	Figure
E	4m & 4.5m	3 rd & 4 th	120mm & 80mm	2 x branches. Prune to achieve minimum 4.3m vertical clearance over Fisher Road.	1
E	4.5m		<75mm	Minor pruning to achieve minimum 4.3m vertical clearance over Fisher Road.	2

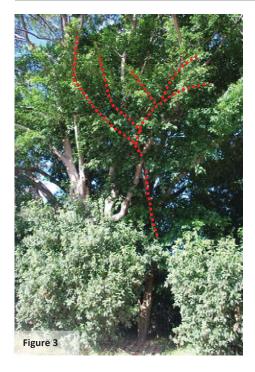
Tree 500 - Ficus microcarpa var. hillii (Hill's Weeping Fig)

Orientation of Branch	Height of Branch above Grade	Order of Branch	Branch Diameter	Comments	Figure
NE	2.5m	1 st	100mm	Prune to achieve minimum 4.3m vertical clearance over Fisher Road.	3

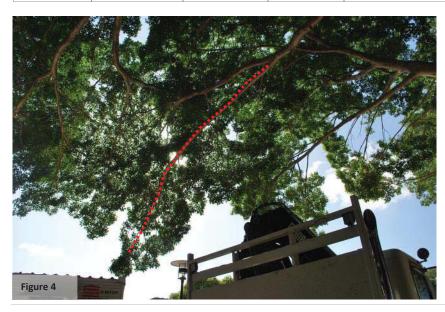
Tree 501 - Ficus microcarpa var. hillii (Hill's Weeping Fig)

Orientation of Branch	Height of Branch above Grade	Order of Branch	Branch Diameter	Comments	Figure
NE	4.5m	5 th	100mm	Remove lower branch at junction.	4

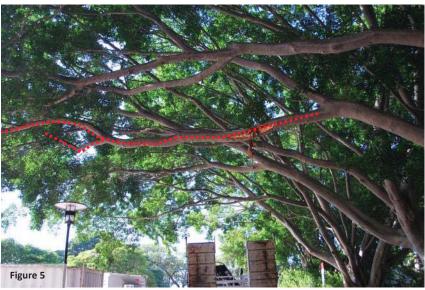
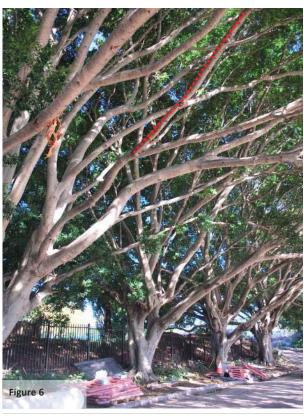
Tree 503 - Ficus microcarpa var. hillii (Hill's Weeping Fig)

- 3.3.2 At the time of a site visit undertaken on the 16th February 2016, it was noted that three (3) lower branches in the crowns of Trees 503 and 505 had sustained vehicle impact damage. One (1) 75mm diameter (approx.) branch in the crown of Tree 505 had been broken off leaving a short, torn branch stub and two (2) lower branches in the crown of Tree 503 had missing/torn bark. The broken branch is of relatively small diameter and the bark wounds appear relatively superficial. However, the broken branch stub should be pruned back to the branch collar and the torn bark should be carefully trimmed back with a sharp knife around the perimeter of the wound margin to leave a clean wound face that will promote wound occlusion.

Orientation of Branch	Height of Branch above Grade	Order of Branch	Branch Diameter	Comments	Figure
N/NE			80mm & 120mm	2 x branches to be pruned for building clearance.	
E	4.5m	2 nd	250mm	Damaged by recent vehicle impact.	5
NE	4.5m	2 nd	150mm	Minor damage by recent vehicle impact.	6

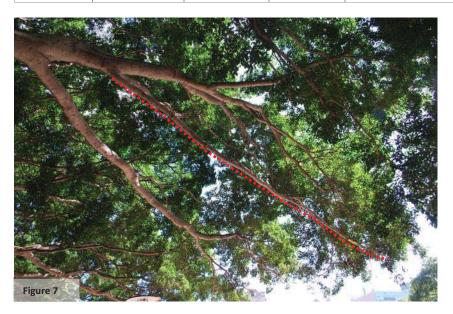
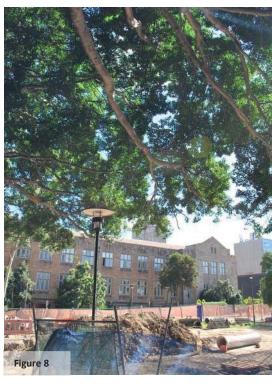
Tree 504 - Ficus microcarpa var. hillii (Hill's Weeping Fig)

Orientation of Branch	Height of Branch above Grade	Order of Branch	Branch Diameter	Comments	Figure
N/NE			100mm & 120mm	2 x branches to be pruned for building clearance.	
E	4.5m	4 th	120mm	Recently torn lateral towards terminal end of branch.	7
NE	4.5m		<75mm	Minor pruning to achieve minimum 4.3m vertical clearance over Fisher Road	8

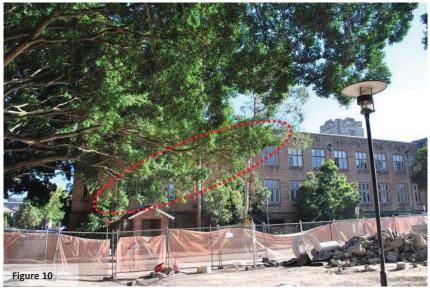
Orientation of Branch	Height of Branch above Grade	Order of Branch	Branch Diameter	Comments	Figure
E	4.5m	Epicormic	25mm	Prune to main branch	9
E/NE	4.5m		<75mm	Minor pruning to achieve minimum 4.3m vertical clearance over Fisher Road and to provide building clearance.	10

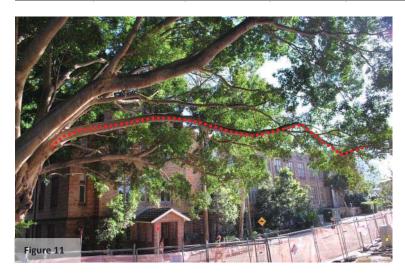
Tree 507 - Ficus microcarpa var. hillii (Hill's Weeping Fig)

- 3.2.5 Tree 507 has a significant bark inclusion located between co-dominant stems. Whist this structural defect is not considered to represent a significant hazard at the present time, ongoing monitoring should be undertaken on an annual basis.

Orientation of Branch	Height of Branch above Grade	Order of Branch	Branch Diameter	Comments	Figure
E	4.5m	3 rd	300mm	Pruning to achieve minimum 4.3m vertical clearance over Fisher Road and basement access road.	11
E/NE	4.5m		<75mm	Minor pruning to achieve minimum 4.3m vertical clearance over Fisher Road and to provide building clearance.

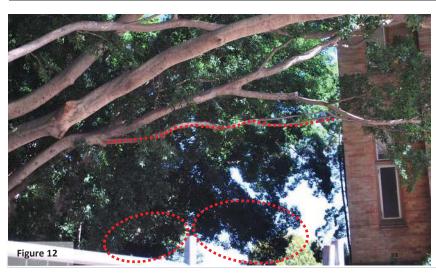
Tree 508 - Ficus microcarpa var. hillii (Hill's Weeping Fig)

Orientation of Branch	Height of Branch above Grade	Order of Branch	Branch Diameter	Comments	Figure
NE	4.5m	3 rd	120mm	Pruning to achieve minimum 4.3m vertical clearance over Fisher Road.	12
E/NE	4.5m		<75mm	Minor pruning to achieve minimum 4.3m vertical clearance over Fisher Road and to provide building clearance.	12
