**Project 85126.02**  
**10 April 2017**  
**85126.02.R.001**  
**DW:jljb**

**Response to Request for Information Regarding Contamination**  
**Proposed Resource Recovery & Recycling Facility**  
**24 Davis Road, Wetherill Park, NSW**

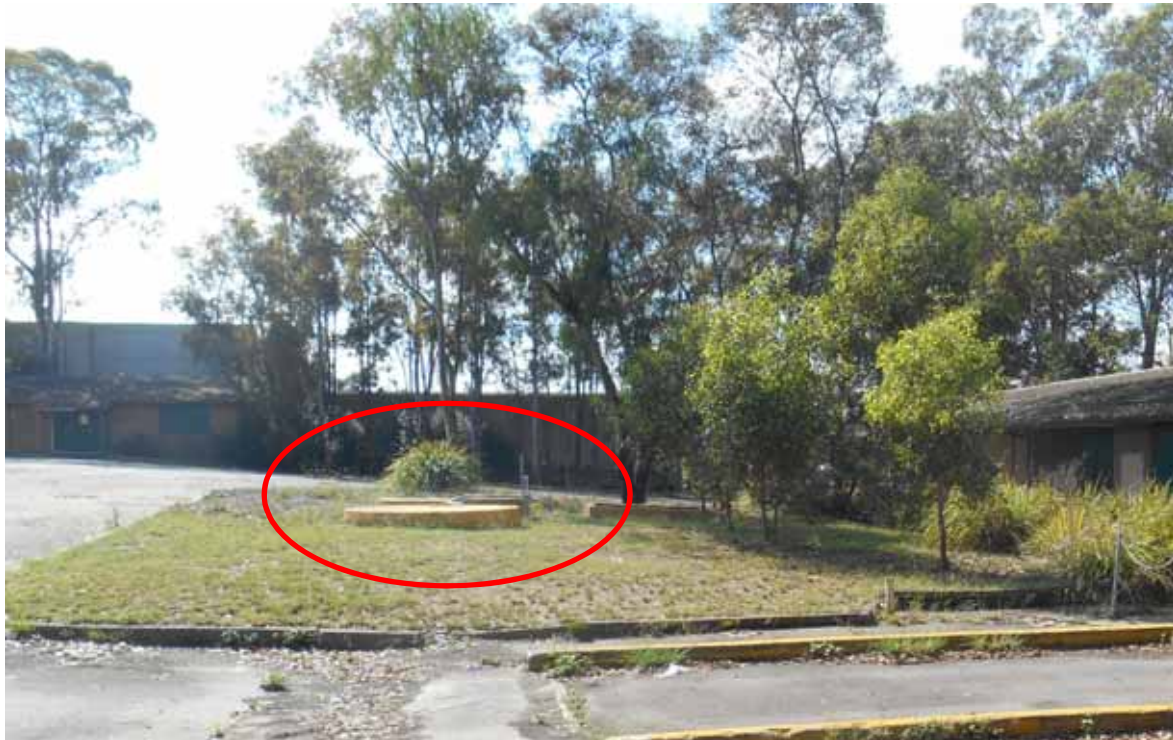
- In-ground recycled water tanks were present at the south of the site near the office building (Photograph 1, attached);
- The workshop, storeroom, laboratory and amenities buildings at the east of the site were present but could not be accessed. A substation was observed between the laboratory and amenities building (Photograph 2, attached). It is understood from conversations with the client that asbestos sheeting remains in the building structure of the laboratory and has been painted to mitigate the potential release of asbestos fibres;
- Concrete stockpile bins were present at the middle level (Bulk Storage Level), but no stockpiles were observed at the site (Photograph 3, attached);

Photograph 1 - Recycled water tanks

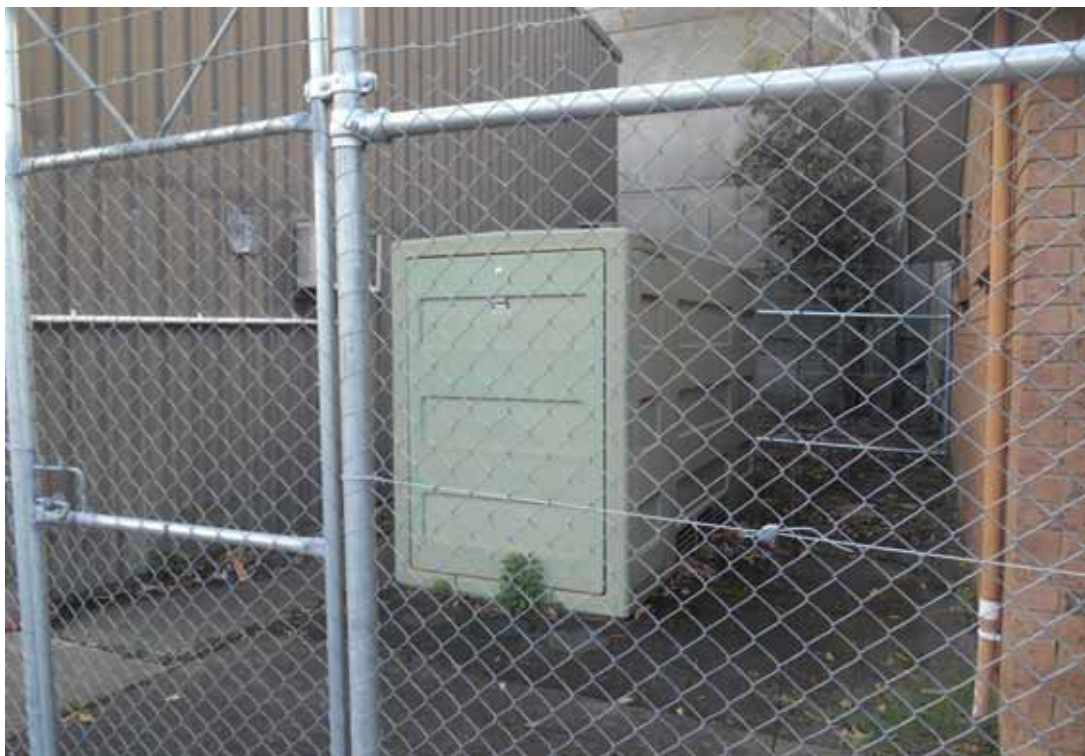
Photograph 2 - Substation

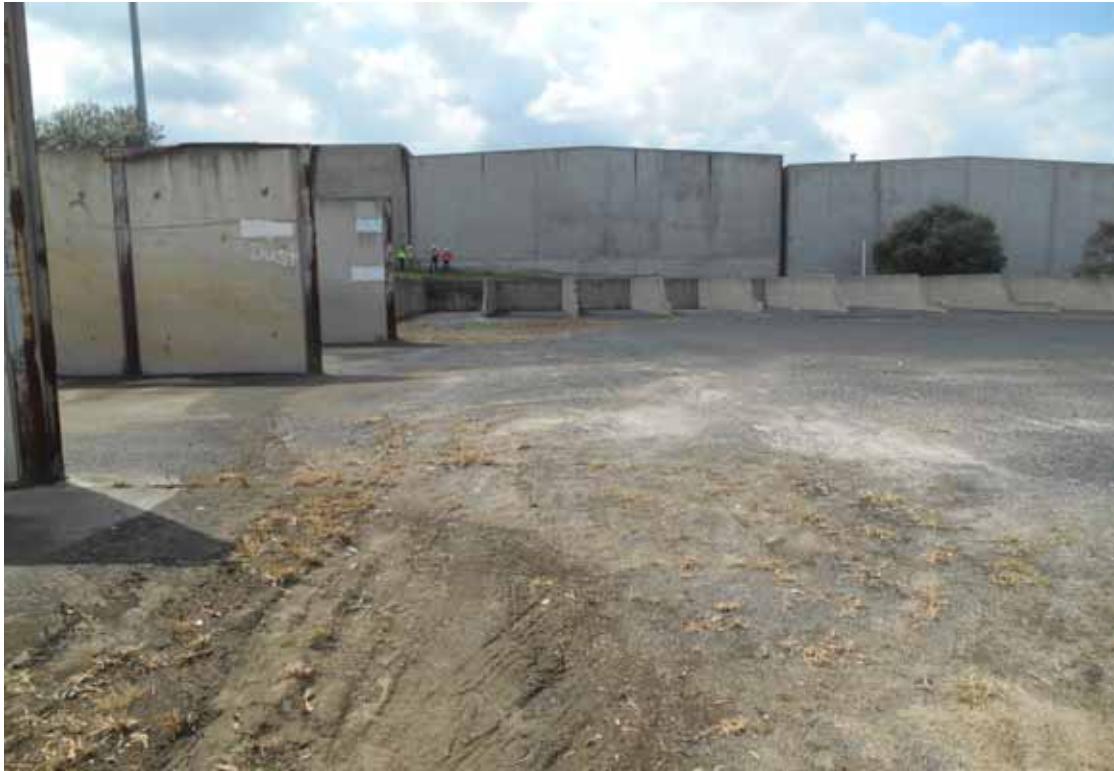
Photograph 3 - Concrete stockpile bins

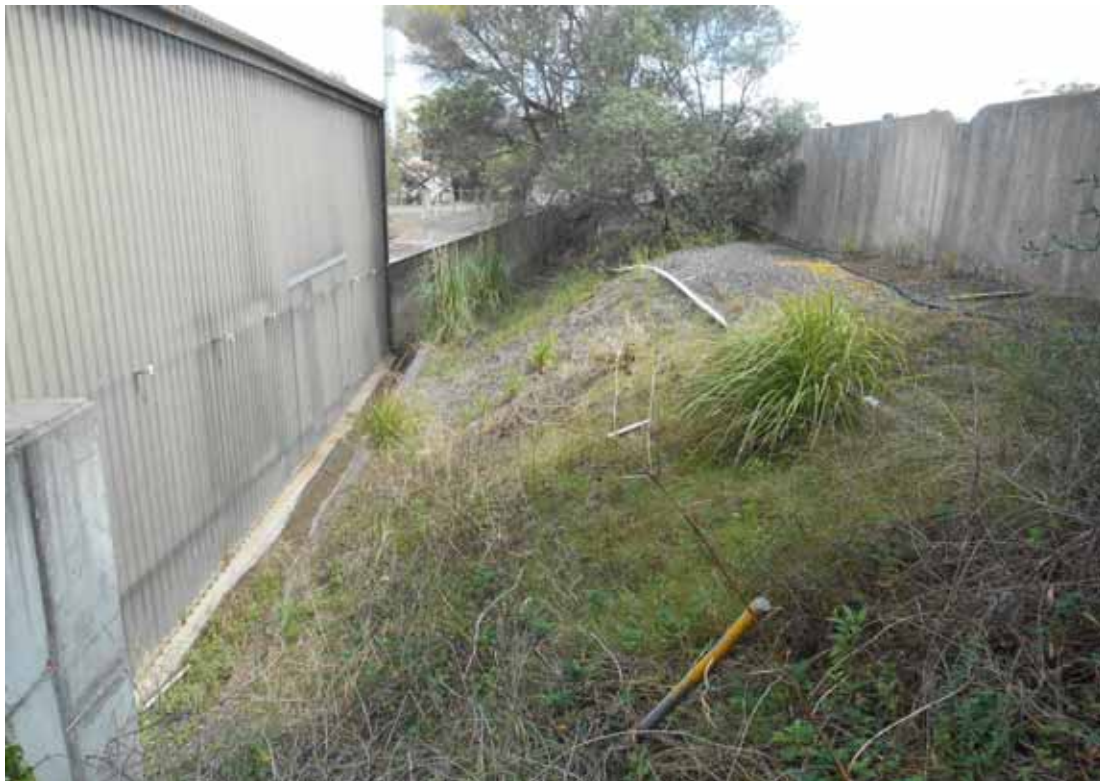
- A remnant shelter was present at the upper level;
- ASTs or signs of existing USTs were not observed during the walkover;
- Batter slopes and retaining walls are present between levels (Photograph 4, attached);

Photograph 4 - Batter slope behind workshop

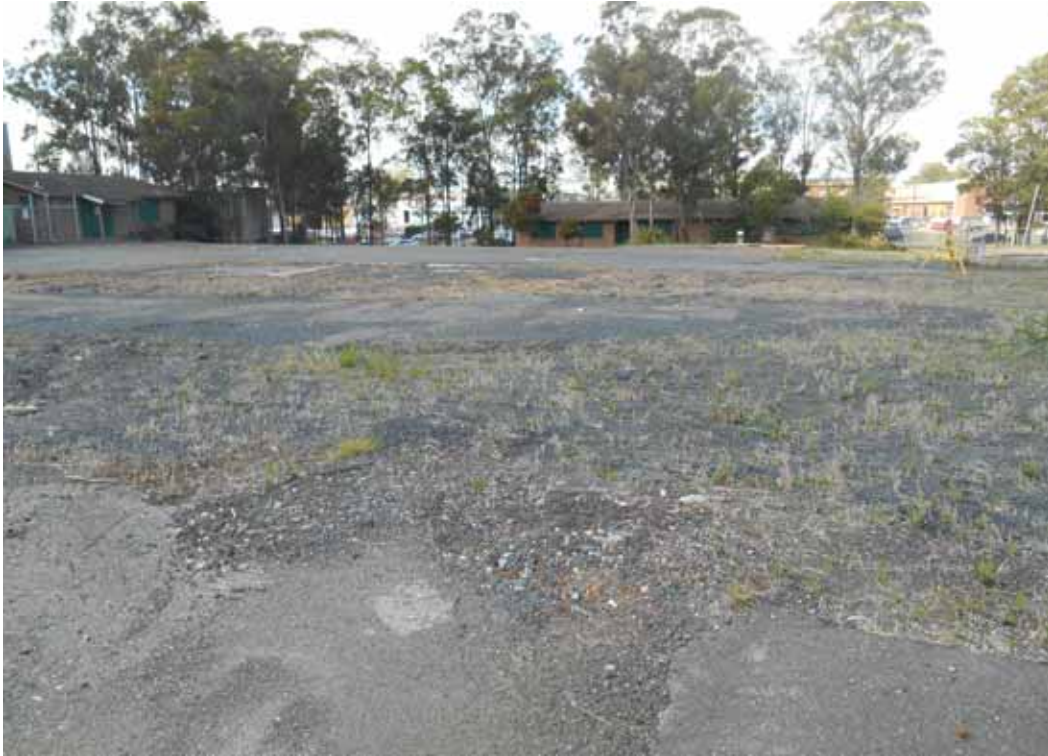
Photograph 5 - Patches of exposed soil surrounded by asphalt at lower level

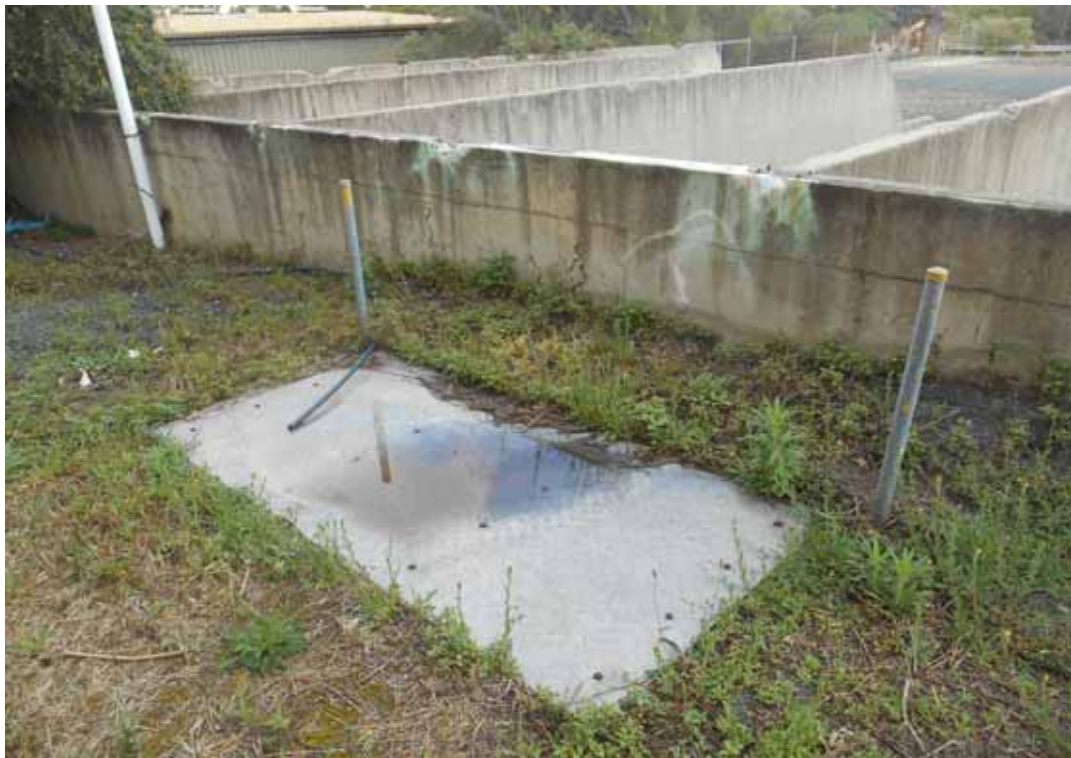
- A pit cover was observed at the eastern boundary and is presumed to be the cover to the interceptor pit referred to URS, 2013b which had not been removed during remediation works (Photograph 6, attached);

Photograph 6 - (Probable) interceptor pit cover
