LINDFIELD LEARNING VILLAGE

ETON ROAD - LINDFIELD, NSW

ARBORICULTURAL ASSESSMENT & DEVELOPMENT IMPACT REPORT

Report Ref No: RTC-15717

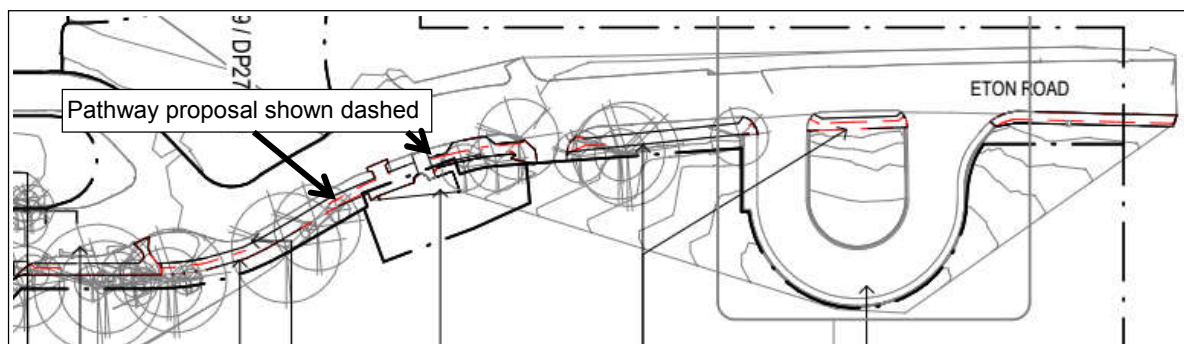
Figure 2, showing Eton Road pathway modification proposal

1.4.1 *Trees of low retention value.* Of the seventeen trees located adjacent footpath widening works three (3) trees have been identified with low retention values. They contain some form of structural fault indicating a potential risk of failure exists. Due to a proposed increased person usage area trees 5, 14 & 15 should be considered for removal.

1.4.2 *Minimising impacts to trees.* The new pathway proposal is located on the majority of an existing pathway footprint where new works are unavoidable within the Structural Root Zone (SRZ), the area required for tree stability (AS4970). To ensure tree anchorage is not disrupted and trees remain viable the following recommendations are provided:

1. The pathway is to be constructed on top of ground level. No demolition, root severing, site grading (cut) or excavation within SRZ setbacks is to occur without onsite project arborist advice and supervision, see SRZ & TPZ distance column Appendix- C.
2. Prior to works the extent of the pathway proposal is to be clearly marked out for review by the project arborist. The arborist is recommended to review & endorse final engineered drawings and construction methodology providing additional tree protection advice such that tree anchorage is not disrupted.
3. *General* - All trees are to be protected during works in accordance with Attachment- A, the generic Tree Management Plan (TMP), specific to Section 1 Tree Protection Fencing and S/- 3 Hold Points.

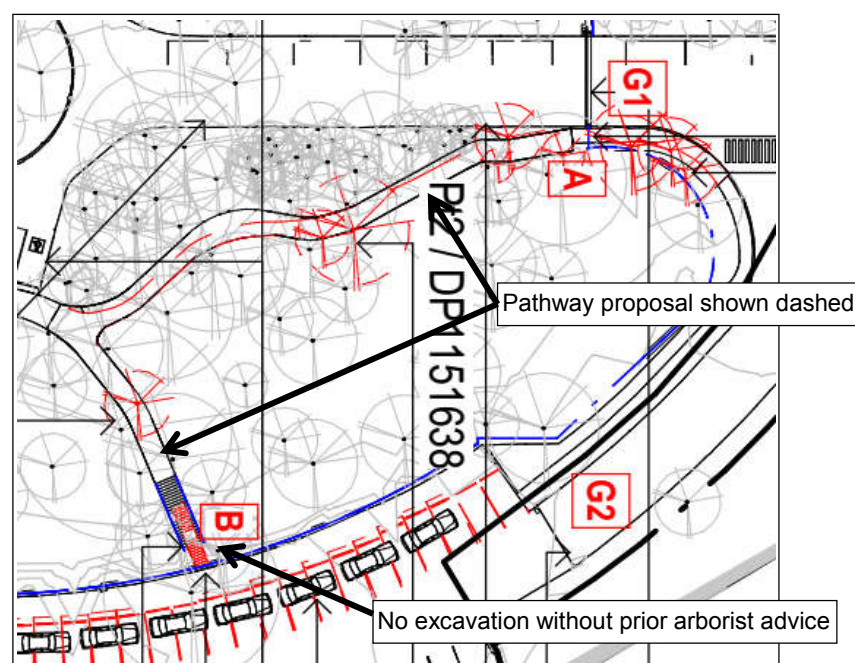
Figure 3, showing site pathway modification proposal

1.5.1 *Trees of low retention value.* Of the trees assessed within this area of proposed footpath widening five (5) trees have been identified with low retention values. They contain some form of structural fault indicating a potential risk of failure exists and should be considered for removal. The trees are identified as trees:

1.5.2 *Trees specified for removal to accommodate design.* Impacts in design are similar to section 1.4 where new works are unavoidable within the SRZ. To accommodate the design, and in specific, those trees requiring removal due to likely impacts affecting tree anchorage and are recommended for removal for safety reasons are identified as trees:

1.5.4 *Minimising impacts to trees.* To ensure the trees remain viable those recommendations provided within section 1.4.2 p6 are to be adopted, specific to *General* - all trees are to be protected during works in accordance with Attachment- A the generic Tree Management Plan. There should be no excavation to accommodate the proposed 2m wide stairs within or near the existing stairway access without prior arborist advice to ensure adjacent trees are not compromised by works.

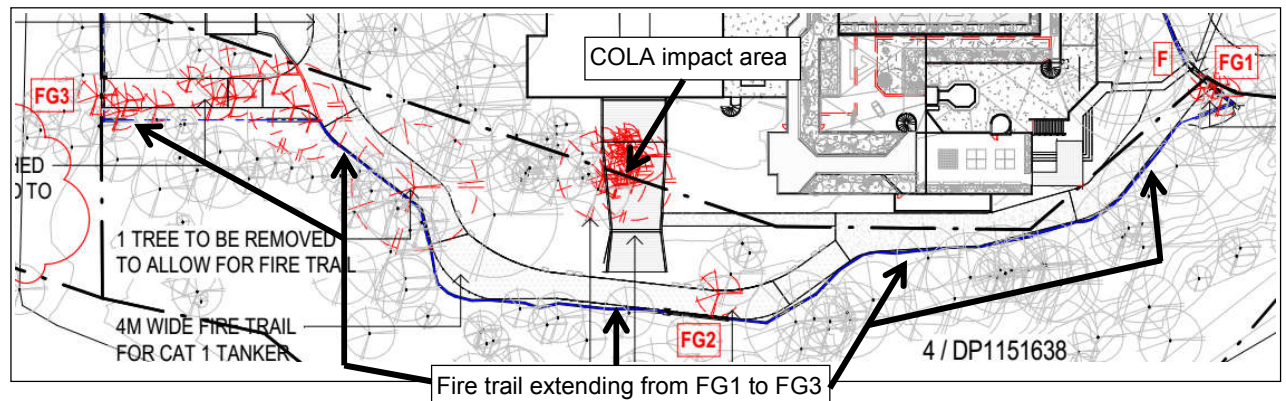
Figure 4, showing fire trail & COLA impact area

- 1.8.1 *Trees of low retention value.* Of the trees assessed within the proposed fire trail upgrade area the following trees have been identified with low retention values. They may be in significant decline, are dead or contain some form of structural fault indicating a potential risk of failure exists and should be considered for removal. The trees are identified as trees:

- 46, 50, 64, 65, 72, 76, 81, 83, 84 & 87
- 1.8.2 *Trees specified for removal to accommodate design.* To accommodate design, and in specific, those trees requiring removal due to likely impacts affecting tree anchorage and are recommended for removal for safety reasons are identified as trees:

- 45, 46, 47, 50, 63, 64, 65, 72, 73, 74, 75, 78, 82, 83, 84 & 87
- Trees which are recommended for removal due to poor condition, are dead or receive development impacts likely to affect tree anchorage are trees:
