ARBORICULTURAL IMPACT ASSESSMENT REPORT

SITE ADDRESS	W6A and W6B Arts Precinct, Macquarie University
CLIENT	Macquarie University
REPORT PREPARED BY	Australian Tree Consultants Pty Ltd
DATE	18 April 2017

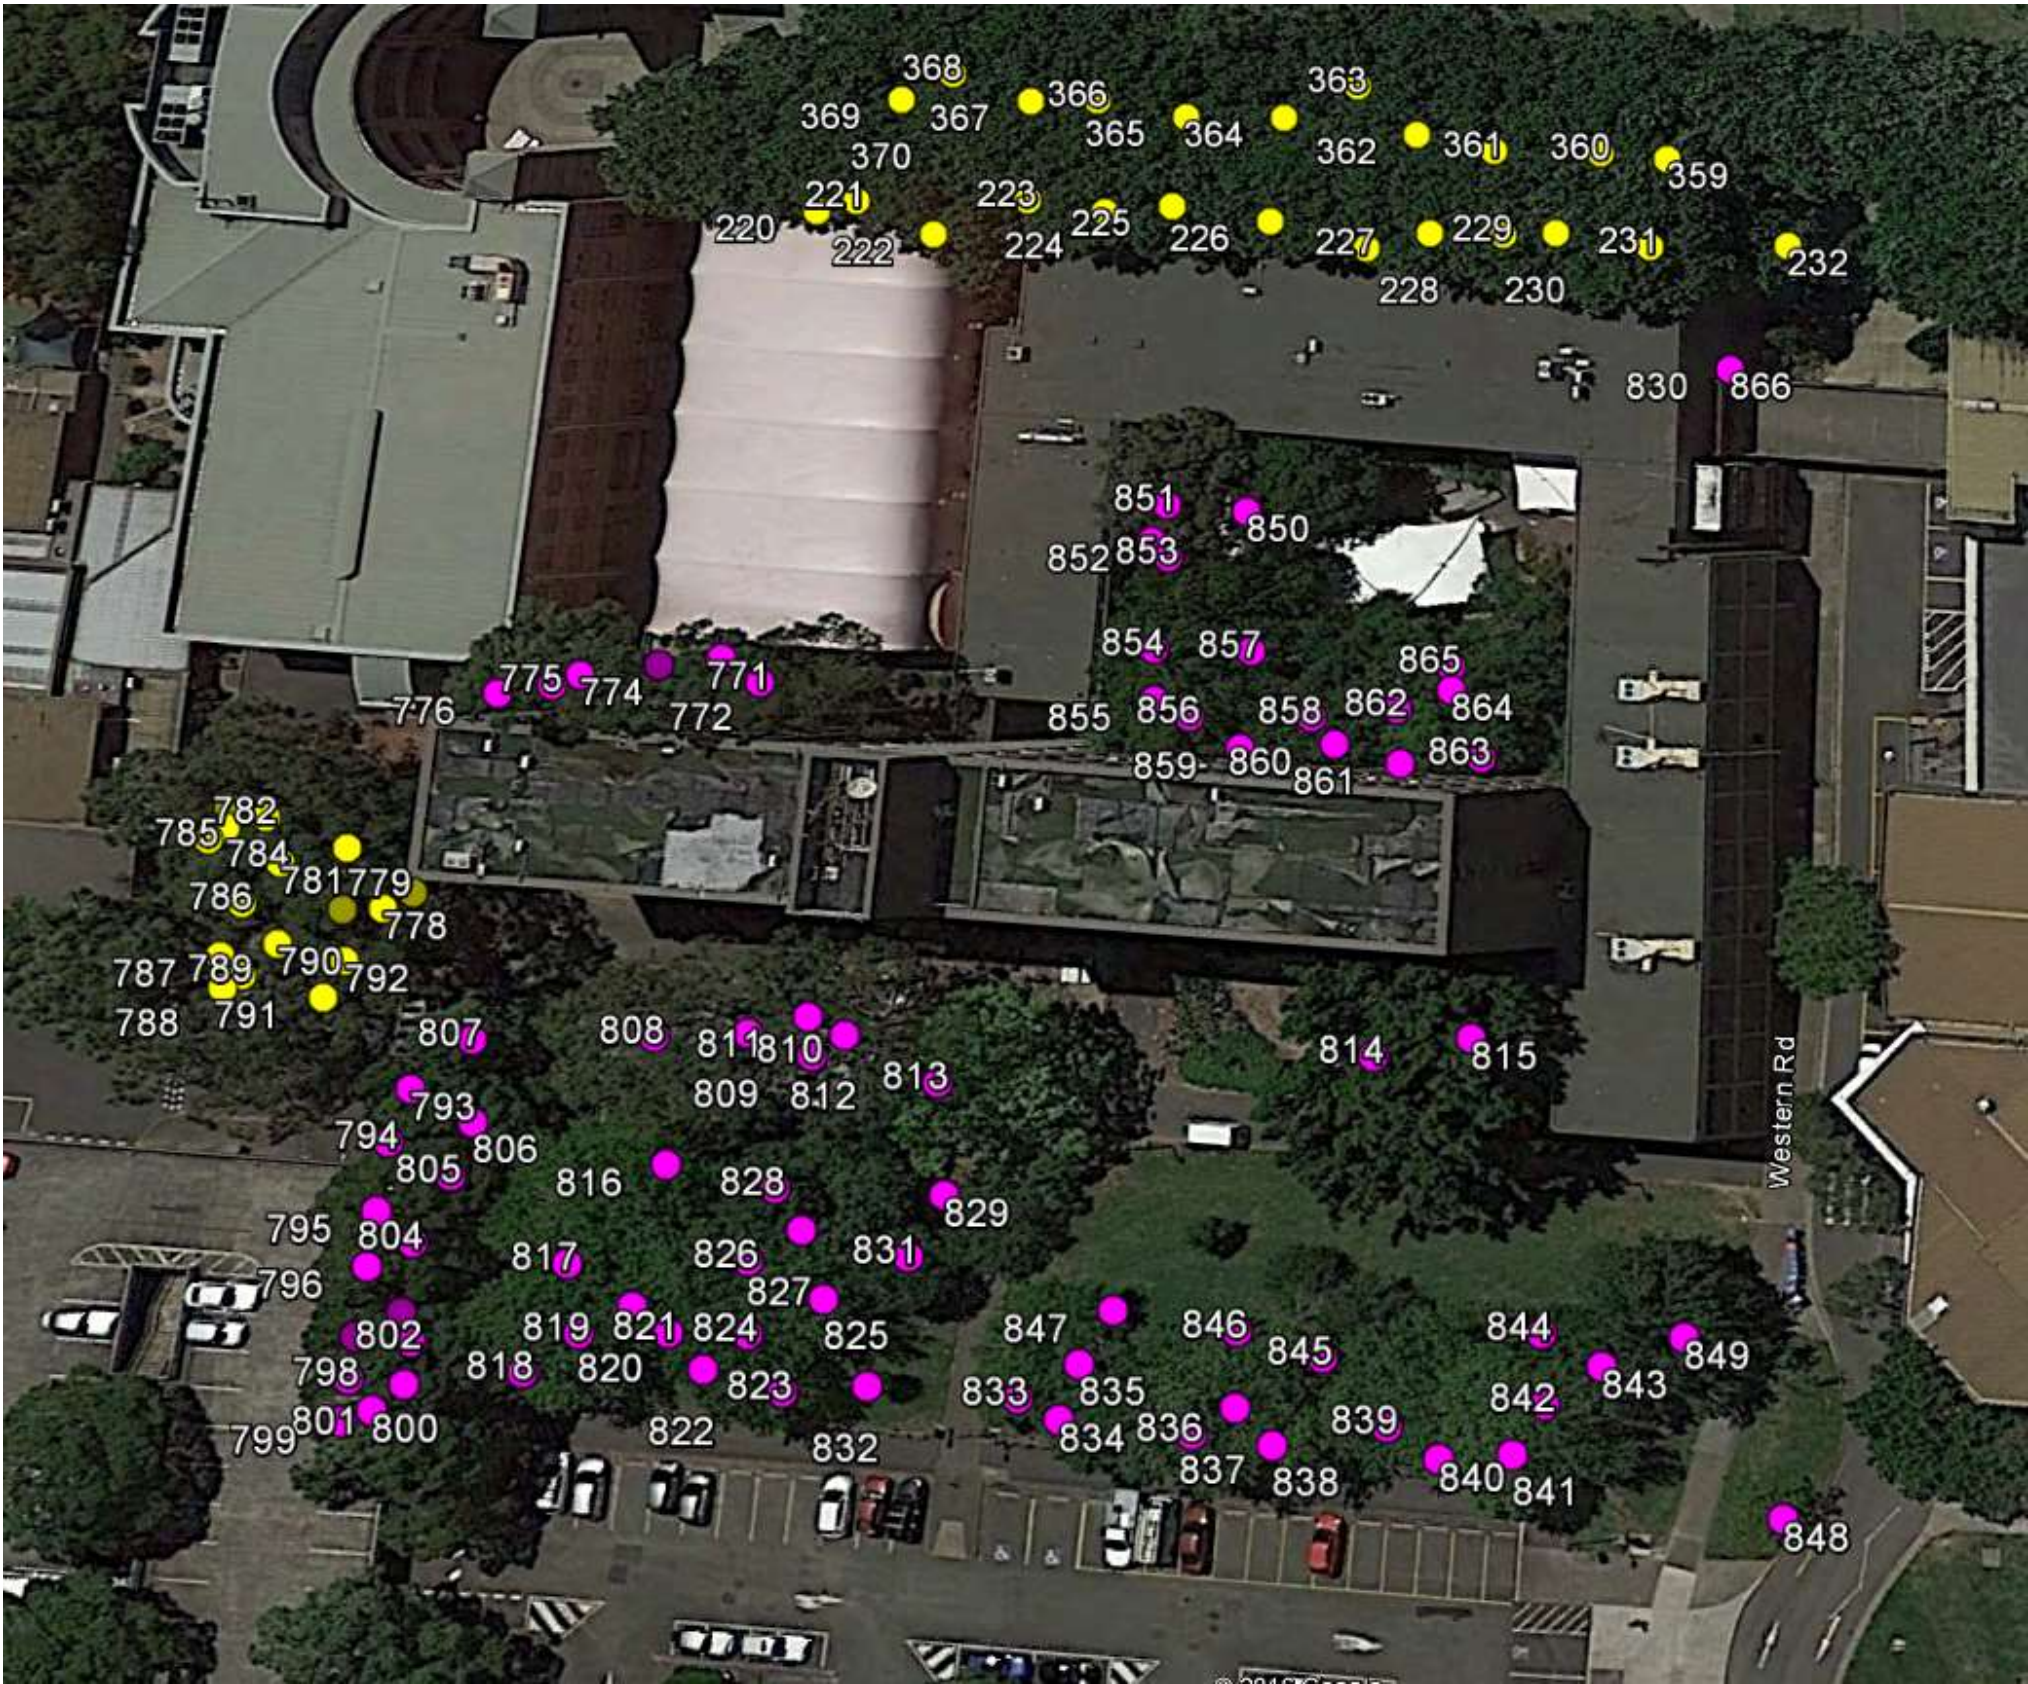
APPENDIX 1: TREE LOCATION PLAN

Map 1. Yellow icon trees retain. Pink icon trees remove.
