ARBORICULTURAL ASSESSMENT AND TREE MANAGEMENT PLAN

**PICTON HIGH SCHOOL
480 ARGYLE STREET
PICTON, NSW 2571**

**REDEVELOPMENT AND
BUILDING ALTERATIONS AND
EXTENSION WORKS**

12th February 2018

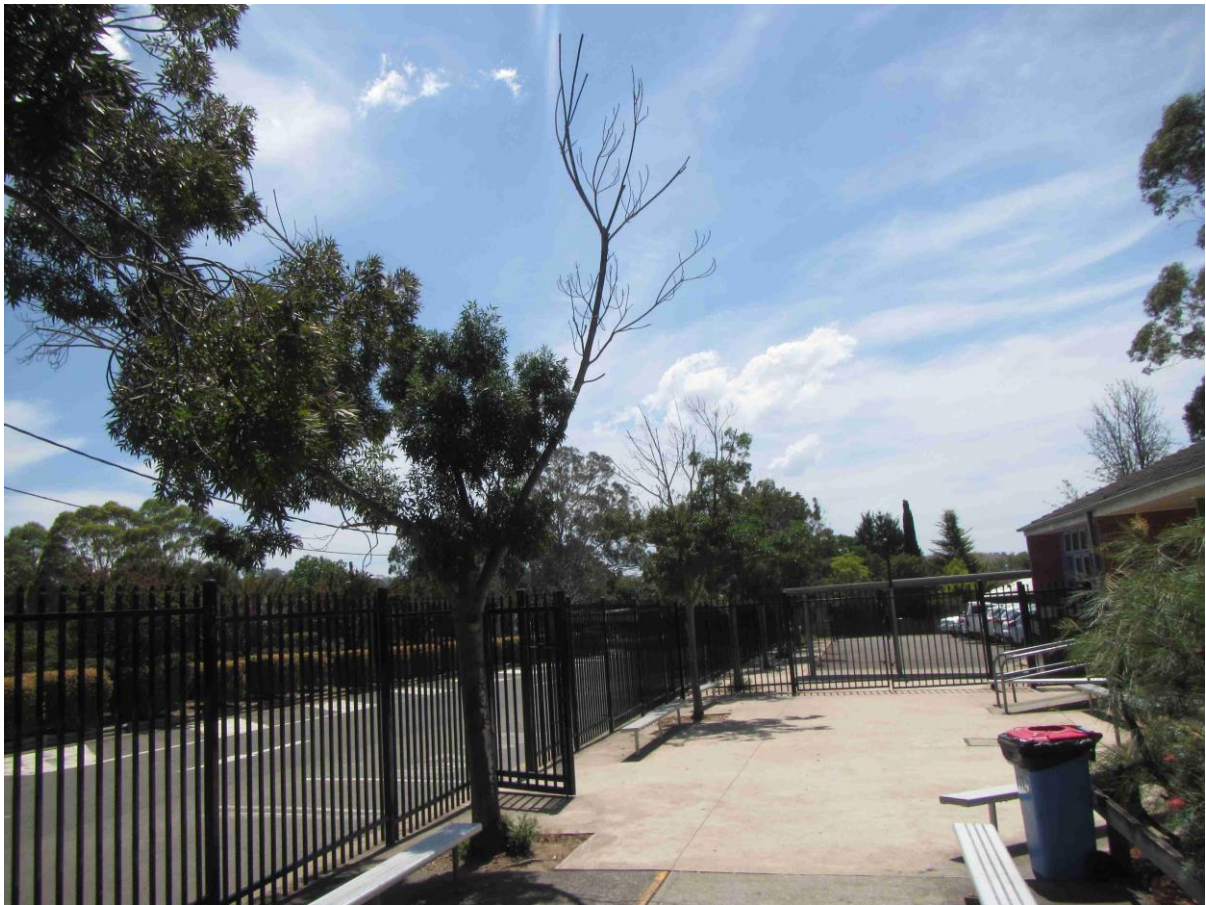
Figure 6 Shows looking at the front of the School with declining canopies.

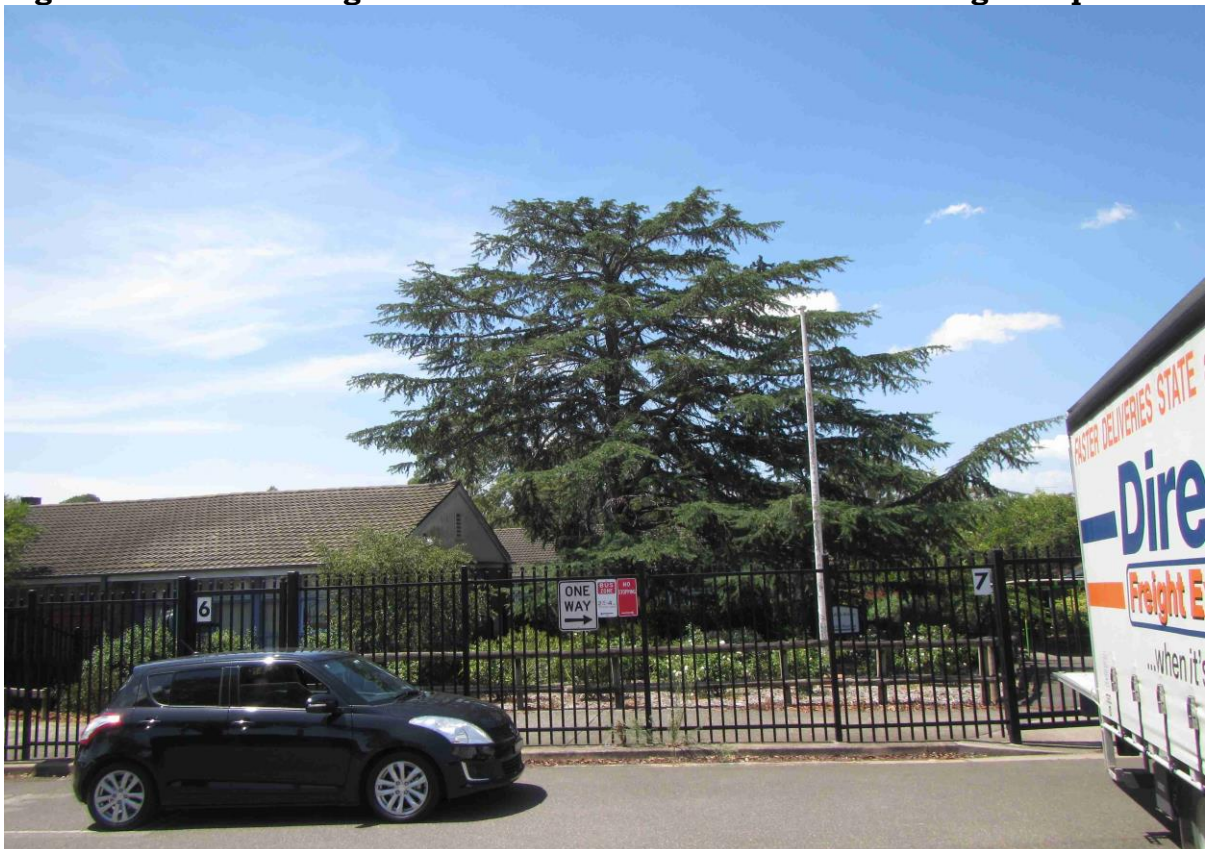
Figure 7 Shows Tree 14 from a distance that is required to be removed.

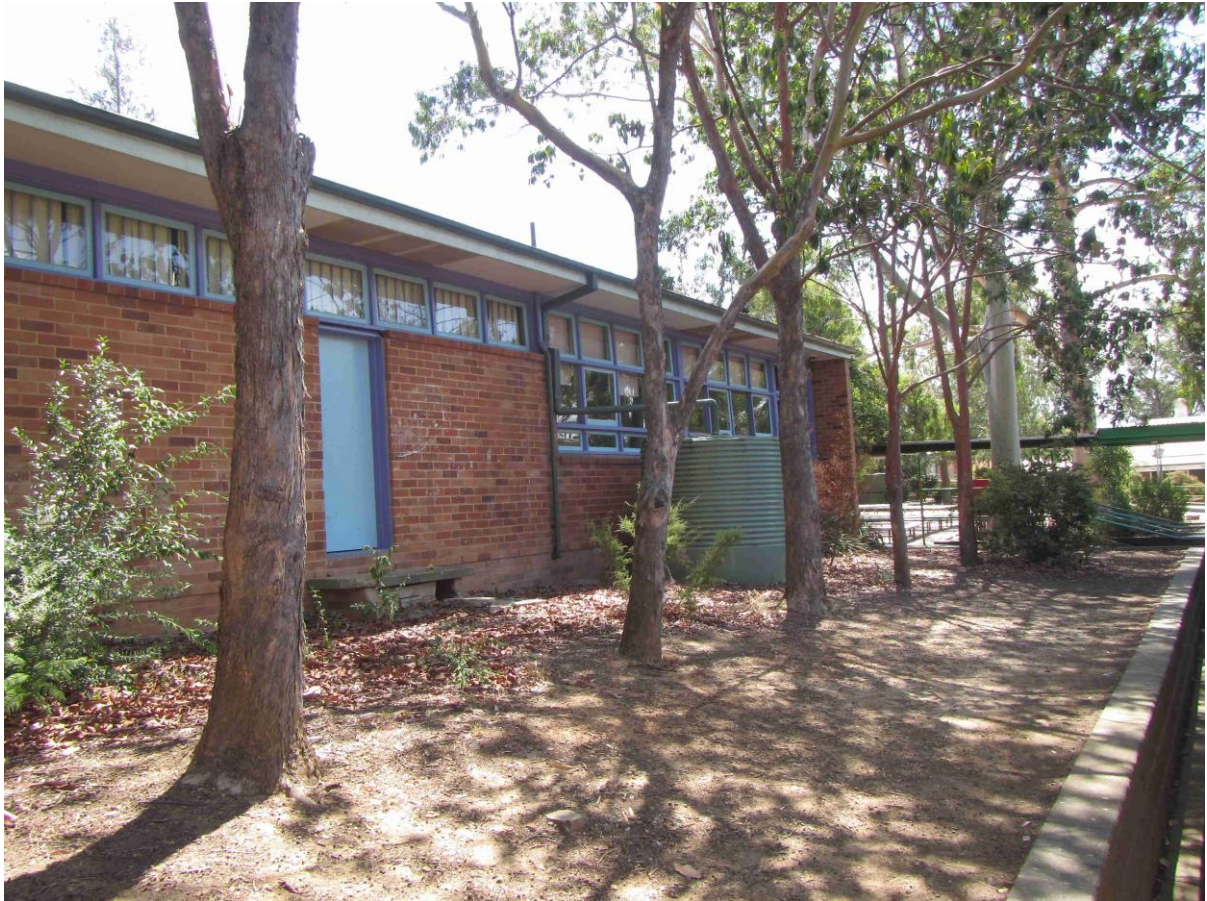
Figure 8 Shows a group planting of Brush Box in poor declining health to be removed as part of this development scope of works.

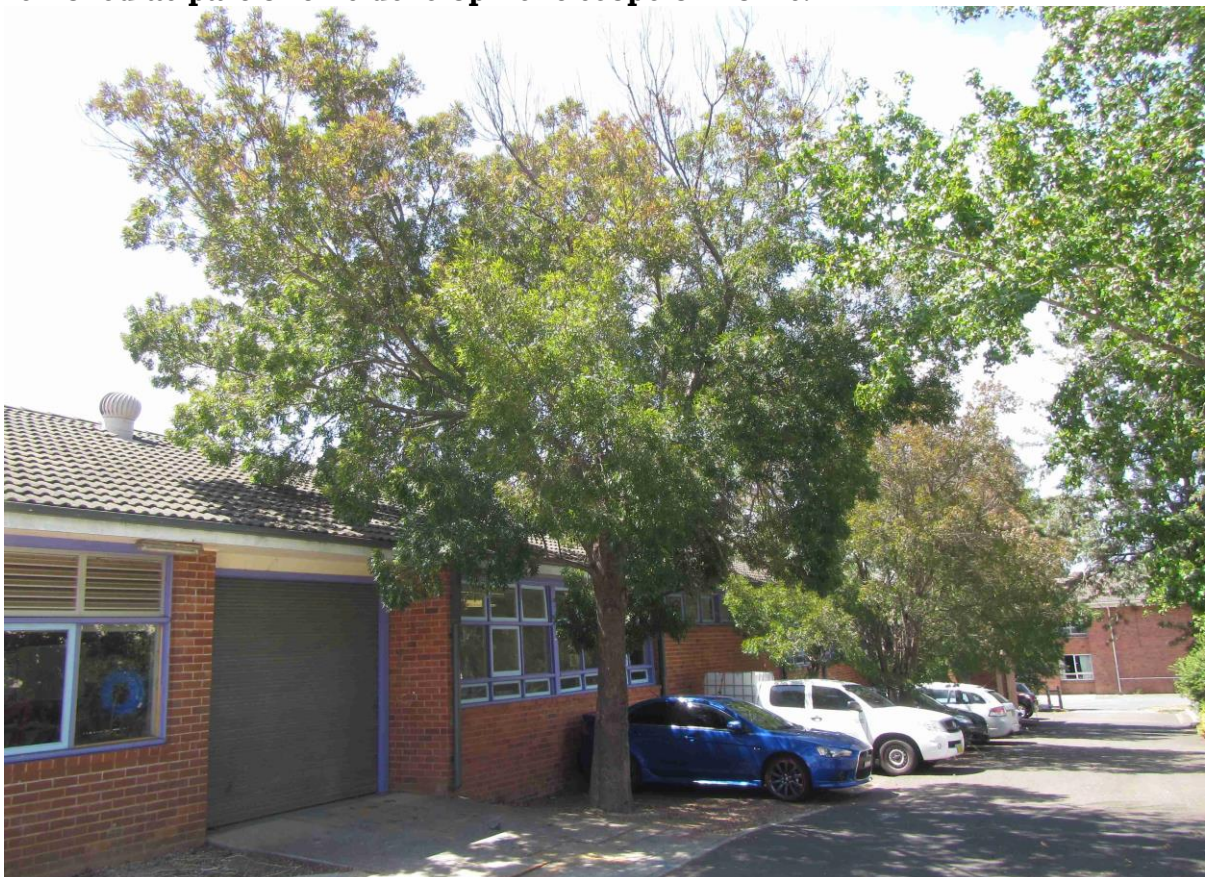
Figure 9 Shows Trees 22 to 26 that are required to be removed.

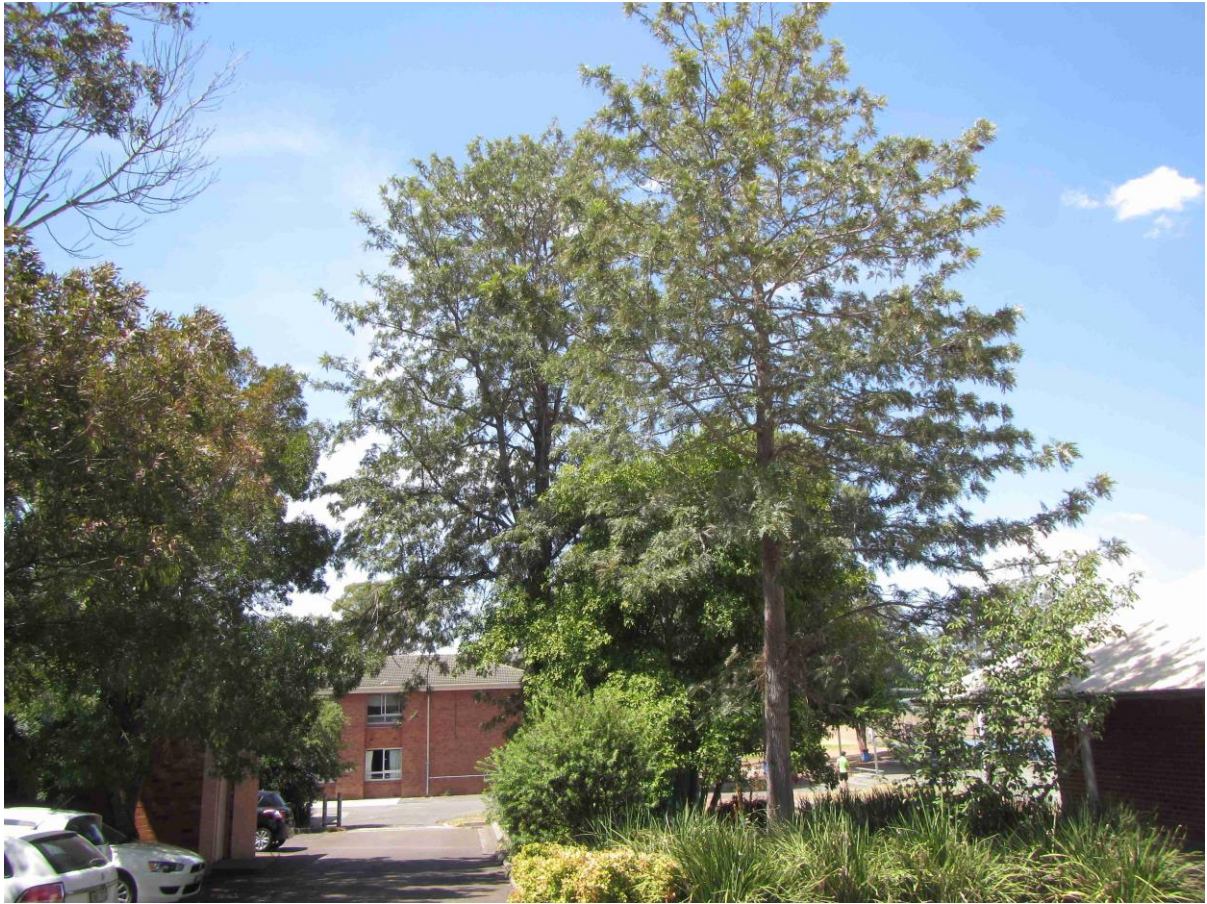
Figure 10 Shows Trees 27, 28 and 29 that are required to be removed.

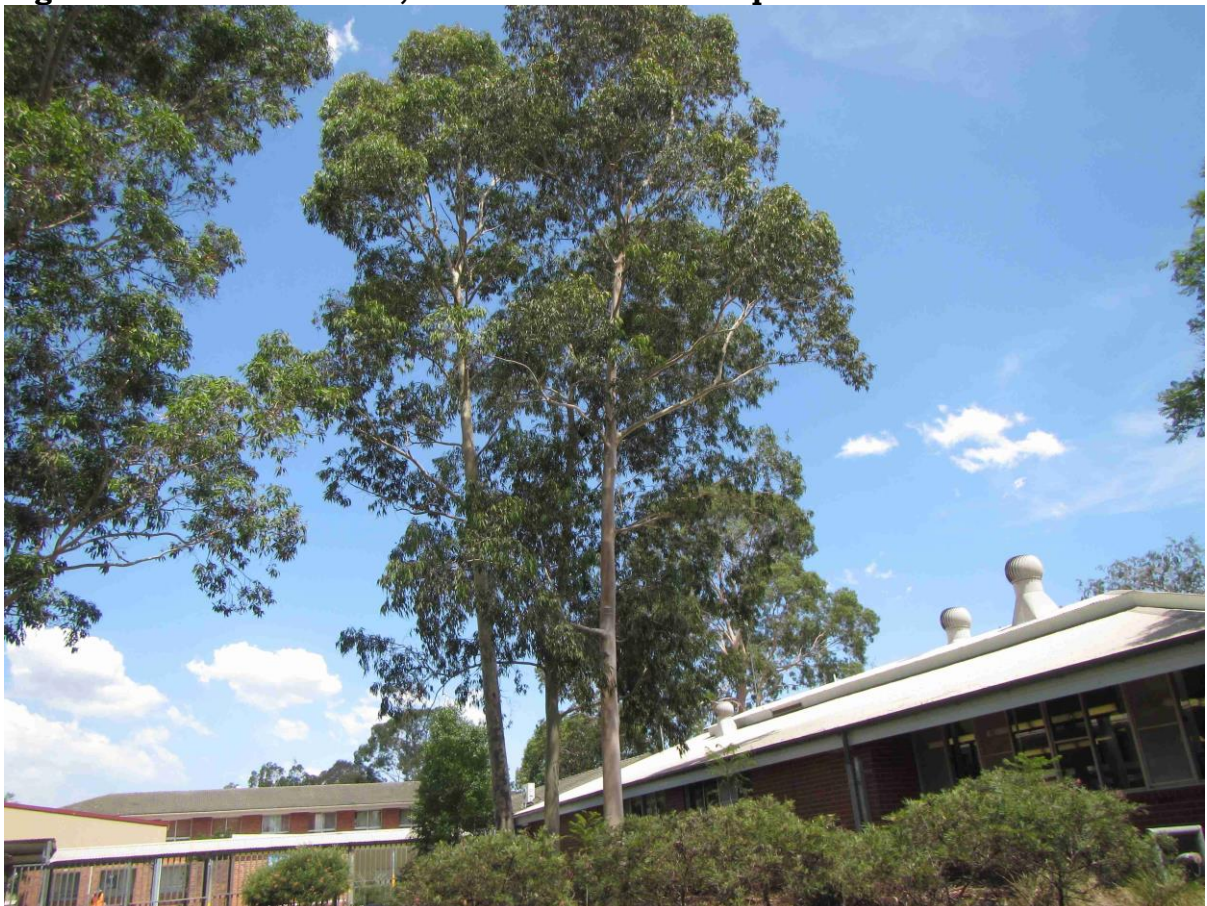
46.	Spotted Gum <i>Corymbia maculata</i>	16m	320mm	N/A	N/A	Mature	Good	Good	3	Low	Low	No, tree is required to be removed as its located within the scope of works and replaced in the landscape upon completion.
47.	Spotted Gum <i>Corymbia maculata</i>	16m	340mm	N/A	N/A	Mature	Good	Good	3	Low	Low	No, tree is required to be removed as its located within the scope of works and replaced in the landscape upon completion.
48.	Spotted Gum <i>Corymbia maculata</i>	16m	340mm	N/A	N/A	Mature	Good	Good	3	Low	Low	No, tree is required to be removed as its located within the scope of works and replaced in the landscape upon completion.

Figure 11 Shows Spotted Gums that are required to be removed.

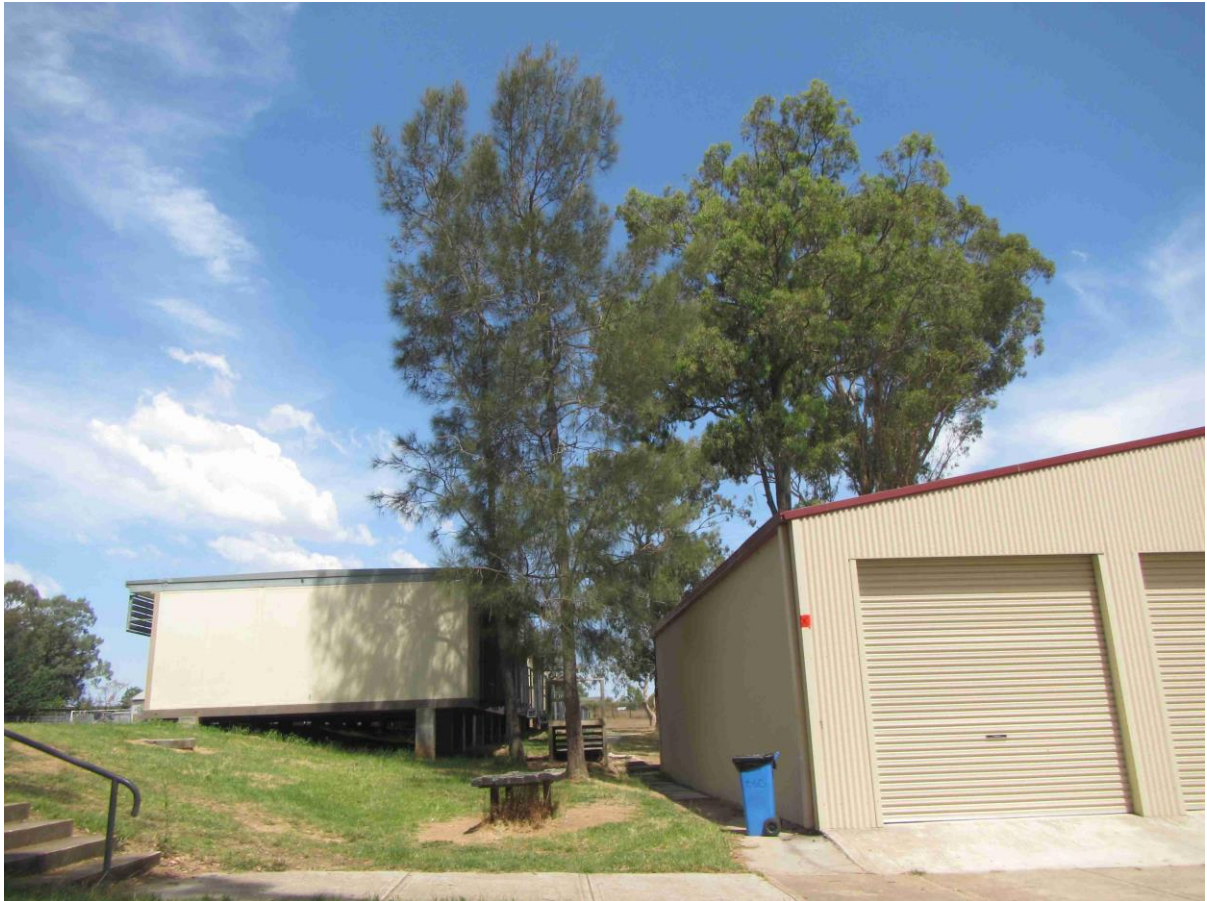
61.	Swamp she-oak <i>Casuarina glauca</i>	10m	300mm	N/A	N/A	Mature	Good	Good	3	Nil	Nil	No, tree is required to be removed as its located within the scope of works and replaced in the landscape upon completion.
62.	Swamp she-oak <i>Casuarina glauca</i>	10m	270mm	N/A	N/A	Mature	Good	Good	3	Nil	Nil	No, tree is required to be removed as its located within the scope of works and replaced in the landscape upon completion.
63.	Narrow-leaved Ironbark <i>Eucalyptus crebra</i>	12m	560mm	N/A	N/A	Mature	Good to Fair	Good to Fair	3	Moderate	Moderate	No, tree is required to be removed as its located within the scope of works and replaced in the landscape upon completion.

Figure 12 Shows Trees 61 and 62 required to be removed.

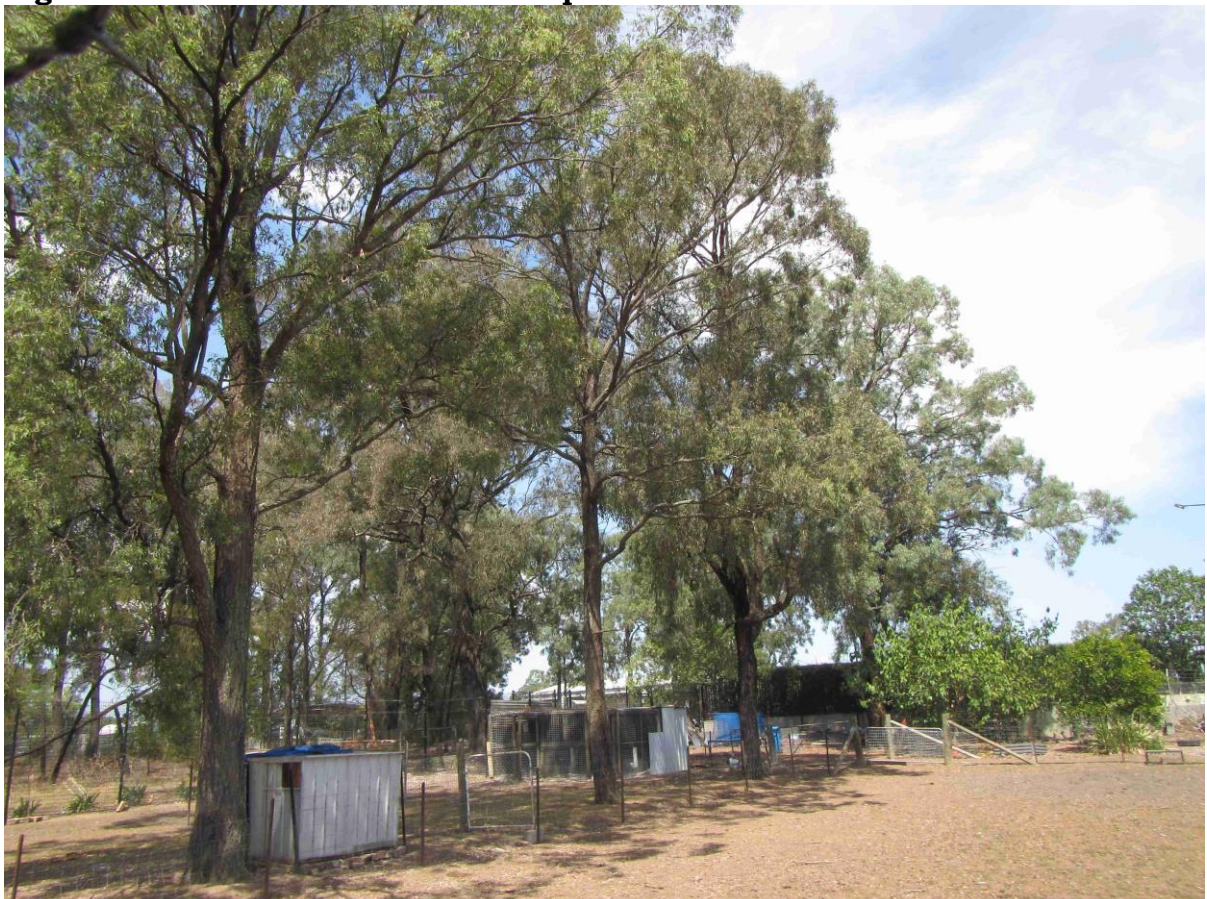
72.	Narrow-leaved Ironbark <i>Eucalyptus crebra</i>	16m	390mm	N/A	N/A	Mature	Good	Good to Fair	3	Moderate	Moderate	No, tree is required to be removed for accessway and vehicle movements and replaced in the landscape upon completion.
73.	Narrow-leaved Ironbark <i>Eucalyptus crebra</i>	16m	400mm	N/A	N/A	Mature	Good	Good to Fair	3	Moderate	Moderate	No, tree is required to be removed for accessway and vehicle movements and replaced in the landscape upon completion.
74.	Narrow-leaved Ironbark <i>Eucalyptus crebra</i>	15m	390mm	N/A	N/A	Mature	Good	Good to Fair	3	Moderate	Moderate	No, tree is required to be removed for accessway and vehicle movements and replaced in the landscape upon completion.

Figure 13 Shows rear trees required to be removed for accessway.
