HAZARDOUS MATERIALS SURVEY JHHIP PROJECT, JOHN HUNTER HOSPITAL CAMPUS

Prepared for HEALTH INFRASTRUCTURE Prepared by RCA Australia RCA ref 14399A-401/2 April 2021

HAZARDOUS MATERIALS SURVEY JOHN HUNTER HEALTH AND INNOVATION PRECINCT PROJECT

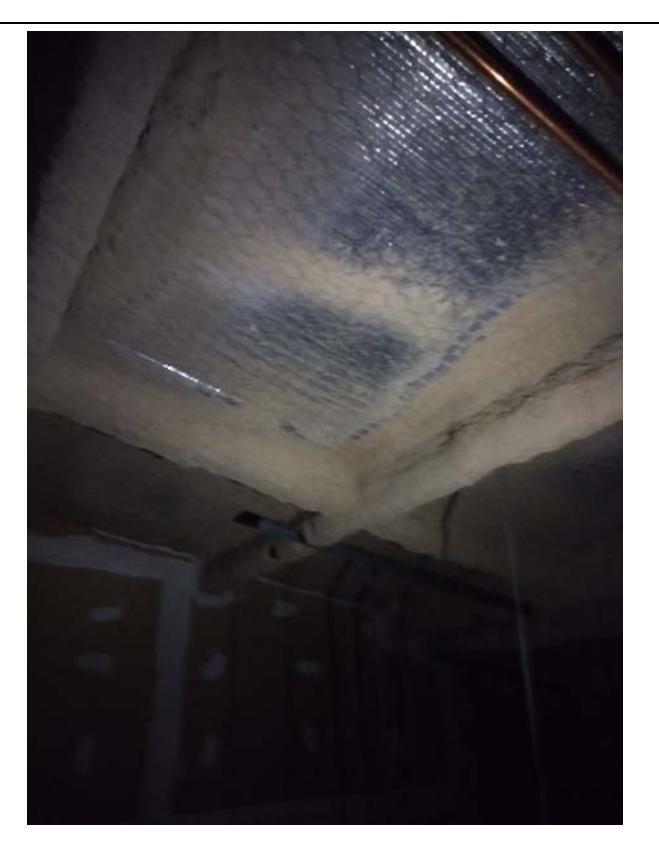
PHOTOGRAPH 7

3	Plant room above operating theatre (accessed via level 4)	N/A	N/A	N/A	SMF within insulation sheets in ceiling cavity (refer to Photograph 7).

Ceiling cavity above Level 3 operating theatres. **SMF in insulation sheeting**. Fire retardant spray material does not contain asbestos, as shown in asbestos register.

- SMF is to be considered a potentially hazardous material and inhalation and contact minimised. The SMF is to be bagged in heavy duty plastic bags / wrap as close as practicable to the location it is situated and mitigation measures to minimise the potential for it to be blown around are to be implemented.

- The bags are to be sealed prior to moving.
- Personnel handling this material are to wear a face mask and disposable clothing to reduce the risk of inhalation and dermal contact and the area is to be vacuumed to remove potential stray fibres prior to the commencement of other works.

- SMF is to be removed to a licensed waste disposal facility. Bags are to be unloaded in a manner which maintains the integrity of the bags and minimises the release of dust. Note that it is the transporter's responsibility to ensure that the bags remain intact during the unloading process.

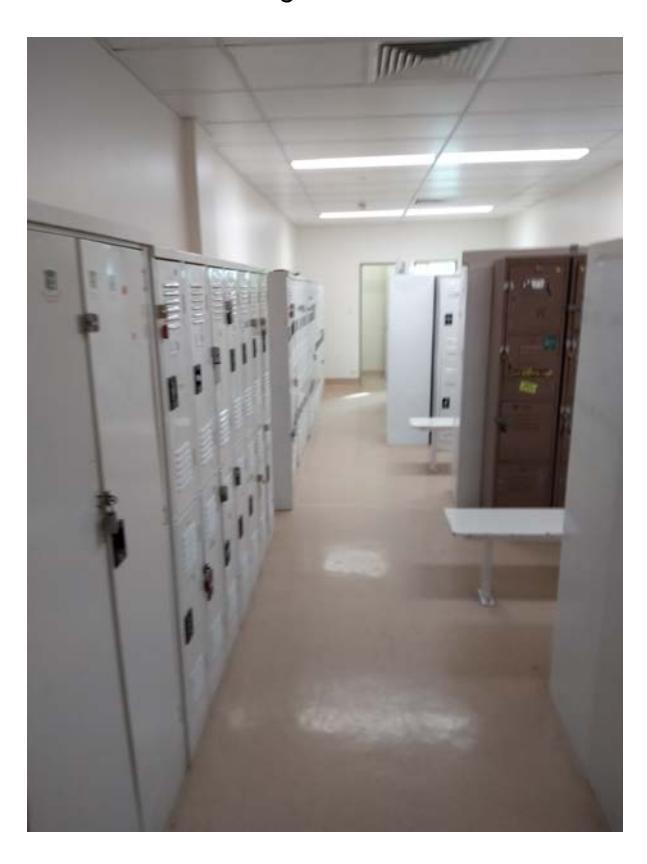
PHOTOGRAPH 8 Level 2, male staff area – no hazardous materials detected.

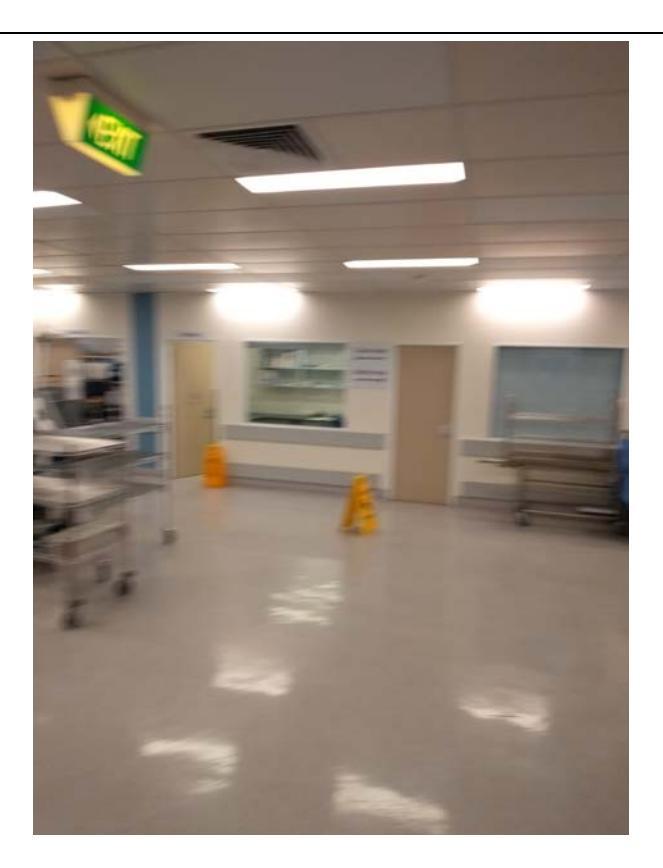
Level 1, CSD common area – no hazardous materials in this location but refer to following photo for Hazardous Materials within Steriliser Plant Room

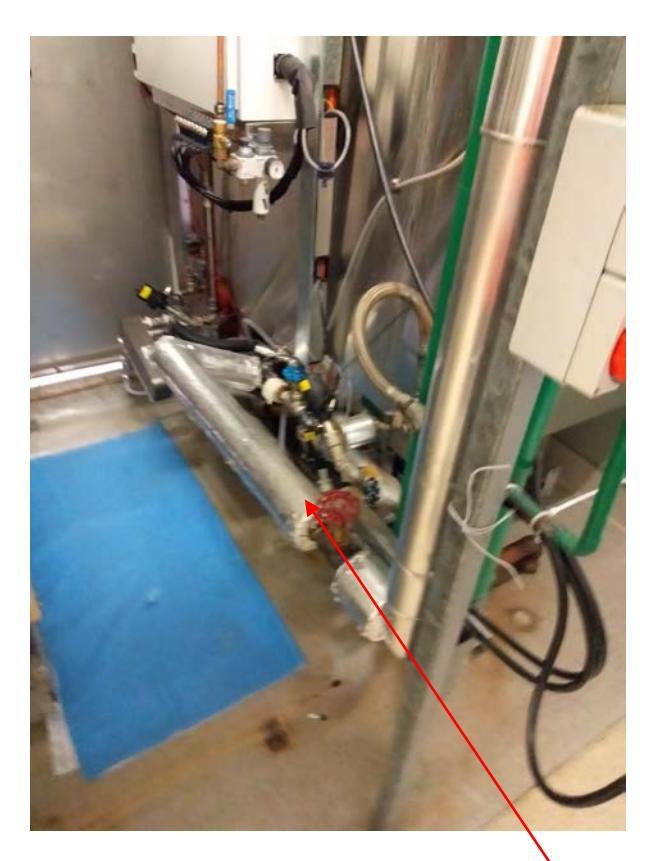
- Level 1, steriliser plant room pipe lagging and insulation in wall panel. It was further advised by site personnel that there were SMF sheets inside the steriliser casing however this wasn't confirmed by inspection by RCA.
- Level 2, ceiling cavity insulation in ductwork.
- Level 3, ceiling cavity above NICU insulation in ductwork.
- Level 3, ceiling cavity above ICU/ PICU insulation sheets.
- Level 3, plant room ceiling cavity above operating theatres insulation sheets.

PHOTOGRAPH 15 Level 1, CSD Steriliser Plant Room. SMF in pipe lagging insulation.
