arboricultural impact assessment & moreton bay fig management plan

AIA-01

Revision A, Issued for Development Application
15 August, 2019

Site 2A and 2B, Sydney Olympic Park

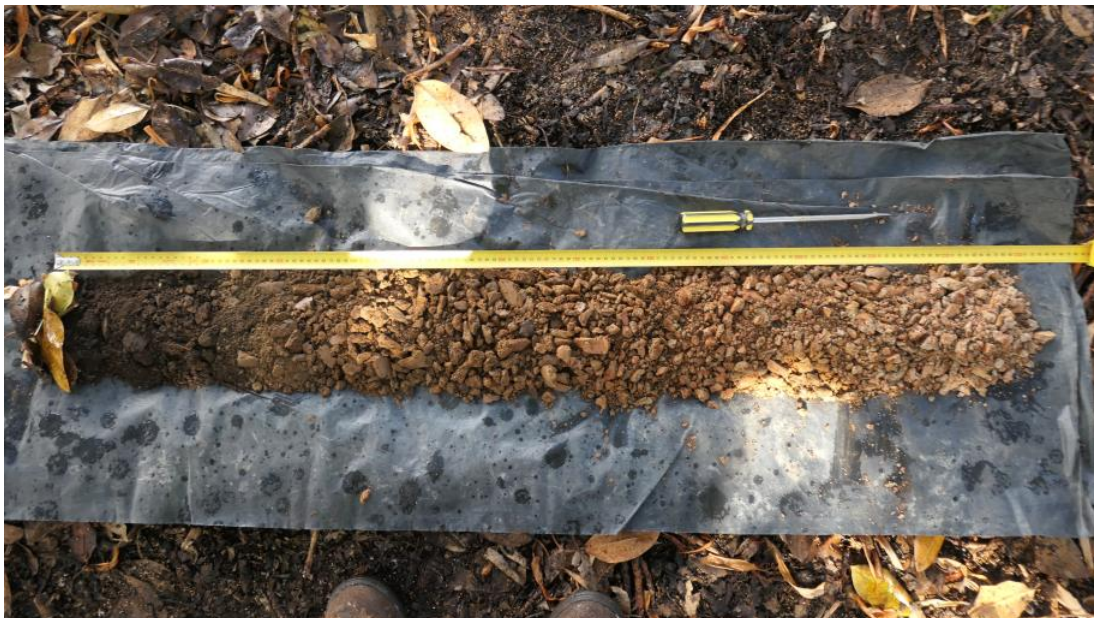
The topsoil was 300-400mm in depth and a very friable clay loam with a slightly acid pH of 6.0. Below this, from 400-1000mm was a heavy reddy-brown clay with an acidic pH of 5.5. Below 1000mm the soil profile was representative of a very weathered shale material and was a very heavy and plastic reddy-grey clay with a very acidic pH of 5.0-5.5.

Figure 6 – View of the natural red-brown podzolic soil profile to the south side of the tree. A similar profile was found on the north side of the tree, although below 300mm depth, the soil was saturated with free water. (Photo Arterra 5/6/19)

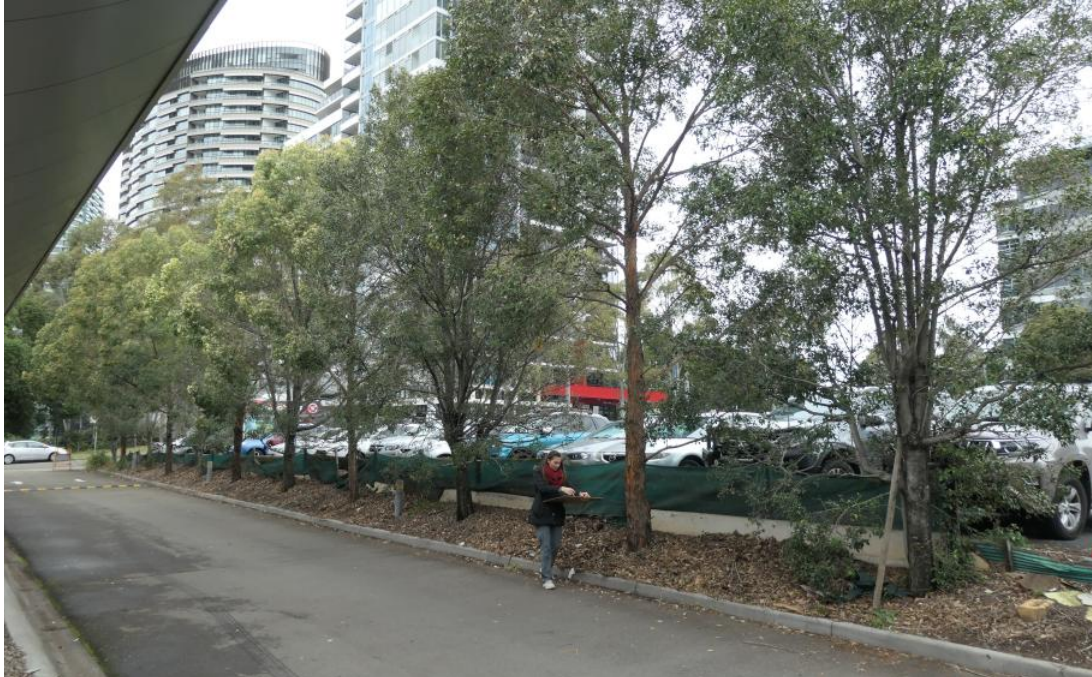
This avenue of trees are situated along the south eastern boundary line on the neighbouring property. The trees are an alternating avenue of *Acmena smithii* (Lilly Pilly) and *Eucalyptus microcorys* (Tallowood) and vary from poor to average form and poor to good vigour.

Figure 8 – The trees located on the neighbouring property and their proximity to the boundary and driveway (Image by Arterra 30/07/19).

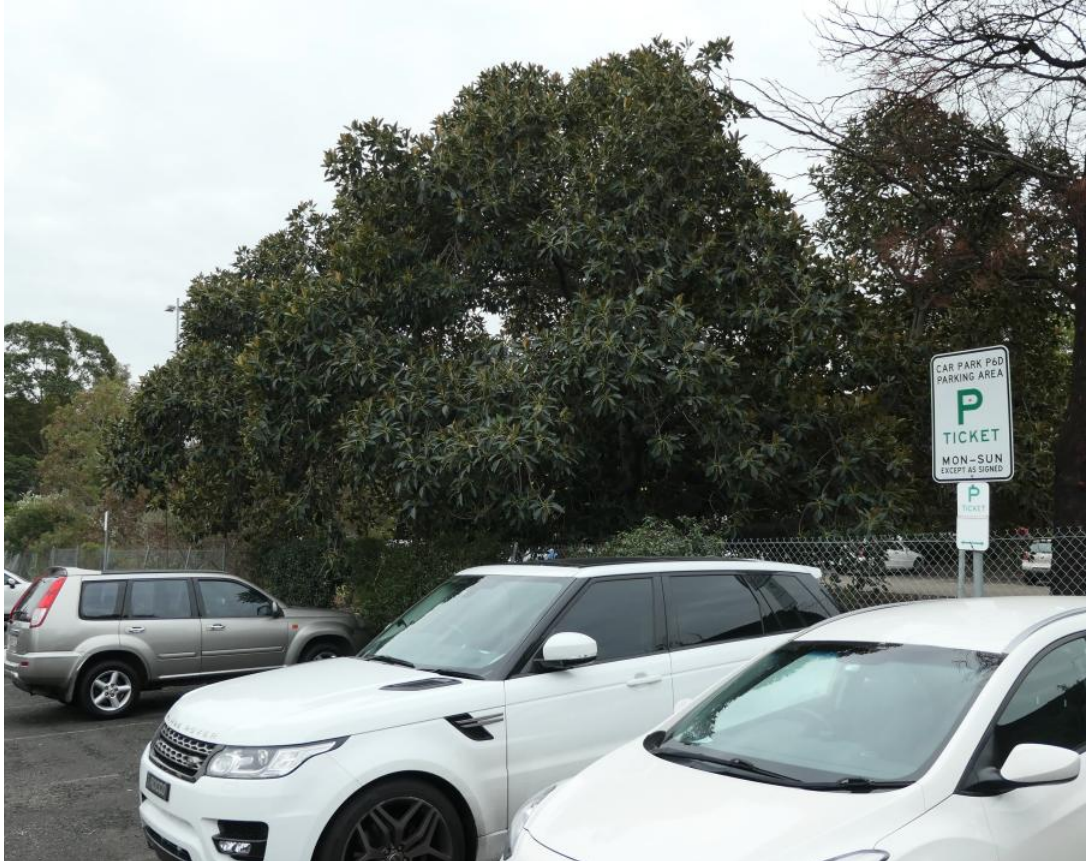
All but one of the noted trees will have major incursions into their TPZs. Many of these trees also have incursions into their structural root zones, resulting in significant impacts. These significant impacts are far from ideal and, from an arboricultural perspective, are an undesirable outcome. This significant impact will most likely adversely affect the health and vitality of the trees and their structural stability may potentially be compromised from the resulting incursions.

Figure 9 – T34 *Ficus macrophylla* located on the neighbouring property highlighting its close proximity to the boundary (Image by Arterra 30/07/19).

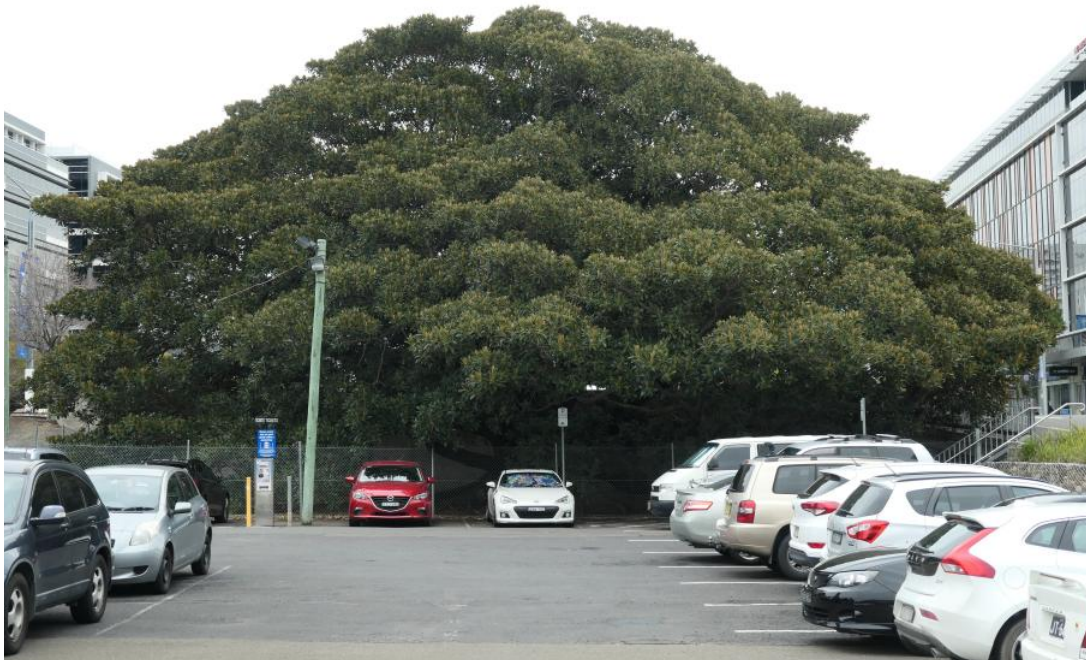
The tree displays the characteristics of this description and may be classed as an above average tree in its habit, form, structure and health. At 14-16m high and a 34-38m spread it is at the upper limit of its naturally expected size. Relatively few specimens have been observed by the author at a larger size. Trees must grow to survive, however, and some consideration for moderate expansion in the trees height and spread should be factored into the design.

Figure 10 – T01 *Ficus macrophylla* located in the north-western corner of the site (Image by Arterra 30/07/19).

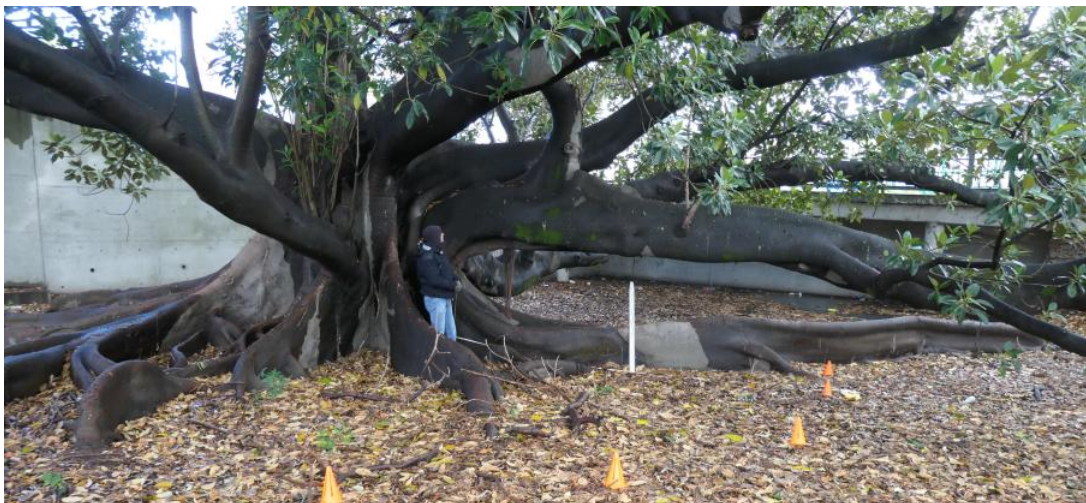
Figure 11 – T01 *Ficus macrophylla* and its extensive buttressing root system and low branching habit (Image by Arterra 05/06/19).

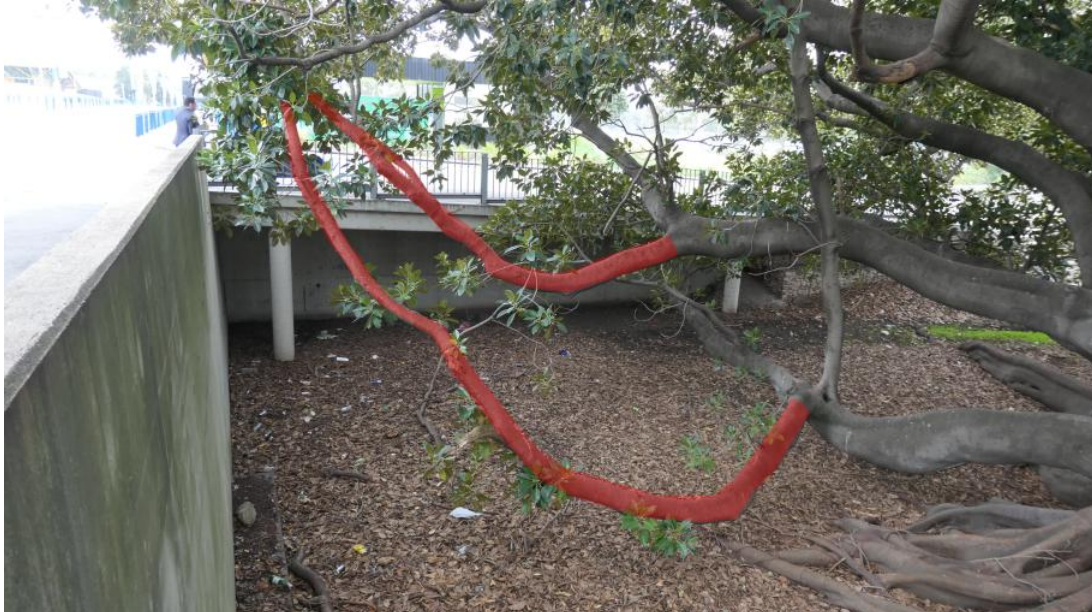
Figure 22 – Proposed canopy pruning for construction access on the north western side of the tree for the proposed 'viewing platform'. All pruning is to be undertaken on lower branches, less than 250mm only. All pruning is to be undertaken with strict supervision from an AQF Level 5 arborist (Image by Arterra 30/07/19)

Canopy pruning is to be undertaken under strict supervision from an AQF Level 5 arborist with a view to restricting pruning to branches less than 250mm diameter and a focus on branches that are around the lower perimeter of the tree. Judicious pruning shall be done selectively and incrementally to ensure that the maximum amount of canopy volume can be retained. Pruning shall aim to maintain the overall aesthetic qualities and general broad domed habit of the tree. The largest pruning is restricted to the eastern side of the tree, that is somewhat asymmetrical in nature, to facilitate the construction of the building and basement and provide access at a critical part of the site. The following images reflect the current expected proposed pruning which may need to be undertaken for construction access.

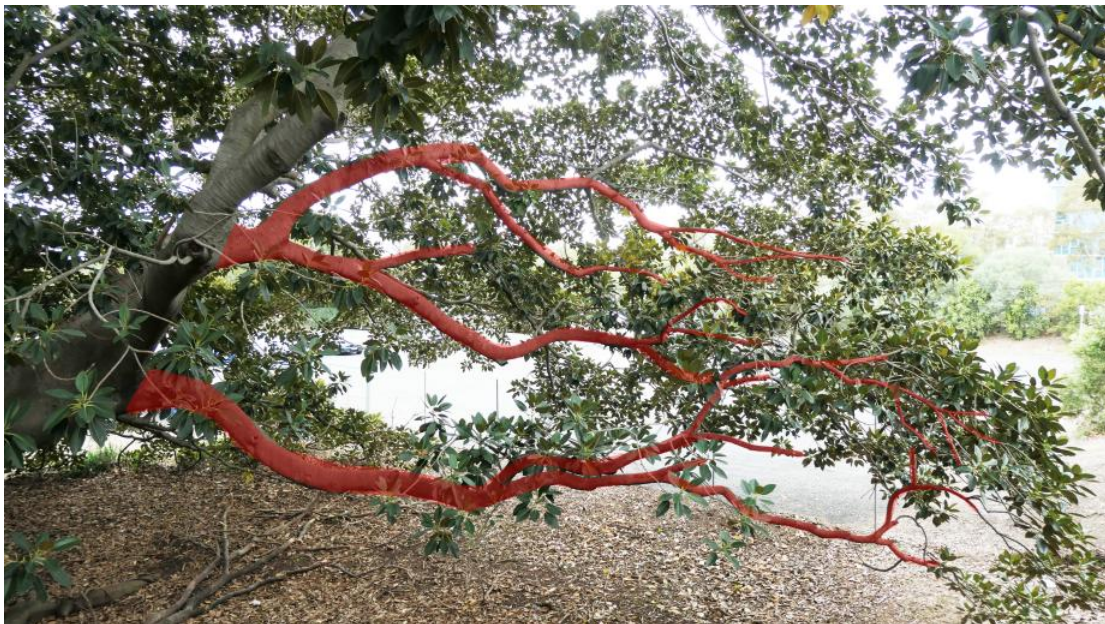
Figure 23 – Proposed canopy pruning for construction access on the south western side of the tree for pedestrian access into the site and to accommodate suspended concrete steps. All pruning is to be undertaken with strict supervision from an AQF Level 5 arborist (Image by Arterra 30/07/19)

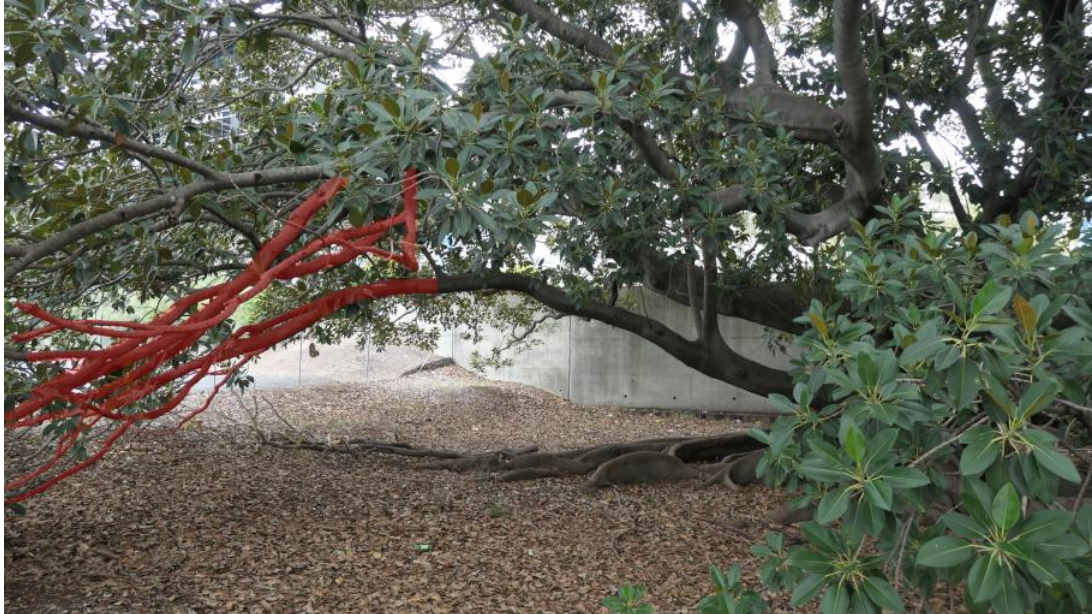
Figure 24 – Proposed canopy pruning for construction access on the south eastern side of the tree for pedestrian access into the site and to accommodate suspended concrete steps. All pruning is to be undertaken with strict supervision from an AQF Level 5 arborist (Image by Arterra 30/07/19)

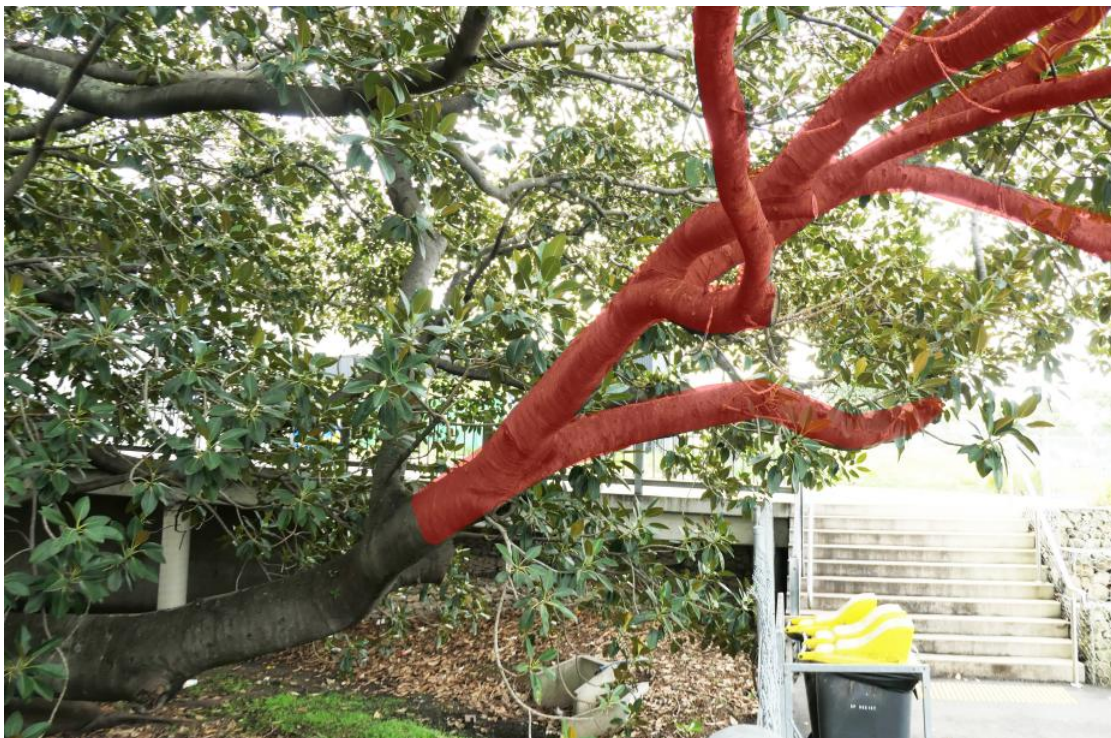
Figure 25 – Proposed canopy pruning for construction access on the eastern side of the tree for pedestrian access into the entry of the hotel. All pruning is to be undertaken with strict supervision from an AQF Level 5 arborist (Image by Arterra 30/07/19)

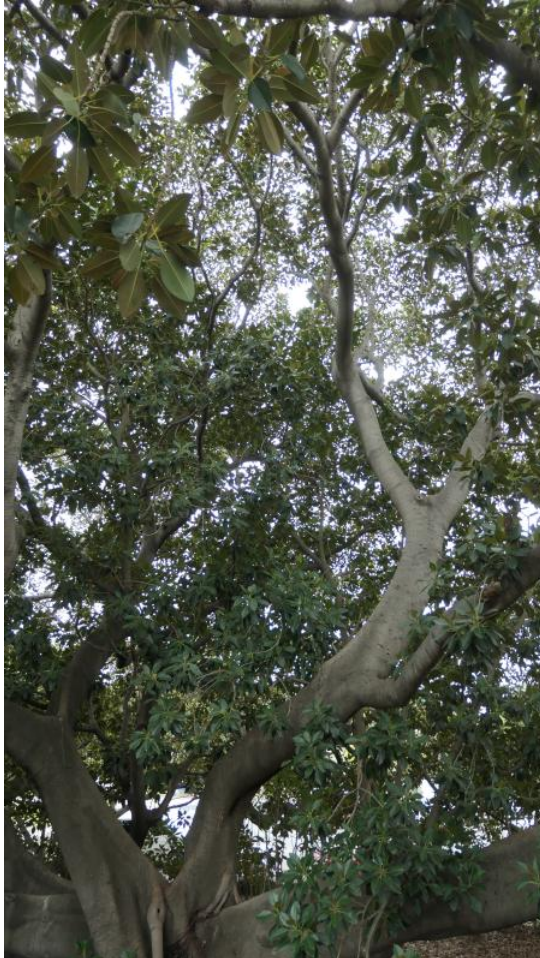
Figure 26 – Existing dense upper canopy of T01 Ficus macrophylla to be retained. Pruning shall be selectively and incrementally undertaken on the lower branches for construction access, to maintain the upper canopy (Image by Arterra 30/07/19)

It is important to ensure that all branches removed consider the impacts on the upper canopy of the tree. Branches that may open up the canopy 'roof' and expose the lower branches and trunk to sunscald are not to be removed. This is also in line with the philosophy of maintaining the overall habit and form of the tree.
