ARBORICULTURAL IMPACT ASSESSMENT

Sydney Football Stadium Village Precinct & Carpark

Prepared for: VENUES NSW

6th September 2021 Revision A

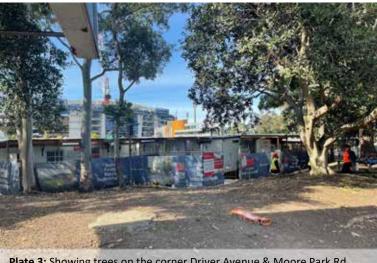
Plate 3: Showing trees on the corner Driver Avenue & Moore Park Rd

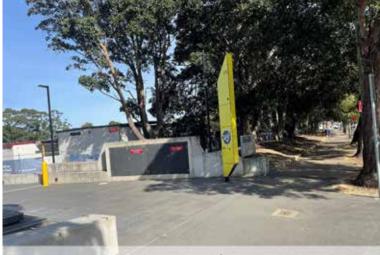
Plate 4: Showing trees on the Moore Park frontage, near the UTS building
