Appendix A: Study Reach Maps

Appendix B: Field Data Sheets

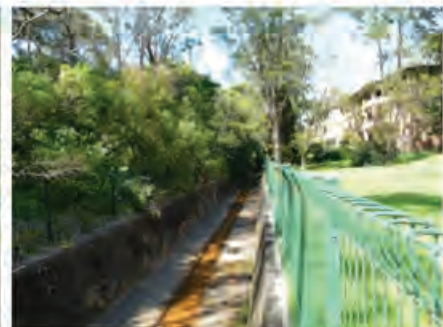
Spatial Integrity - Only small patches of well-separated native vegetation remain

Nativeness - One or more strata dominated by exotic species, 'high threat' species present

Structural Integrity - One stratum missing or extra, cover within remaining strata 50% lower or higher than natural

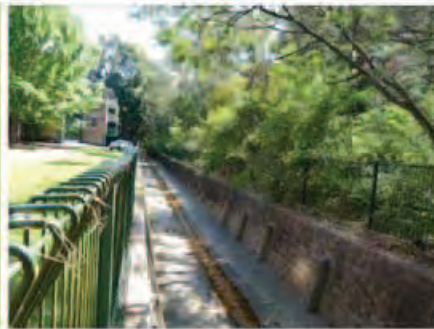
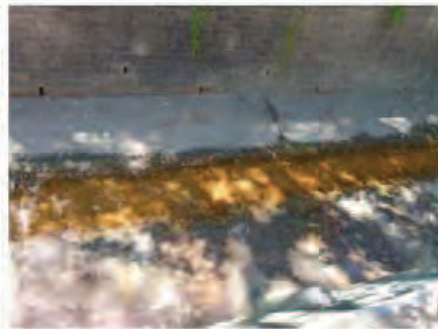
01. Aquatic Habitat**Condition:**

**Hydrology** - Large creek; urban/bush catchment**Physical form** - Steep concrete/brick channel**Water quality** - Very clear; urban runoff**Habitat variability** - Homogenous concrete channel 3m wide; 100% run; no woody debris**Aquatic flora** - Absent

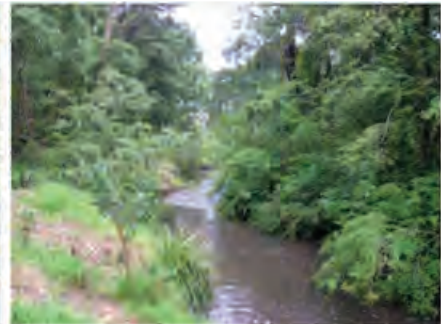
Site: Reach 02, Devlins Creek (downstream of M2)

Devlins Creek is a large tributary of Lane Cove River that dissects Beecroft, Cheltenham and North Epping. It connects several bushland reserves with Lane Cove National Park. Devlins Creek and the surrounding reserves have a long history of bush regeneration and recreation. The most recent impacts to the creek are due to the construction and more recent upgrade of the M2 Motorway, which traverses Reach 02 and follows its right bank. The riparian zone is in moderate condition and has high potential for restoration. The aquatic habitat is in good condition and also has high potential for restoration. The proposed rail alignment at this reach will be a bored tunnel. Potential impacts to the creek's water-holding capacity may occur if the tunnelling creates small rock fractures causing water leaching. Any cracks formed within the stream beds due to tunnelling would be expected to eventually fill with fine material (alluvium) once the tunnel lining is installed, and no long term impacts to the stream surface flows are anticipated. A construction staging area is proposed for the bushland to the west of Cheltenham Oval and does not encroach into the riparian buffer zone (**Tile 02**). Groundwater will not be discharged from this site. Other construction impacts may include weeds, erosion and sedimentation of the creek and riparian zone (due to minor surface runoff).

Spatial Integrity - Width reduced by up to 1/3 and/or some breaks in continuity

Nativeness - One or more strata dominated by exotic species, 'high threat' species present

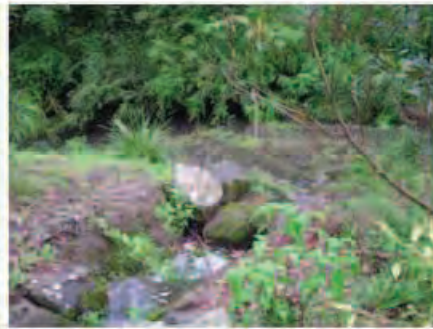
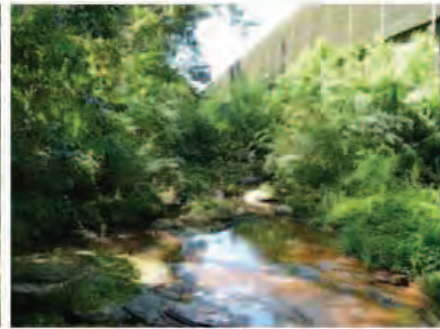
02: Aquatic Habitat**Condition:**

Hydrology - Large creek; urban/bush catchment

Physical form - Mostly natural banks except where M2 lies directly on right bank; culvert upstream; bank slope 30-70°; 40% undercut

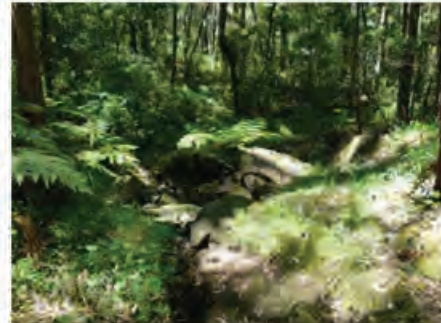
This small tributary of Devlins Creek runs through Chilworth and Beecroft Reserves. The riparian zone is intact and well protected with a forested surrounding. Nearby residential blocks may occasionally put pressure on the creek through weeds, sediment and water quality. The creek is a steep series of narrow rocky ledges with intermittent flows during rain events only. The aquatic habitat is in good condition (albeit dry at the time of survey). The proposed rail alignment at this reach will be a bored tunnel (**Tile 03**). The tunnel will have no surface impacts on Reach 03. Potential impacts to the creek's water-holding capacity may occur if the tunnelling creates small rock fractures causing water leaching. However, due to the steepness and ephemeral nature of the creek, water flows would be fast and intermittent. At best, instream micro-topography may create small rock pools valuable to frogs and some aquatic insects. Cracks would be expected to eventually fill with fine material (alluvium) once the tunnel lining is installed, and no long term impacts to the stream surface flows are anticipated.

Spatial Integrity - No or little evidence of broadscale loss of native vegetation

Nativeness - Vegetation predominantly native, few weeds and no 'high threat' species

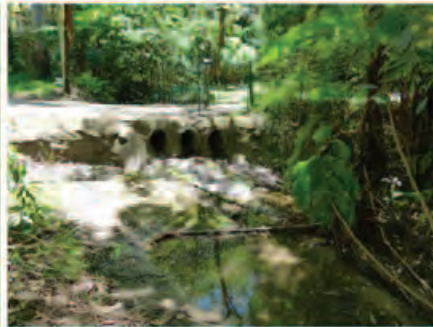
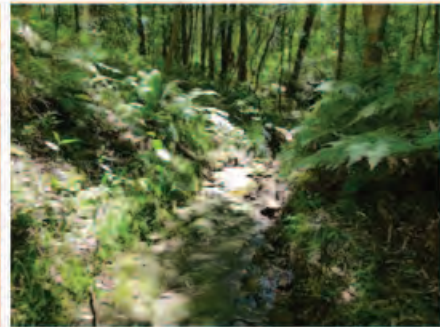
03. Aquatic Habitat**Condition:**

Hydrology - Large Medium size intermittent creek; urban catchment

Physical form - Steep incised toe of banks; banks 30-70°; 25% undercut; culvert downstream

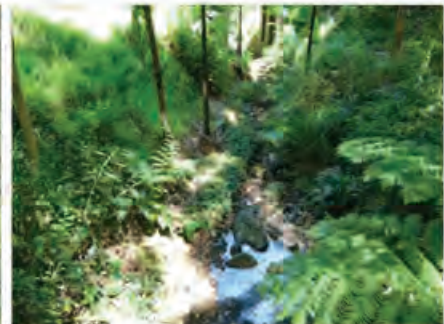
This reach forms the upper catchment of Devlins Creek in Fearnley Park. Upstream is a narrow riparian corridor surrounded closely by residential houses. Downstream is Pennant Hills Golf Course with a stabilised rocky channel and scattered Eucalypt habitat. Both the riparian zone and aquatic habitat are in moderate condition with urban pressures evident, especially weed invasion and some undercutting of banks due to fast flowing events. The rock and cobble substrate indicated that water flows swiftly during heavy rains, which is common in dense urban catchments. Aquatic flora did not occur, likely due to the steep banks and dense canopy shading the narrow channel. The value of this reach is likely important for frogs, reptiles and birds, especially as the corridor links urban bushland upstream and larger forest patches downstream. The riparian habitat has high restoration potential due to the adjacent reserve. However, the aquatic habitat has only moderate restoration potential due to the narrow channel, steep banks and sporadic fast flows.

The proposed rail alignment at this reach will be a bored tunnel (**Tile 04**). The tunnel will have no surface impacts on Reach 04. Potential impacts to the creek's water-holding capacity may occur if the tunnelling creates small rock fractures causing water leaching. Even though the creek would flow fast during heavy rain, the deep permanent pools would be at risk of draining if fissures occur. This would decrease the aquatic value to fauna dependant on permanent water, especially frogs. Any cracks formed within the stream beds due to tunnelling would be expected to eventually fill with fine material (alluvium) once the tunnel lining is installed, and no long term impacts to the stream surface flows are anticipated.

Spatial Integrity - Width reduced by up to 1/3 and/or some breaks in continuity

Nativeness - Exotic species present but not dominating any strata, 'high threat' species rare

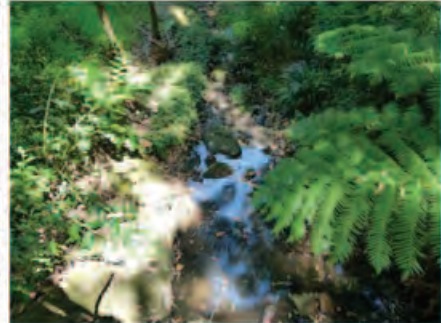
Hydrology - Medium size intermittent creek; urban catchment

Physical form - Steep incised toe of banks; banks 30-70°; 25% undercut; culvert downstream

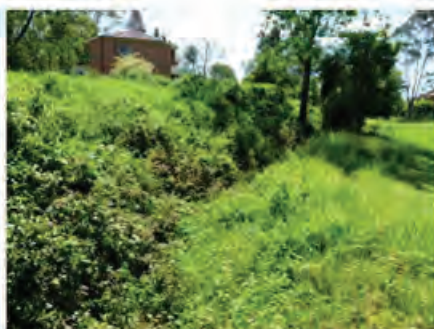
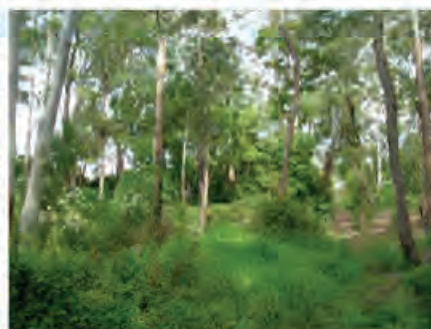
This reach upstream of Roberts Road is divided into an open-canopy narrow channel, a small woodland creek and numerous drainage depressions eroded through dense bushland. Downstream of the road the creek is piped for nearly a kilometre. The lower portion of the reach is highly degraded with dense weed cover and a narrow incised channel. Slashing of vegetation occurs close to the right bank. This area provides little aquatic and riparian value, although has moderate potential for restoration. The upper portion of the reach is in relatively better condition within a small woodland reserve. Habitat here is improved and variable compared to the lower portion. Drainage depressions within the surrounding bushland are straight and incised, indicating they have been intentionally dug as part of the surrounding residential development. Dense bushland helps slow the flow of overland water, thus preventing significant erosion downstream. The intersection of all drainage depressions with the creek occurs upstream of a small culvert (vehicle access track) and forms a small weedy swamp, with numerous frogs.

Spatial Integrity - About 50% of the native vegetation remains, either in strips or patches

Nativeness - One or more strata dominated by exotic species, 'high threat' species present

Structural Integrity - One stratum missing or extra, cover within remaining strata 50% lower or higher than natural

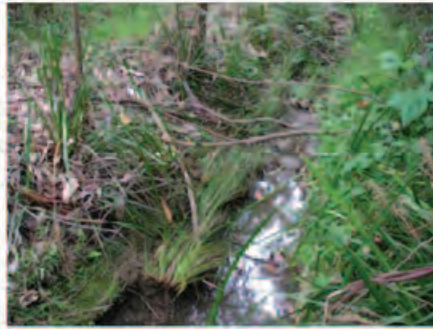
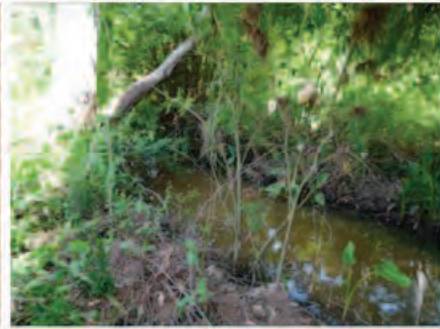
Hydrology - Very small creek with overland drainage paths; urban catchment

Physical form - Bank slope <30°; 10% undercut; downstream piped

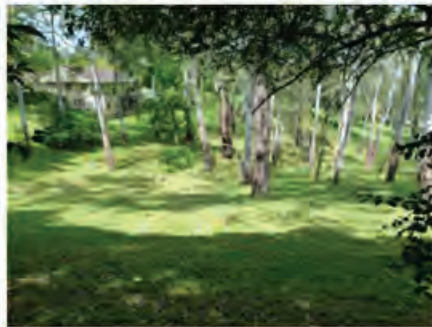
This reach is a minor headwater gully with no aquatic habitat and limited riparian value. Regular slashing of the grass in and around the reach has prevented any understorey growth (besides lawn). Large *Eucalyptus* trees provide the most valuable terrestrial habitat, however these trees are not dependant on any waterway. The proposed rail alignment at this reach will be a bored tunnel (**Tile 06**). The tunnel will have no surface impacts on Reach 06. Potential impacts such as substrate cracking will not impact the reach as no aquatic habitat exists.

Spatial Integrity - About 50% of the native vegetation remains, either in strips or patches

Nativeness - One or more strata dominated by exotic species, 'high threat' species present

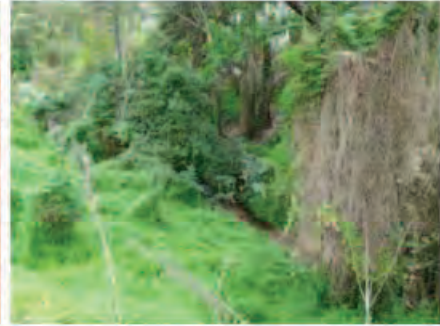
Cattai Creek is a large tributary of the Hawkesbury River. The location of Reach 07 is nearly at the headwaters of its catchment. The riparian zone is in moderate condition, with surrounding pressures from urban/semi-industrial land uses. The aquatic habitats were variable but condition was overall degraded-moderate. The rock and cobble substrate indicated that water flows swiftly during heavy rains, common in dense urban catchments. Aquatic flora did not occur, likely due to the steep banks and dense canopy shading the narrow channel. The value of this reach is likely important for frogs, reptiles and birds, especially as the corridor links urban bushland upstream and larger forest patches downstream. Although weeds dominate the riparian zone, it has high potential for restoration, especially due to its width and isolation from public access.

The proposed rail alignment will be a bored tunnel passing beneath Cattai Creek (**Tile 10**). The adjacent Hills Centre Station will be a cut and cover construction. Potential impacts to the creek's water-holding capacity may occur if the tunnel creates small rock fractures causing water leaching. Any cracks formed within the stream beds due to tunnelling would be expected to eventually fill with fine material (alluvium) once the tunnel lining is installed, and no long term impacts to the stream surface flows are anticipated. Tunnel construction operations may discharge groundwater into Cattai Creek at a rate of 1,728,000 L per day. Recommendations to mitigate impacts of water discharge during construction and operation are provided in **Sections 5.3** and **5.4**.

Spatial Integrity - About 50% of the native vegetation remains, either in strips or patches

Nativeness - Most strata dominated by exotic species, 'high threat' species abundant

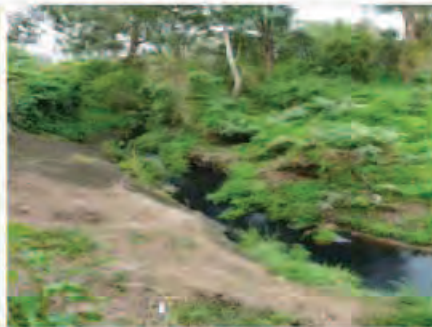
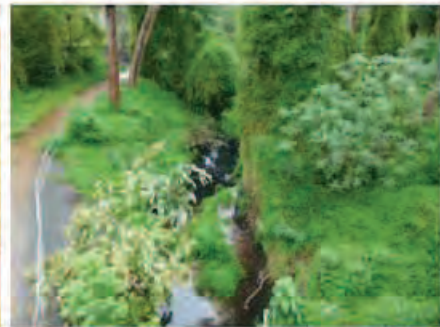
Hydrology - Large creek; urban catchment

Physical form - Steep banks >70°; culverts upstream and downstream; 70% undercut

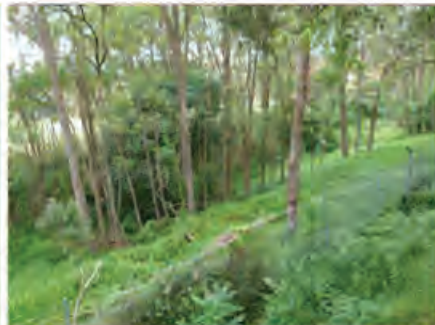
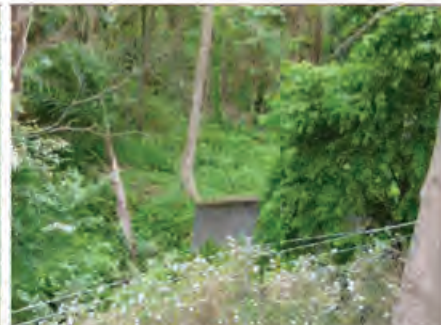
The proposed rail alignment at this reach will be a bored tunnel (**Tile 10**). The tunnel will have no surface impacts on Reach 08. Potential impacts to the creek's water-holding capacity may occur if the tunnelling creates small rock fractures causing water leaching. Any permanent pools would be at risk of draining if fissures occur. This would decrease the aquatic value to fauna dependant on permanent water, especially frogs. Any cracks formed within the stream beds due to tunnelling would be expected to eventually fill with fine material (alluvium) once the tunnel lining is installed, and no long term impacts to the stream surface flows are anticipated.

Spatial Integrity - About 50% of the native vegetation remains, either in strips or patches

Nativeness - One or more strata dominated by exotic species, 'high threat' species present

Structural Integrity - One stratum missing or extra, cover within remaining strata 50% lower or higher than natural

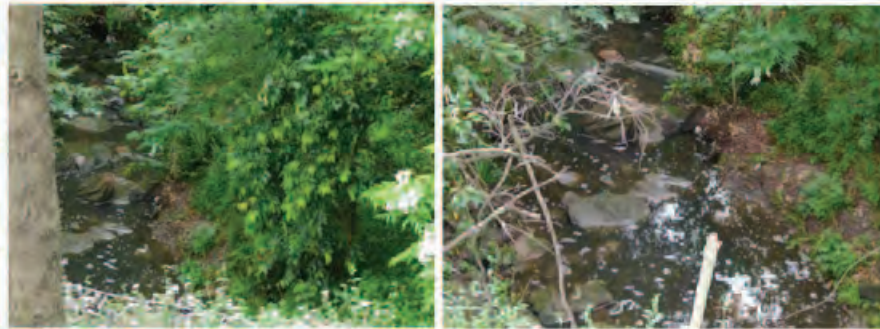
08. Aquatic Habitat**Condition:**

Hydrology - Small creek with piped upper and lower reaches; urban catchment

Physical form - Natural stable banks; no erosion; bank slope 30-70°; piped upstream and downstream;

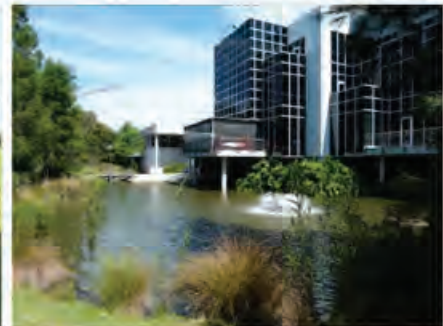
The proposed rail alignment at this reach will be a bored tunnel (**Tile 12**). The tunnel will have no surface impacts on Reach 09. Potential impacts such as substrate fracturing from vibrations may compromise the water-holding capability of the lake and result in impacts on habitat viability. Groundwater will not be discharged from this site.

Spatial Integrity - About 50% of the native vegetation remains, either in strips or patches

Nativeness - Vegetation predominantly native, few weeds and no 'high threat' species

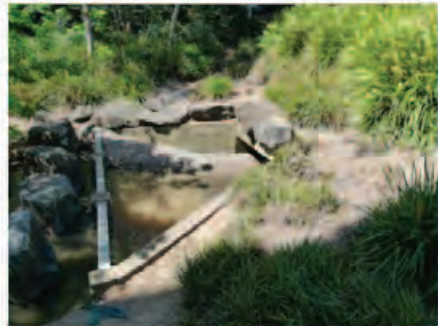
09. Aquatic Habitat**Condition:**

Hydrology - Artificial lake with upper reaches piped; urban catchment

Physical form - Banks gentle and stabilised by rock armour; creek upstream of lake is piped under landscaped ponds and urban land

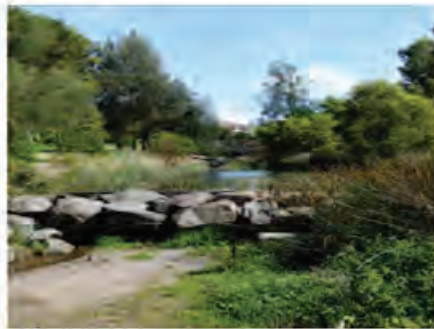
The proposed rail alignment at this reach will be a bored tunnel (**Tile 13**). The tunnel will have no surface impacts on Reach 10. Potential impacts such as concrete fracturing from vibrations may compromise the water-holding capability of the creek and result in impacts on habitat viability. Groundwater will not be discharged from this site.

Spatial Integrity - About 50% of the native vegetation remains, either in strips or patches

Nativeness - Vegetation predominantly native, few weeds and no 'high threat' species

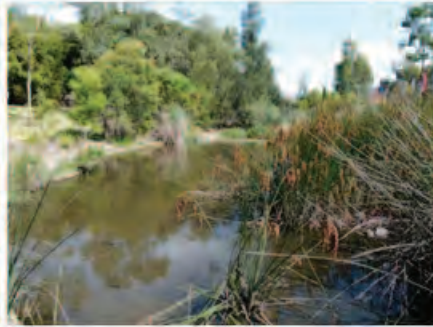
10. Aquatic Habitat**Condition:**

Hydrology - Artificial tiered ponds; urban catchment

Physical form - Gentle banks with concrete edge lining; no erosion; piped upstream

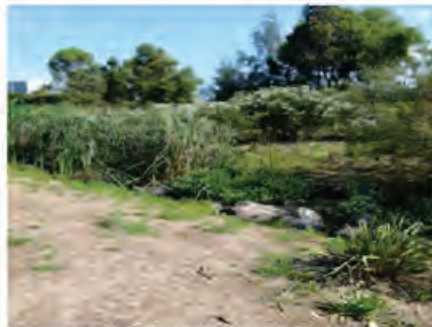
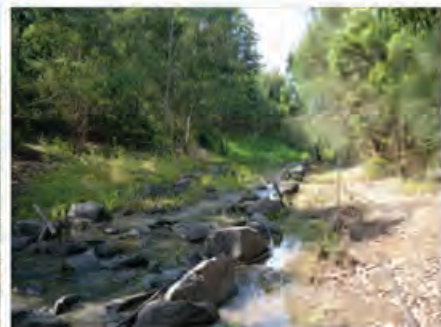
The proposed rail alignment at this reach will be a bored tunnel, raising to open cut and entering Bella Vista Station (**Tiles 13 and 14**). The tunnel will have no surface impacts on Reach 11. Potential impacts such as concrete fracturing from vibrations may compromise the water-holding capability of the creek and result in impacts on habitat viability. Any cracks formed within the stream beds due to tunnelling would be expected to eventually fill with fine material (alluvium) once the tunnel lining is installed, and no long term impacts to the stream surface flows are anticipated. Groundwater will not be discharged from this site.

Spatial Integrity - About 50% of the native vegetation remains, either in strips or patches

Nativeness - Exotic species present but not dominating any strata, 'high threat' species rare

Structural Integrity - One stratum missing or extra, cover within remaining strata 50% lower or higher than natural

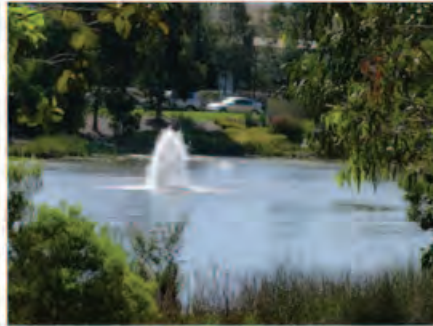
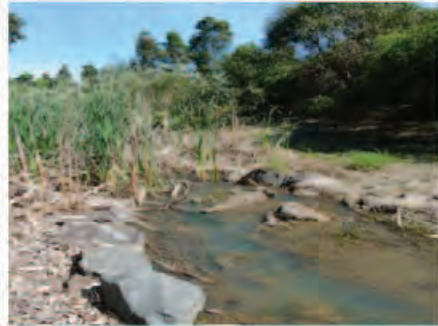
11. Aquatic Habitat**Condition:**

Hydrology - Small creek with central lake; urban catchment

Physical form - Rehabilitated rocky channel with artificial lake; several culverts; gentle stable banks <30°

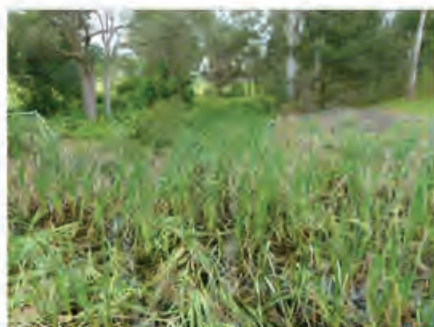
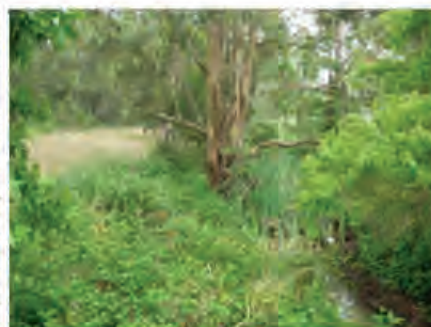
This reach of Elizabeth Macarthur Creek has a mostly degraded riparian zone, with clearing up to the bank and weed invasion common. However, small patches of good riparian vegetation do occur. With good management this reach has very high potential for riparian restoration. Even in its mostly degraded state it is still of value as it contributes to a long green corridor that will eventually be constricted by development. Numerous small dams scatter the reach, which break the hydrological connectivity for fish movement. The aquatic habitat is in moderate condition and restoration potential instream is moderate.

Spatial Integrity - Only small patches of well-separated native vegetation remain

Nativeness - One or more strata dominated by exotic species, 'high threat' species present

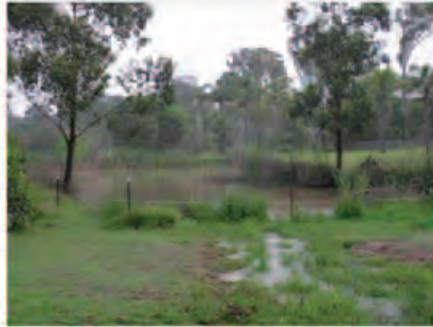
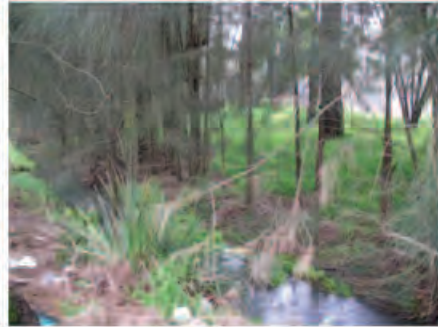
Hydrology - Small creek with two instream dams; urban/rural catchment

Physical form - Banks mostly stable, slope 30-70°; 10% undercut; culverts upstream and downstream

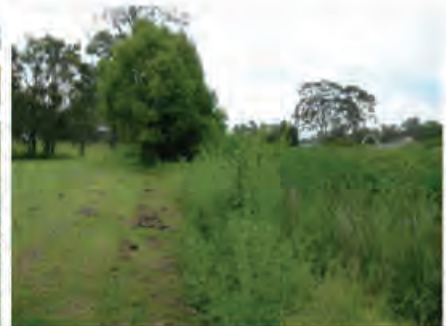
Site: Reach 13, Elizabeth Macarthur Creek (Balmoral Road to Burns Road)

This reach of Elizabeth Macarthur Creek has a mostly degraded riparian zone, with clearing up to the bank and weed invasion common. With good management this reach has very high potential for riparian restoration. Even in its mostly degraded state it is still of value as it contributes to a long corridor that will eventually be constricted by development. Numerous weedy swamps scatter the reach, which breaks the hydrological connectivity for fish movement. The aquatic habitat is also degraded and restoration potential instream is moderate.

Spatial Integrity - Only small patches of well-separated native vegetation remain

Nativeness - Few native species remaining, cover dominated by exotic species

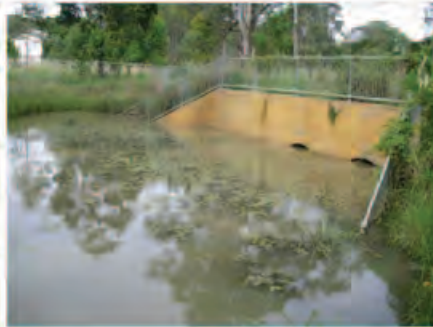
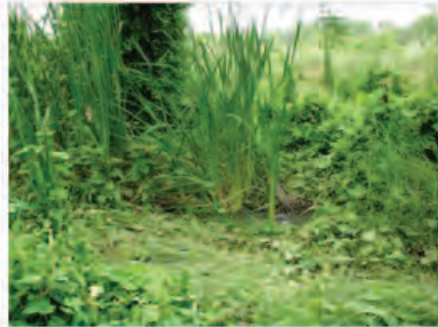
Hydrology - Small creek with swamp and straighten channel mix; urban/rural catchment

Physical form - Banks mostly stable, slope 30-70°; culverts upstream and downstream

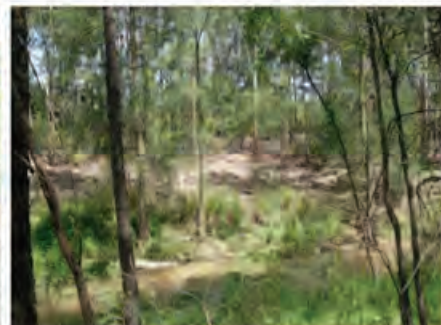
Site: Reach 14, Elizabeth Macarthur Creek (Burns Road to Samantha Riley Drive)

This reach of Elizabeth Macarthur Creek is in mostly moderate condition. The riparian zone is generally uncleared, but with a weedy understorey common. With good management this reach has very high potential for riparian restoration. This reach is of great value as it contributes to a long corridor that will eventually be constricted by development. In the southern portion of the reach several small dams and swamps break the hydrological connectivity for fish movement. Restoration potential for instream habitat is high, due to its mostly unmodified channel and stable banks.

Spatial Integrity - About 50% of the native vegetation remains, either in strips or patches

Nativeness - One or more strata dominated by exotic species, 'high threat' species present

Structural Integrity - One stratum missing or extra, cover within remaining strata 50% lower or higher than natural

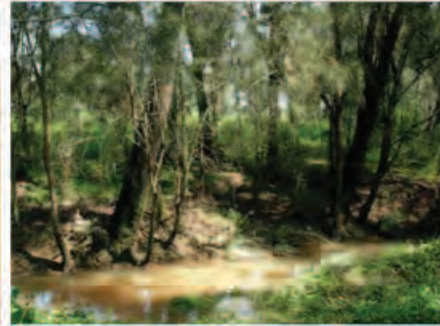
Hydrology - Medium size creek with two instream dams; urban/rural catchment

Physical form - Variable bank slope <30-70°; 20% undercut, 5% slumped; culverts upstream and downstream

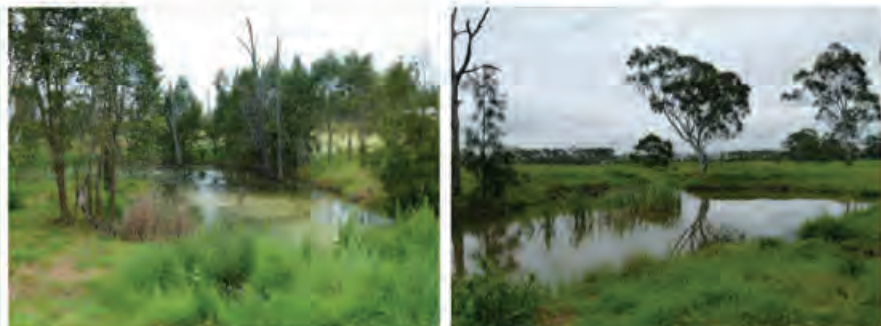
This reach of Elizabeth Macarthur Creek varies in condition, with a degraded riparian zone to the south and a moderate riparian zone to the north. Clearing and continued slashing to the bank is common. Weeds are abundant, except under areas with dense canopy cover. With good management this reach has very high potential for riparian restoration. Even in its partly degraded state it is still of value as it contributes to the long corridor, however this will eventually be constricted by development. Aquatic habitat is in moderate condition and restoration potential instream is high, especially if coinciding with riparian restoration.

Spatial Integrity - Only small patches of well-separated native vegetation remain

Nativeness - One or more strata dominated by exotic species, 'high threat' species present

Structural Integrity - One stratum missing or extra, cover within remaining strata 50% lower or higher than natural

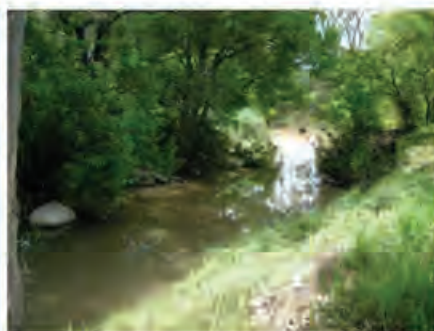
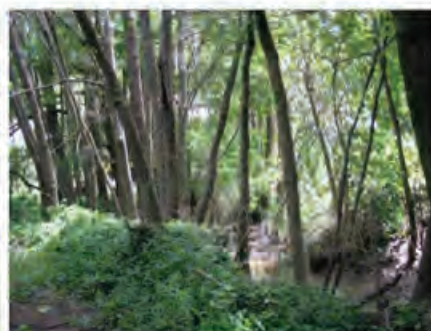
This reach of Caddies Creek is in moderate condition. The left bank is highly disturbed in parts due to the adjacent land use. The right bank is relatively intact with a good cover of riparian trees and adjacent woodland. Understorey weeds are prevalent. With good management this reach has very high potential for riparian restoration. The reach is of great value as it contributes to a long green corridor that will eventually be constricted by development. The aquatic habitat is substantially vaster compared to that upstream in Elizabeth Macarthur Creek. Large carp were observed swimming here. The aquatic habitat is in moderate condition and restoration potential instream is high.

Spatial Integrity - About 50% of the native vegetation remains, either in strips or patches

Nativeness - One or more strata dominated by exotic species, 'high threat' species present

Age Structure - Reduced cover (<50%) of canopy, and only one age class present

Debris - Very small quantities of debris present

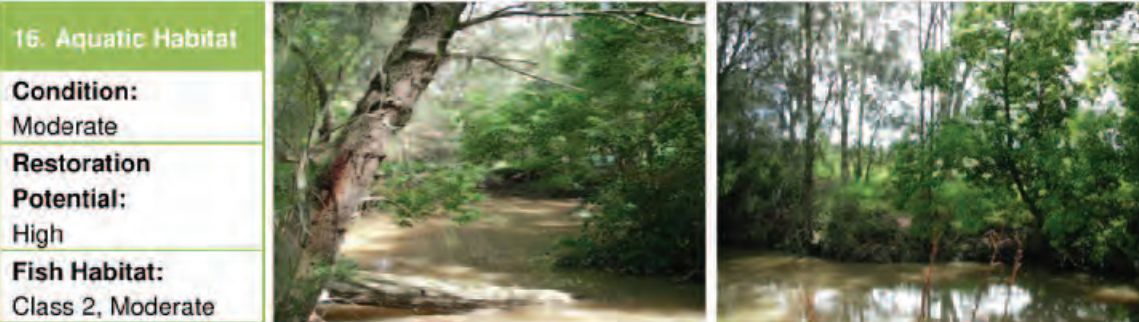
Hydrology - Medium size creek; urban/rural catchment

Physical form - Steep banks >70°; 40% undercut; culvert upstream

Habitat variability - Long continuous channel 0.5-8m wide; up to 1m deep; good overhanging trees; homogenous clay substrate; carp observed

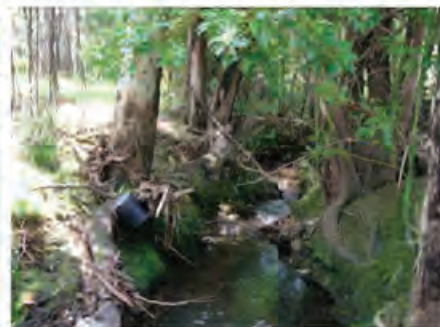
This small tributary to Caddies Creek is in degraded-moderate condition. The sections that receive inflows from three culverts beneath Windsor Road are highly degraded, with no riparian vegetation and dense *Typha* and Blackberry stands within the channel. Further downstream, the riparian zone is in moderate condition with occasional weeds and some regeneration. Despite its condition, the reach has high potential for riparian restoration, especially if providing a wider vegetation corridor. The connectivity value of the riparian zone is important from a downstream perspective (links to The Outlook Nature Reserve). However from an upstream perspective, Windsor Road creates a significant break in riparian connectivity to the engineered upper reaches of this creek. Overall in Reach 17, the aquatic habitat is in degraded-moderate condition, with only small patches of valuable instream habitat. Restoration potential instream is low-moderate, with greater potential downstream.

The proposed rail alignment at this reach is an elevated viaduct with one crossing over the upper extent of the reach (**Tile 18**). Therefore, the alignment will enter the 30 m riparian buffer zone. This crossing will dissect the three channels inflowing from culverts beneath Windsor Road. Here, the reach is highly degraded and due to the close proximity of Windsor Road and the existing culverts upstream, potential impacts from this crossing would be indistinguishable from that already present. However, mitigation measures to prevent disturbance downstream during construction are still warranted. This includes: avoiding viaduct footings instream, as this may change the hydrology and increase bank scouring; installation of erosion and sediment control fences during construction; minimal night works involving excessive noise and large floodlights (a possible disruption to nocturnal birds, bats and mammals foraging in the riparian corridor); and revegetation or stabilisation of disturbed areas post construction. Weed control within the footprint will reduce transportation of propagules downstream.

Spatial Integrity - Only small patches of well-separated native vegetation remain

Nativeness - Most strata dominated by exotic species, 'high threat' species abundant

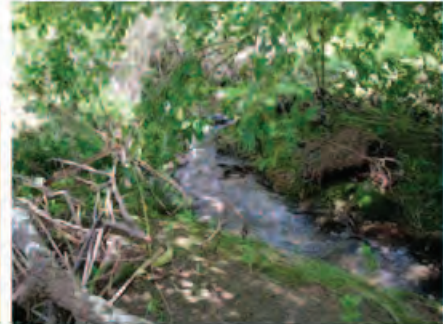
Hydrology - Small headwater creek; urban catchment

Physical form - Steep banks >70°; 25% undercut; 10% slumped; culverts upstream

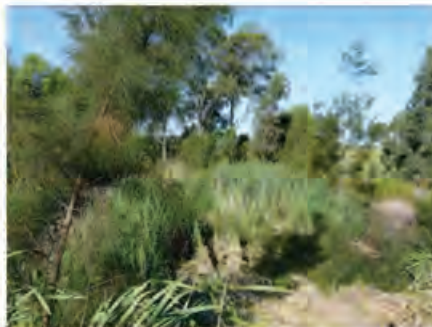
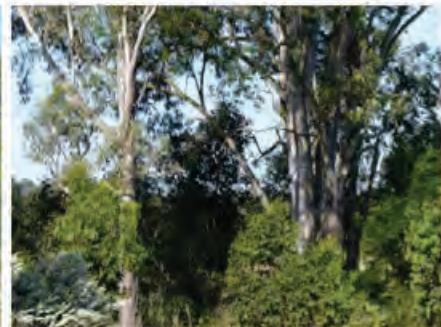
This small tributary to Caddies Creek has a riparian zone in moderate condition and appears to be establishing well after restoration works. The reach has high potential for continued riparian restoration, especially if providing a wider vegetation corridor on the right bank. The connectivity value of the riparian zone is moderate as it provides a link to larger woodland habitats downstream. Upstream of this reach is a culvert beneath Windsor Road and then becomes heavily cleared with little to no riparian vegetation. The aquatic habitat in Reach 18 is engineered and includes curved channels and gentle steps stabilised by riprap. Generally the aquatic habitat is in degraded-moderate condition, with only small patches of valuable instream habitat, especially for frogs. Restoration potential instream is low-moderate.

Spatial Integrity - About 50% of the native vegetation remains, either in strips or patches

Nativeness - One or more strata dominated by exotic species, 'high threat' species present

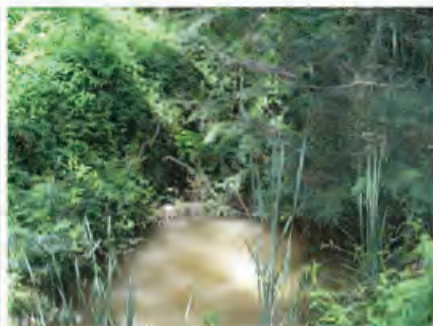
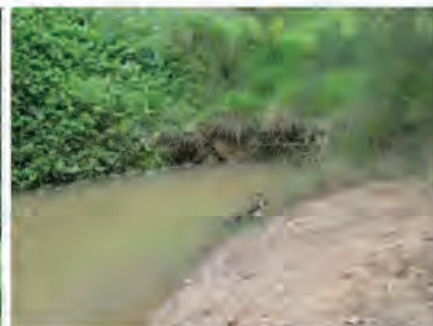
This reach of Second Ponds Creek was assessed by ELA (2010) as part of the Area 20 Biodiversity Assessment. Eight reaches were assessed for hydrologic change, fringing vegetation condition, physical form, water quality and aquatic habitat. Half of the reaches were classed as degraded. The others were classed as being in moderate condition. The proposed rail alignment at this reach is a 250 m long elevated bridge similar to the viaduct design, with one creek crossing (**Tile 19**). The exact location of the crossing was not assessed as part of this study or by ELA (2010) due to access restrictions. However, ELA (2010) assessed the reaches immediately upstream and downstream of the proposed crossing and adjacent footprint. Both reaches were classed as degraded. After reviewing aerial photographs of this site, we conclude that Reach 19 is in no better condition than these adjacent reaches. Despite its current ecological condition, Second Ponds Creek is an important riparian corridor and its value will increase as development encroaches in the future. Therefore, the proposed crossing structure should recognise this significance and be designed accordingly to minimise penetration into the 50 m buffer zone from top of bank. It is recommended that bridge/viaduct footings are not placed within the channel or the bank slope as this may change the hydrology and increase bank scouring.

Spatial Integrity - About 50% of the native vegetation remains, either in strips or patches

Nativeness - High density of weeds on ground and within other strata. *Cardiospermum grandiflorum*

(Balloon Vine) prolific and causing significant damage to canopy and prevention of future recruitment

Structural Integrity - One stratum missing or extra, cover within remaining strata 50% lower or higher than natural

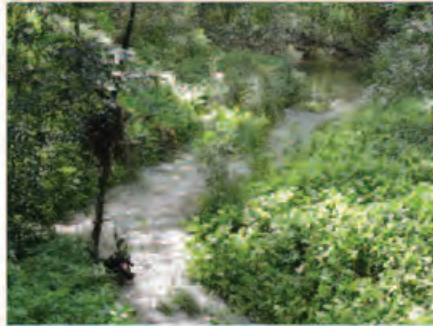
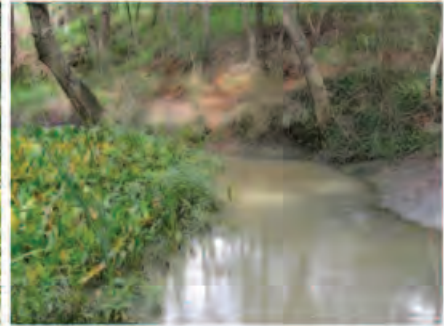
Hydrology - Medium size creek broken by numerous instream dams; urban/rural catchment

Physical form - Moderate bank stability; relatively homogenous structure within reach

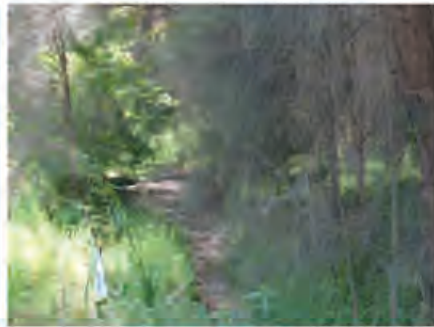
This reach of First Ponds Creek (and a small tributary) is outside of the study area but has been included because the proposed Tallawong Stabling Facility is upslope of the creek and may cause indirect impacts during construction (**Tile 20**). Potential impacts could arise unless appropriate erosion control and sediment fences are used during construction. Revegetation and/or soil stabilisation works will be necessary post stabling construction to prevent surface erosion and sedimentation of the creek.

Spatial Integrity - Only small patches of well-separated native vegetation remain

Nativeness - Most strata dominated by exotic species, 'high threat' species abundant

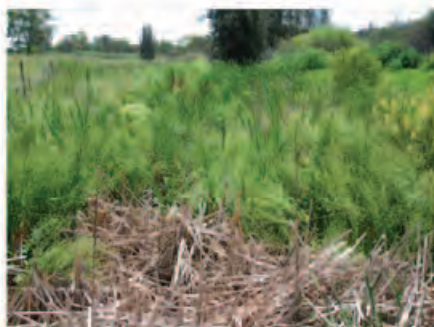
20. Aquatic Habitat**Condition:**

Hydrology - Small creek; rural catchment

Physical form - Gentle banks stabilised by weeds; little erosion; culvert under road
