GHD Pty Ltd (GHD) has been engaged by Australian Rail Track Corporation (ARTC) to undertake an Arboricultural Assessment of landscape trees within and adjoining the project site for The Cabramatta Loop Project ("the project").

The purpose of this arboricultural assessment report is to determine those trees which will require removal and those trees which could be retained, given appropriate protection. This report identifies the following:

ARTC Cabramatta Rail Loop Arborist Assessment

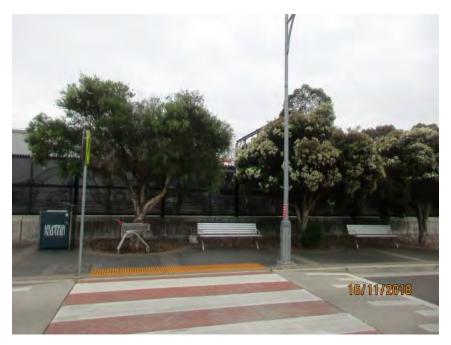
For example, Photo 1 indicates a group of small trees, which are located within a fenced garden area adjacent to Warwick Farm railway station. The trees are in a straight line, are evenly spaced and appear to be the same age.

Photo 1 Tree group 1 planted within the footpath

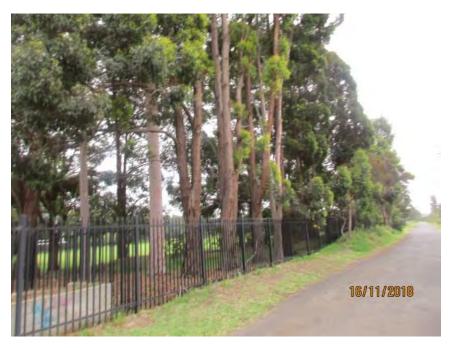
Photo 2 indicates a group of trees, mainly *Eucalyptus* and *Corymbia* species, which appear to have been planted as a visual screen along the boundary of Lawrence Hargrave School. The trees have probably all been planted over the same period.

Photo 2 Tree group 6 in Lawrence Hargrave school yard

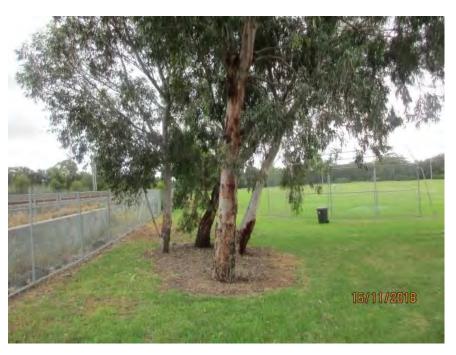
Photo 3 indicates a group of trees, which form part of a line of trees which delineate the boundary between the railway reserve and Jacquie Osmond Reserve and Softball Centre. It is apparent that some groups were planted more than 50 years ago, while others appear to be less than 30 years old.

Photo 3 Part of Tree group 20 in parkland

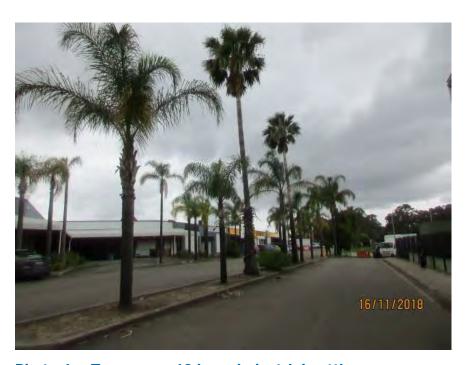
Photo 4 indicates lines and groups of trees, especially exotic palm species, planted within small, narrow planter beds adjacent to access roads and car-parks. It is apparent that there have been several plantings, over the last 30 years.

Photo 4 Tree group 19 in an industrial setting

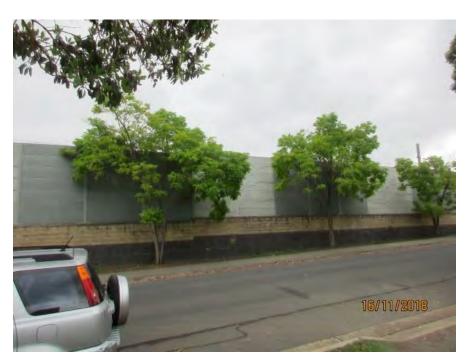
Photo 5 indicates a section of footpath planting along Broomfield Street, near Cabramatta Station. All plantings in this area are recent (ie within the last ten years).

Photo 5 Trees that form part of tree group 40 in footpath

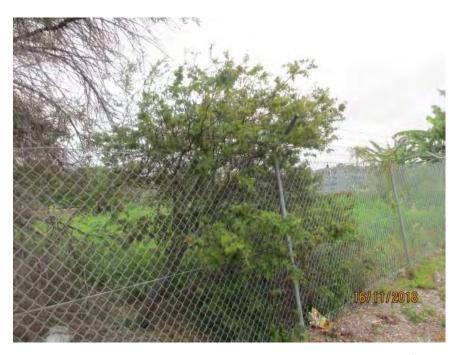
A small patch of Downy Wattle (*Acacia pubescens*) is located within a section of railway reserve about 60 metres south of the project site (Photo 6). *Acacia pubescens* is listed as a vulnerable species under the NSW *Biodiversity Conservation Act 2016* (BC Act) and Commonwealth *Environment Protection and Biodiversity Conservation Act 1999* (EPBC Act). These trees will not be affected by the proposed works (Figure 2.1)

Photo 6 The threatened species, *Acacia pubescens* (Tree Group 4) growing along the outside edge of the rail corridor

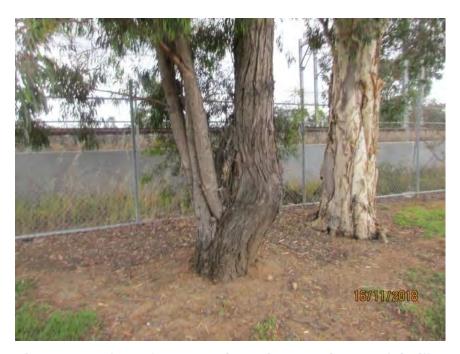
A Narrow-leaved Black Peppermint (*Eucalyptus nicholii*) occurs within Tree Group 22 along the western boundary of Jacquie Osmond Reserve. This specimen has been planted and has codominant leaders as a result of mechanical damage to the leader (Photo 7). *Eucalyptus nicholii* is listed as a vulnerable species under the BC Act and EPBC Act. This specimen is proposed for removal.

Photo 7 Epicormic regrowth on the *Eucalyptus nicholii* (part of Tree Group 22)

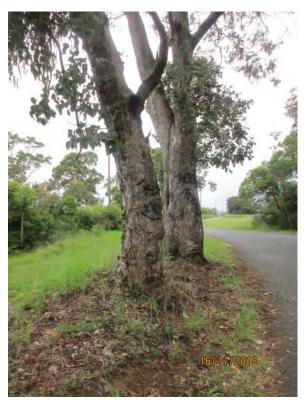
Blue Box (*Eucalyptus baueriana*) is located and described as Tree Group 10 and Trees 11, 12 and 13 in this report (Photo 8). Blue Box is described as "regionally vulnerable" by James *et al.* (1999) but is not listed as a threatened species under the BC Act or EPBC Act. As stated in James *et al.* (1999) "...Regional significance of species should also be considered as part of strategies for their conservation...". The listings of regionally significant plant species by James et al (1999) are proposed as guidelines for local government and other agencies that are engaged in conservation and bush regeneration. The specimens identified in the study area will not be removed for the project.

Photo 8 Eucalyptus baueriana (Tree Group 10)

compaction within the TPZ of many trees. Photo 8 indicates a group of Blue Box growing close to a pathway. The leaders show bias and wounds, probably caused by mechanical damage associated with vehicular and pedestrian impact.

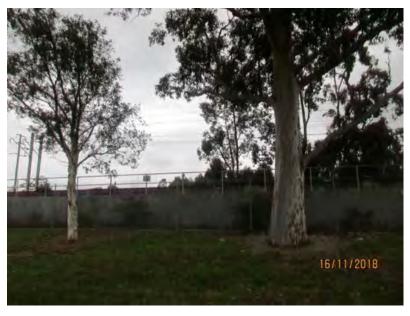
The large Spotted Gum (*Corymbia maculata*) which is a component of Tree 23 (Photo 9) is the largest tree in the project site and has some landscape value due to its size. The tree is mature and in good health with typical structure for the species. It contains hollows and may have habitat value for fauna species that use tree-hollows for refuge and nesting. This specimen is proposed for removal (see Section 4.1). Landscape and visual impacts of tree removal in the project site are discussed in the Landscape and Visual Amenity Impact Assessment (GHD 2019b). The impacts of tree removal on flora and fauna are assessed in the Biodiversity Development Assessment Report (2019a).

Photo 9 The large *Corymbia maculata* (on the right) growing along the boundary of Jacquie Osmond Reserve (Tree Group 23)
