Report on the Provision of additional umbrella shade structures at Q Station – Paul Davies Pty Ltd (2015)

Q Station

Provision of Additional Umbrella Shade Structures

Paul Davies Pty Ltd

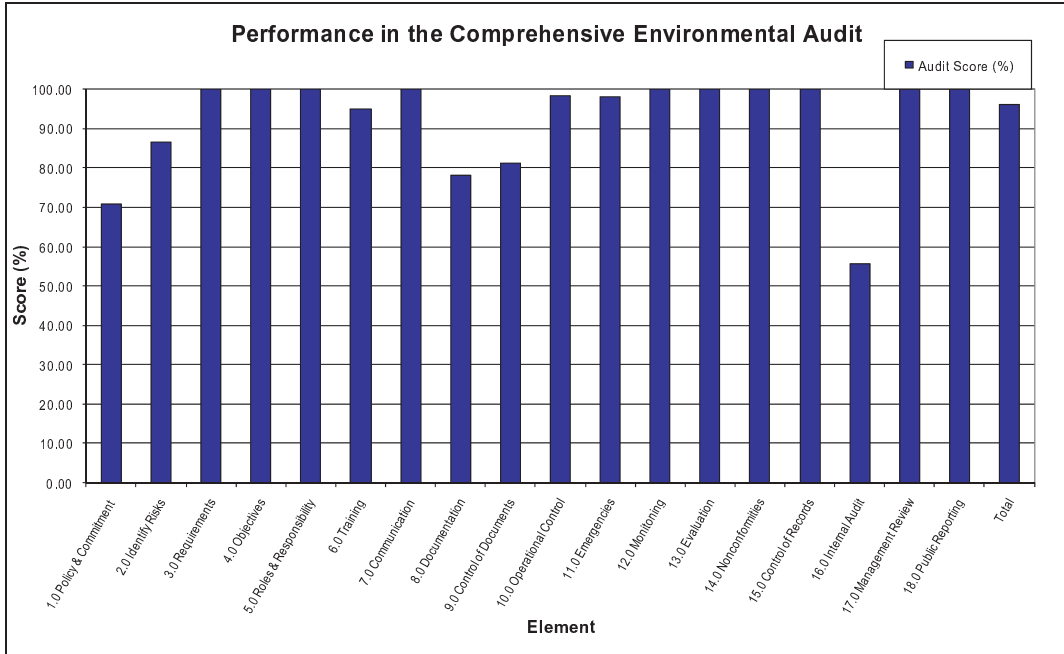
The following graphs show scores by element. The elements with lower scores are those which have generally given rise to audit recommendations.

The audit protocol includes a scoring system which provides a general guide to performance of the site in terms of environmental compliance, management and performance. The overall score for the audit was 96%, which higher than the score of 92% achieved in the 2007 Audit by GHD. In comparing the scores, however, it should be noted that progress on the project, and particularly the move from the construction to the operational phase, have meant that different issues are now relevant in a number of areas. Both scores reflect the very high standard of environmental management that has been maintained throughout the project.

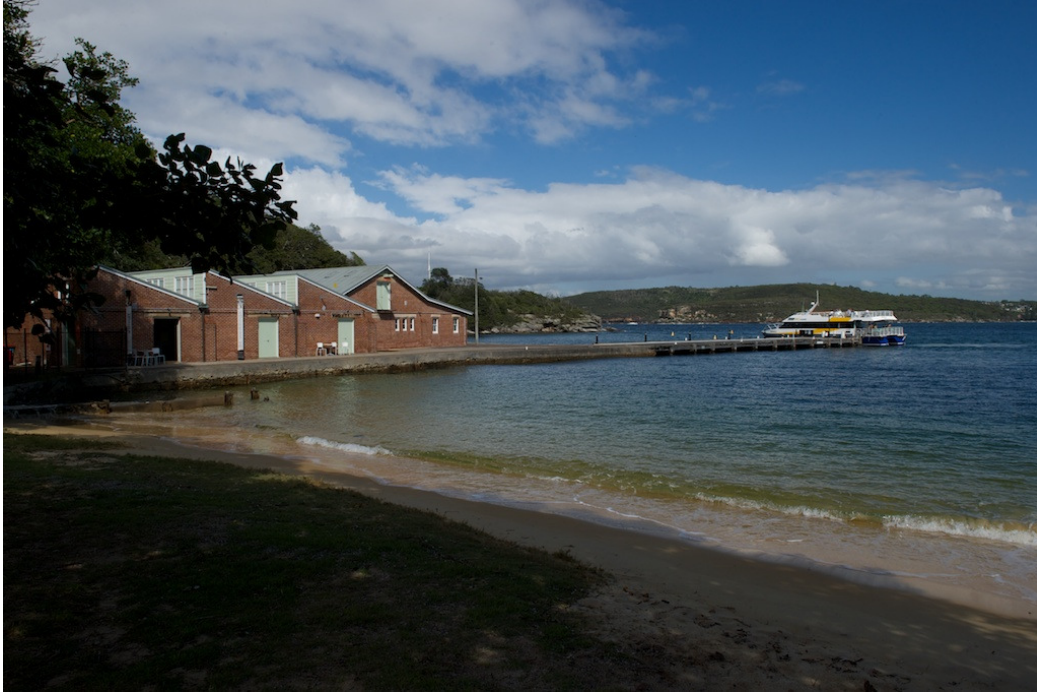
View from beach to wharf, this is the reverse view to those following.

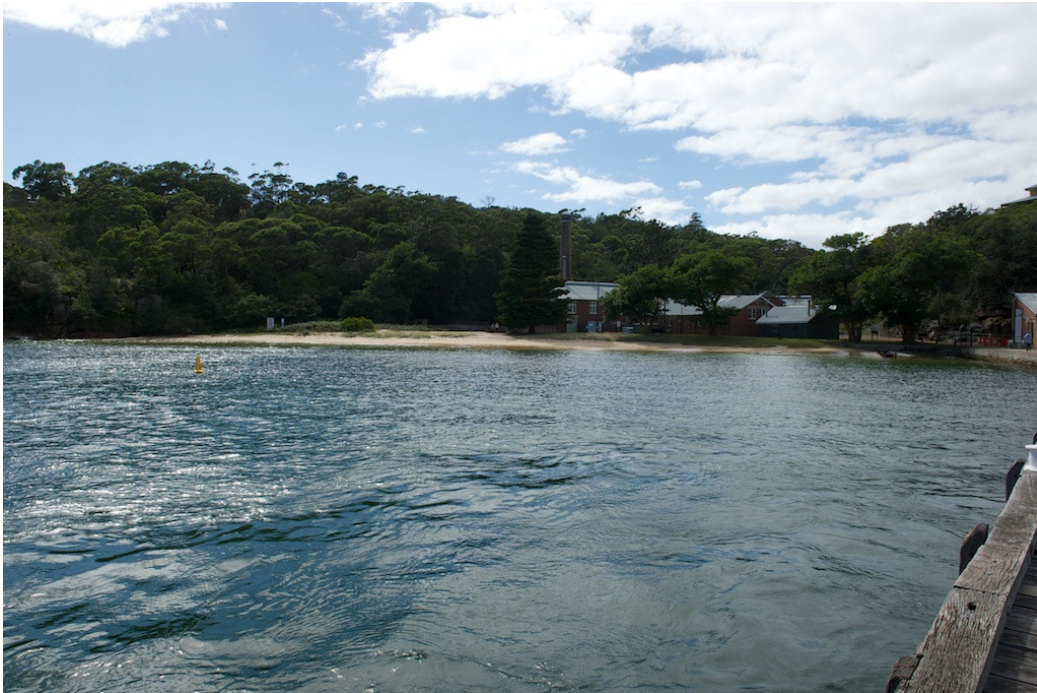
View from end of wharf, the umbrella is located behind the tree on the beach.

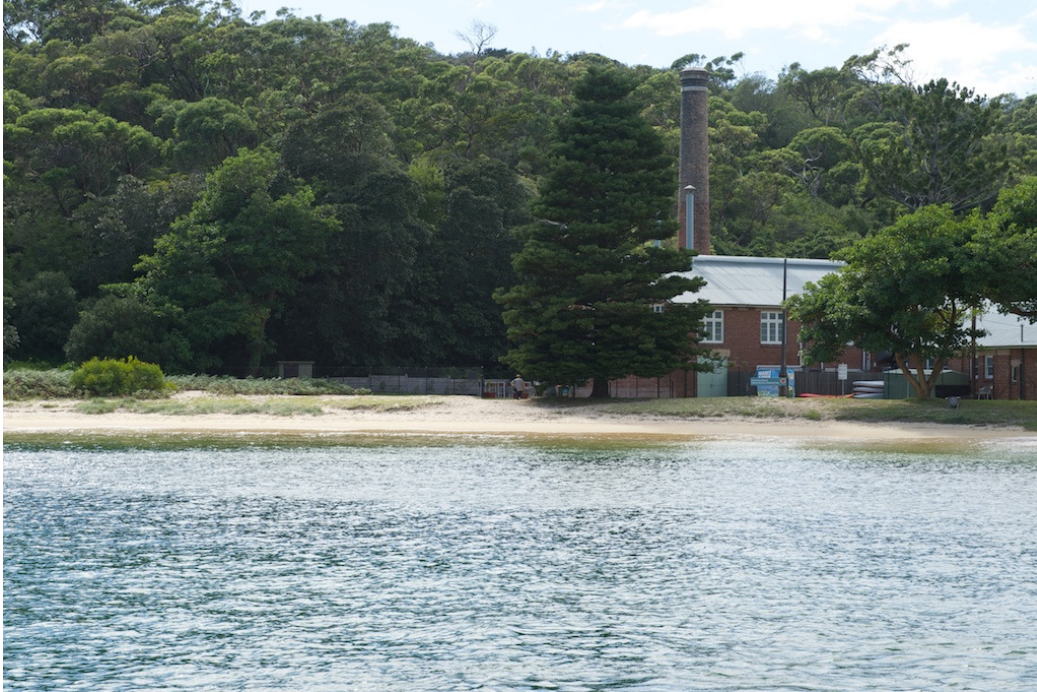
A telephoto (not actual view seen by eye) image to make clearer the layout of the area. Tables can just be seen to the left of the pine tree but the umbrella is set behind the tree.

A large pine located at the end of A6 effectively removes any view of the building and the seating area.

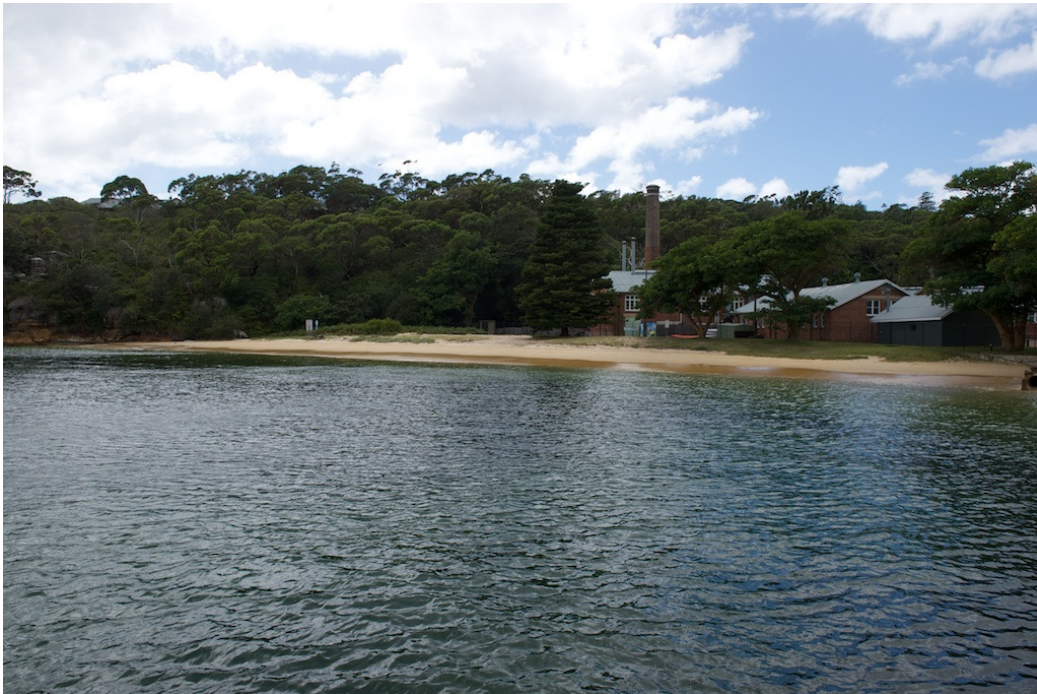
A view from the join between concrete and timber wharf sections. There is no view of the area from this location.

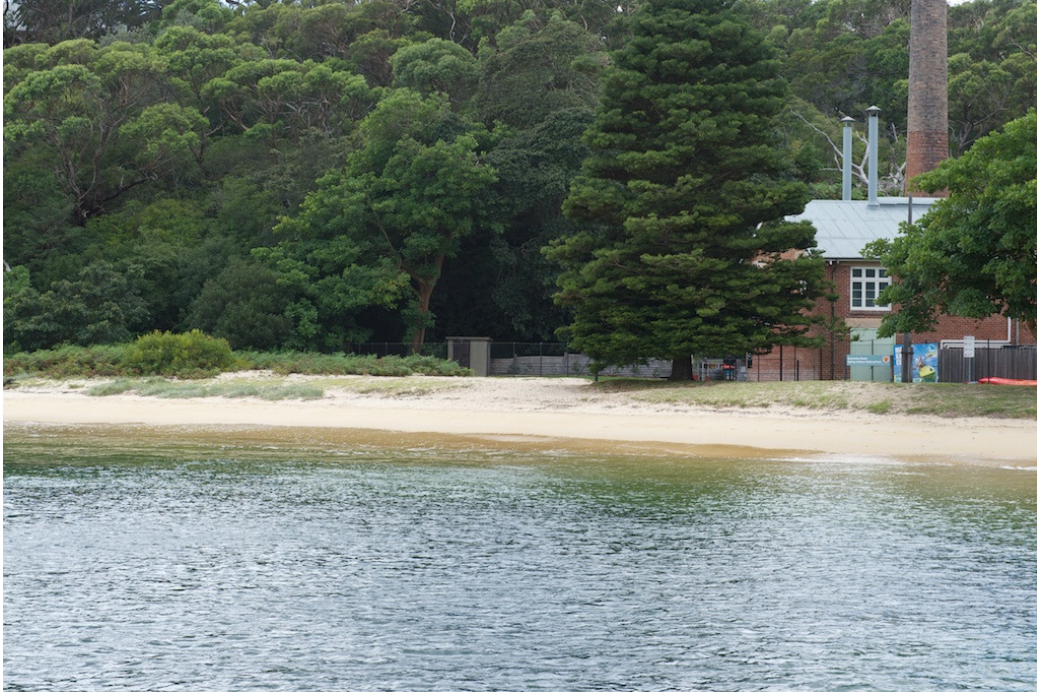
A close up of the same view. A small section of lawn and the concrete switchroom can be seen only.

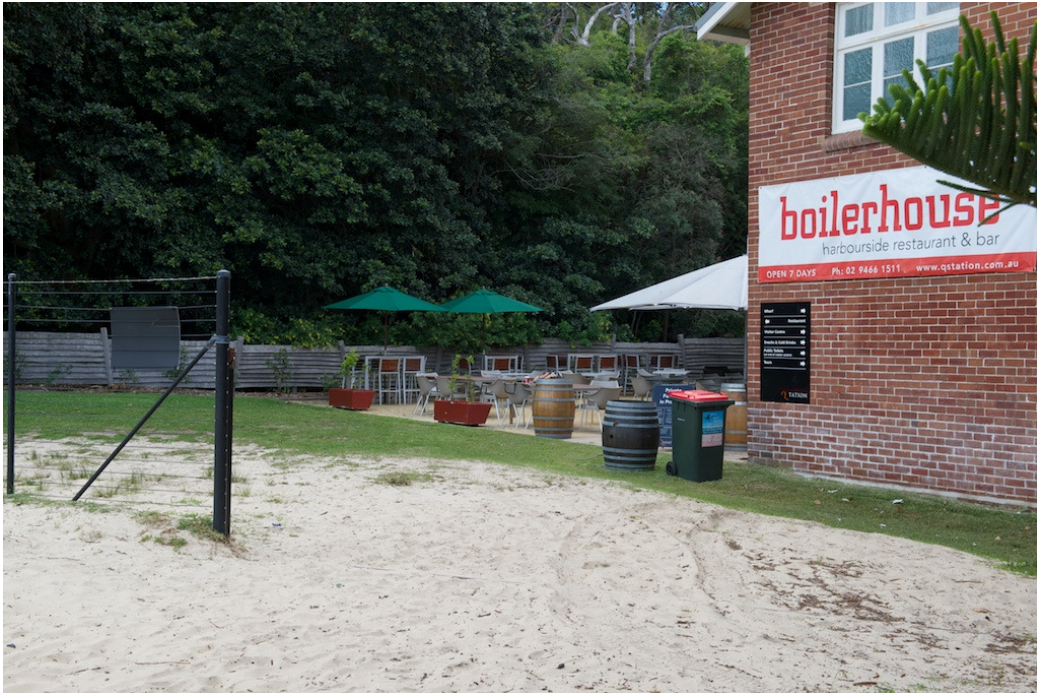
The view to the area from the beach entry. The umbrella on the right is proposed to be replicated and an additional element will be seen extending part way across the right hand green umbrella.

The paved area adjacent to A6 accommodates most of the external dining in the precinct. It is to the side of the building and well back from the waterfront. There are presently three 4.5 metre square umbrellas installed (with approval) and the proposal is to provide one additional umbrella to match the existing ones. It would be located to complete a 9 x 9 metre covered area.

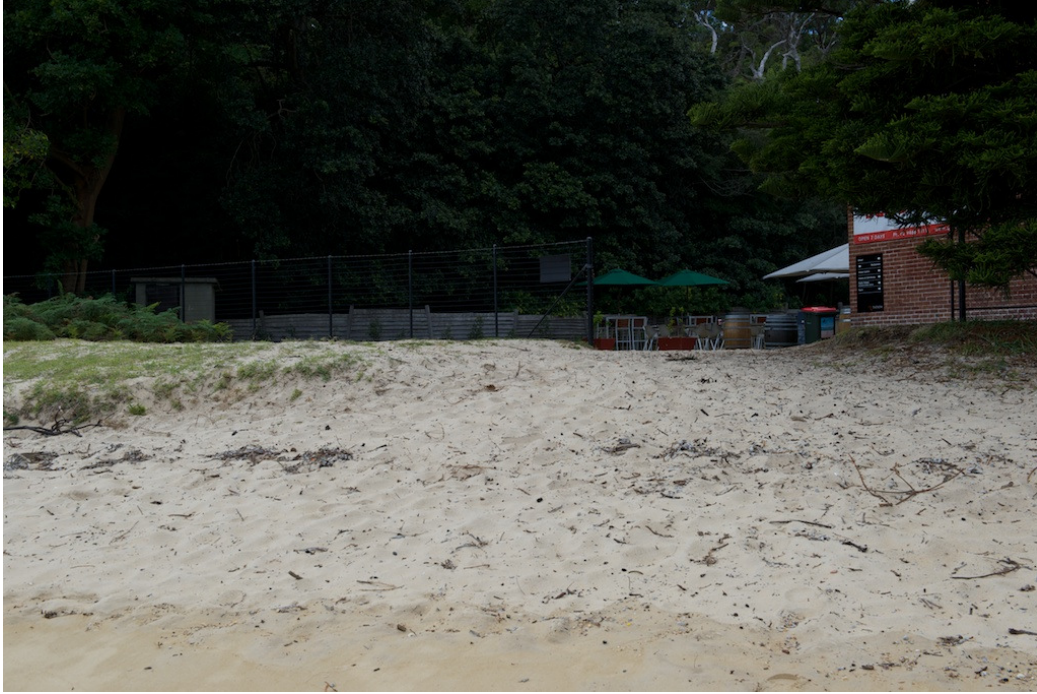
The view from further away on the beach at water's edge. The new umbrella is visible from here along with the existing umbrella. The edge of the rear umbrella can be seen in this photo.

There is no visual impact when viewed from the beach in alignment with the wharf area. The umbrella is out of the view line or if it is seen it would only just be seen. As a visitor moves along the beach the umbrellas can be seen behind and set back from the building, the additional umbrella will add slightly to this but when seen square on there will be no change in what is now seen.

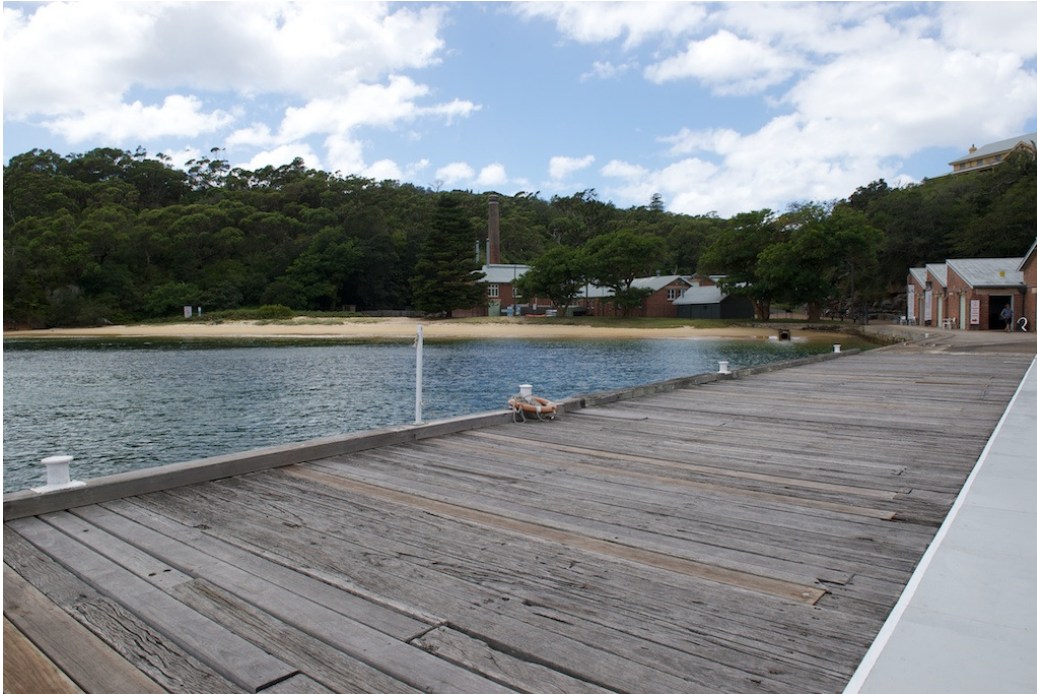
A broad overview from the wharf of both areas.

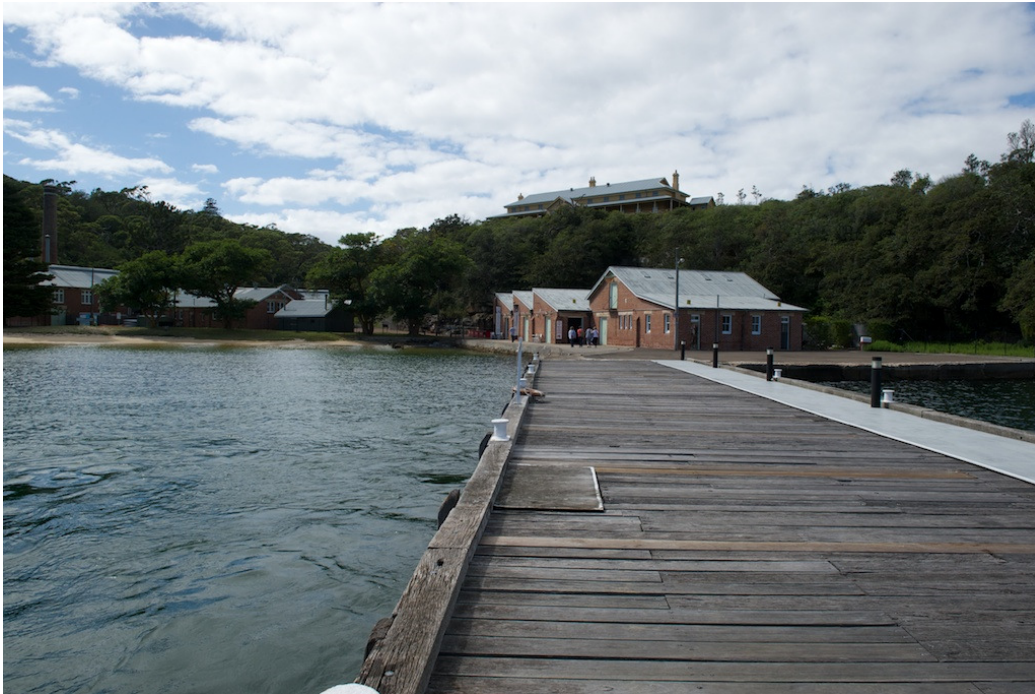
View from end of wharf to A14-16. The proposed umbrella may just be visible behind the building and trees but will not be discernible.

Visually, this new element will not be seen from the wharf on approach to the precinct and there will be no visual impact.

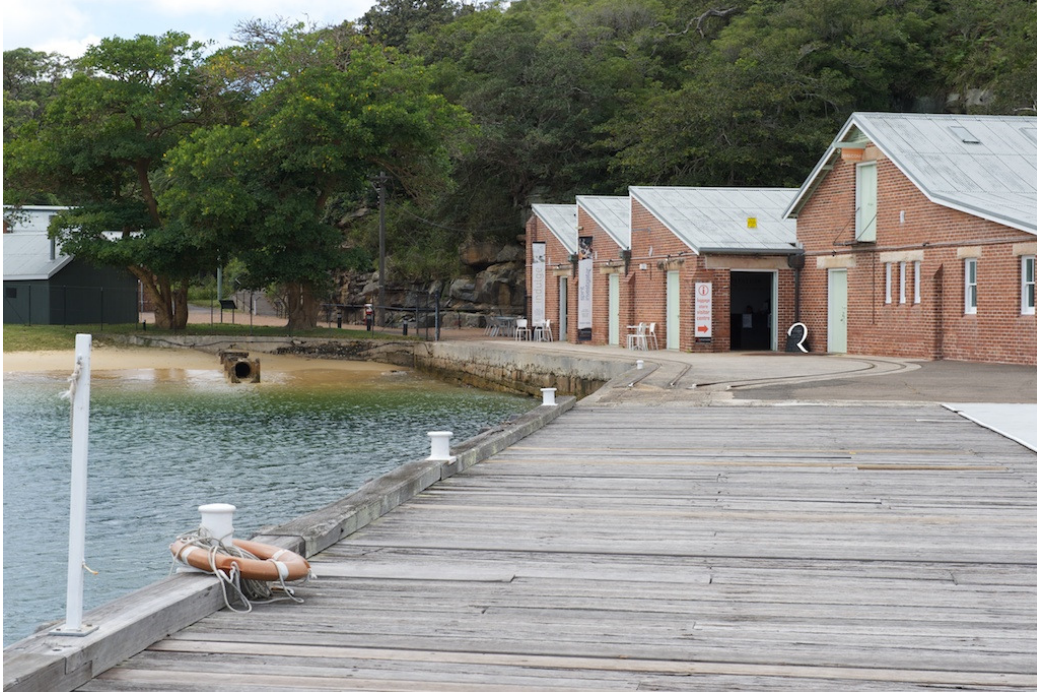
Closer view. Umbrella is located to be out of this view line.

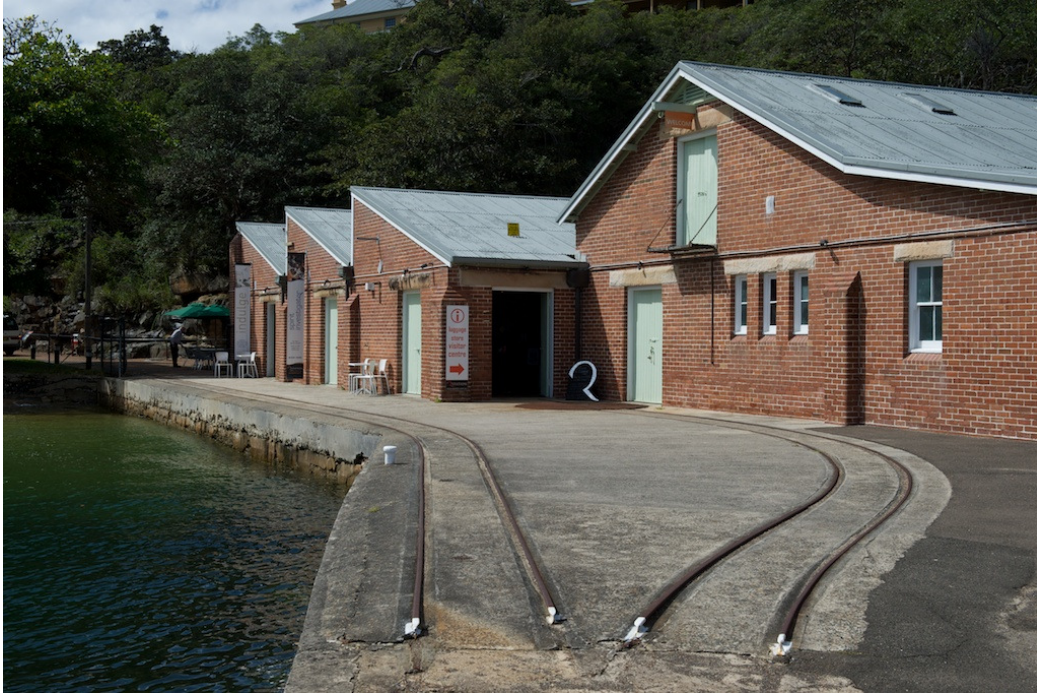
As the viewer approaches the building the umbrella is further behind the building.

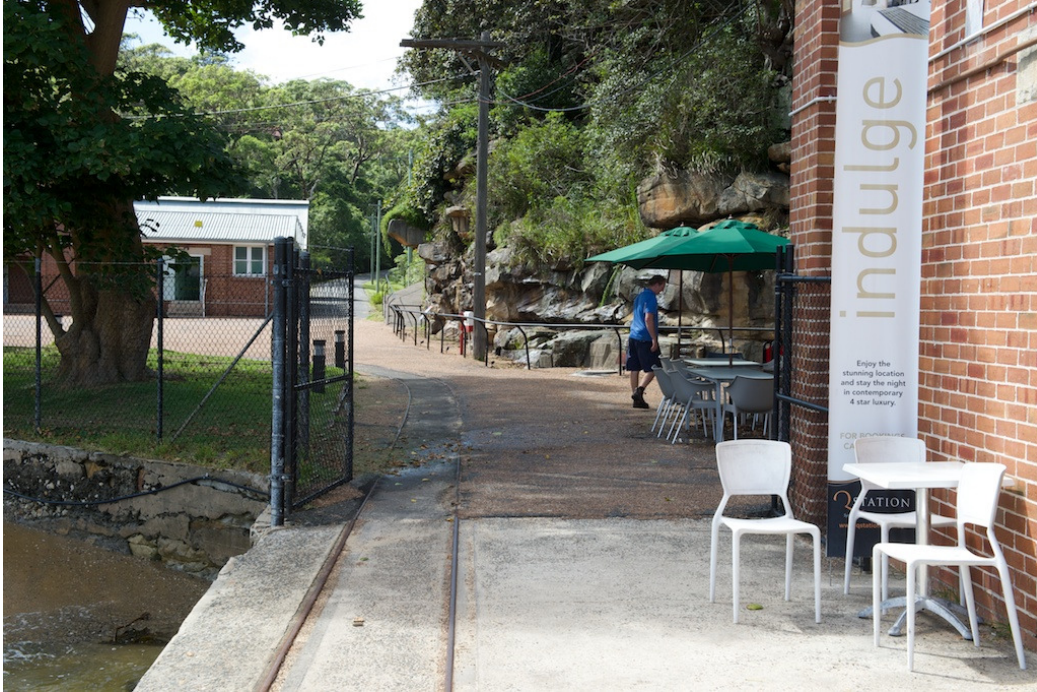
This shows the loose wharf seating and the locations of current umbrellas. The proposed umbrella is to be set further back to allow the cliff face to be seen as visitors approach.

The photos show some umbrellas in place in this location, it is recommended that a single larger umbrella be used as it will create the minimum visual impact, de-clutter the area visually and as it will be fixed in position can be located to keep the openness of the view down the wharf. The sketch shows the preferred location for an umbrella.

The umbrella should be no larger than 4 x 4 metres and should be set back as dimensioned on the sketch. It is also important not to add any barriers around the tables and chairs to delineate them, but rather to create a more open and inclusive setting. Chairs, tables and shade elements should be kept back from the railing to allow visitors to see the inscriptions.

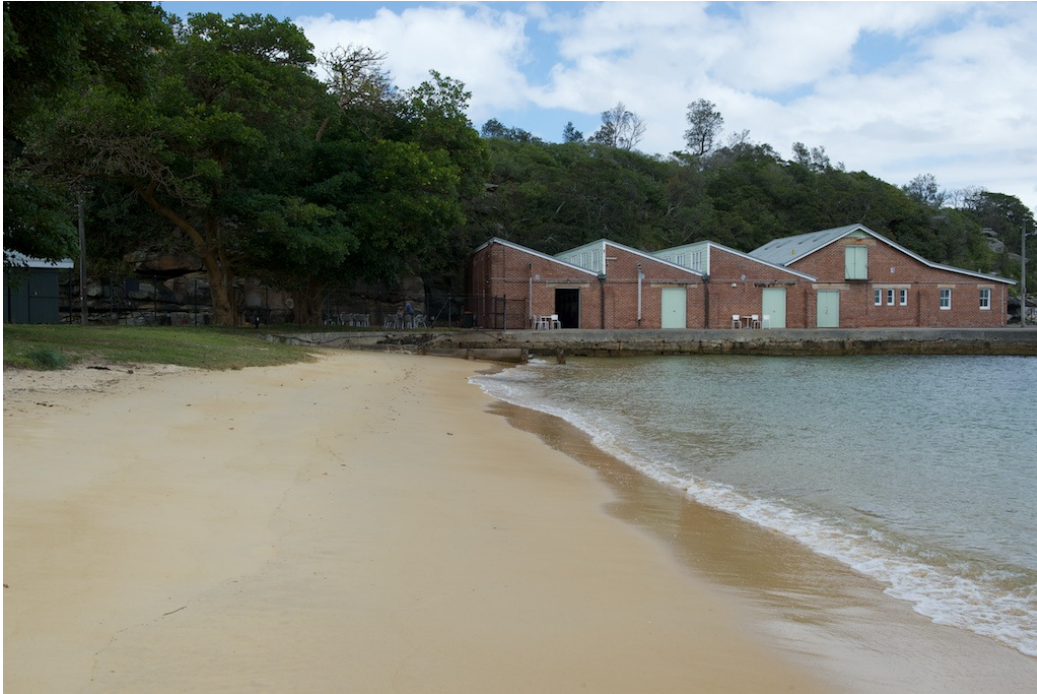
View across the beach. The proposed umbrella is located behind the trees in the middle ground and may be seen in small sections but will not be discernible.

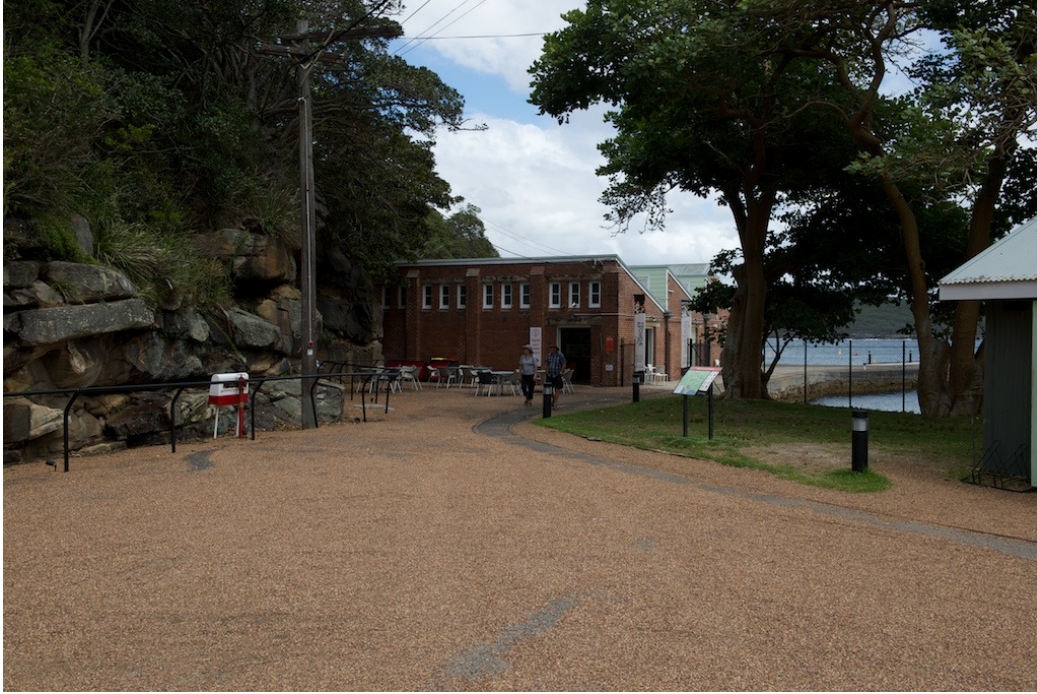
View to building from courtyard> The umbrella will be seen from here. This photo was taken without umbrellas in place, setting the umbrella back allows the building to be seen.

The structure will be seen from the central area of the precinct, however, as a single element it will not detract from the setting.
