### Re: Glenmore Hotel, 96-98 Cumberland Street, The Rocks - Preliminary Assessment of Historical Archaeological Potential

## **Appendix A: Preliminary Assessment of Historical Archaeological Potential for the Proposed Development at the Glenmore Hotel, 96-98 Cumberland Street, The Rocks**

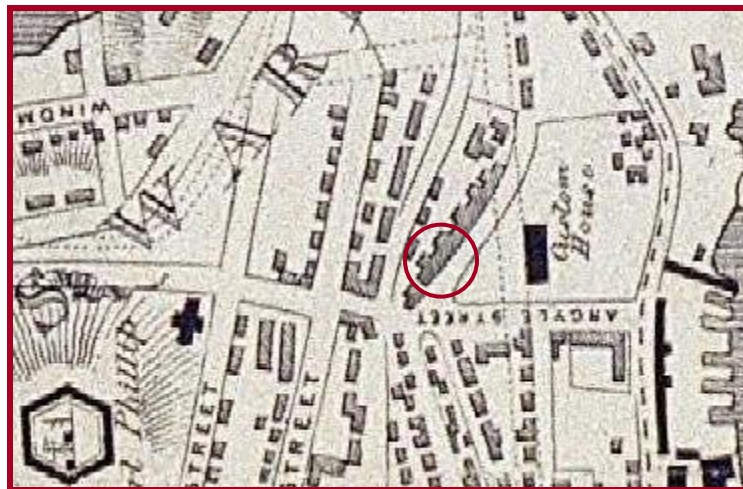
Figure 6. The study area in 1843 (source: William Henry Wells, 1843, *Map of the City of Sydney*, State Library of NSW, ZM2 811.17/1843/1, online edition).

The 1811 plan indicates that tracks, at least, existed along the lines of the later Cumberland and Gloucester Streets in the vicinity of the study area (**Figure 3**). However, no buildings are shown in this area. By comparison with later plans, the 1835 plan indicates that the study area consists of parts of two allotments, Nos. 10 and 11, between Gloucester and Cumberland Streets (**Figure 4**). The northern allotment was claimed by John Hunter, and the southern by James Curtis. Buildings had been constructed on both of the allotments by this time. The 1836 and 1843 plans show the building on the northern allotment, but appear to show the southern allotment vacant (**Figure 5** and **Figure 6**).

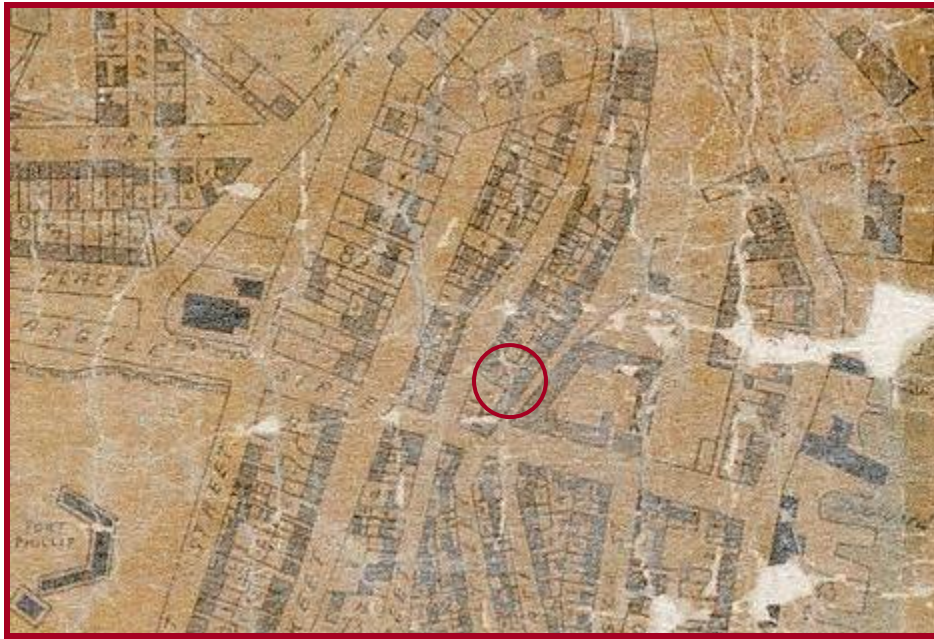
Figure 7. The study area in 1850 (source: William Henry Wells, 1850, *The City of Sydney*, including the environs of Pyrmont, Balmain, Redfern, Chippendale, the Glebe, Surry Hills, Paddington &c., State Library of NSW, Zm4 811.17gbbd/ 1850/1, online edition).

The 1850 plan shows a terrace on each of the two allotments (**Figure 7**). These two buildings remained standing in 1854 and 1865 (**Figure 8** and **Figure 9**). The colouring in the 1865 plan indicates that the two terraces were built of stone, with timber outbuildings. By 1889, the southern terrace had been demolished (**Figure 10**). There was a terrace on the northern part of the study area. It is not clear whether this was the original building, as shown in the 1836 plan, or a replacement. By 1895 a new terrace had been built in the southern part of the study area. This building comprised six houses; three facing Cumberland Street, and three facing Gloucester (**Figure 11**). The northern terrace remained standing. The buildings are shown in two photographs probably dating to the first years of the twentieth century (**Figure 12** and **Figure 13**).

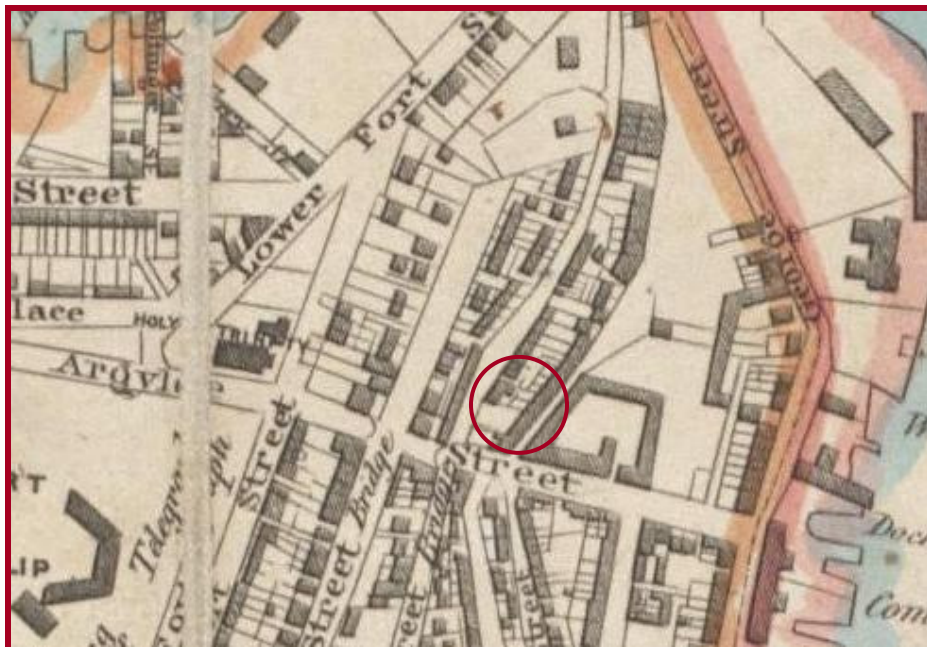
Figure 8. The study area in 1854 (source: WH Baron, Woolcot and Clarke's map of the City of Sydney with the environs of Balmain and Glebe, Chippendale, Redfern, Paddington, &c, National Library of NSW, Map NK 3963, online edition, <http://nla.gov.au/nla.map-nk3963>).

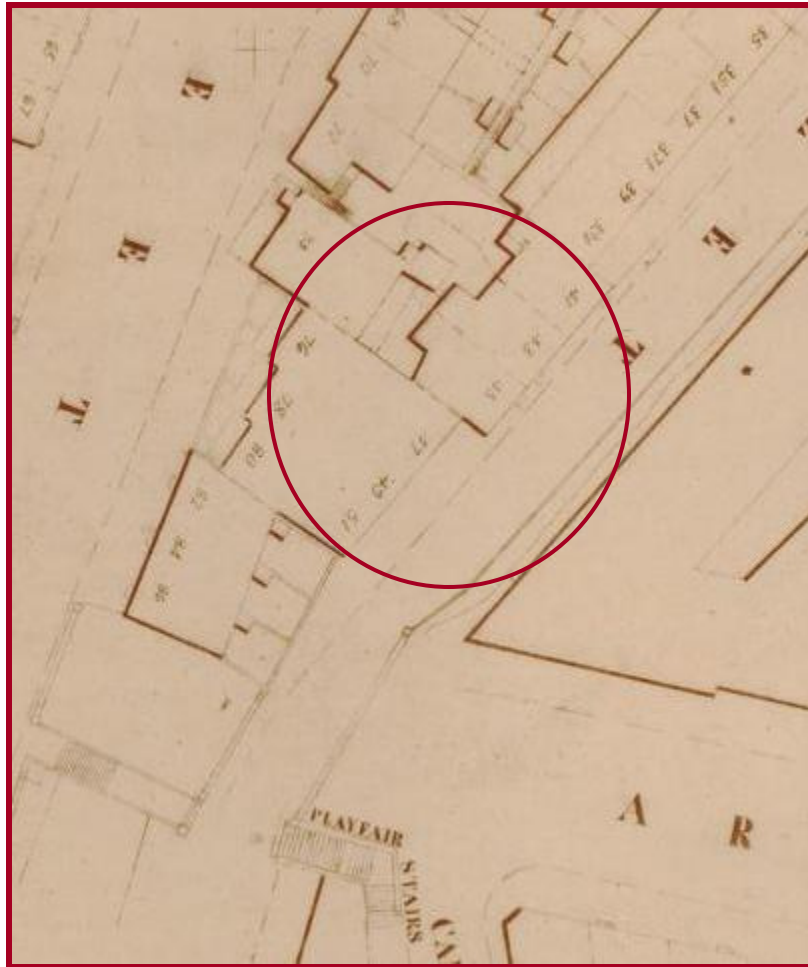
Figure 11. The study area in 1895 (source: NSW Department of Lands, Sydney Metropolitan Detail Series, City of Sydney Sections 85, 86, part 87, and 88, State Library of NSW, ZM Ser 4 811.17/1, online edition).

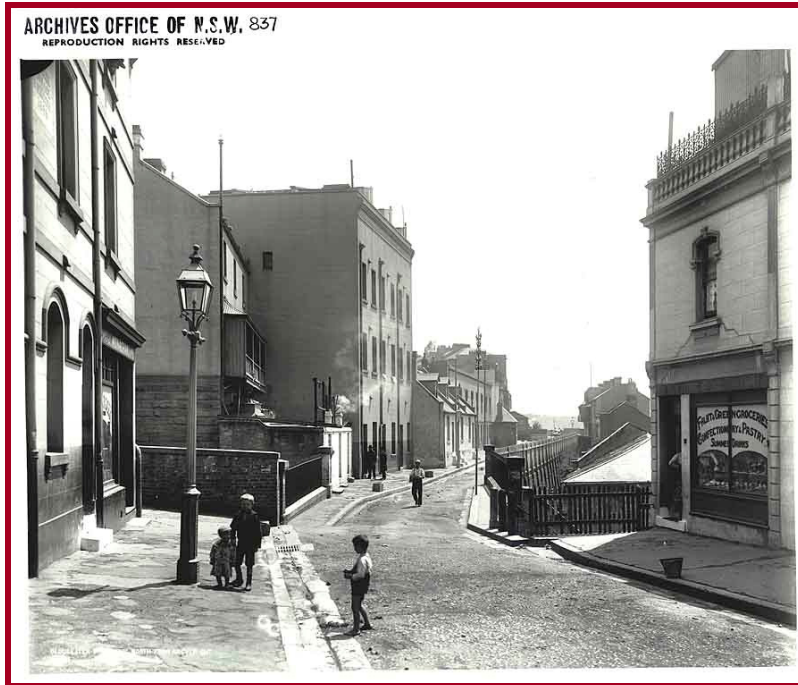
Figure 12. An undated photograph showing the buildings in the study area, looking north. The study area may include part of the three-storey terrace in the middle ground, and parts of the two terraces to the north (source: Gloucester Street looking north from Argyle Cut, State Records NSW, Digital ID 4481\_a026\_000035.jpg).

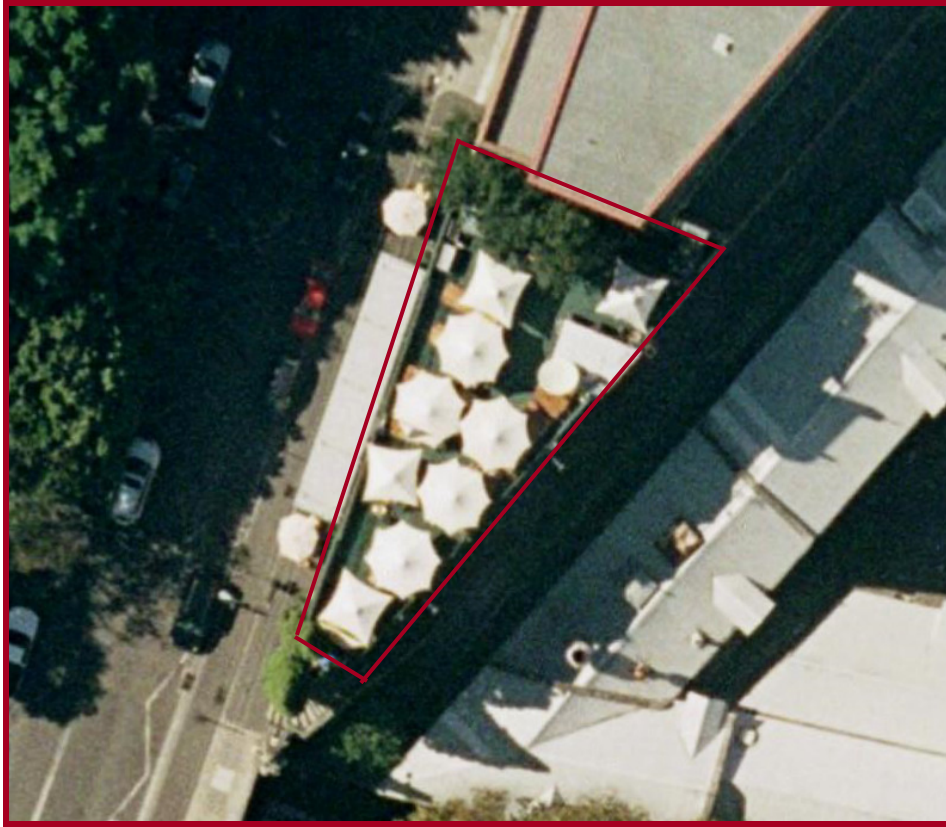
Figure 16. A recent aerial photograph showing the study area, outlined in red (source: Google Earth).
