**Darling Anabranh Project  
Additional In-stream Infrastructure**

# **Cultural heritage investigation**

**Report to the New South Wales  
Department of Environment and Climate Change**

**January 2008**

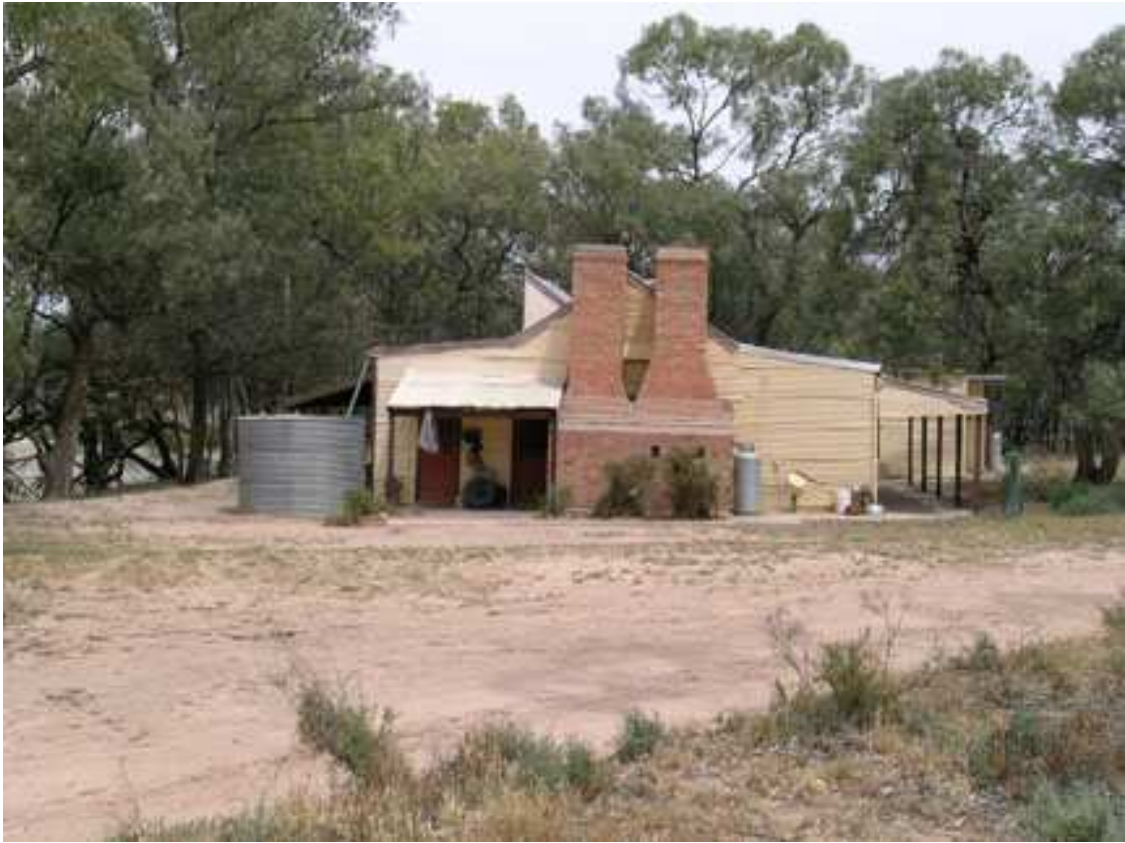
**Figure 2.** Willow Point Shearers Quarters.

Willow Point Shearers Quarters (Wentworth Shire Council Heritage Item Number 100) were constructed in 1926 on Willow Point Station (Figure 2). This historic site is located approximately 400 m northeast of Old Willow Point bridge and 600 m southeast of Willow Point dam, both of which are proposed to be removed. The shearers quarters are constructed of timber-framed corrugated iron and retain a large bakers oven with two red brick chimneys (Wentworth Shire Council 2007).

| Heritage Item Number | Heritage Listing Type | Name | GDA (mE) | GDA (mN) |
|---|---|---|---|---|
| 100 | Wentworth Shire Council LEP, NSW Heritage Inventory | Willow Point Shearers Quarters | 571685 | 6311555 |

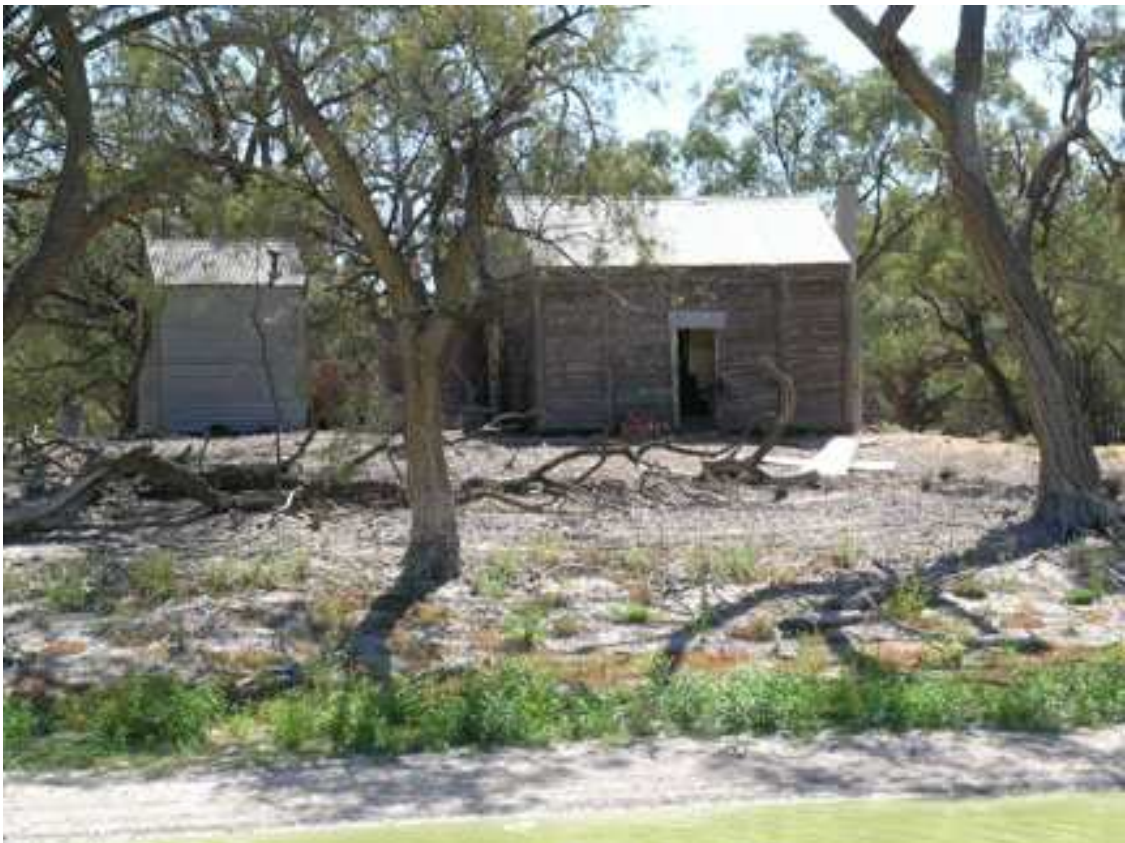
**Figure 3.** Toora homestead outbuildings.

Toora homestead and outbuildings were constructed by James Maynard and Walter Ross from c. 1912 to c. 1924 (Withers 1989). The homestead complex consists of a native pine drop-log motor shed, a corrugated iron storeroom, a timber-framed meat-house and a rough-sawn native pine two room cottage (Figure 3). The main homestead has been dismantled, with only the milled timber floor remaining.

| Heritage Item Number | Heritage Listing Type | Name | GDA (mE) | GDA (mN) |
|---|---|---|---|---|
| DAH03 | na | Toora homestead ruins and outbuildings | 566620 | 6269527 |

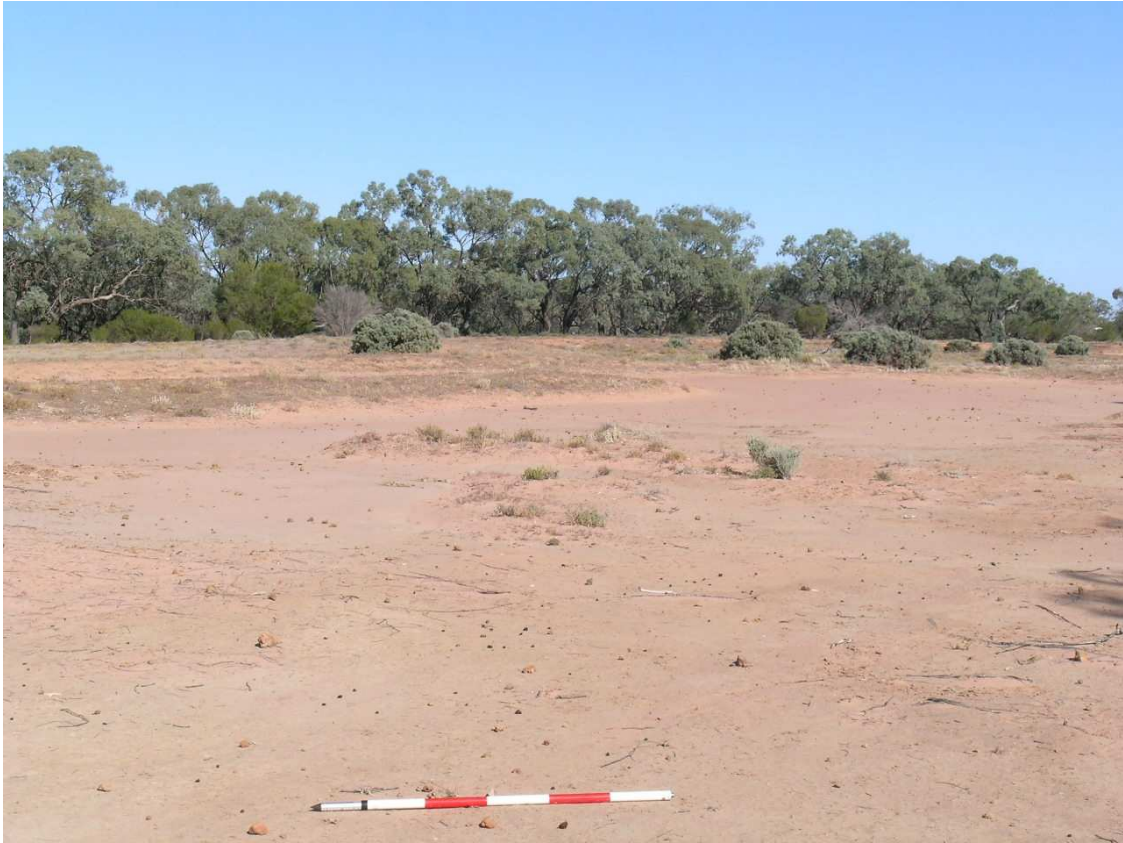
**Site condition:** This site is in poor condition having been disturbed by erosion by wind, water and stock and vehicular traffic.

**Figure A1.** Stone artefact scatter and hearth site DA161.

**Management considerations:** The site is approximately 100 m W of Warwicks Crossing by-wash, which is proposed to be removed. The proponent should avoid disturbing the site, possibly by erecting a temporary barrier fence around it during the construction phase of the project. Aboriginal representatives of the Barkindji Elders should be engaged to oversee the erection of the protective barrier. Access to the work area should be from the east. The proponent should also engage Aboriginal site monitors to oversee construction activities involving earthworks in the vicinity of the site.

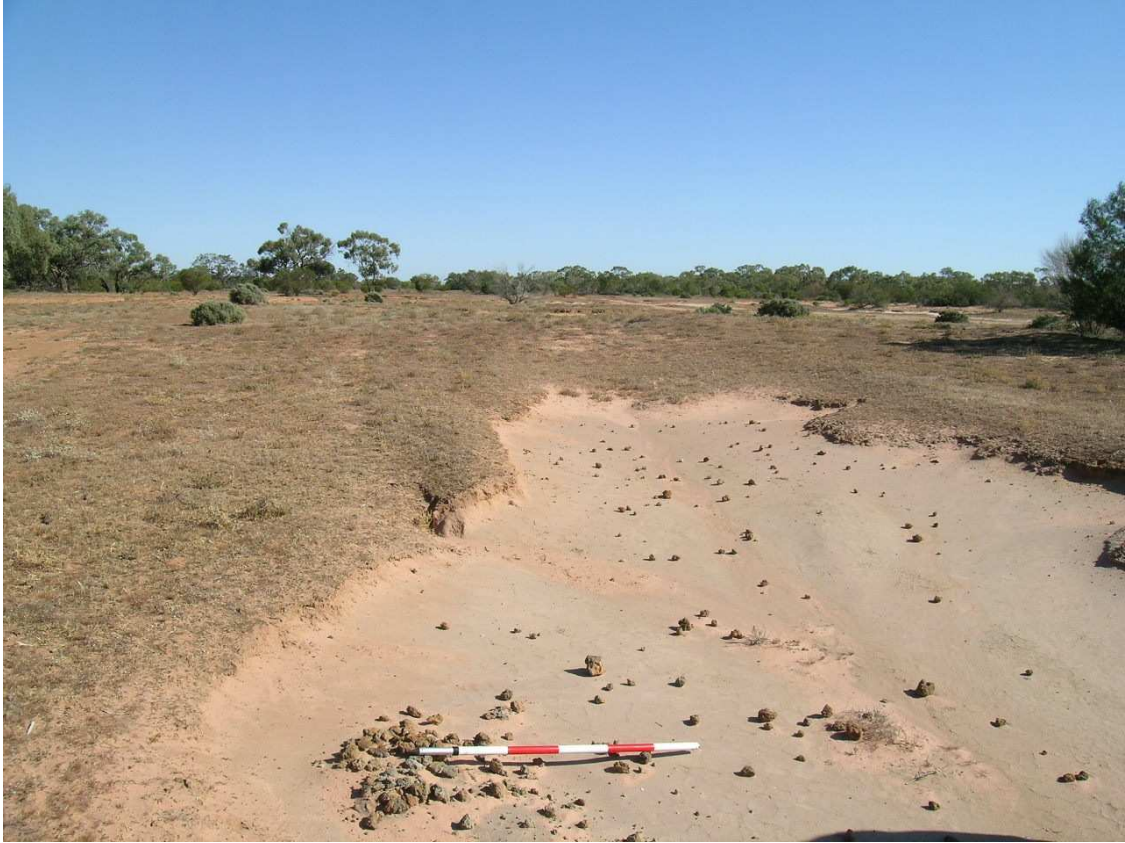
**Figure A2.** Stone artefact scatter and hearth site DA162.

**Site condition:** This site is in poor condition having been disturbed by erosion by wind, water and stock and vehicular traffic.

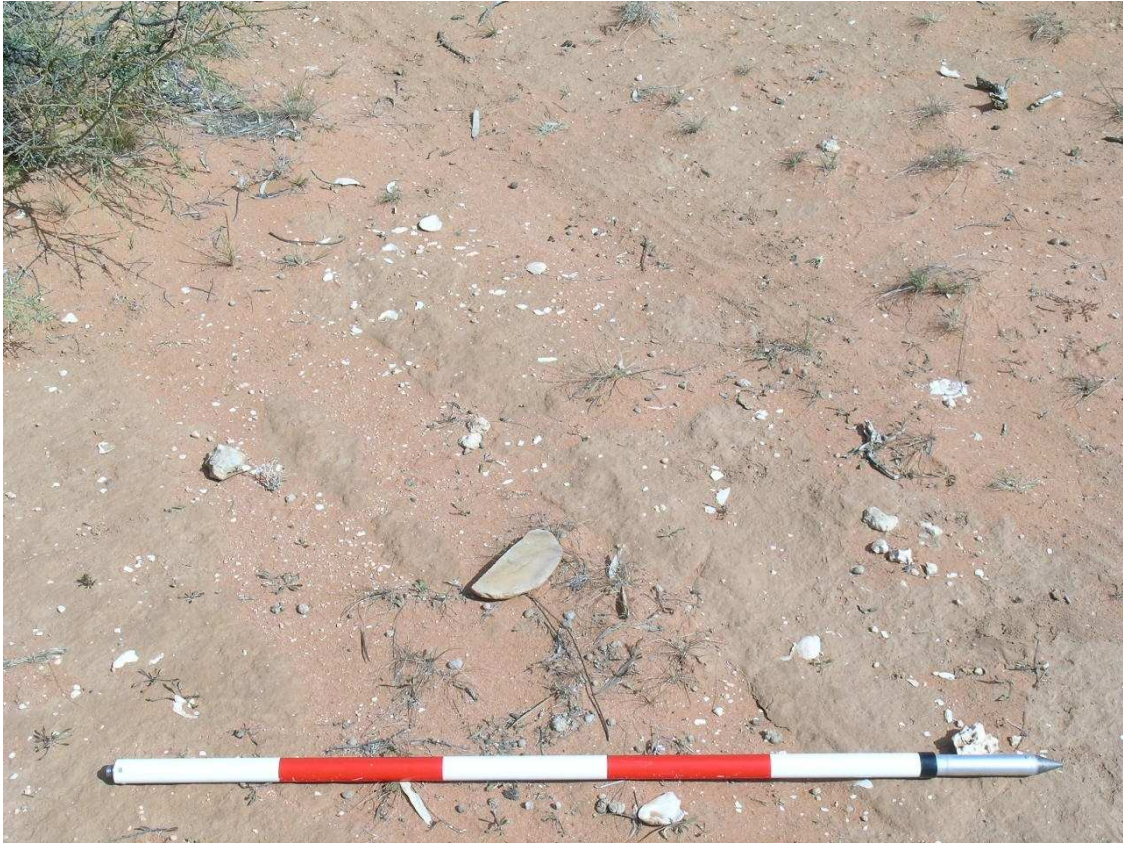
**Figure A3.** Stone artefact scatter, hearth and shell midden site DA163.

**Site condition:** This site is in poor condition having been disturbed by erosion by wind, water and stock and vehicular traffic.

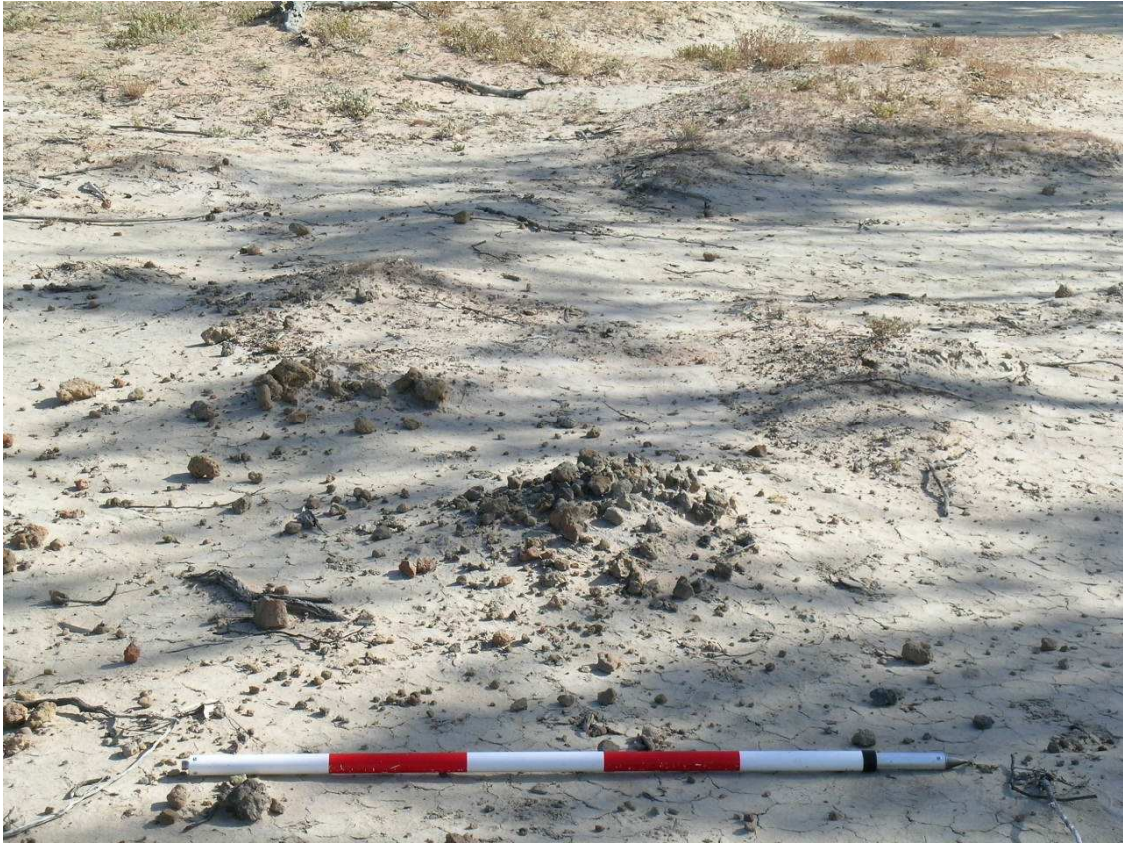
**Site condition:** This site is in poor condition having been disturbed by erosion by wind, water and stock and vehicular traffic.

**Figure A6.** Stone artefact scatter and hearth site DA166.

**Management considerations:** The site is approximately 5 m SW of a proposed rock ford/causeway (Patagorah main dam alternative causeway). The proponent should avoid disturbing the site, possibly by erecting a temporary barrier around the site when works are occurring in its vicinity and engaging Aboriginal site monitors to oversee construction activities involving earthworks. Access to the work area should be from the north. The design of works should be modified so that the low-level rock ford/causeway is not installed near any cultural heritage places or items. Alternatively, if engineering constraints dictate that disturbance to cultural heritage places or items is unavoidable, and the cultural heritage consists of isolated midden shell, hearthstones/heat retainers or stone artefacts, Aboriginal representatives of the Barkindji Elders and/or an archaeologist should move the cultural heritage items to a nearby location outside the zone of disturbance under a NSW *National Parks and Wildlife Act 1974* Section 87 Permit.

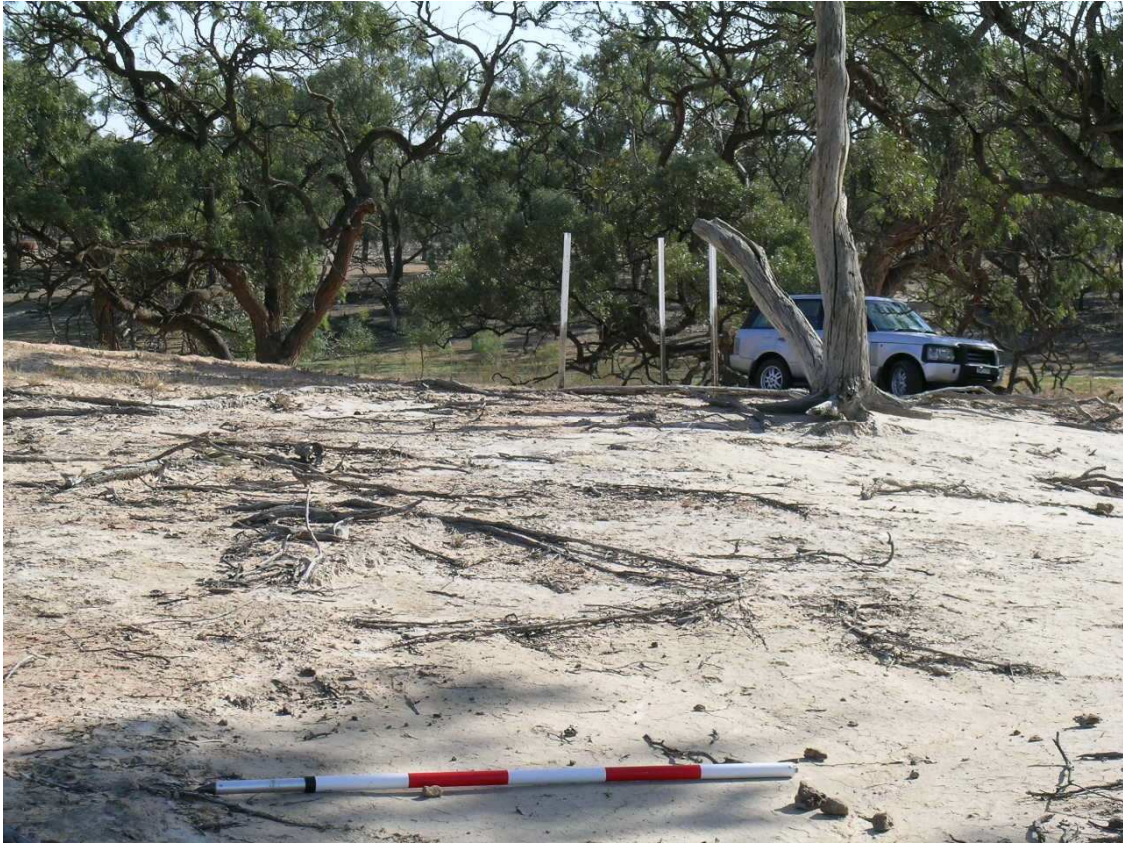
**Site condition:** This site is in poor condition having been disturbed by erosion by wind, water and stock and vehicular traffic.

**Figure A7.** Stone artefact scatter and hearth site DA167.

**Management considerations:** The site is approximately 5 m SE of a proposed rock ford/causeway (Patagorah main dam alternative causeway). The proponent should avoid disturbing the site, possibly by erecting a temporary barrier around the site when works are occurring in its vicinity and engaging Aboriginal site monitors to oversee construction activities involving earthworks. Access to the work area should be from the north. The design of works should be modified so that the low-level rock ford/causeway is not installed near any cultural heritage places or items. Alternatively, if engineering constraints dictate that disturbance to cultural heritage places or items is unavoidable, and the cultural heritage consists of isolated midden shell, hearthstones/heat retainers or stone artefacts, Aboriginal representatives of the Barkindji Elders and/or an archaeologist should move the cultural heritage items to a nearby location outside the zone of disturbance under a NSW *National Parks and Wildlife Act 1974* Section 87 Permit.

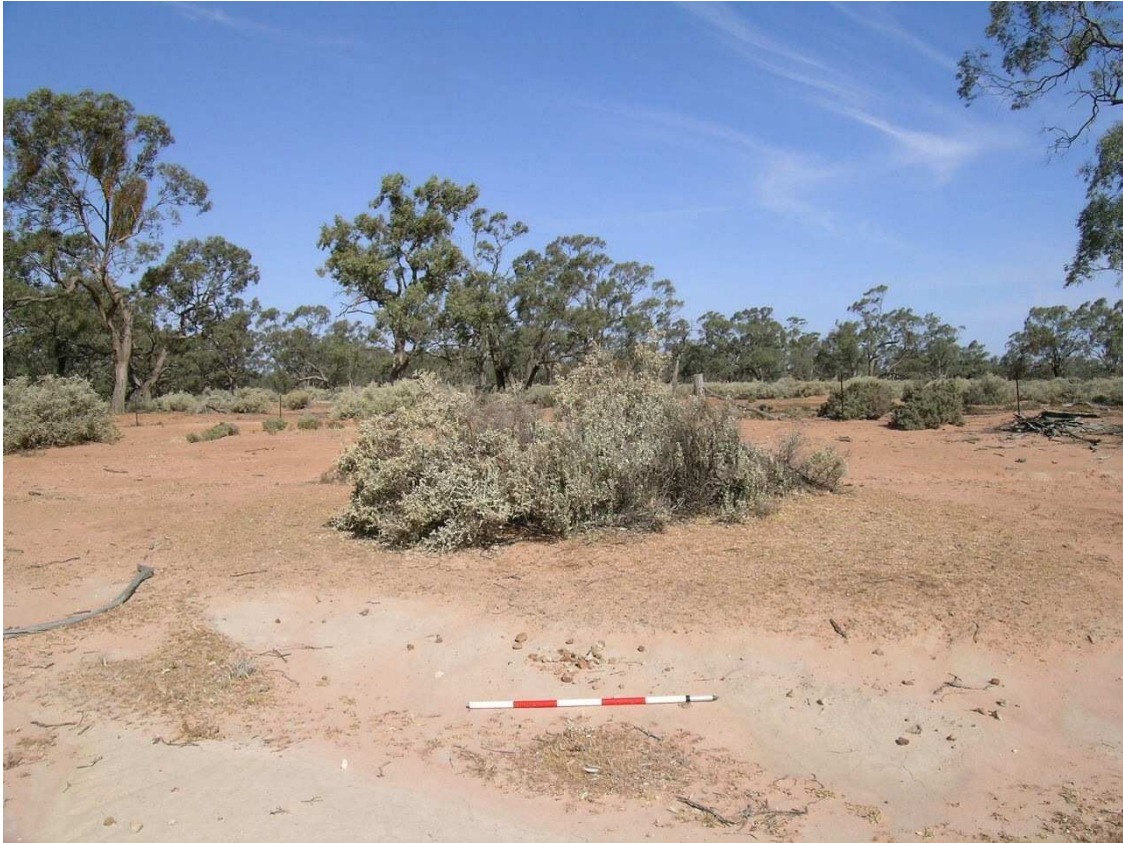
**Figure A9.** Stone artefact scatter and hearth site DA169.

**Site condition:** This site is in poor condition having been disturbed by erosion by wind, water and stock and vehicular traffic.

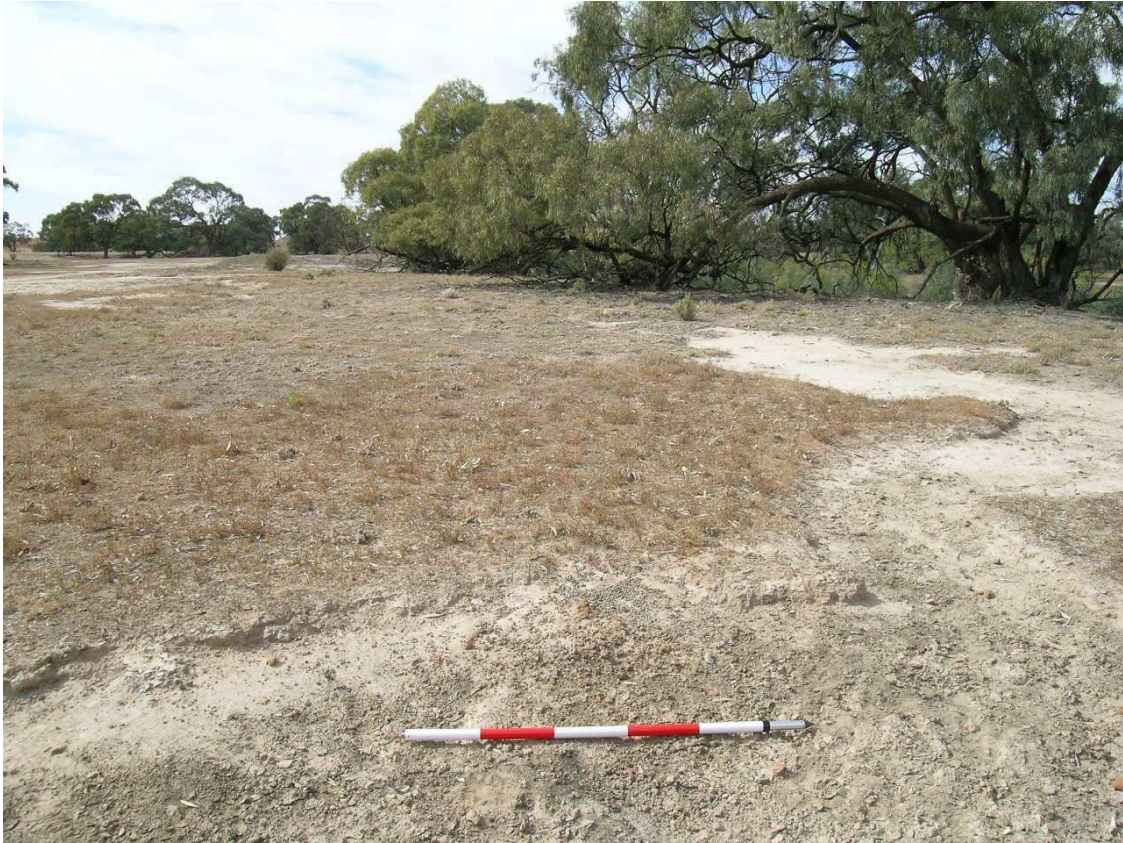
**Figure A10.** Stone artefact scatter and hearth site DA170.

**Site condition:** This site is in poor condition having been disturbed by erosion by wind, water and stock and vehicular traffic.

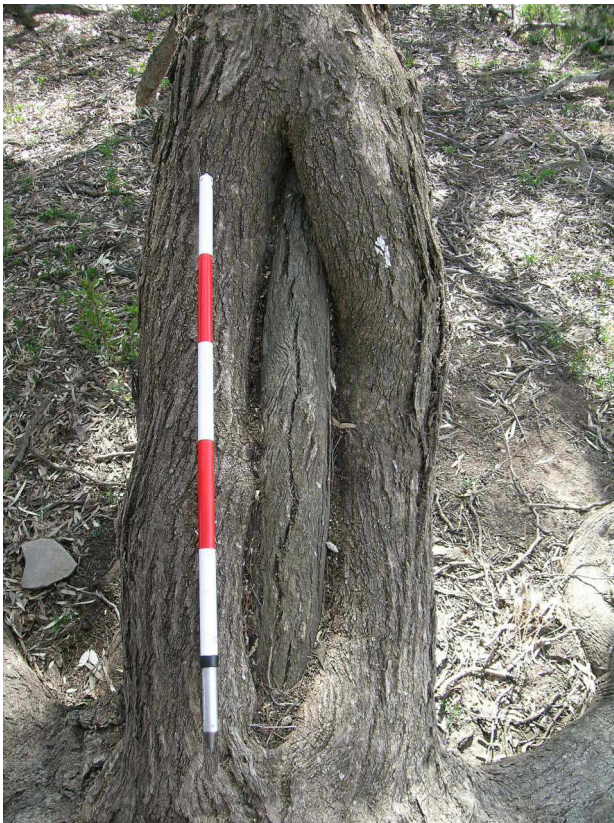
**Description:** The scar is elliptical in shape. There are no diagnostic axe or adze marks. It is possible that a slab of bark was removed from the tree to serve as dish-like container or coolamon.

**Scar condition:** The scar is in good condition, with no fungal or insect attack.

**Figure A11.** Possible modified tree DA171.

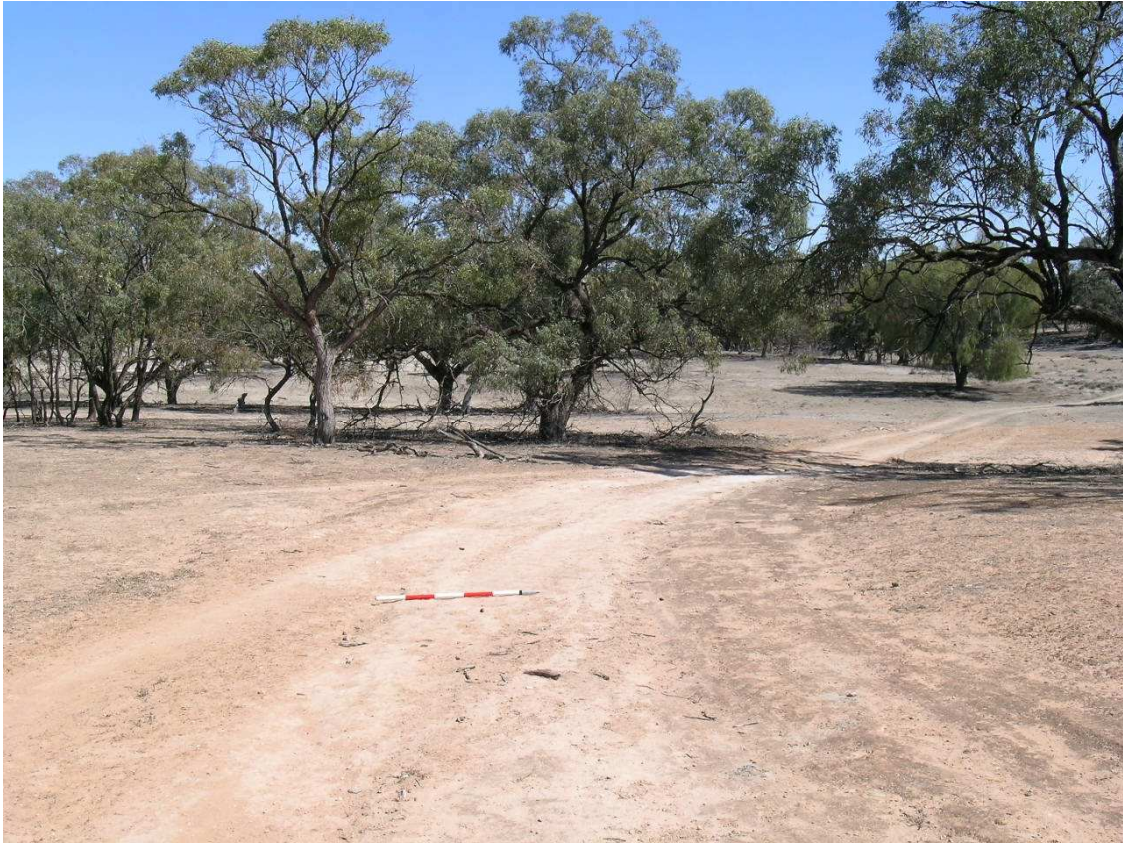
**Site contents:** Fragmented freshwater mussel shell valves are eroding from the present land surface at the site (Figure A12).

**Figure A12.** Shell midden site DA173.

**Site condition:** This site is in poor condition having been disturbed by erosion by wind, water and stock and vehicular traffic.

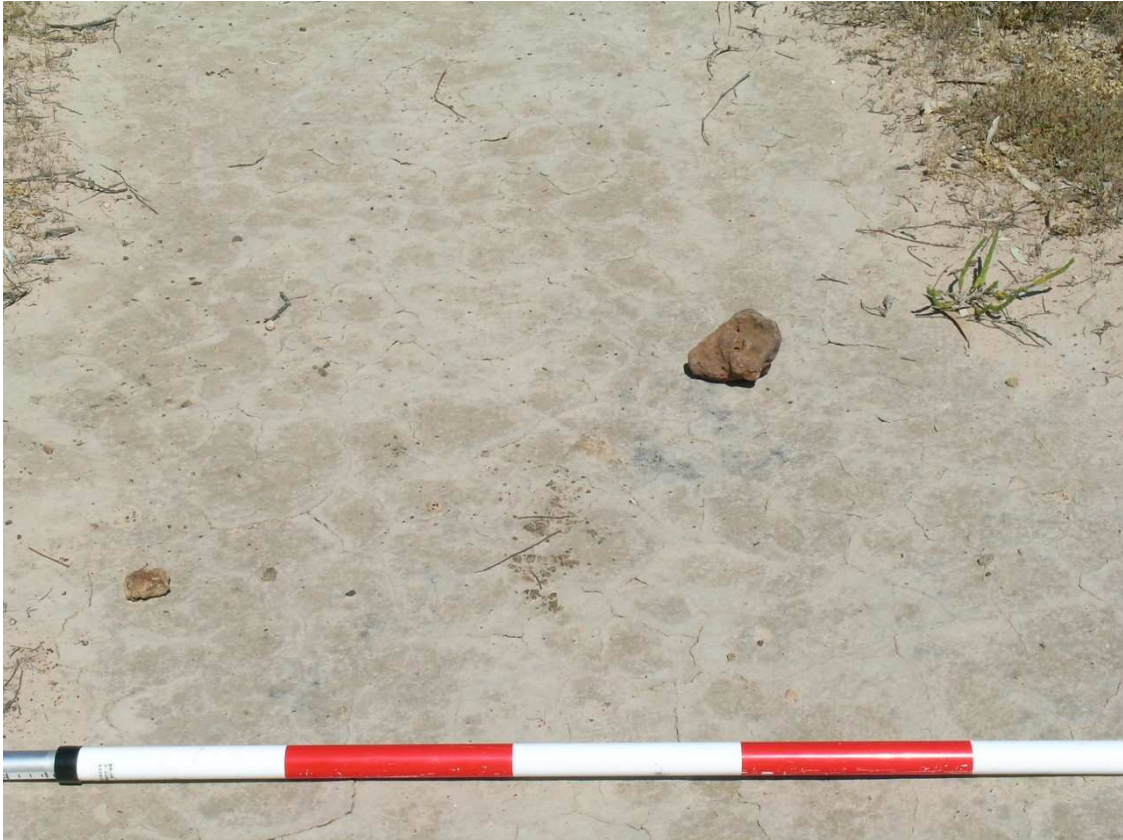
**Visibility:** Site surface visibility was very high (~90%) due to erosion by deflation and scalding and stock and vehicular traffic. Off site visibility was also very high (~90%) due to erosion by wind, water and stock and vehicular traffic.

**Figure A13.** Hearth site DA174.

**Site contents:** Scattered baked clay heat retainers occur at the site (Figure A13).

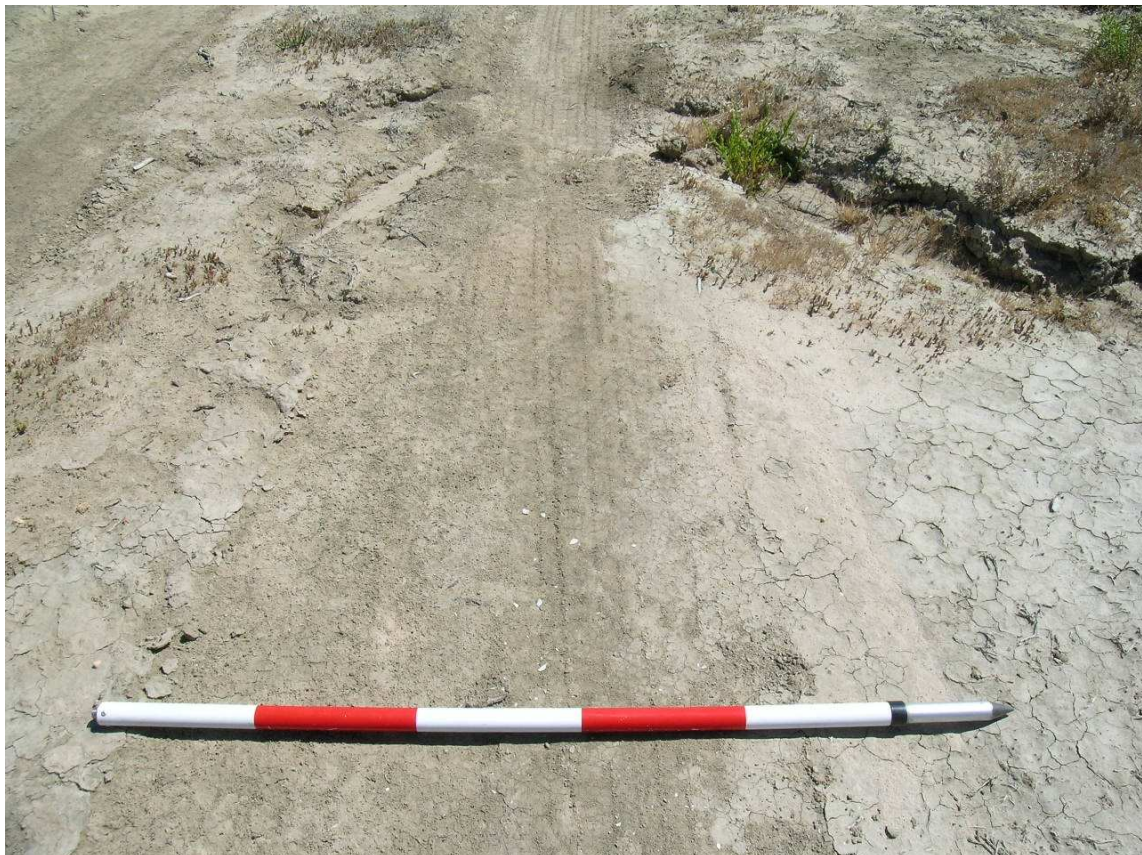
**Visibility:** Site surface visibility was very high (~60%) due to erosion by gullying, deflation and scalding and stock and vehicular traffic. Off site visibility was also very high (~50%) due to erosion by wind, water and stock and vehicular traffic.

**Figure A14.** Shell midden site DA175.

**Site contents:** Fragmented freshwater mussel shell valves are eroding from the present

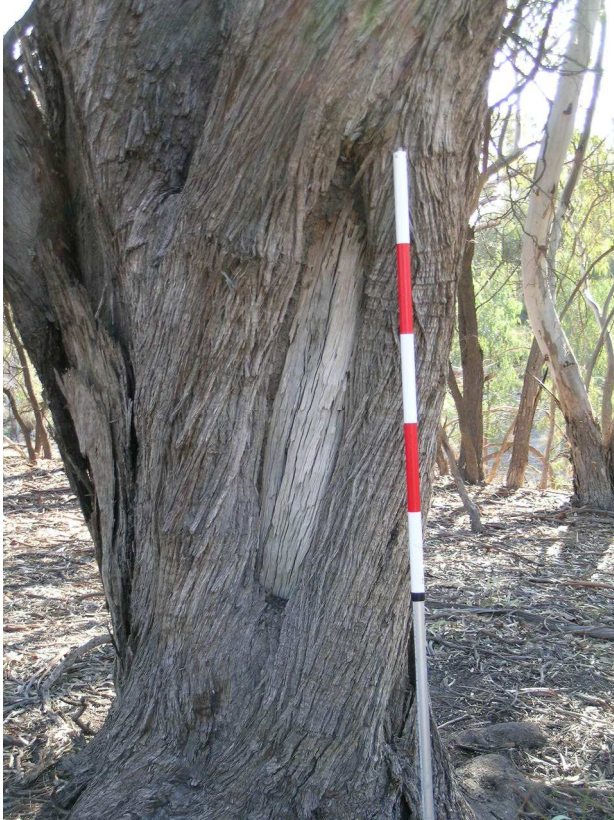
**Figure A15.** Possible modified tree DA176.

**Management considerations:** The site is approximately 20 m N of Tara Downs middle by-wash, which is proposed to be removed. The proponent should avoid disturbing the site, possibly by erecting a temporary barrier fence around it during the construction phase of the project. Aboriginal representatives of the Barkindji Elders should be

engaged to oversee the erection of the protective barrier. The proponent should also engage Aboriginal site monitors to oversee construction activities involving earthworks in the vicinity of the site.

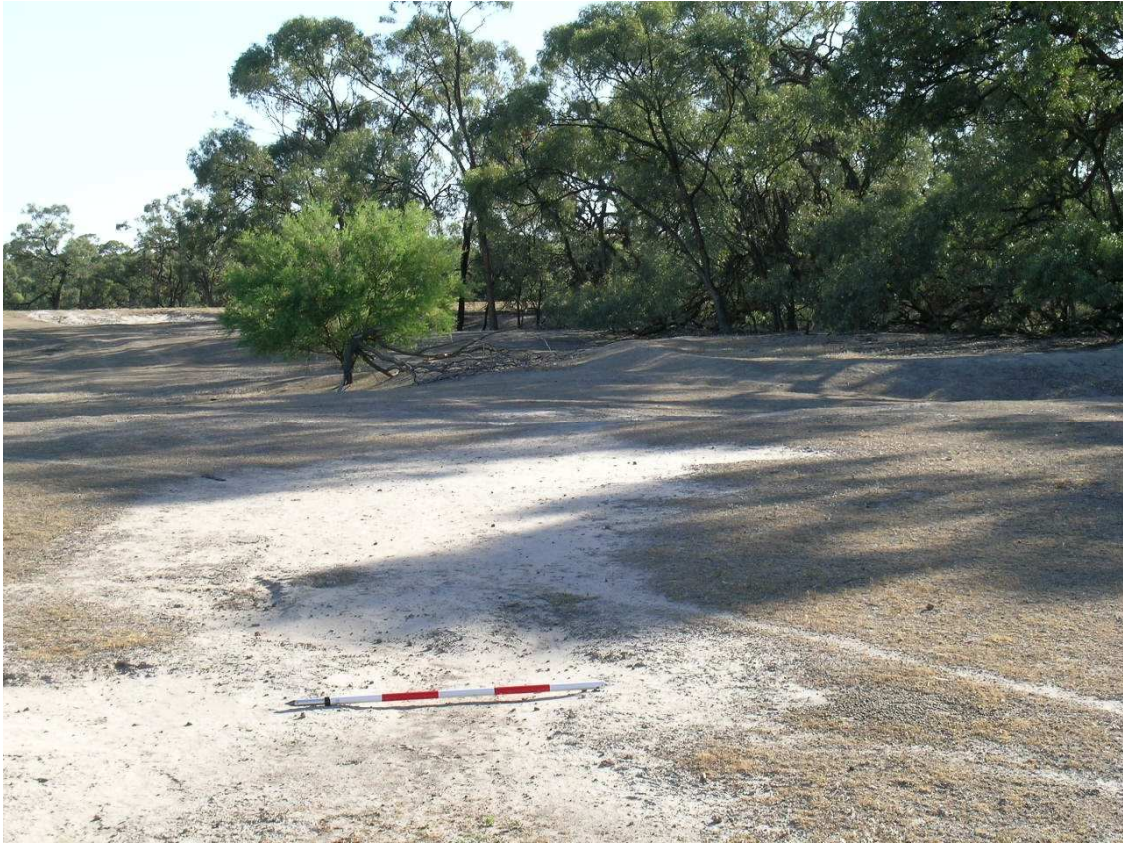
**Figure A16.** Stone artefact scatter and hearth site DA177.

**Site condition:** This site is in poor condition having been disturbed by erosion by wind, water and stock and vehicular traffic.

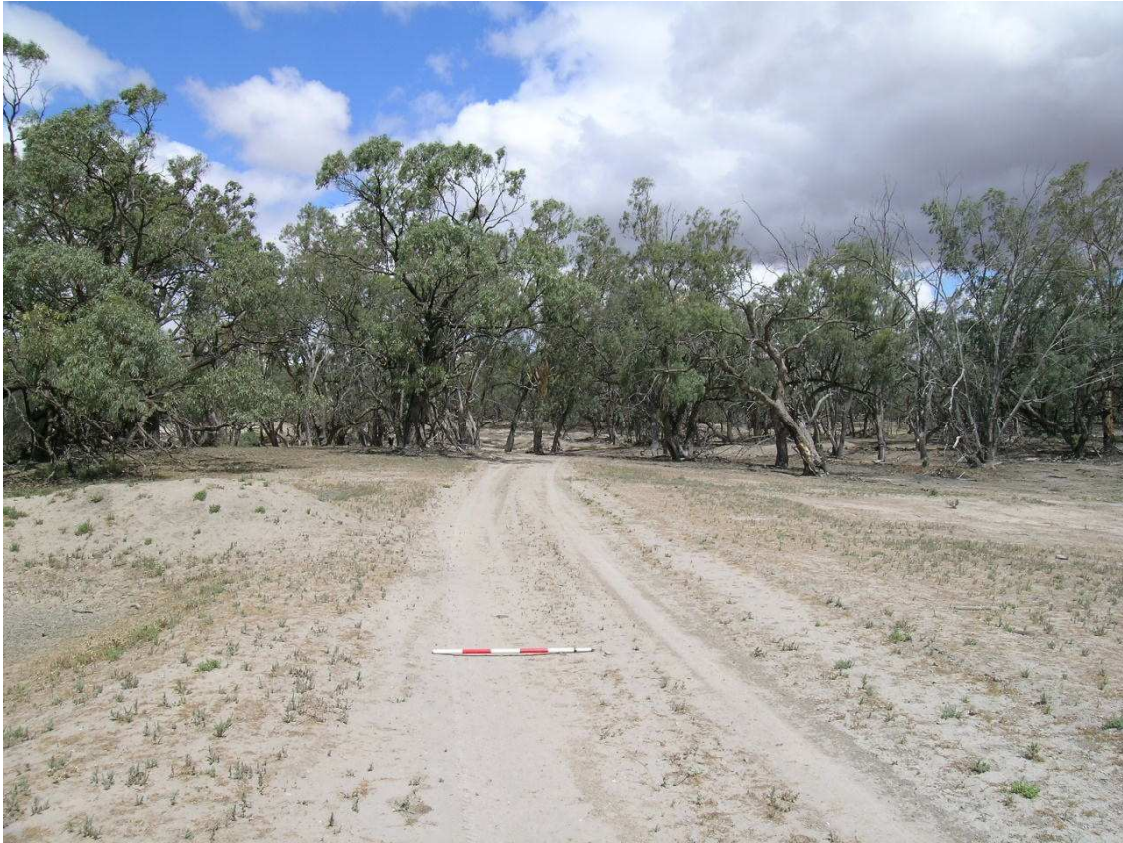
**Figure A17.** Stone artefact scatter, hearth and shell midden site DA178.

**Site condition:** This site is in poor condition having been disturbed by erosion by wind, water and stock and vehicular traffic.

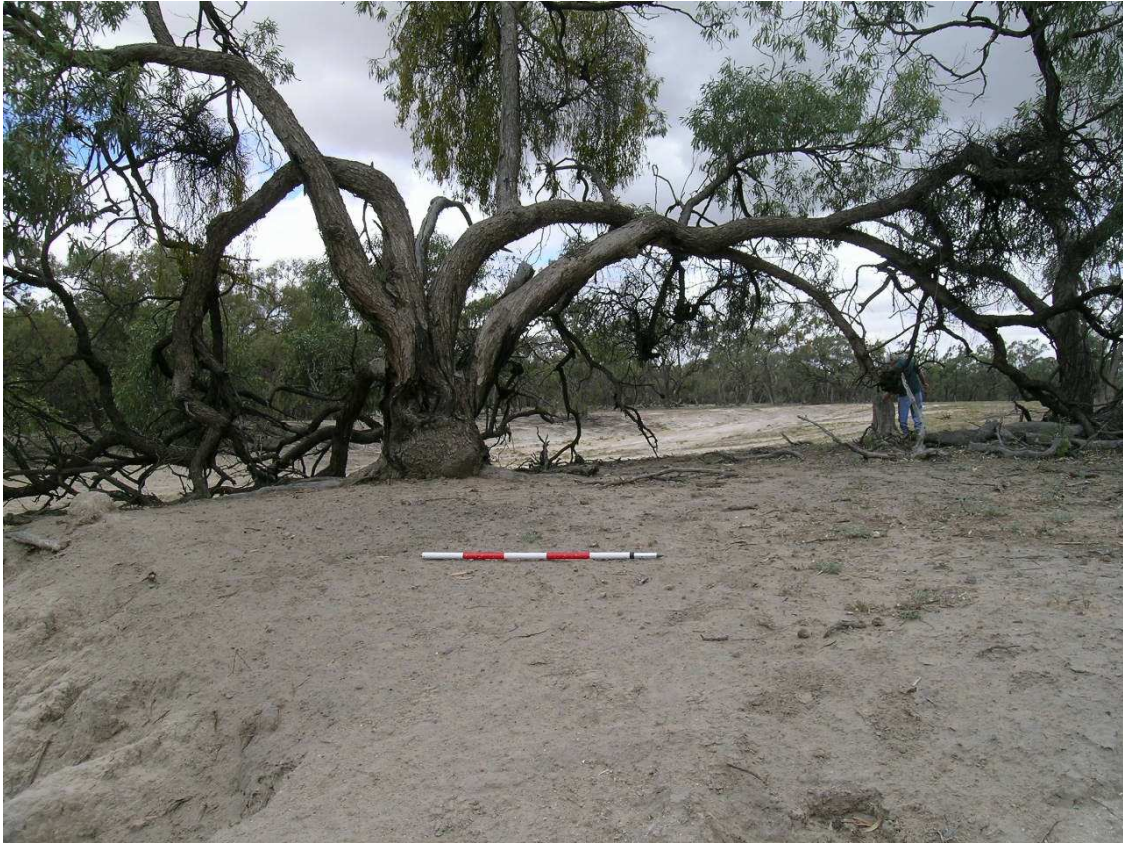
**Figure A18.** Stone artefact scatter and hearth site DA179.

**Site condition:** This site is in poor condition having been disturbed by erosion by wind, water and stock and vehicular traffic.
