## HERITAGE IMPACT ASSESSMENT REPORTS (UMWELT AUSTRALIA)

**Aboriginal Cultural Heritage  
Assessment, Proposed Extension of  
Shipping Channels, Port of Newcastle**

August 2003

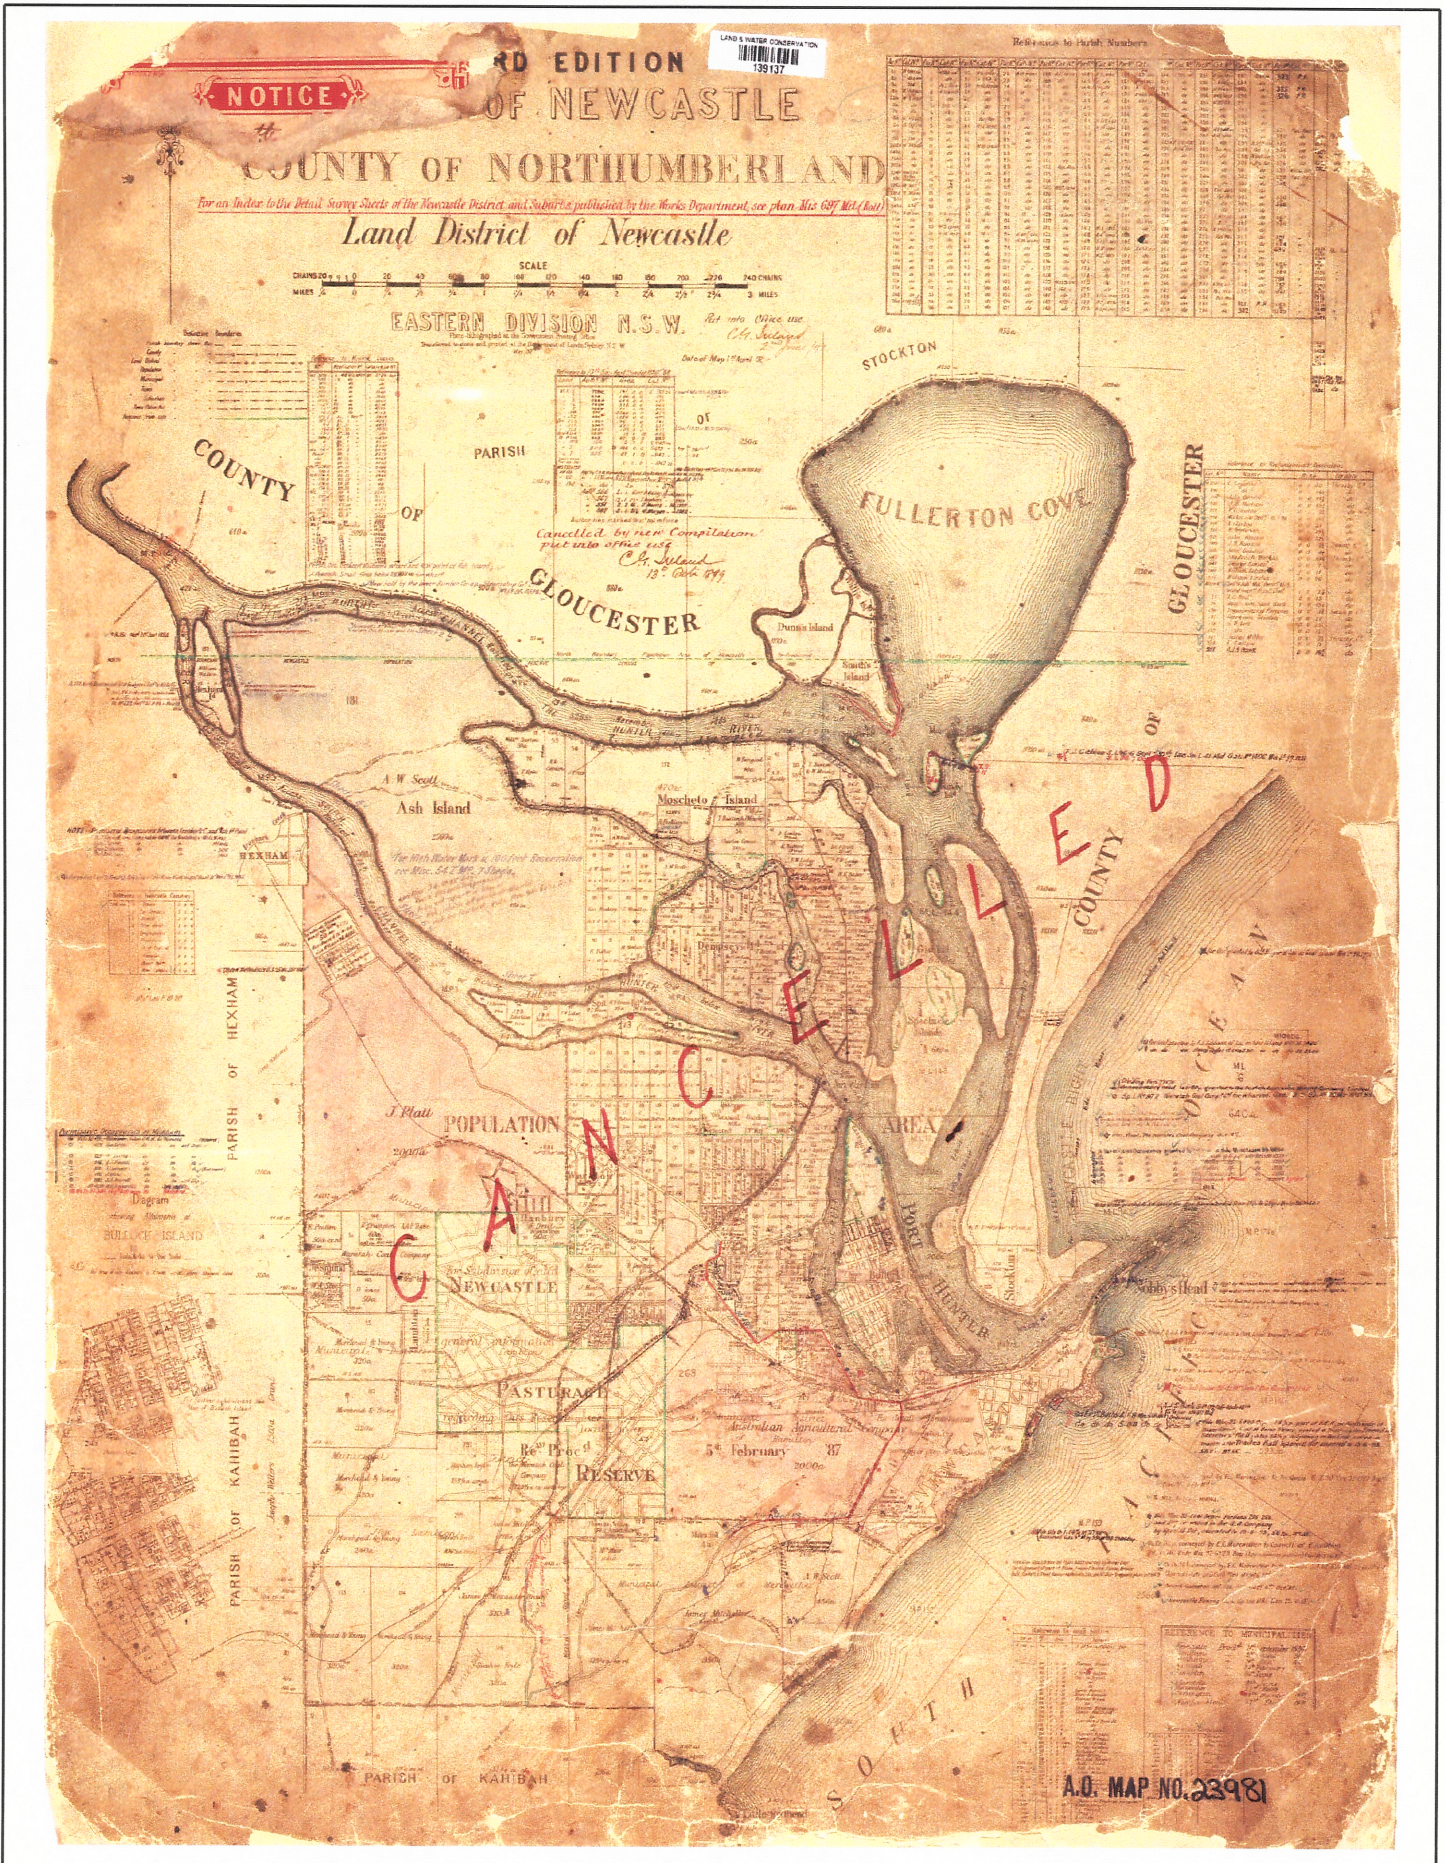
**FIGURE 3.1**  
 Historic Map

Umwelt (Australia) Pty Limited  
 Source: NSWLPI, Newcastle County  
 Northumberland, 3rd Edition, 139137

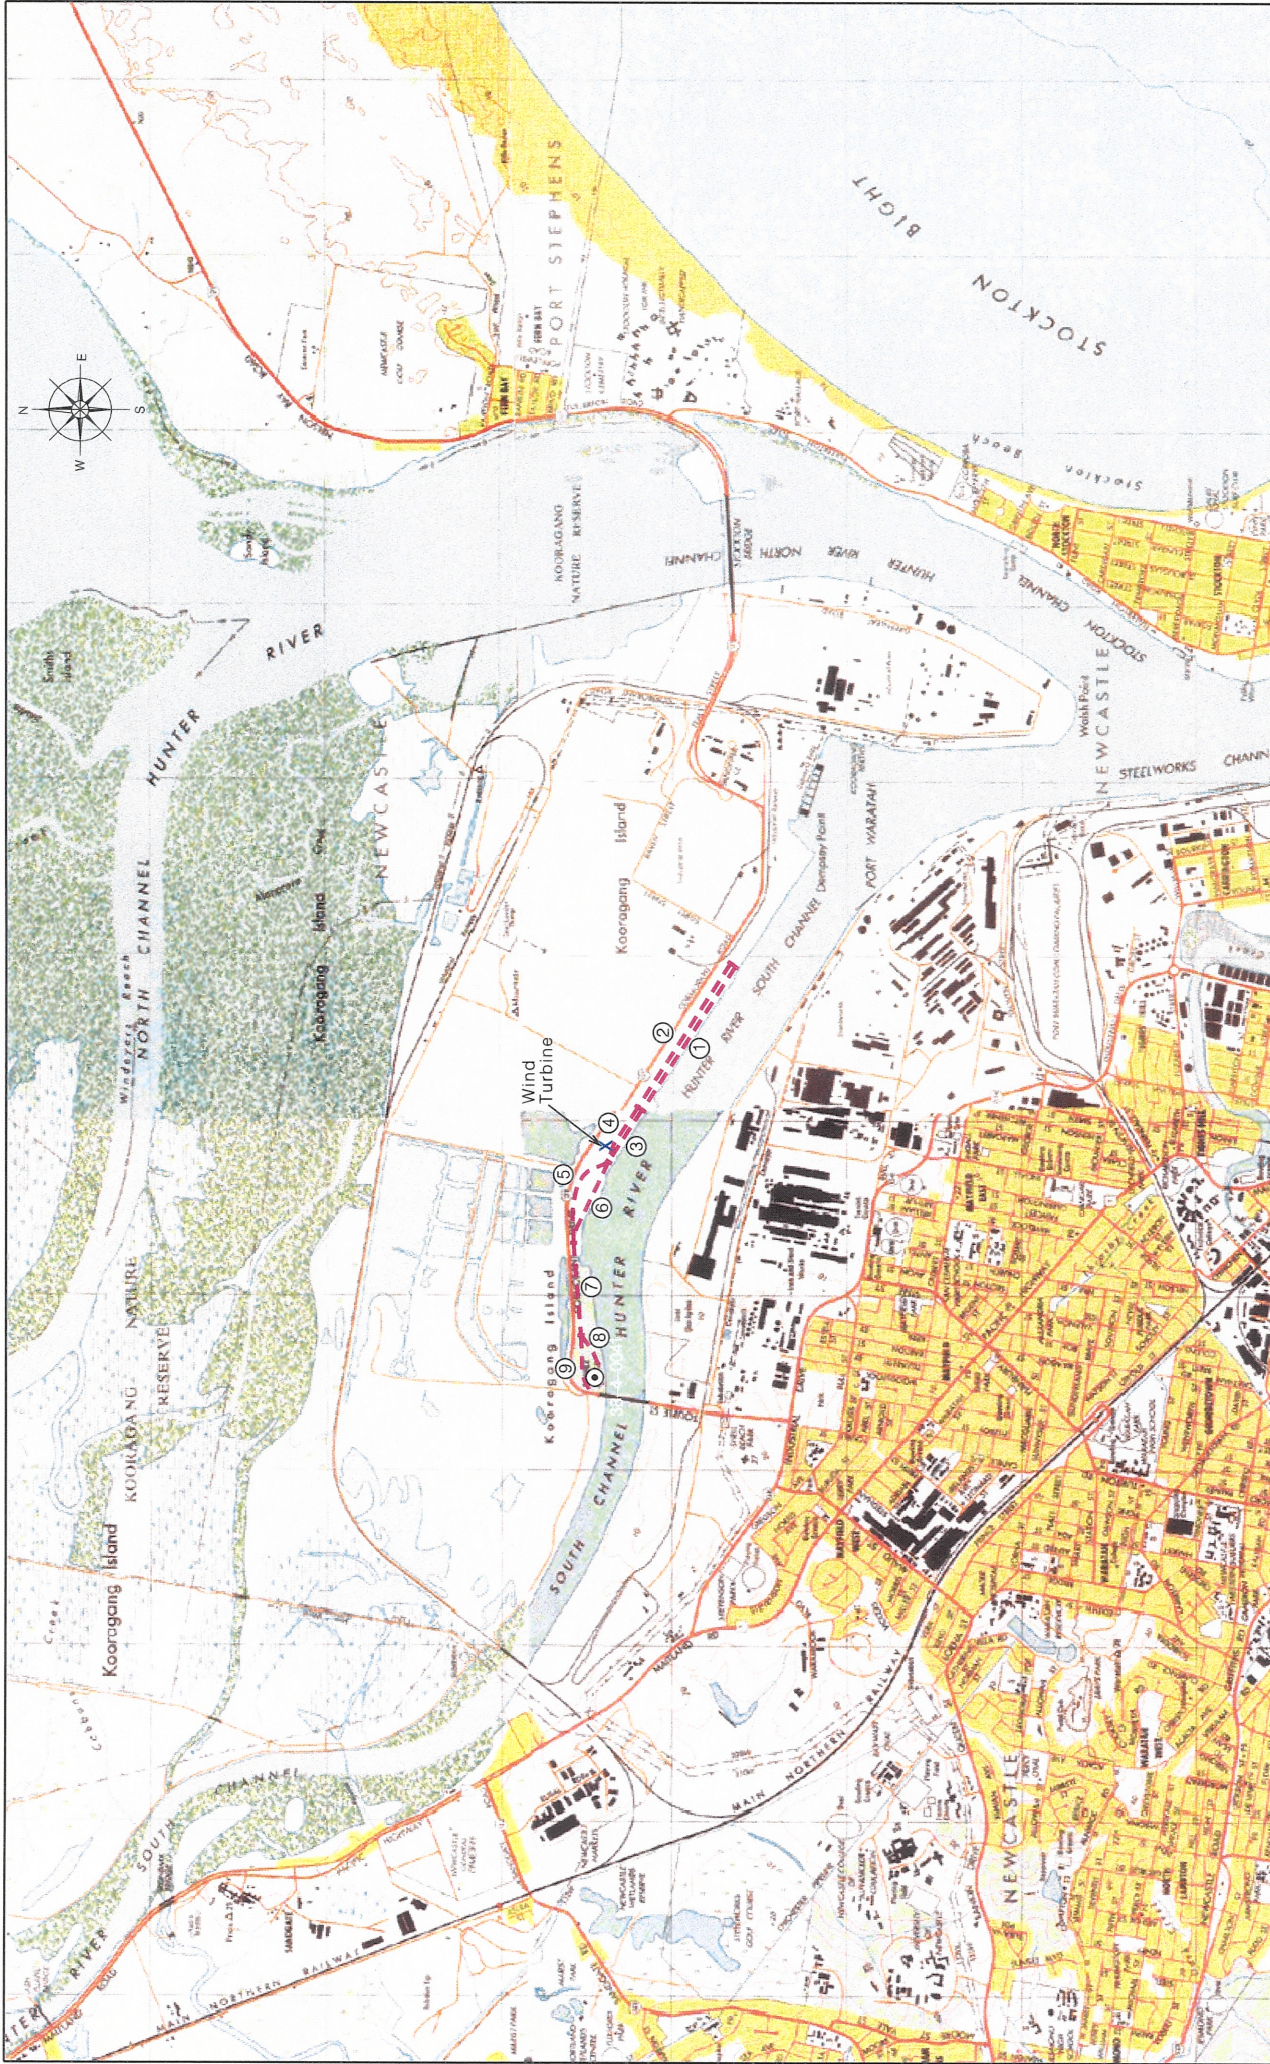
**FIGURE 5.1**  
Location of Transects

No Aboriginal heritage sites were located during the survey. This result was not unexpected due to the fact that a large proportion of the study area appears to consist of imported fill.

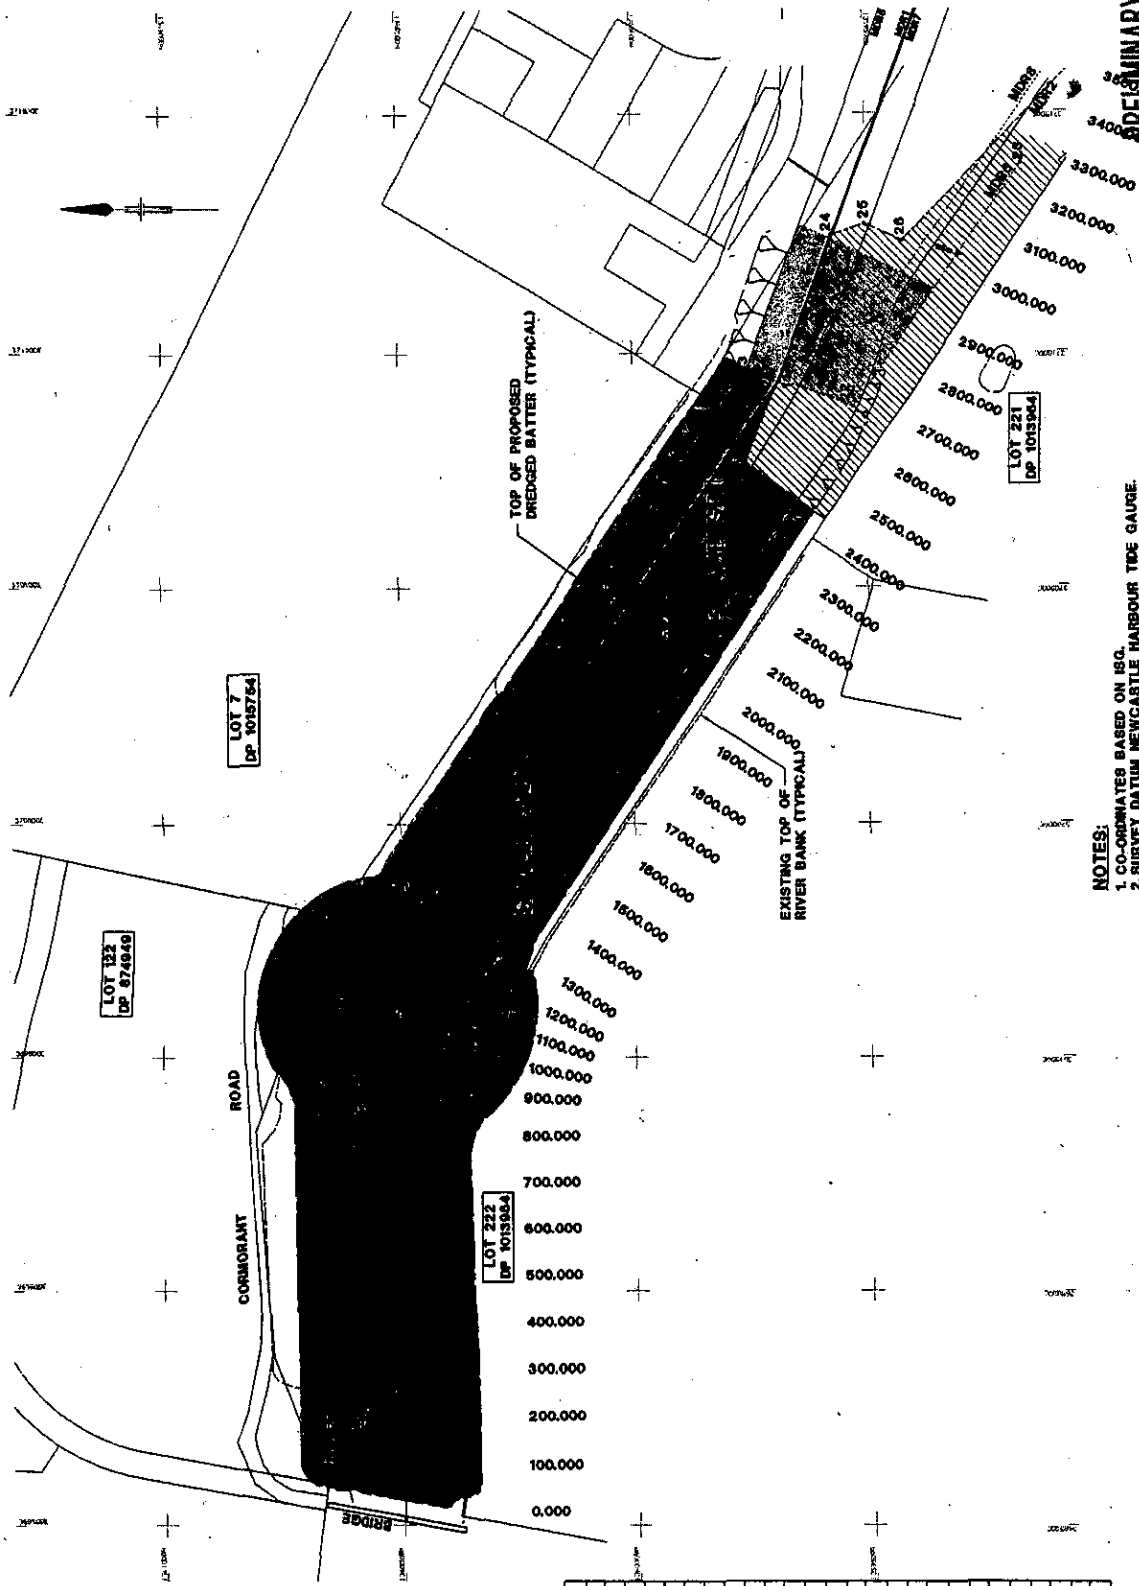
TOP OF BANK

POINT	EASTING	NORTHING
1	370938.051	1359684.774
2	370921.695	1359695.805
3	370969.350	1359751.866
4	369852.001	1360417.299
5	369863.446	1360498.718
6	369858.837	1360511.438
7	369415.965	1360677.583
8	369404.737	1360672.269
9	368643.693	1360660.720
10		
11		
12		
13	368596.365	1360415.106
14		
15	369376.275	136028.910
16	369366.488	1360597.782
17	369732.893	1360291.375
18		
19		
20		
21		
22	370083.673	1359527.679
23		
24	371241.739	1359572.889
25	371266.496	1359500.275
26	371230.843	1359220.411
27	371793.080	1358871.332

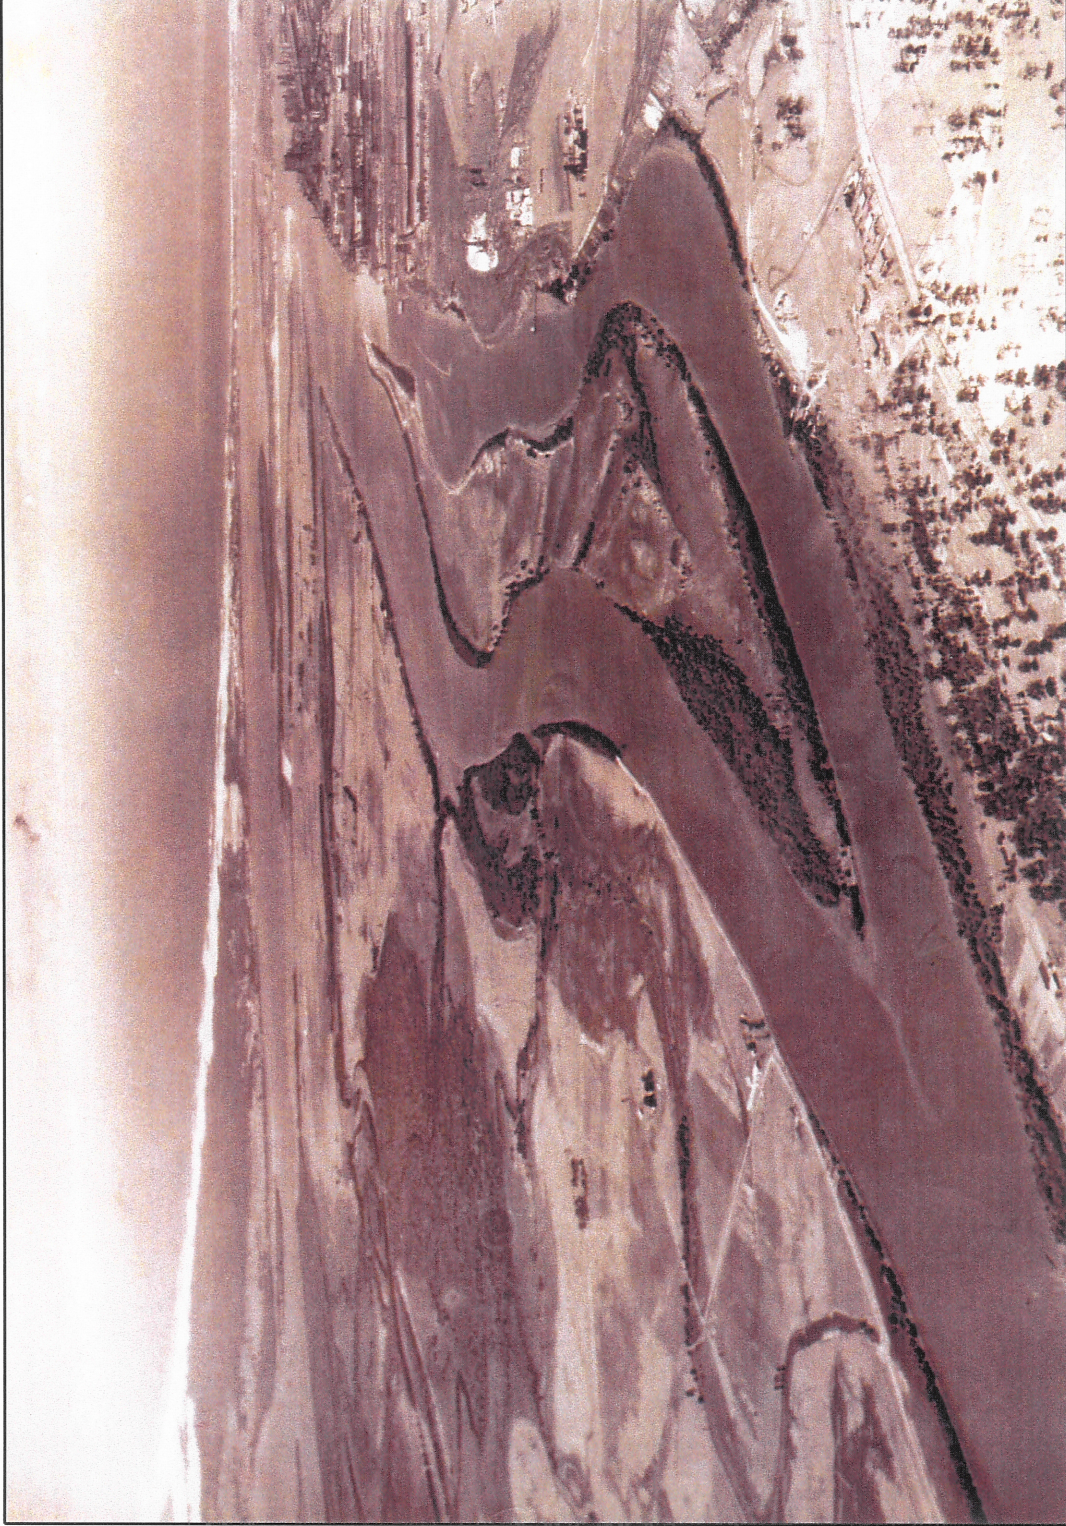
**FIGURE 3.4**  
Aerial Photo showing Ash, Dempsey  
Spit and Moscheto Islands

Oblique aerial photograph from west across the eastern end of Ash Island and across Spit, Dempsey and Moscheto Islands to Stockton Bight. The lack of development and signs of former development are demonstrated.

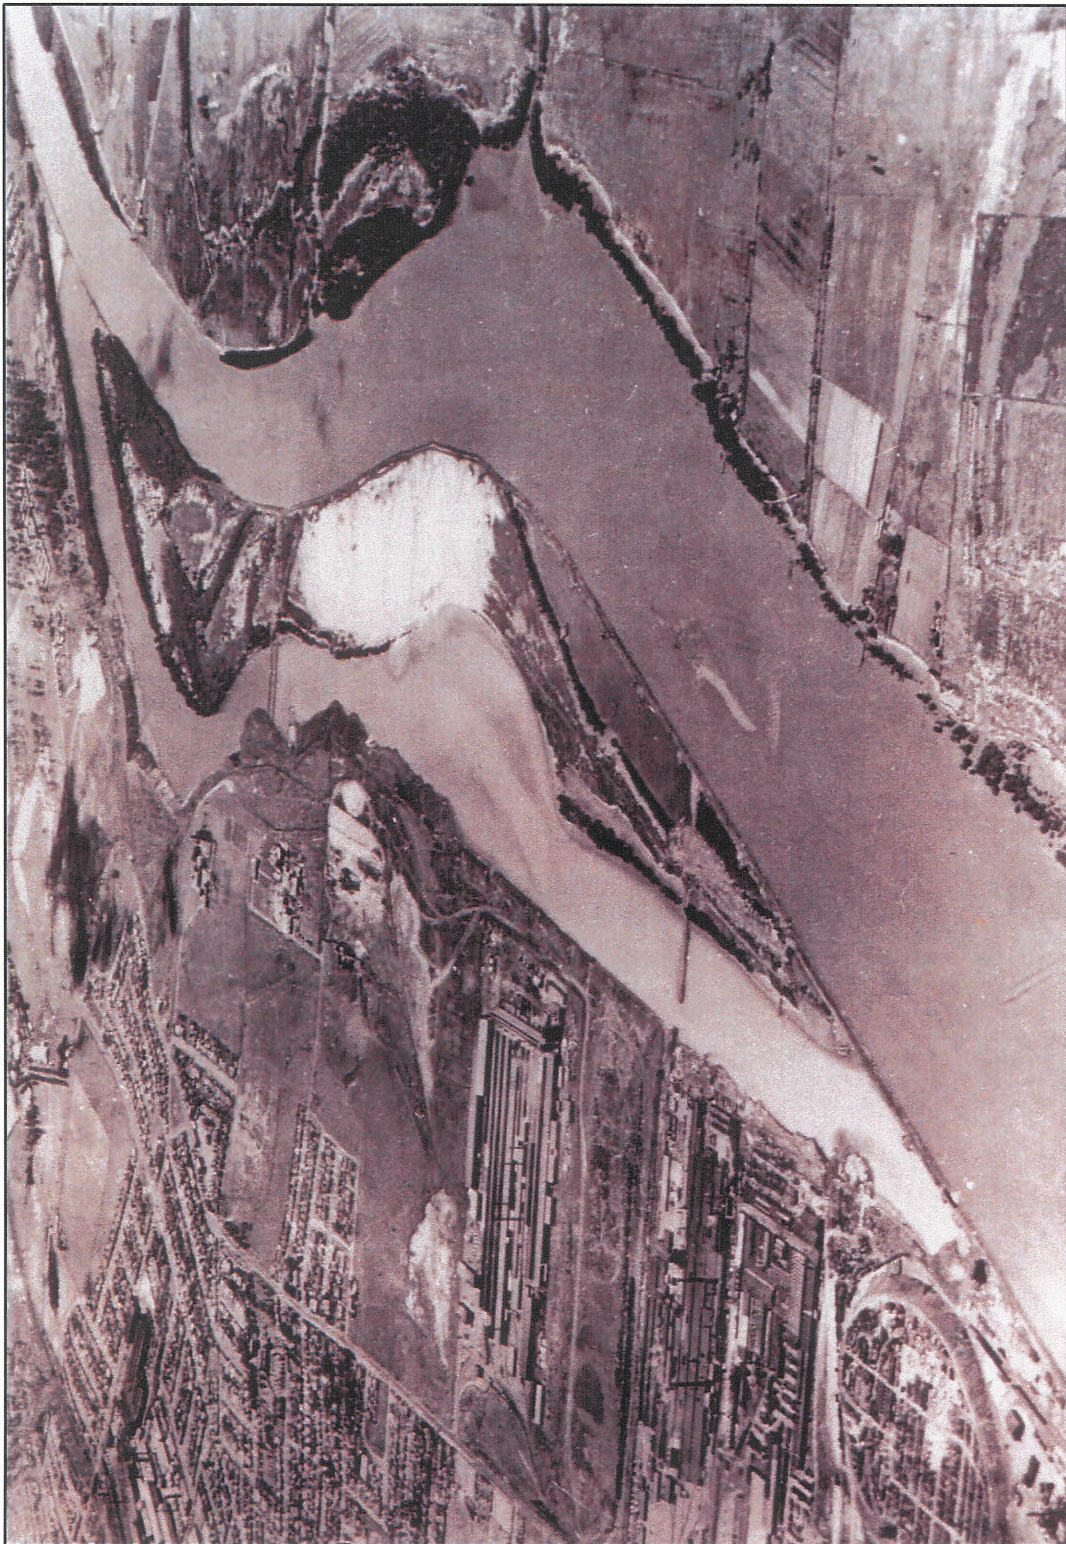
**FIGURE 3.5**

The impending Platts Channel and the reclamation area north of Spit Island can be seen – Dated 1950

Aerial looking west from a point adjacent to the BHP Newcastle Steelworks

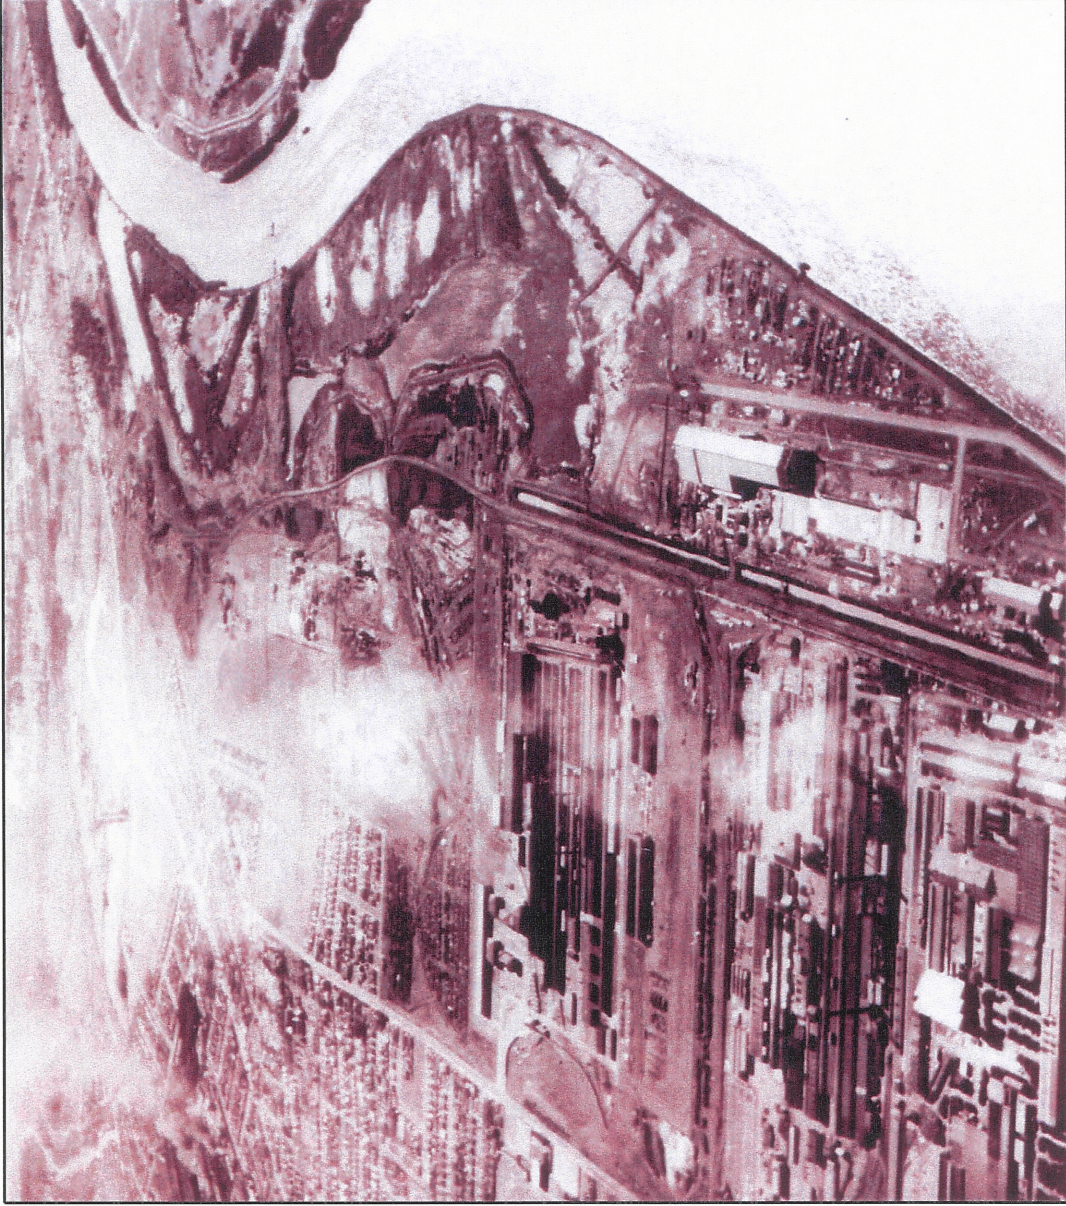
**FIGURE 3.6**  
Aerial looking west across Steelworks  
and Reclamation Area

In this view, comparable to Figure 3.5, the river frontage has been reclaimed and the reclamation of Platts Channel works complete. One substantial building stands on reclaimed land - Dated 1961

During the period 1950-2000 the only other substantial building that appears to have been erected upon reclaimed land in proximity to the study area is the No.2 Bar Mill located due west of the Rod Mill, which can be clearly identified in **Figure 3.6**.

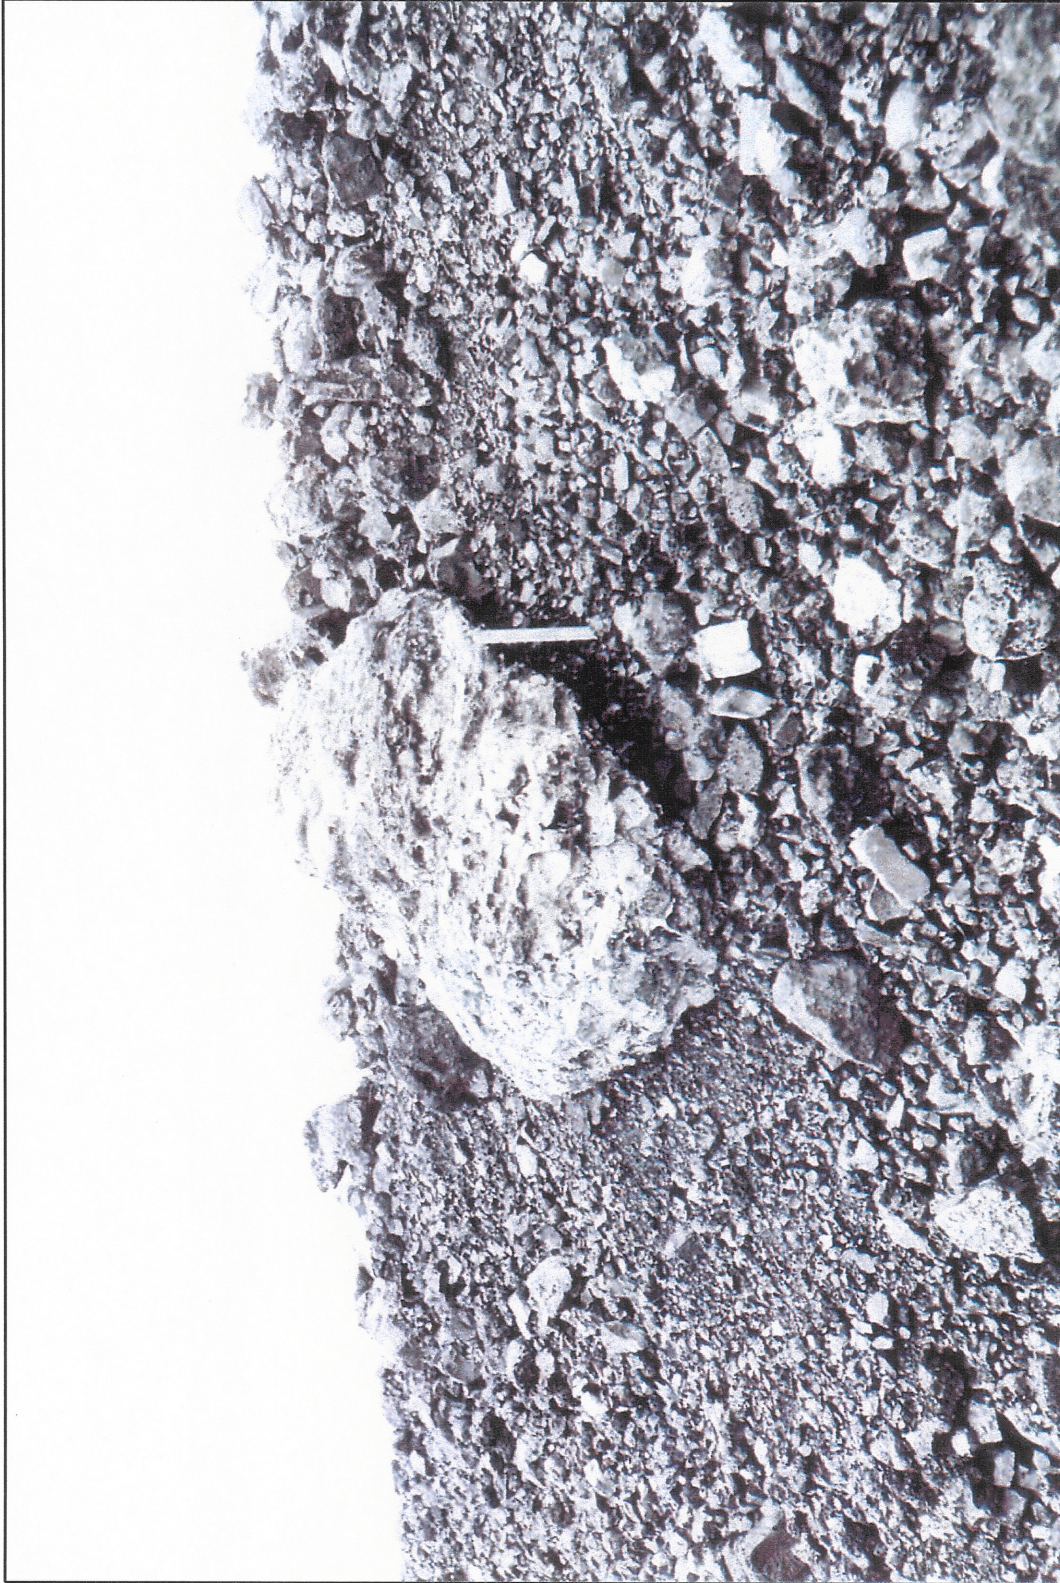
**FIGURE 3.7**

Coarse steelmaking material (slag and skulls).  
The marker beside the large boulder is a 1-foot ruler. Dated 5/12/62.

As an illustration of the size and composition of fill material used in the reclamation, **Figure 3.7** comprises a photograph taken on 5 December 1962. The photograph depicts fill of steelworks slag and includes one large boulder. Based on the one foot marker placed beside the boulder, it is estimated that this boulder was over two metres in length and one metre in width, probably between 600 and 750 ml thick.

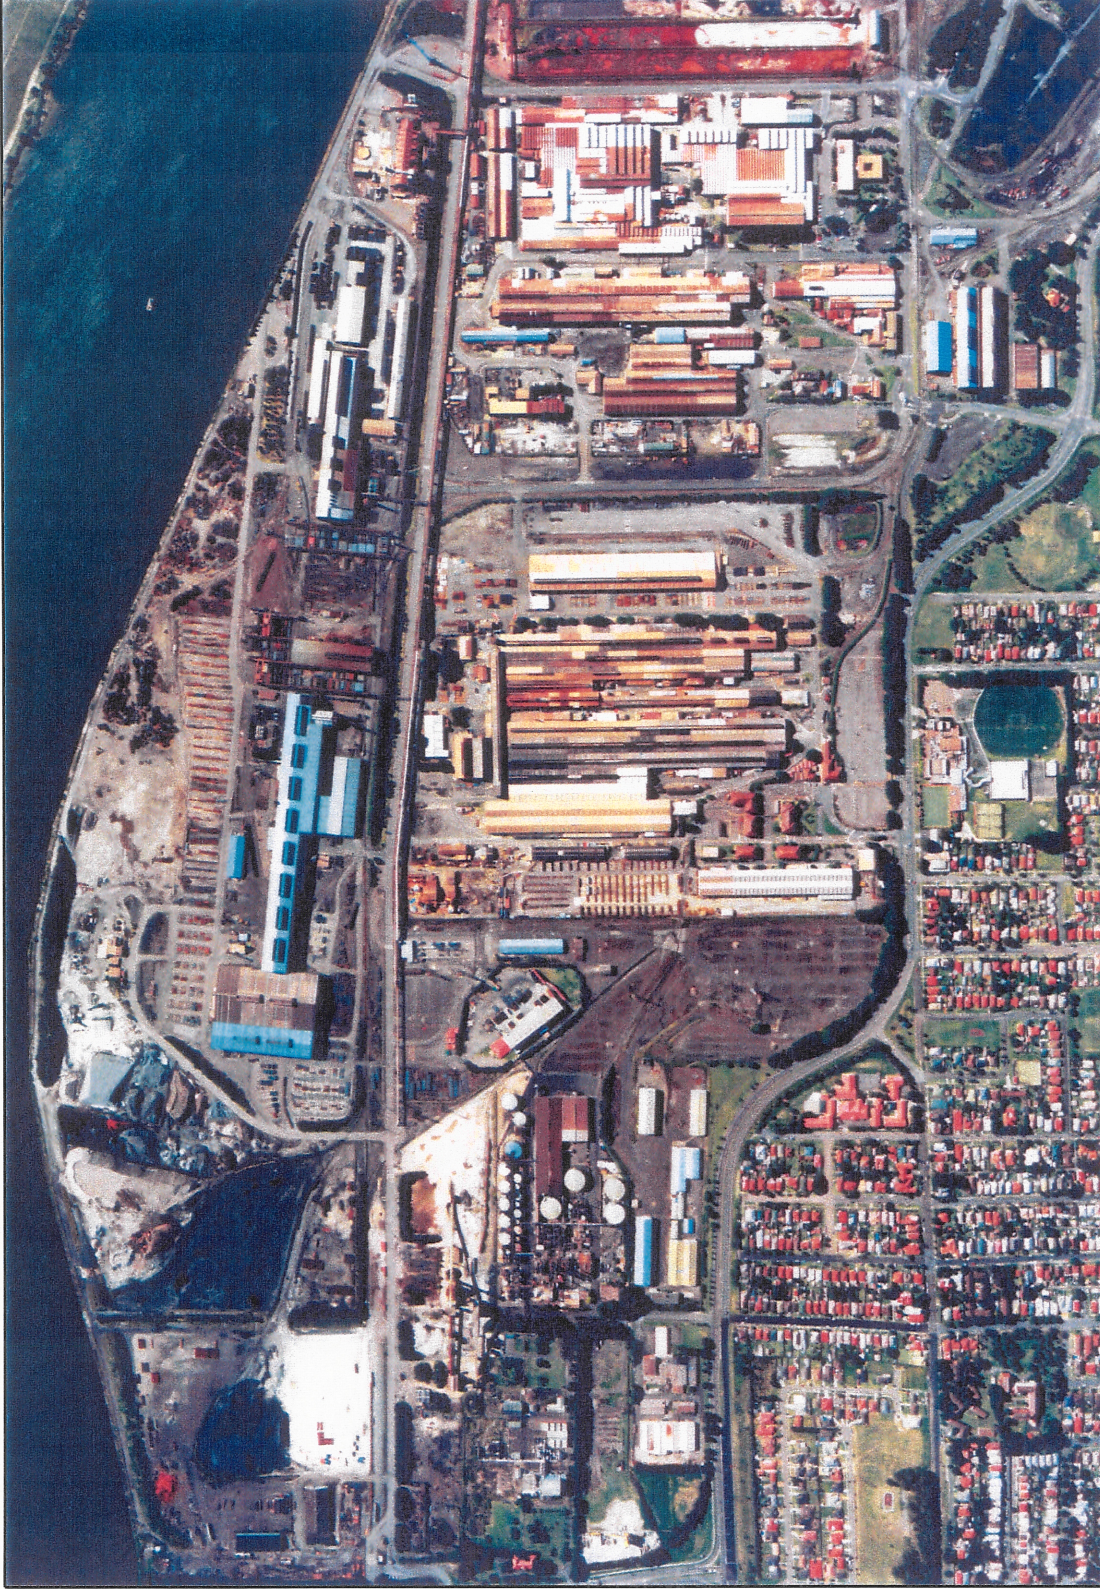
**FIGURE 3.8**  
Concurrent aerial view of the southern part of the Study Area

The Rod Mill building can be identified and, west of that building, the No.2 Bar Mill

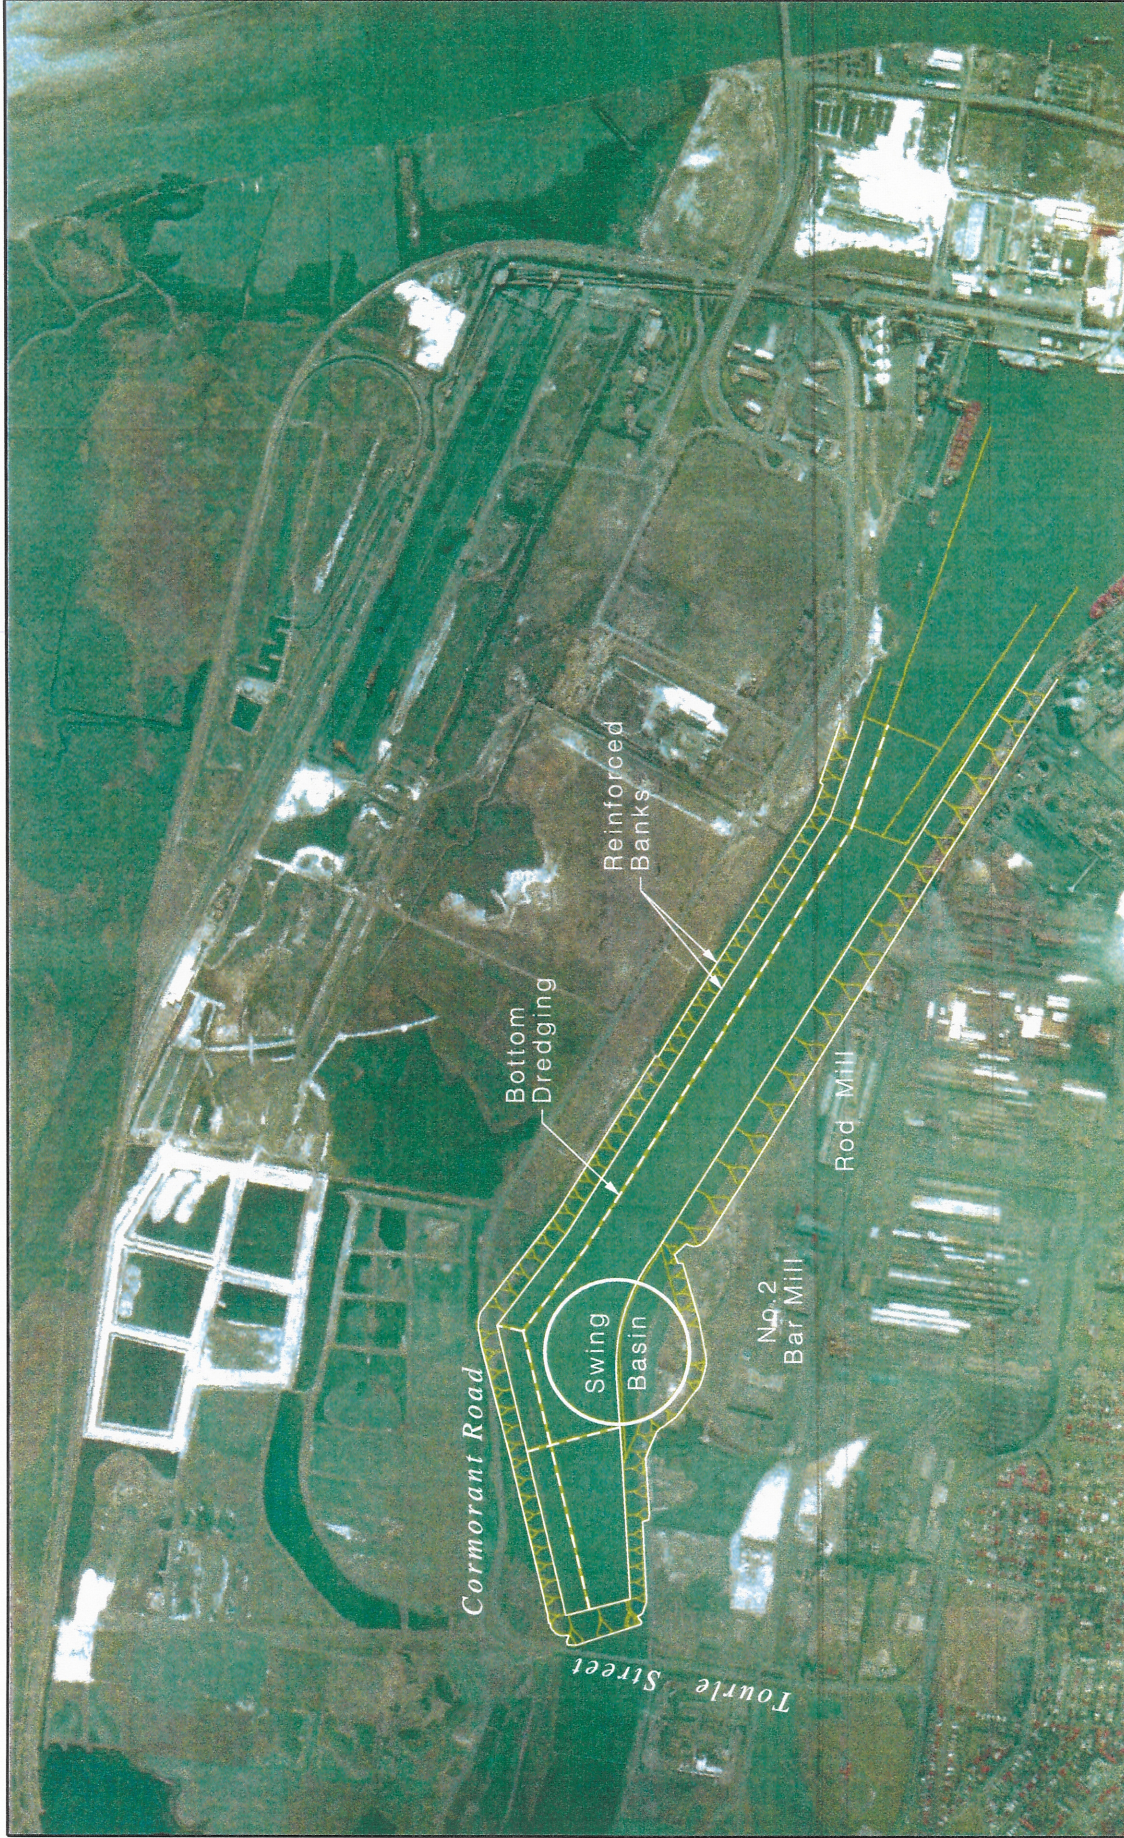
**FIGURE 5.1**  
Schematic representation of  
Development Impact Area

- the allocation on the bank(s) of the South Arm of an area for the establishment, assembly and management of dredging equipment and the provision of surface facilities;
- the extraction of material from the river bottom by a variety of methods including suction, cutter-suction and land based excavation. It is not intended that excavation of the river bottom include substantial damage to banks other than in the area of the swing basin;
- the excavation by conventional excavation plant of reclamation fill, and the underlying natural sediment formerly comprising the surface and substrate of Spit Island, to a level consistent with adjacent dredging methodology;
- establishment of a temporary stockpile of spoil within the BHP Closure Area, at a location that has been previously investigated for heritage values and which has been subsequently cleared;
