Dixon Sand Pty Ltd

Haerses Road Quarry, Maroota

Annual Review

2020 – 2021

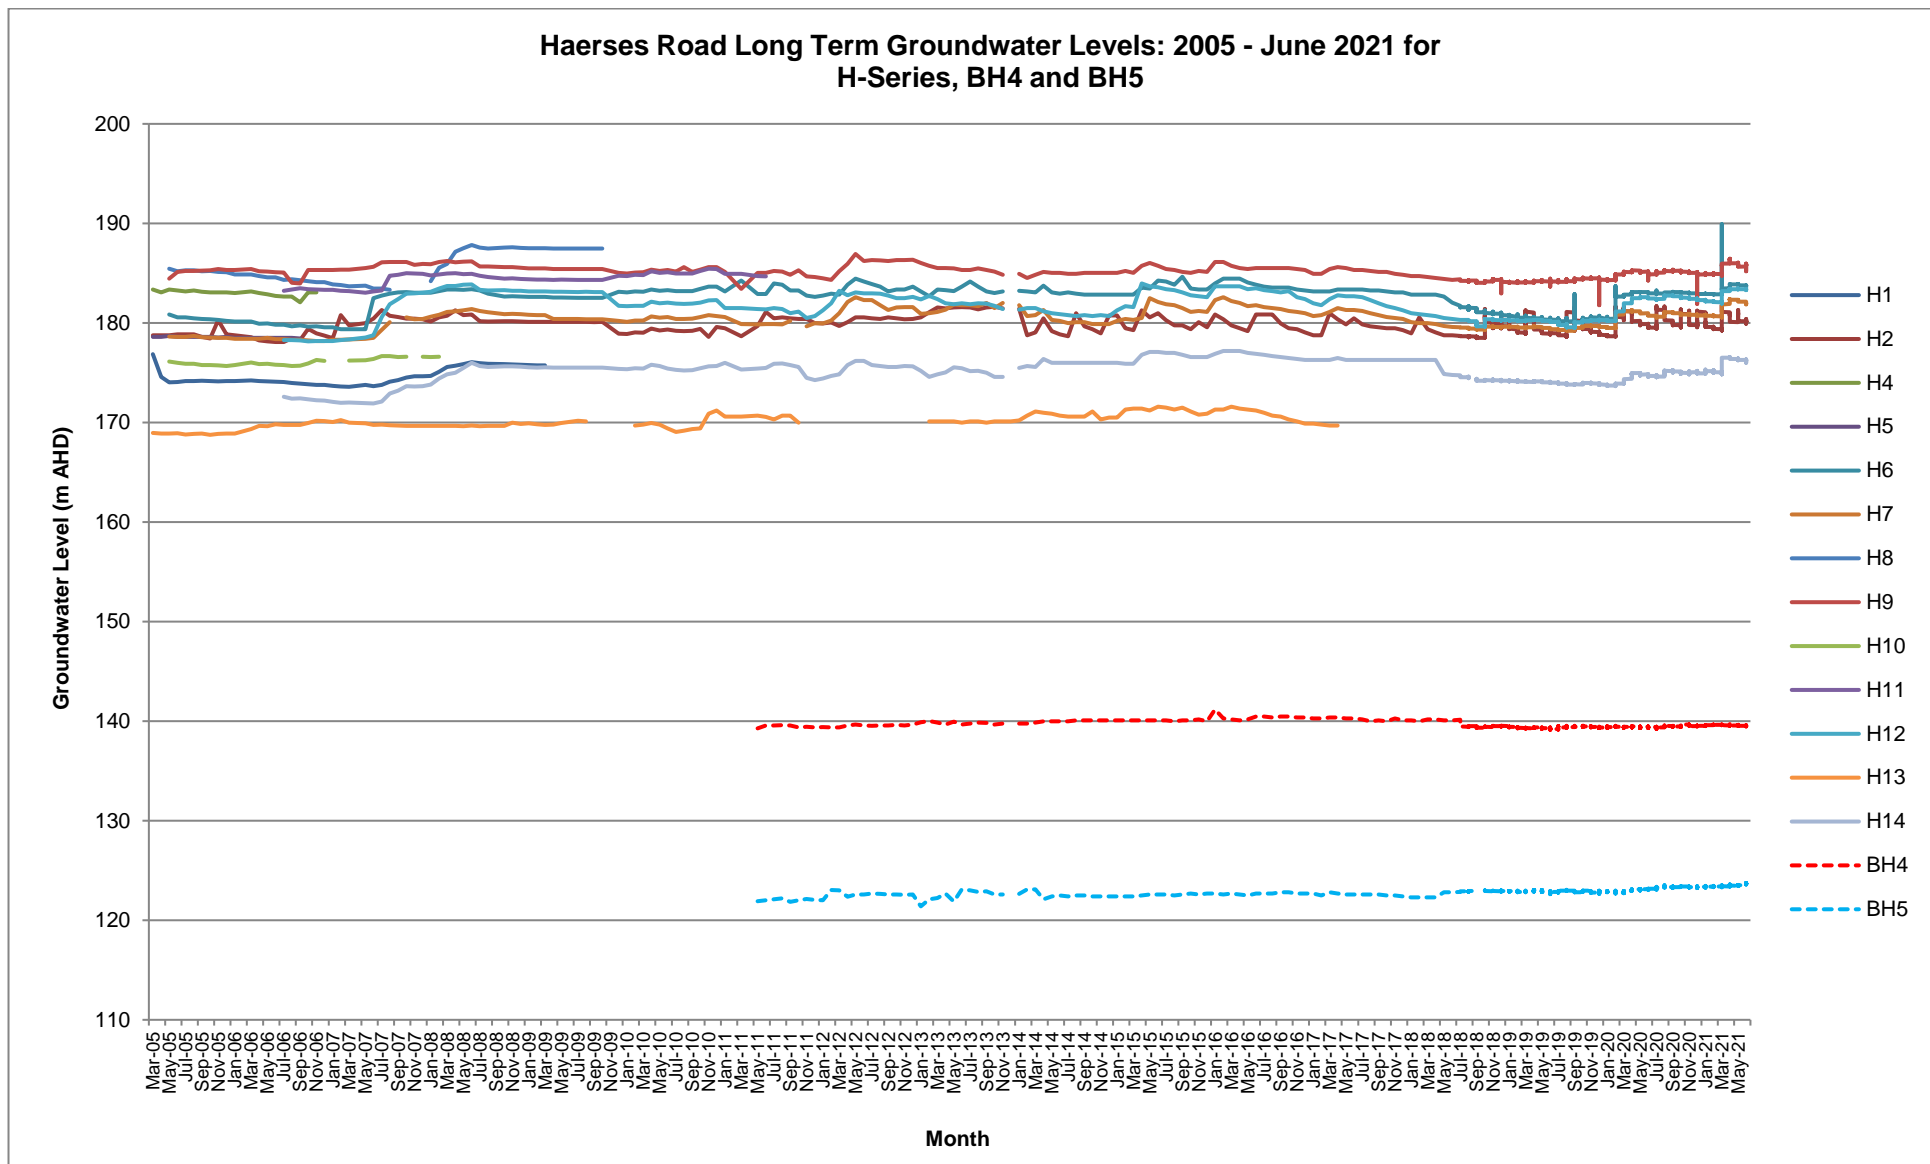
Chart 19: Haerses Road Long Term Groundwater Levels for H-Series, BH4 and BH5.

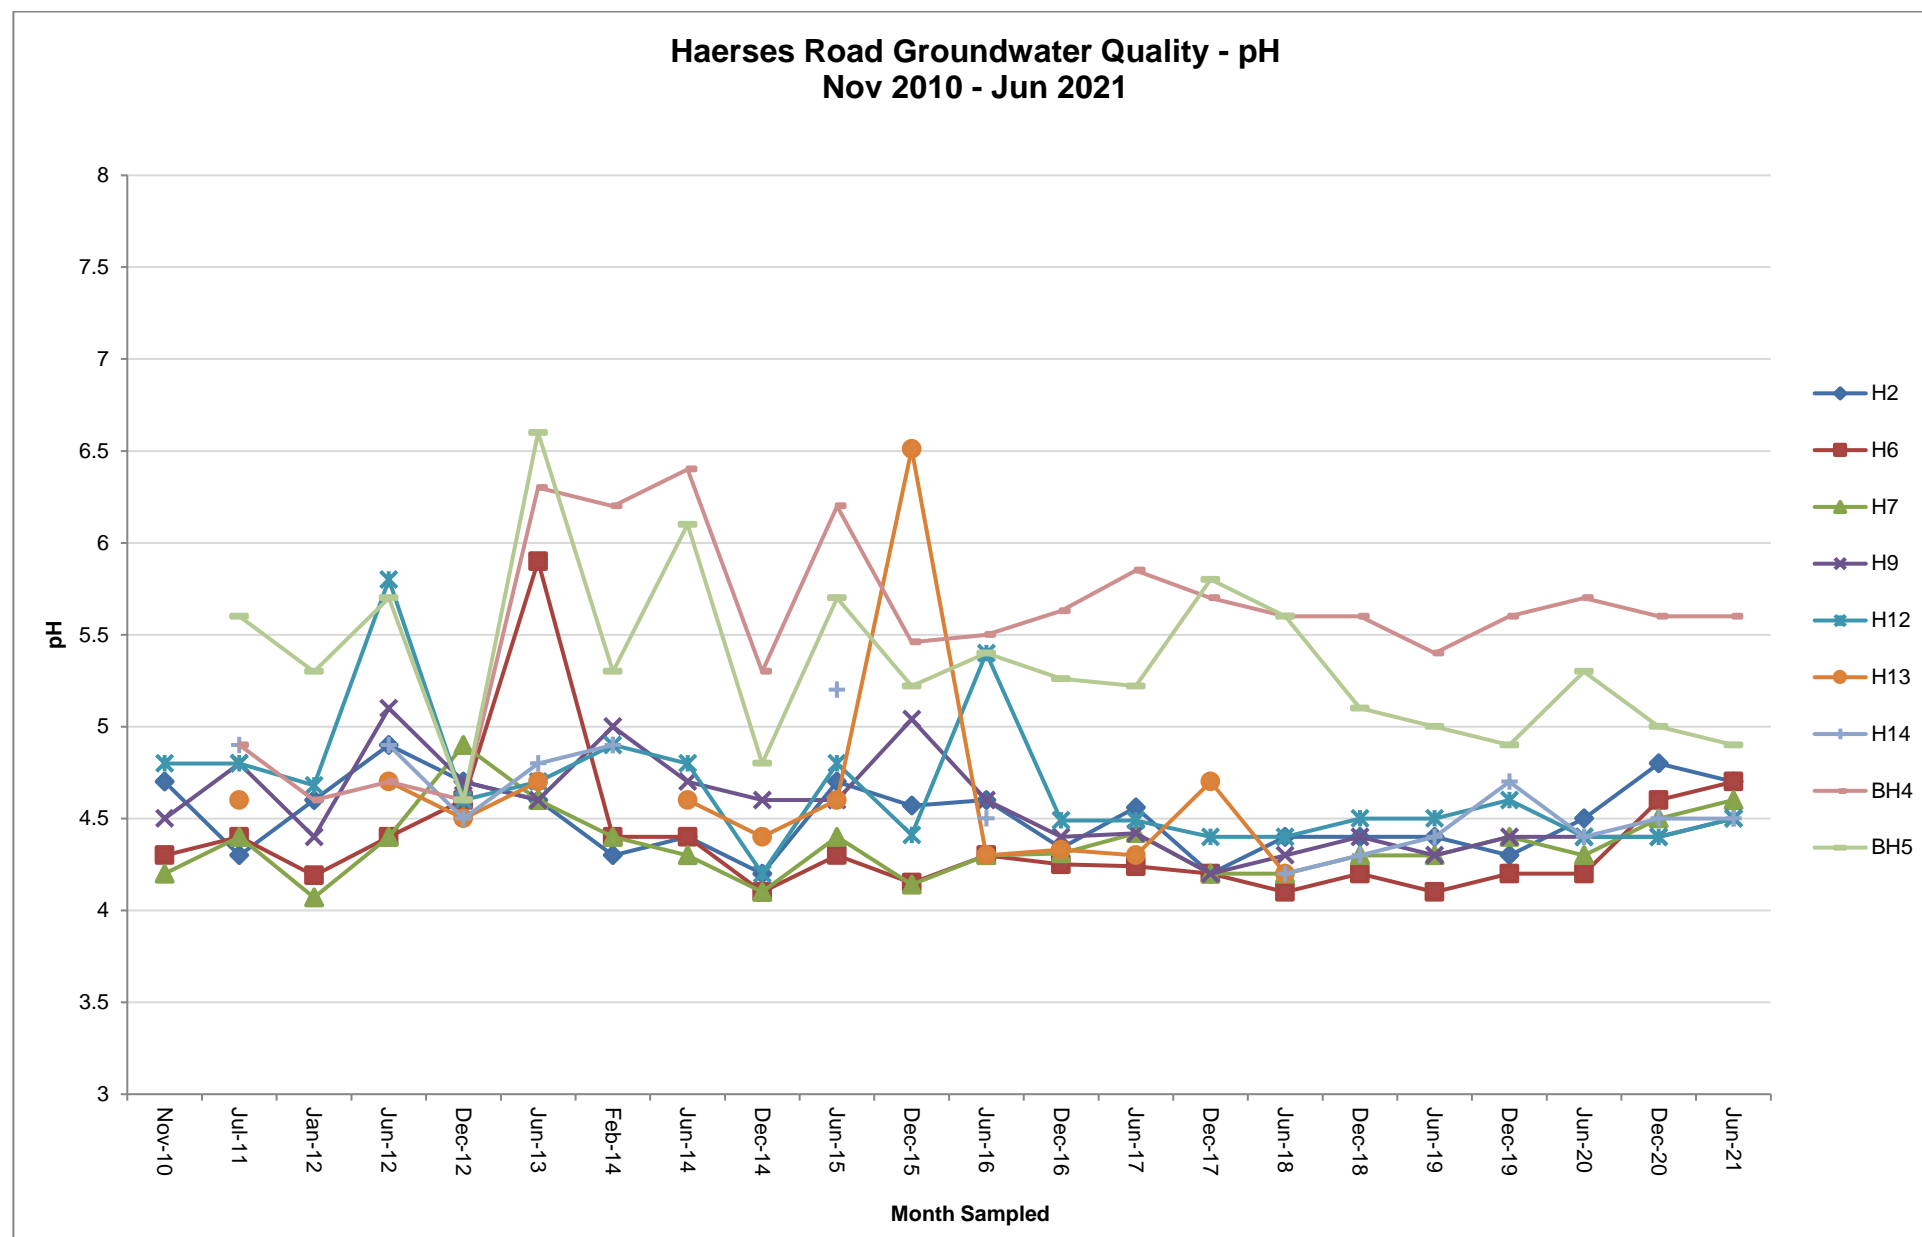
Chart 41: Haerses Road Long Term pH – H series, BH4 and BH5

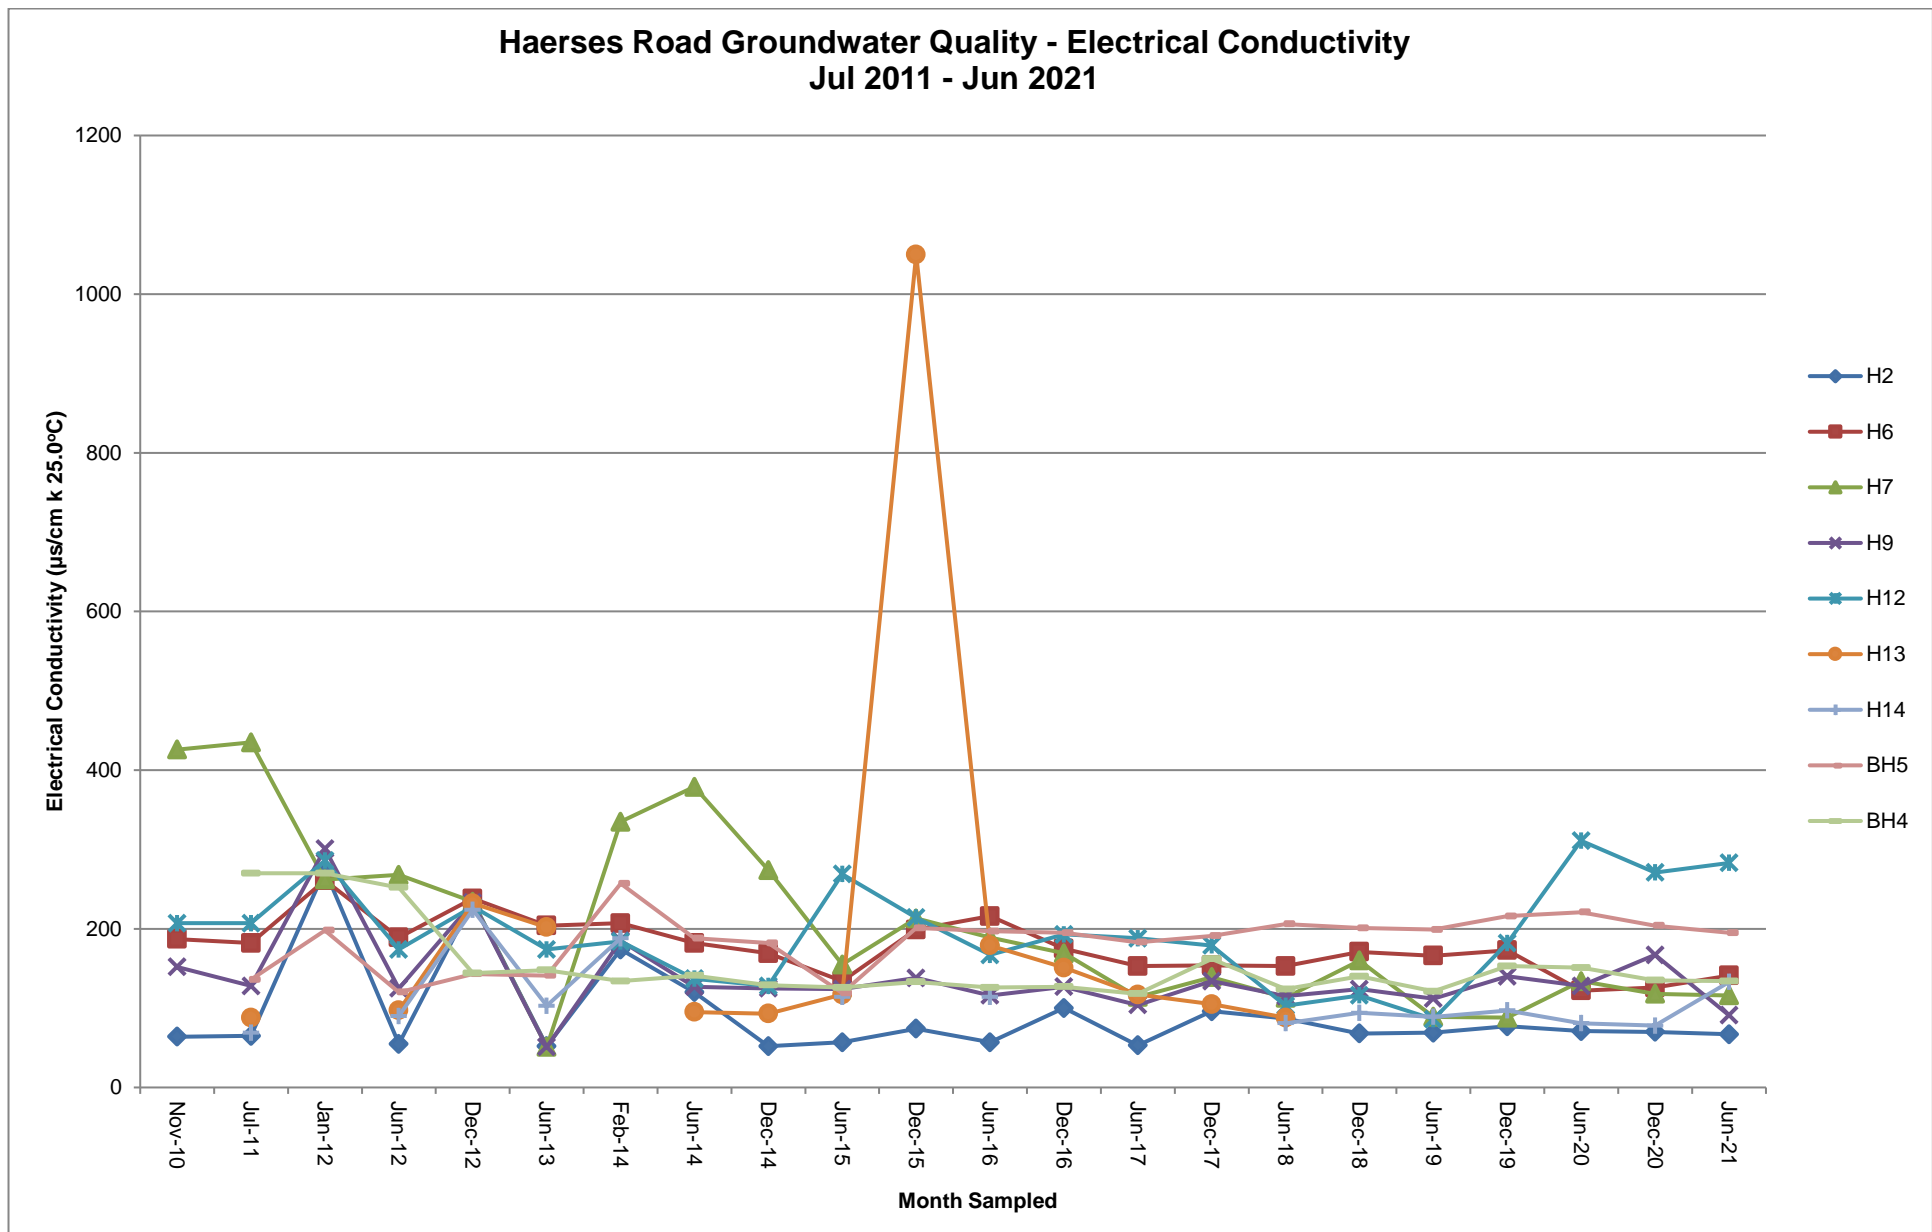
Chart 55: Haerses Road Long Term Electrical Conductivity – H series, BH4 and BH5

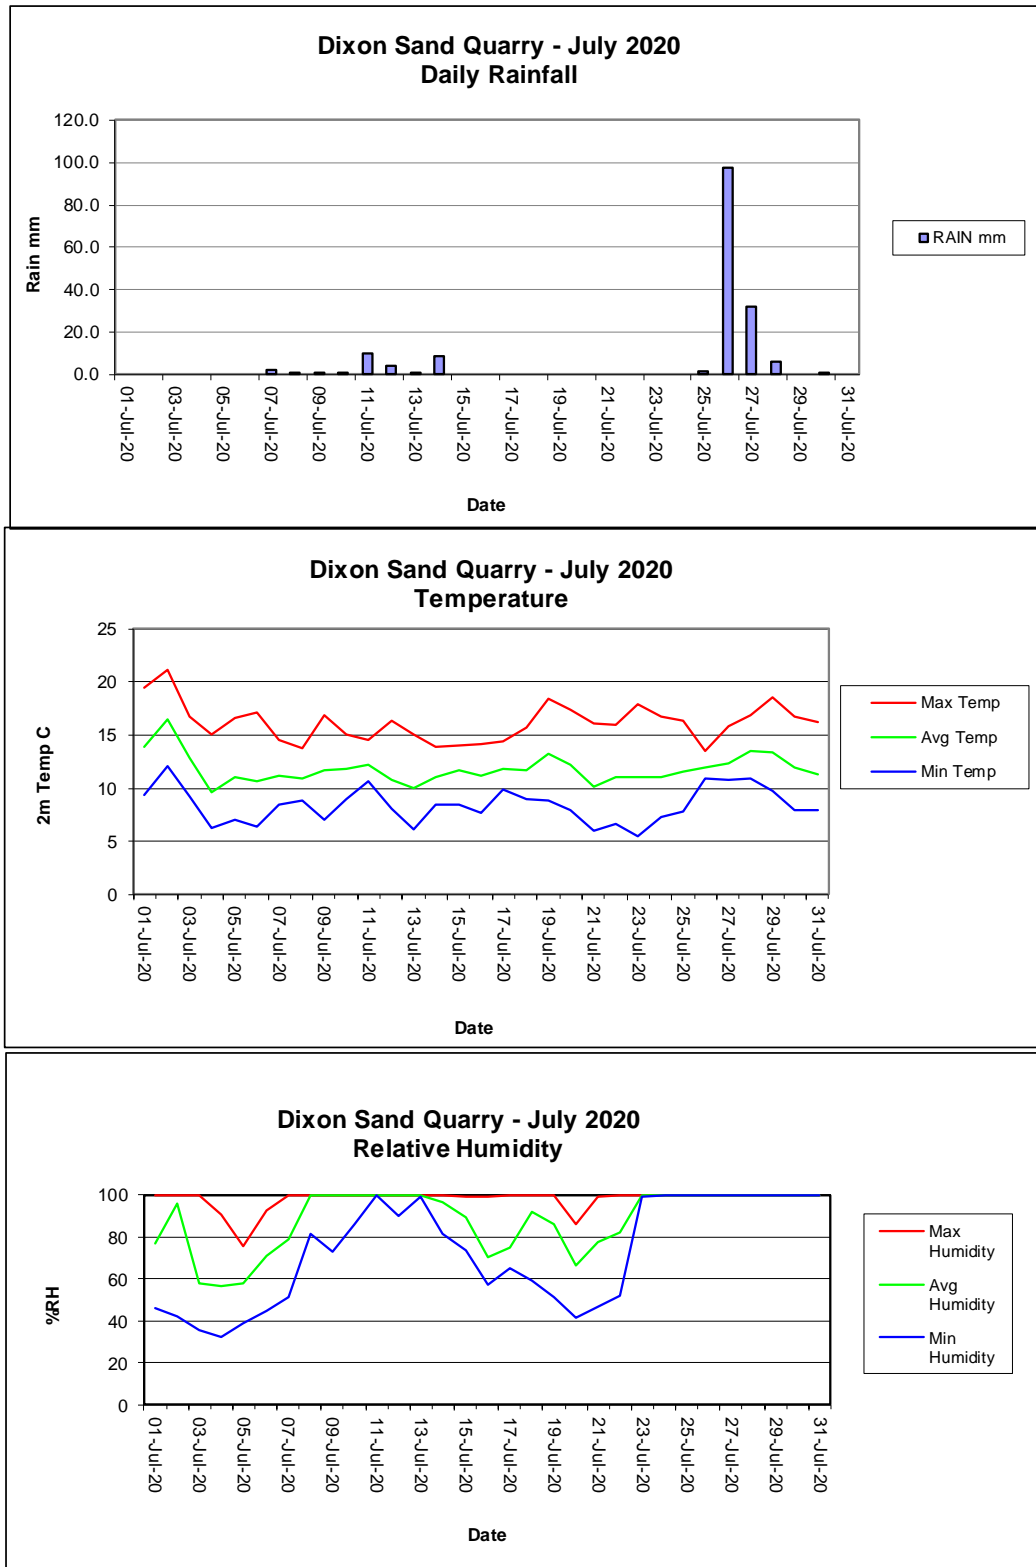
Figure 2: Daily Rainfall, Temperature and Relative Humidity Charts

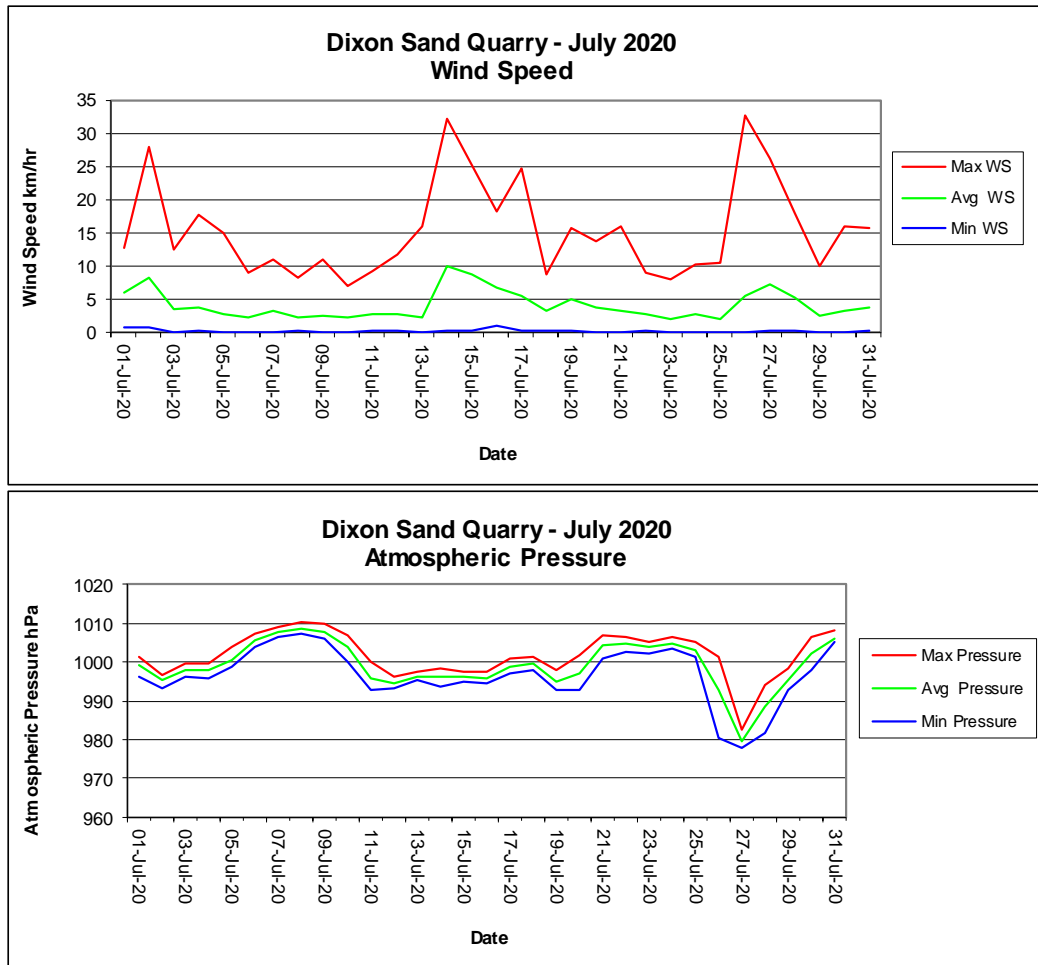
Figure 3: Wind Speed and Atmospheric Pressure Charts

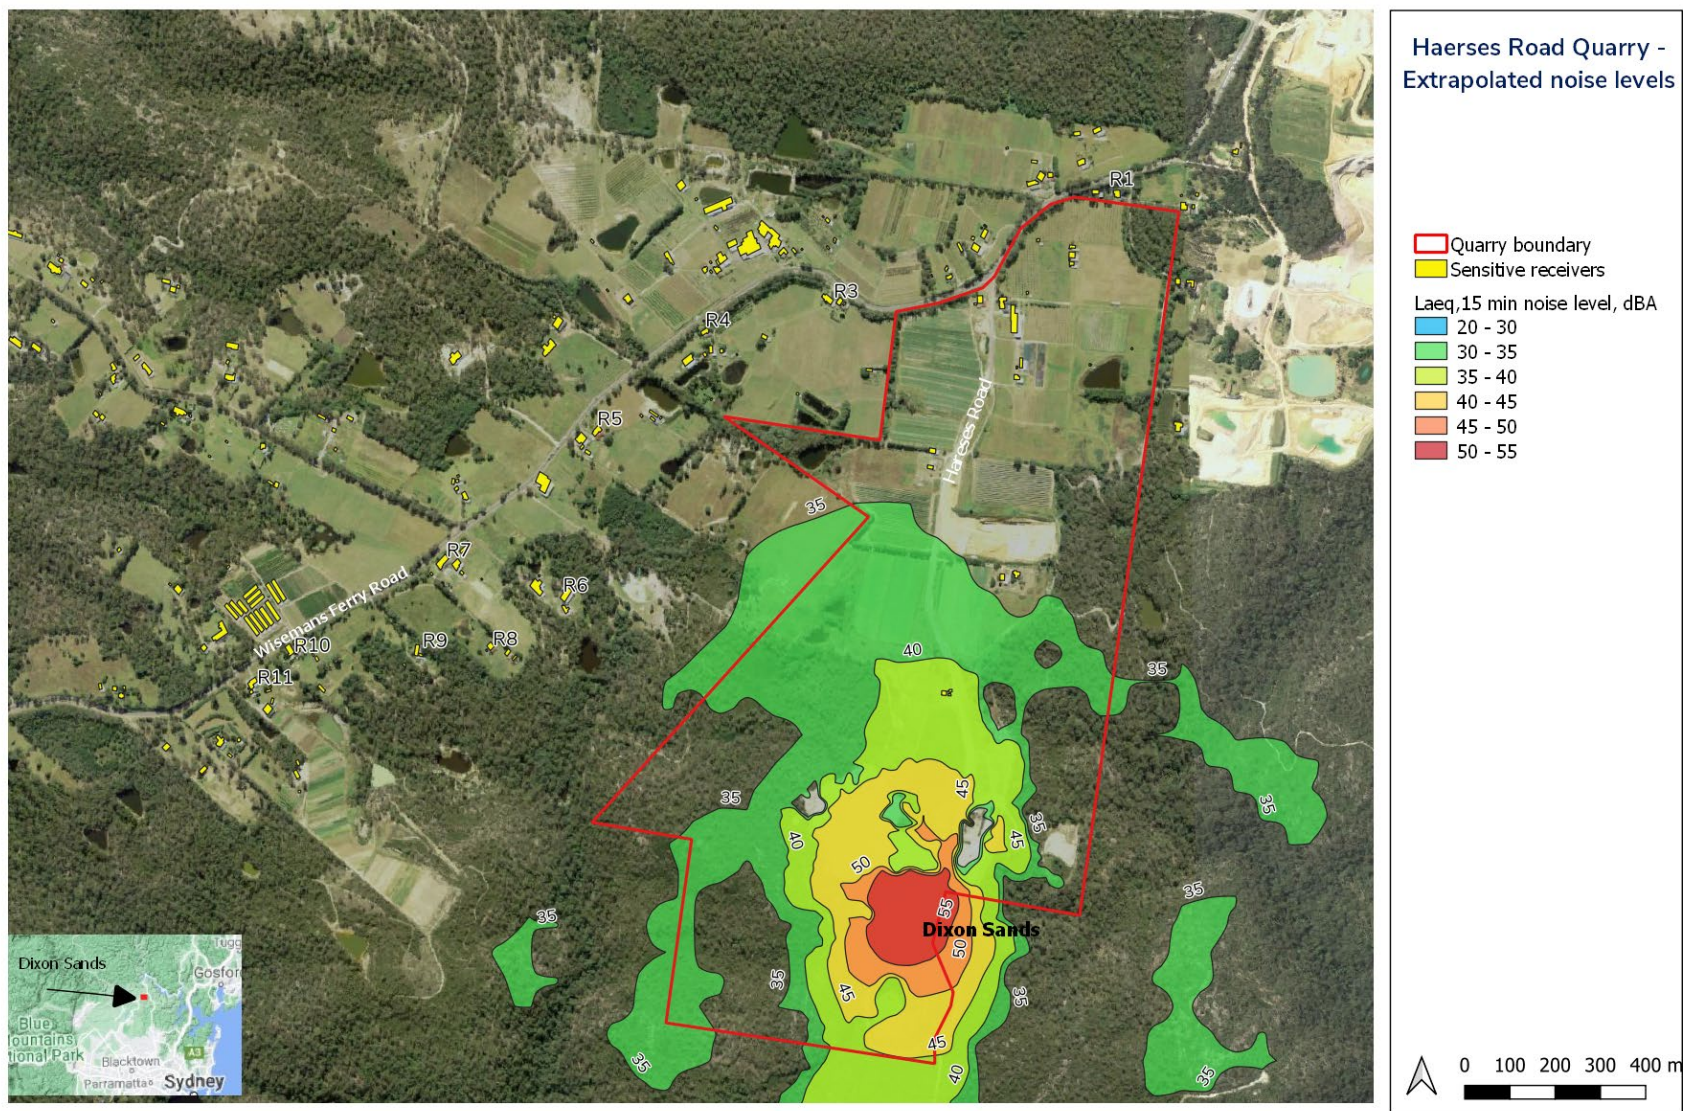
Figure 2 Extrapolated noise levels from Haerses Road quarry based on on-site measurements.

Results of attended monitoring and extrapolated noise levels demonstrate observed operations during shoulder and day periods were compliant with the noise criteria at each receiver under the meteorological conditions at the time.

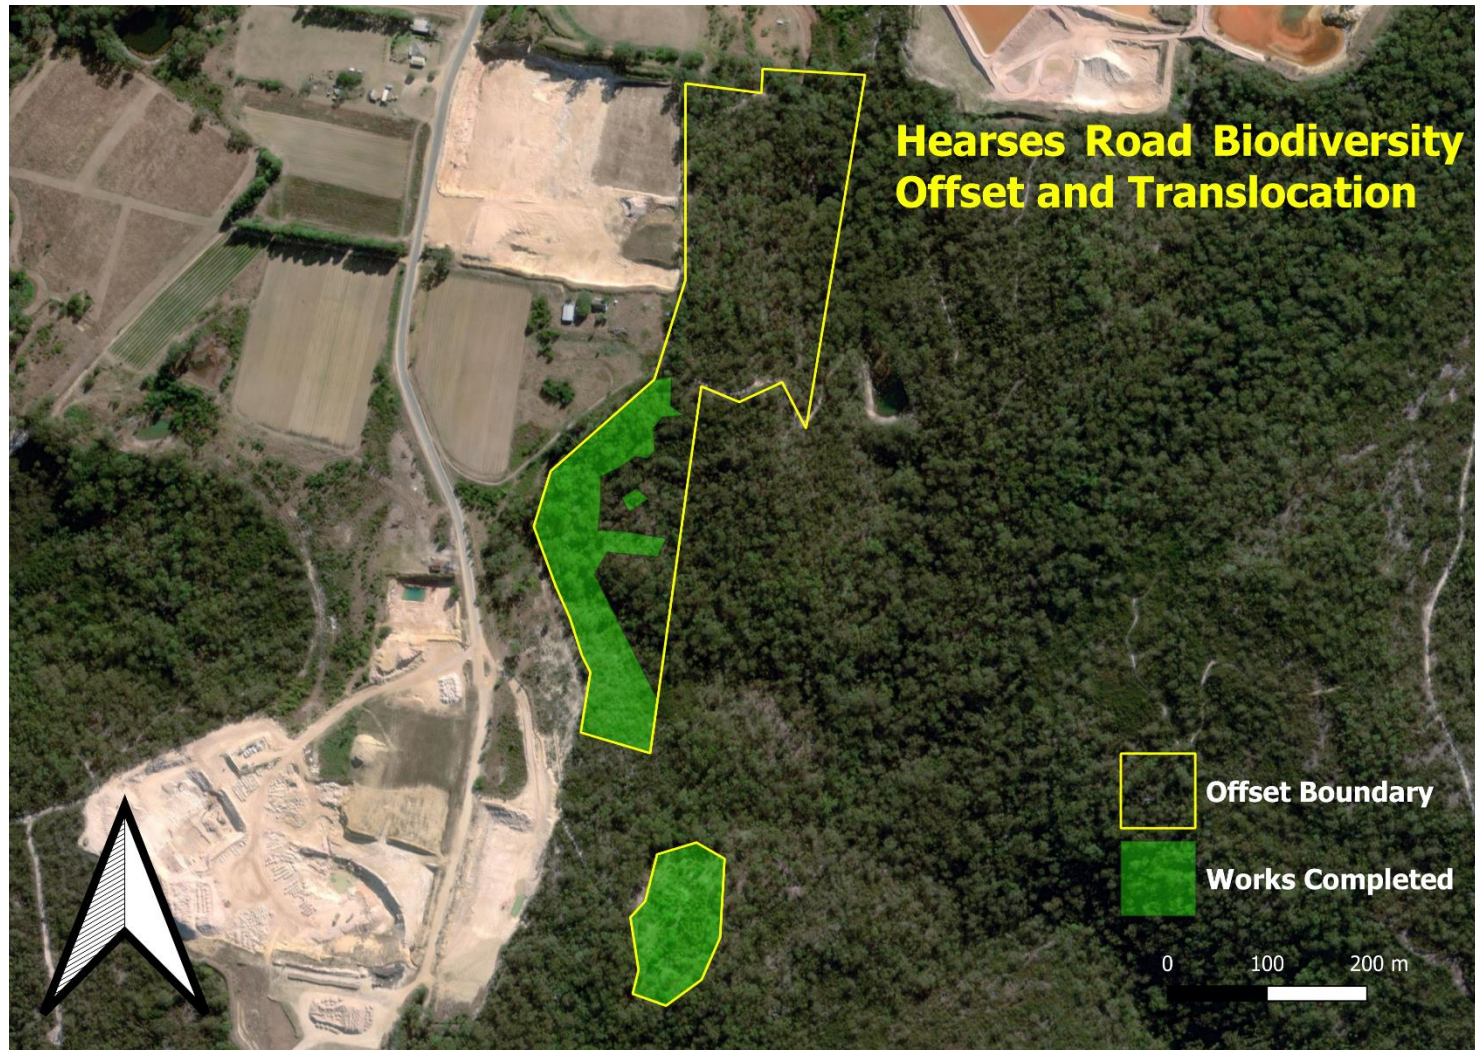
Figure 1 – Aerial photo illustrating the areas worked and overall biodiversity offset boundary

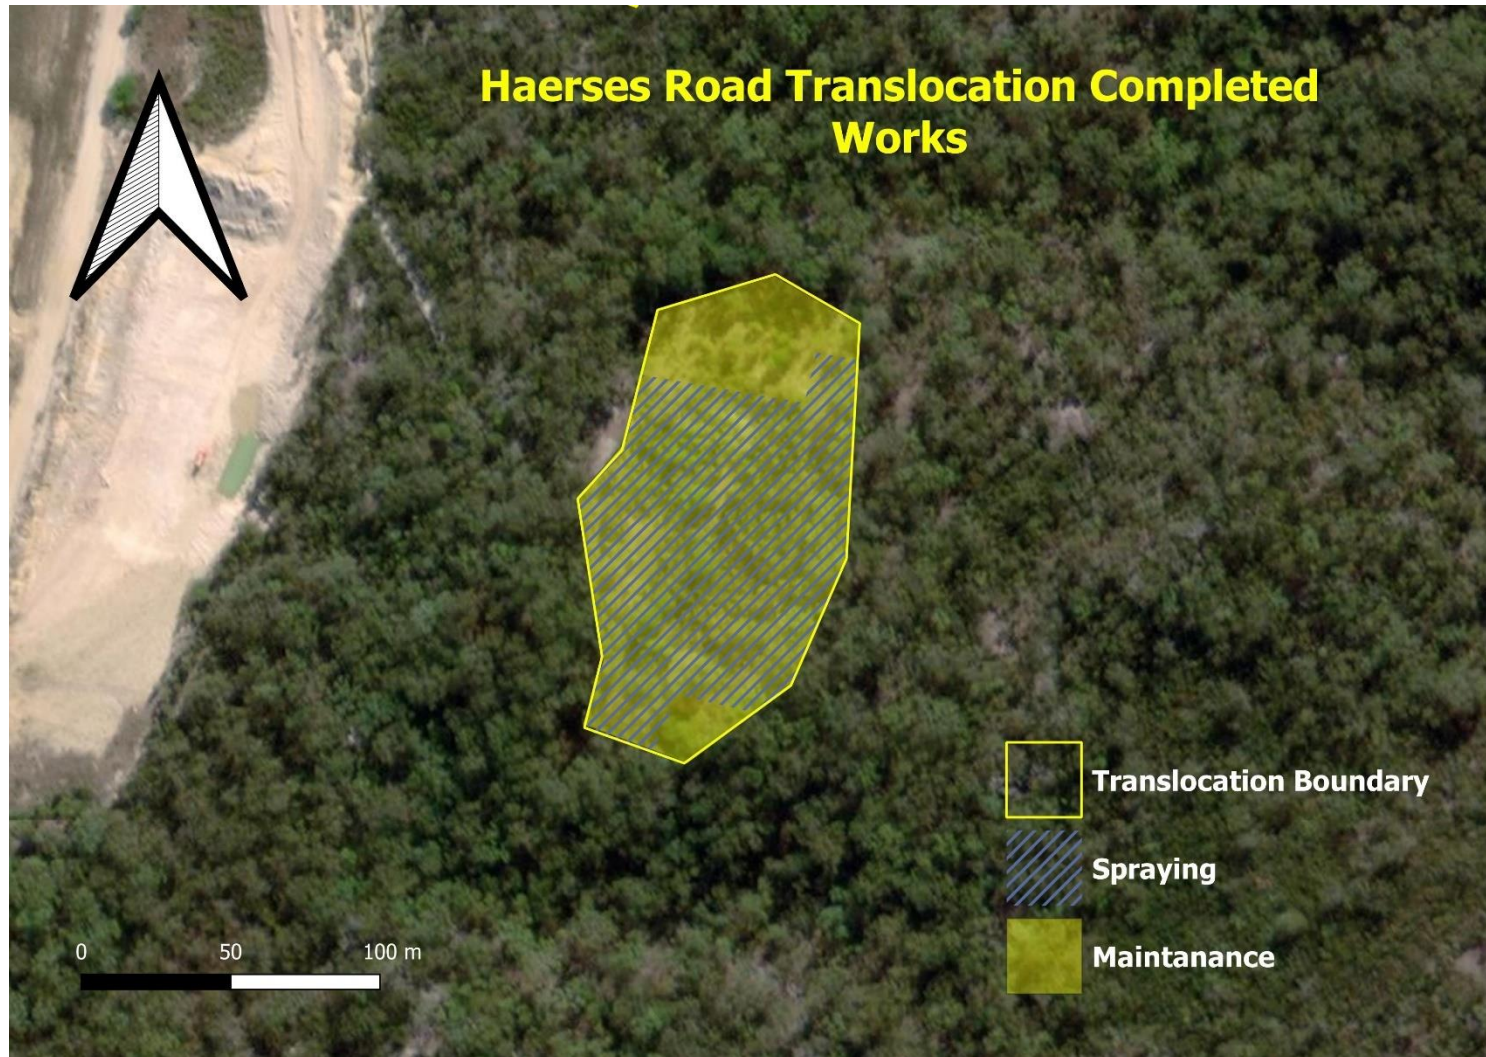
Figure 2 – Aerial overview of specific works undertaken in the translocation area.
