**Erection of 5 Temporary and 8 Permanent Wind Monitoring Guyed Masts at  
Taralga Wind Farm  
Due Diligence Assessment**

**Date:** 18 October 2013

**Proponent:** Geolyse, on behalf of Taralga Wind Farm Pty Ltd

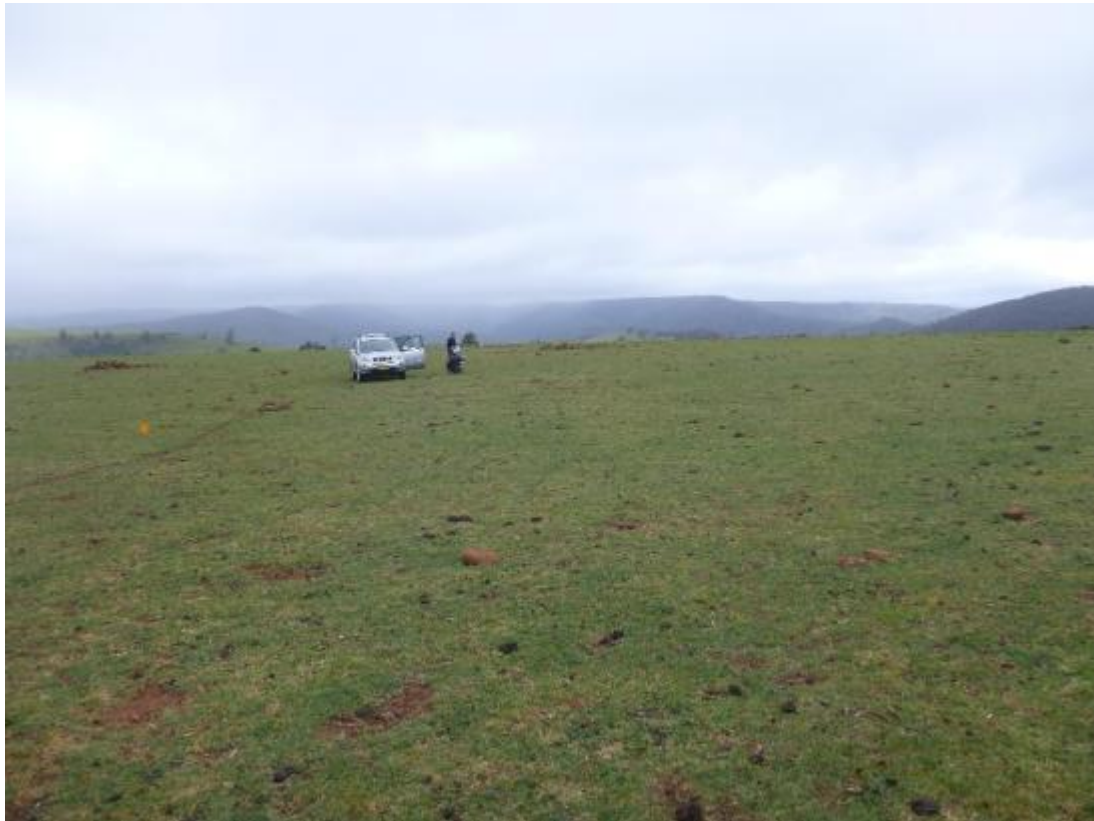
This site is located near to the north end of a broad relatively flat ridge landform (Plate 1). The area in which the met-mast is proposed is flat and highly exposed. The site is in a paddock of introduced pasture and, has presumably, been subject to repeated ploughing events. It has been

cleared of basalt cobbles which are piled up, but is still very rocky. The area is highly eroded by wind, and in places, clay and decomposing bedrock are exposed. At the time of the survey, pasture was well grazed. Ground exposed as bare earth patches measured c. 10% with c. 80% of that estimated to be archaeological visibility. Effective exposure is relatively low. No Aboriginal artefacts were seen in the impact area. Given the landform context and highly exposed nature of the site, the area is assessed to be of low archaeological potential and sensitivity.

Plate 1 Met-mast #SD4 near to car; looking 330°; note piles of cobbles to left and right of car in distance.

Previously recorded Aboriginal site *TWF OS2* is located near to the proposed electrical connection trench. No artefacts were observed during the field survey. Management and mitigation measures will need to be implemented in order to ensure avoidance of impacts to this site.

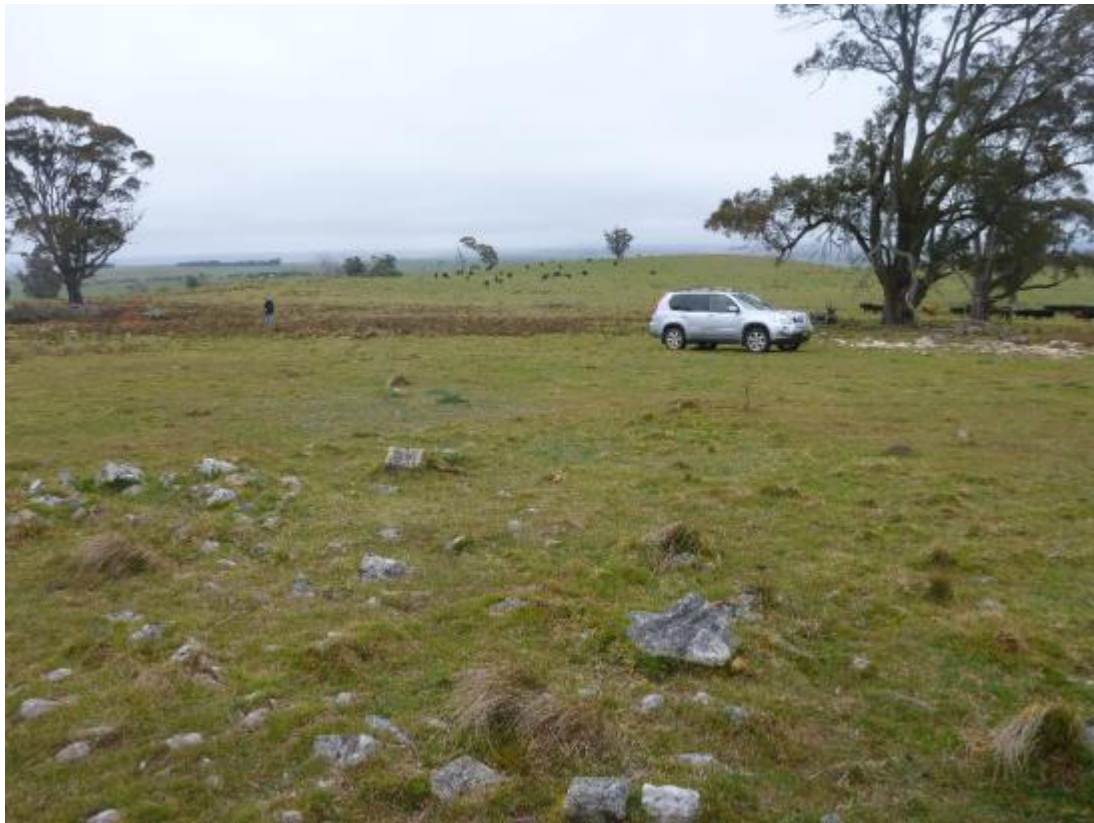
Plate 2 Met-mast #SD5 between figure and car; looking 230°. Note electrical trench would extend to Turbine #51 on knoll in distance immediately behind car.

This site is located on a broad, very gently undulating ridge landform (Plate 2). The area in which the met-mast is proposed slopes very gently to the west. The trench alignment is gently undulating along the ridge. The site is in paddocks with some scattered trees. The underling geology is meta-sedimentary, exposed in numerous places as broad areas of low bedrock. At the time of the survey ground exposure was found to be negligible. No previously recorded Aboriginal sites are located near the impact area. No artefacts were observed in this location during the field survey.

Given the landform context and exposed nature of the site, the impact area is assessed to be of low archaeological potential and sensitivity.

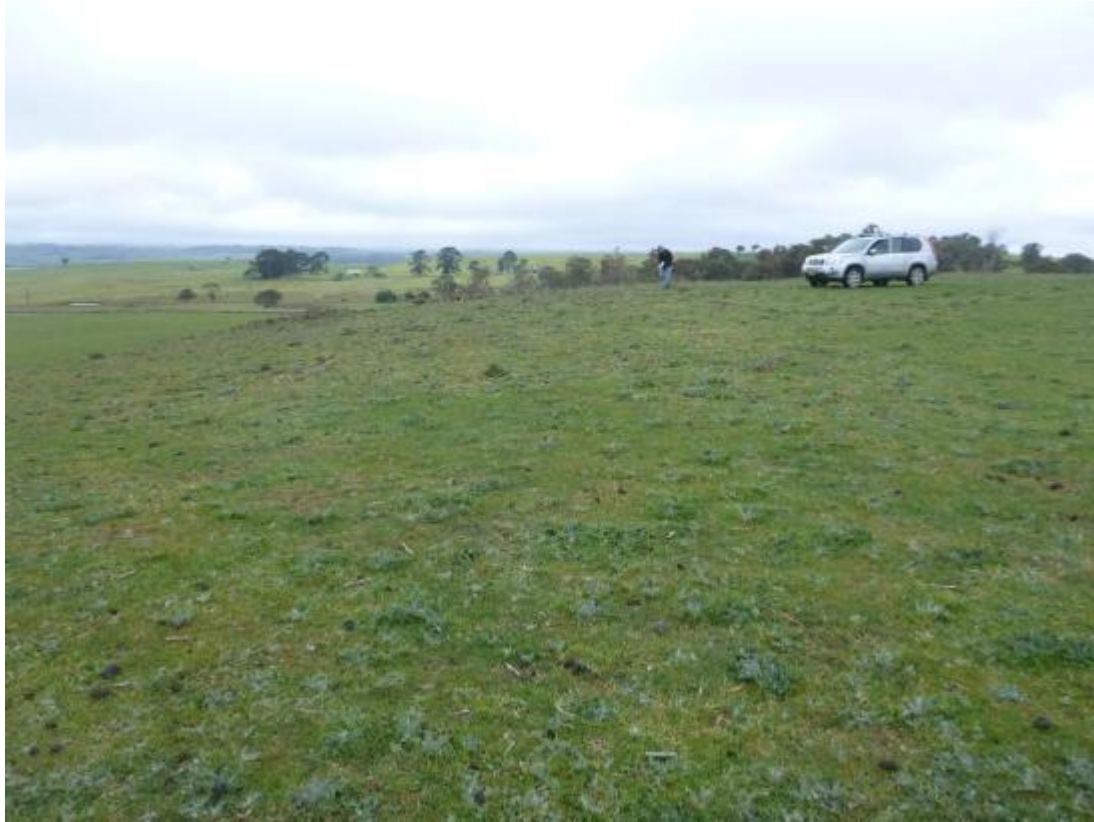
Plate 3 Met-mast #MET4243 near figure; looking 350°.

This site is located on a broad, very gently undulating ridge landform (Plate 3). The area in which the met-mast is proposed slopes very gently to the west. The trench alignment is very gently undulating across the crest of the ridge. The site is in a paddock in a highly exposed location. The underling geology is basalt and cobbles are extensive. At the time of the survey, pasture was well grazed. Ground exposed as bare earth patches measured c. 5% with c. 80% of that estimated to be archaeological visibility. Effective exposure is low. No previously recorded Aboriginal sites are located near the impact area. No artefacts were observed in this location during the field survey.

Given the landform context and exposed nature of the site, the impact area is assessed to be of low archaeological potential and sensitivity.

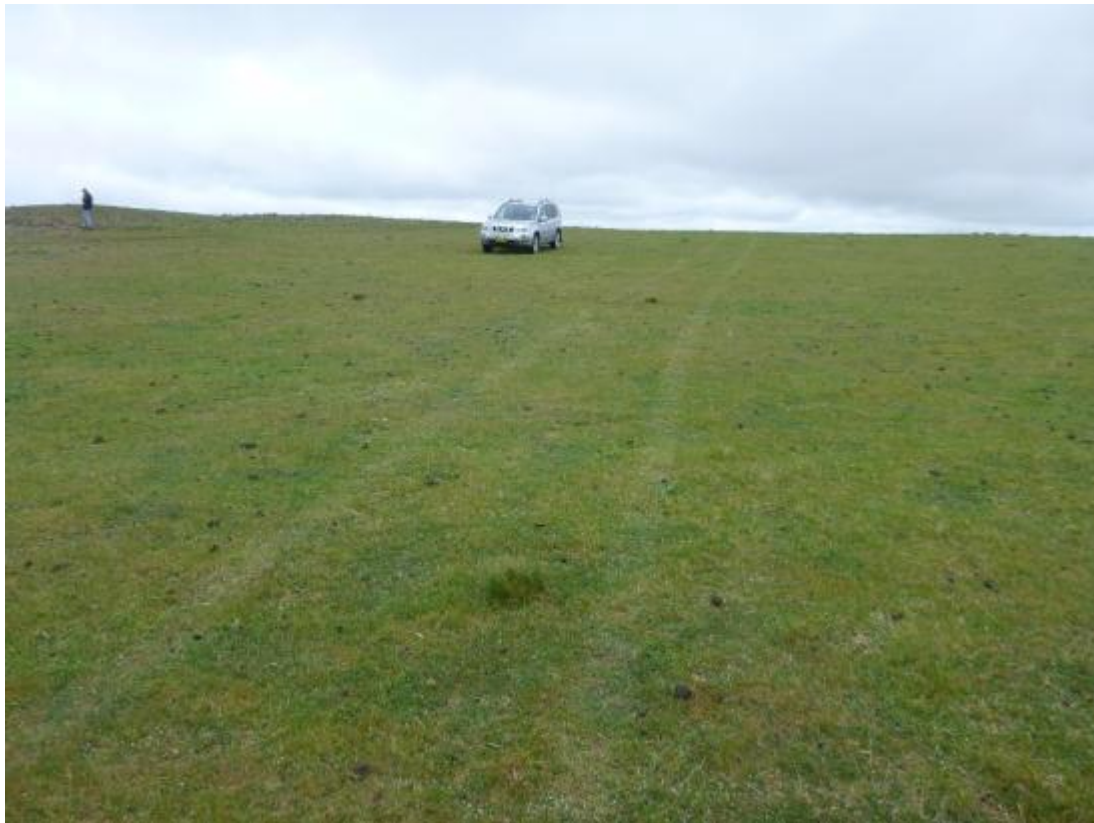
This site is located on a broad, very gently undulating ridge landform (Plate 4). This is the site of proposed Turbine #43 which has previously been assessed and approved. The met-mast would occupy a smaller footprint. The area in which the met-mast is proposed slopes very gently to the north. The geomorphological context is erosional. The site is in a grazed paddock of introduced pasture. The underling geology is basalt and cobbles are extensive. Ground exposure was negligible at the time of the survey. No previously recorded Aboriginal sites are located near the impact area. No artefacts were observed in this location during the field survey.

Given the landform context and exposed nature of the site, the impact area is assessed to be of low archaeological potential and sensitivity.

Plate 4 Met-mast #MET SC43 at car; looking south; note this is the site of Turbine #43.

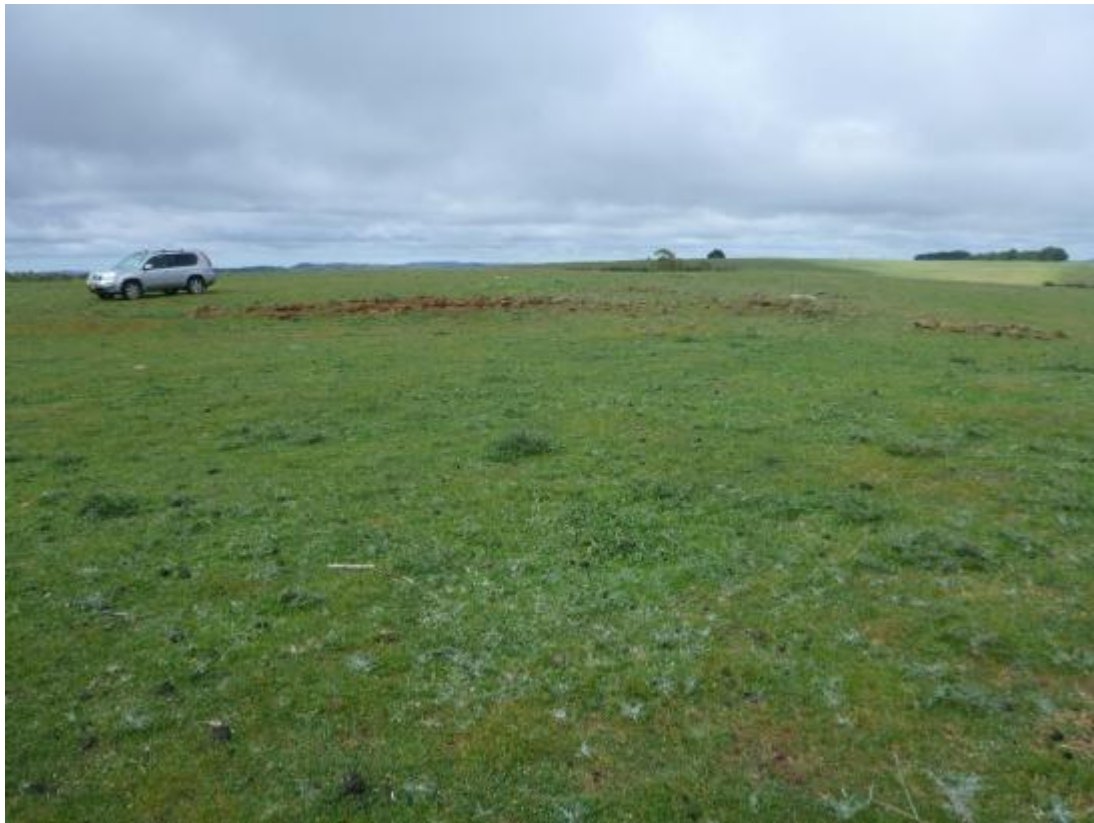
This site is located on a broad, very gently undulating ridge landform (Plate 5). This is the site of proposed Turbine #42 which has previously been assessed and approved. The concrete supports for a previous wind monitoring mast is at the site. The site is in a paddock which is highly disturbed by a deep excavation (possible silage pit). The underling geology is basalt and cobbles are extensive. At the time of the survey, pasture was well grazed. Ground exposed as bare earth patches and sections in the excavation cut measured c. 2% with c. 80% of that estimated to be archaeological visibility. Effective exposure is very low. No previously recorded Aboriginal sites are located near the impact area. No artefacts were observed in this location during the field survey.

Given the landform context and exposed nature of the site, the impact area is assessed to be of low archaeological potential and sensitivity.

Plate 5 Met-mast #MET SC42 at car; looking south; note this is the site of Turbine #42.

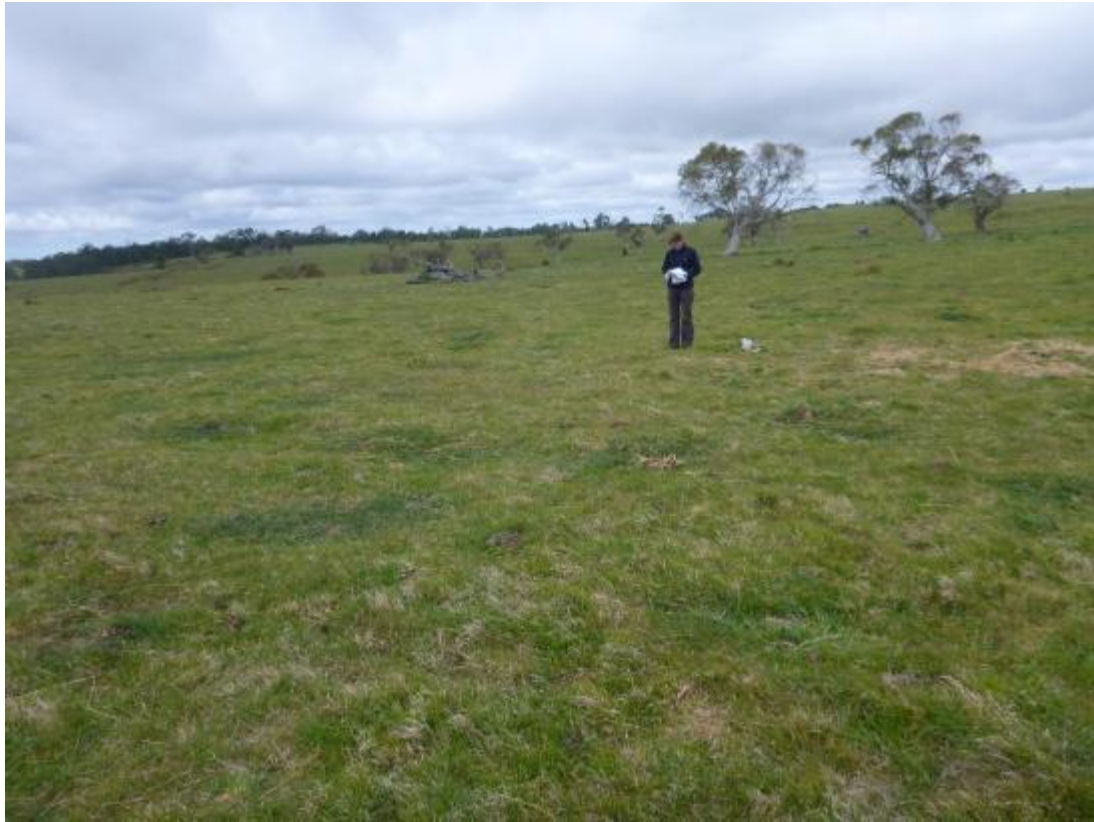
This site is located on a broad, very gently undulating ridge landform (Plate 6). The area in which the met-mast is proposed is flat. The trench alignment is along a very gently undulating ridge. The site is in paddocks with some scattered trees. The underling geology is basalt which is exposed as cobbles. During the survey ground exposure was negligible. No previously recorded Aboriginal sites are located near the impact area. No artefacts were observed in this location during the field survey.

Given the landform context and exposed nature of the site, the impact area is assessed to be of low archaeological potential and sensitivity.

Plate 6 Met-mast #SD1 at figure; looking 180°. Note electrical trench would extend to Turbine #19 on ridge in distance to left of figure.

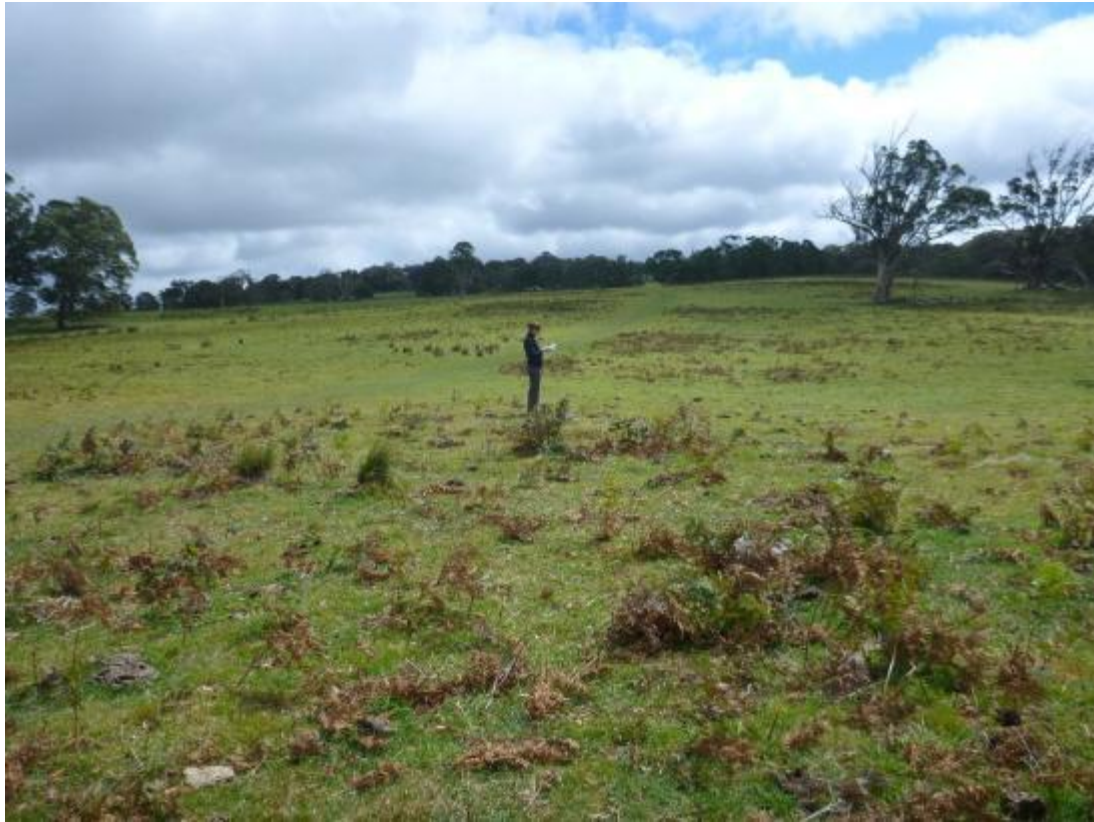
This site is located on a broad, gently undulating ridge landform (Plate 7). The area in which the met-mast is proposed is flat and highly exposed. The trench alignment is along a very gently undulating ridge. The site is in a paddock with some scattered trees. The geomorphological context is erosional. The underlying geology is basalt. Ground exposed as bare earth patches and a recent grader scrape measured c. 100 sq m with c. 80% of that estimated to be archaeological visibility. No Aboriginal artefacts were seen in the impact area of the met-mast. Given the landform context and highly exposed nature of the site, the area is assessed to be of generally low archaeological potential and sensitivity.

Plate 7 Met-mast #MET28 at figure; looking 310°.

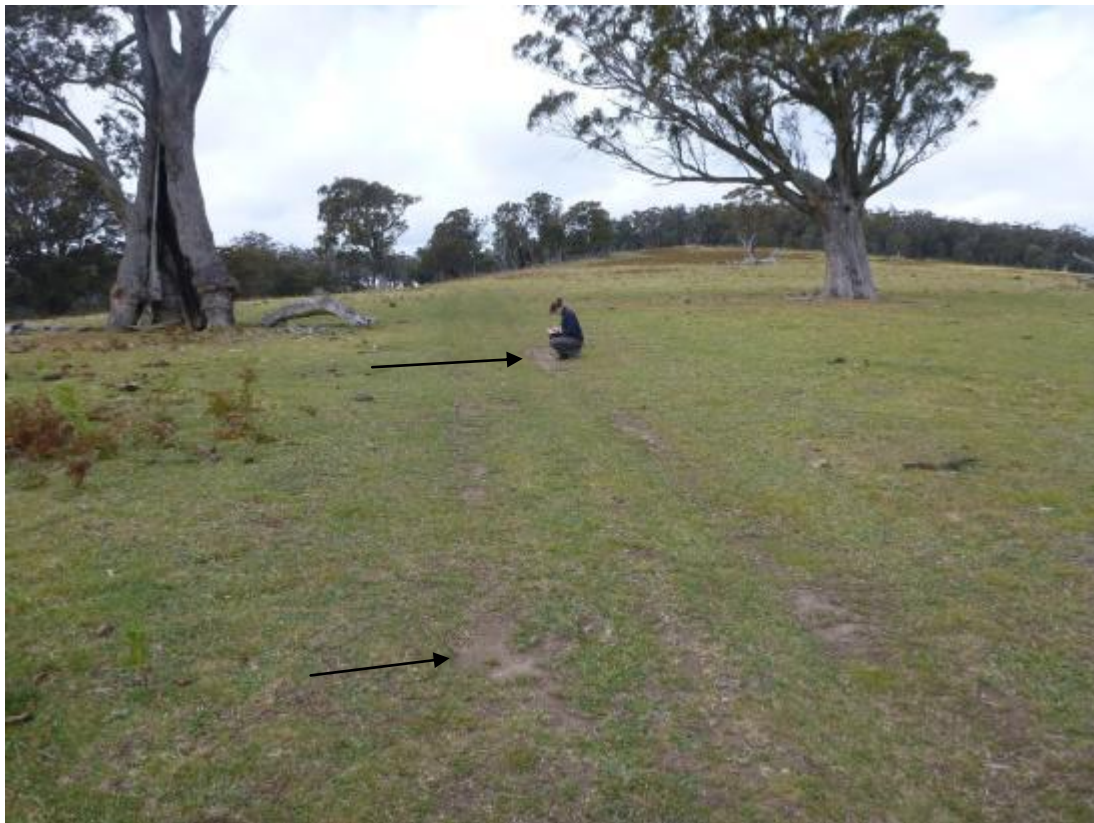
An Aboriginal site *TWF OS7* (nomenclature is continuous & sequential from OzArk's [2004] previous recording) is located near to the proposed electrical connection trench. Four artefacts were observed in a section of eroded vehicle track. Management and mitigation measures will need to be implemented in order to ensure avoidance of impacts to this site.

*TWF OS7* is located at coordinates: 765193.6186857 (Plate 8). Four artefacts were found in an area measuring c. 8 x 2 metres on a track. The ground surface is erosional. The artefacts are:

- Brown tuff proximal flake portion, focal platform, measuring 14 x 15 x 3 mm.
- Brown chert medial flake portion (parallel arises on dorsal surface) measuring 18 x 16 x 3 mm.
- Brown tuff proximal flake portion, focal platform, measuring 18 x 28 x 5 mm.
- Grey chert flake, broad plain platform, feather termination measuring 38 x 22 x 13.

Plate 8 Site TWF OS7, looking south. Artefacts were observed between the arrows. Note Turbine #28 location in distance to left of figure.

In the next section of this report it will be recommended that harm is avoided to the two known Aboriginal sites by re-routing the electrical trenches and incorporating a no-development area in the site design. However, if impacts cannot be avoided, an AHIP would be required.

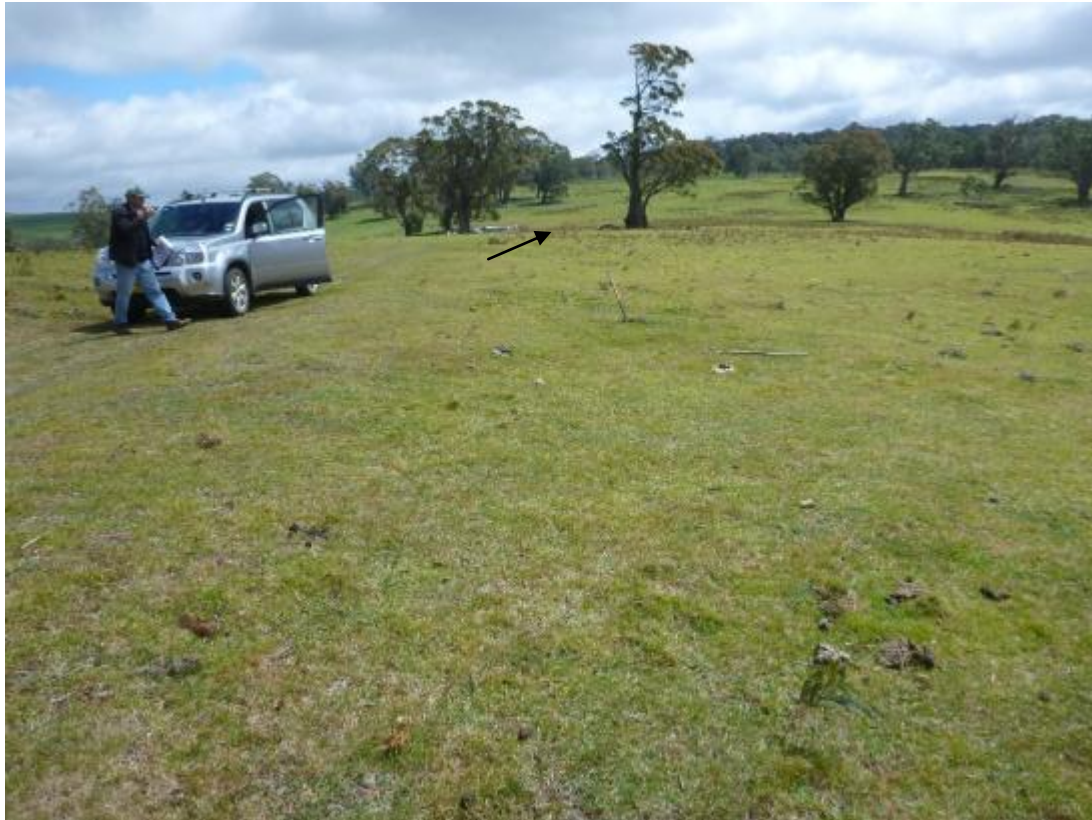
This site is located on a broad, gently undulating ridge landform (Plate 9). This is the site of proposed Turbine #28 which has previously been assessed and approved. The met-mast would occupy a smaller footprint. The area in which the met-mast is proposed slopes very gently to the north. The geomorphological context is erosional. The site is in a grazed paddock of introduced pasture with scattered trees. The underling geology is meta-sedimentary. Ground exposure measured c. 2 sq m with 90% of that assessed to be archaeological visibility. Effective survey exposure is low. No artefacts were recorded in the impact area. Given the landform context and exposed nature of the site, the impact area is assessed to be of low archaeological potential and sensitivity.

Plate 9 Met-mast #MET SC28 at peg in ground; looking 300°. Note Aboriginal site denoted by arrow.

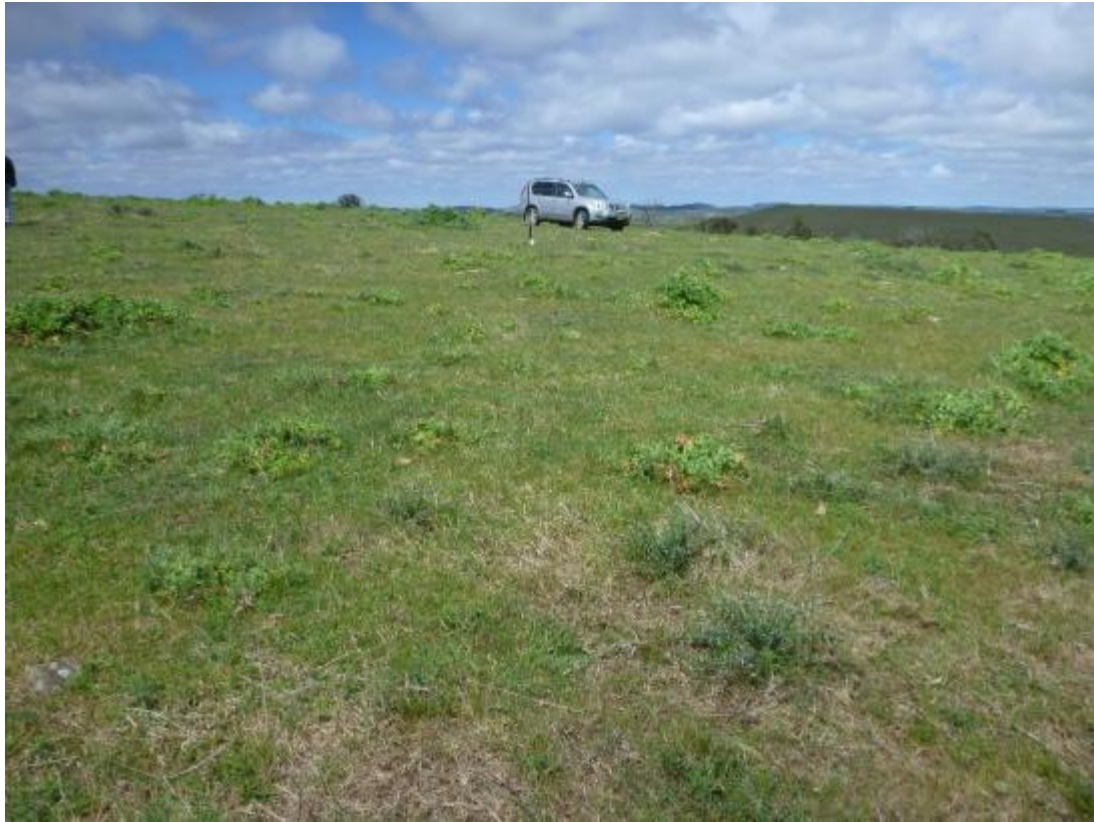
This site is located on a broad, gently undulating ridge landform (Plate 10). This is the site of proposed Turbine #45 which has previously been assessed and approved. The geomorphological context is erosional. The area in which the met-mast is proposed slopes very gently to the west and is highly exposed to weather. The site is in a grazed paddock of introduced pasture. The underling geology is basalt, exposed as cobbles. Ground exposure was found to be negligible. No artefacts were recorded in the impact area. Given the landform context and exposed nature of the site, the impact area is assessed to be of low archaeological potential and sensitivity.

Plate 10 Met-mast #MET SC45 at peg in ground; looking 140°.

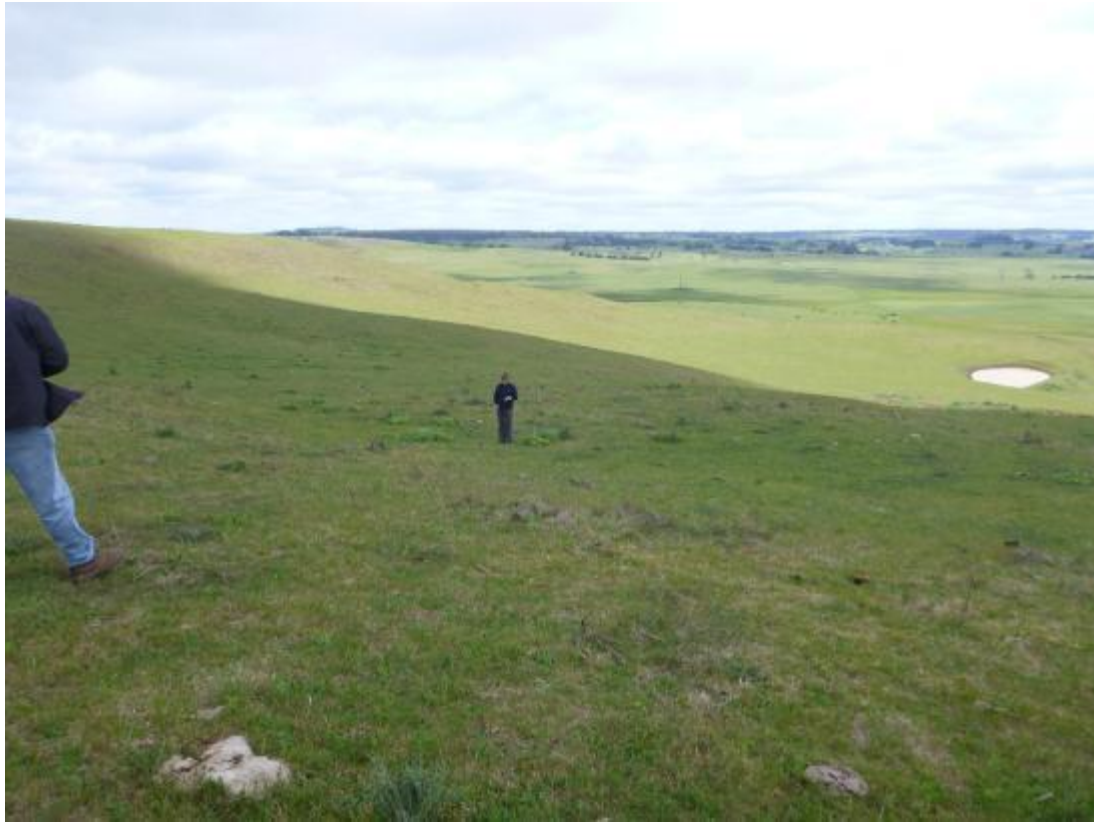
This site is located on a broad, gently undulating ridge landform (Plate 11). The area in which the met-mast is proposed is gently sloping to the west and highly exposed. The geomorphological context is erosional. The trench alignment is along the crest of the gently undulating ridge. The site is in a paddock which was well grazed at the time of the survey. The underling geology is basalt. Ground exposure encountered was negligible. No Aboriginal artefacts were seen in the impact area. Given the landform context and highly exposed nature of the site, the area is assessed to be of generally low archaeological potential and sensitivity.

Plate 11 Met-mast #MET 4546 at figure; looking 240°.

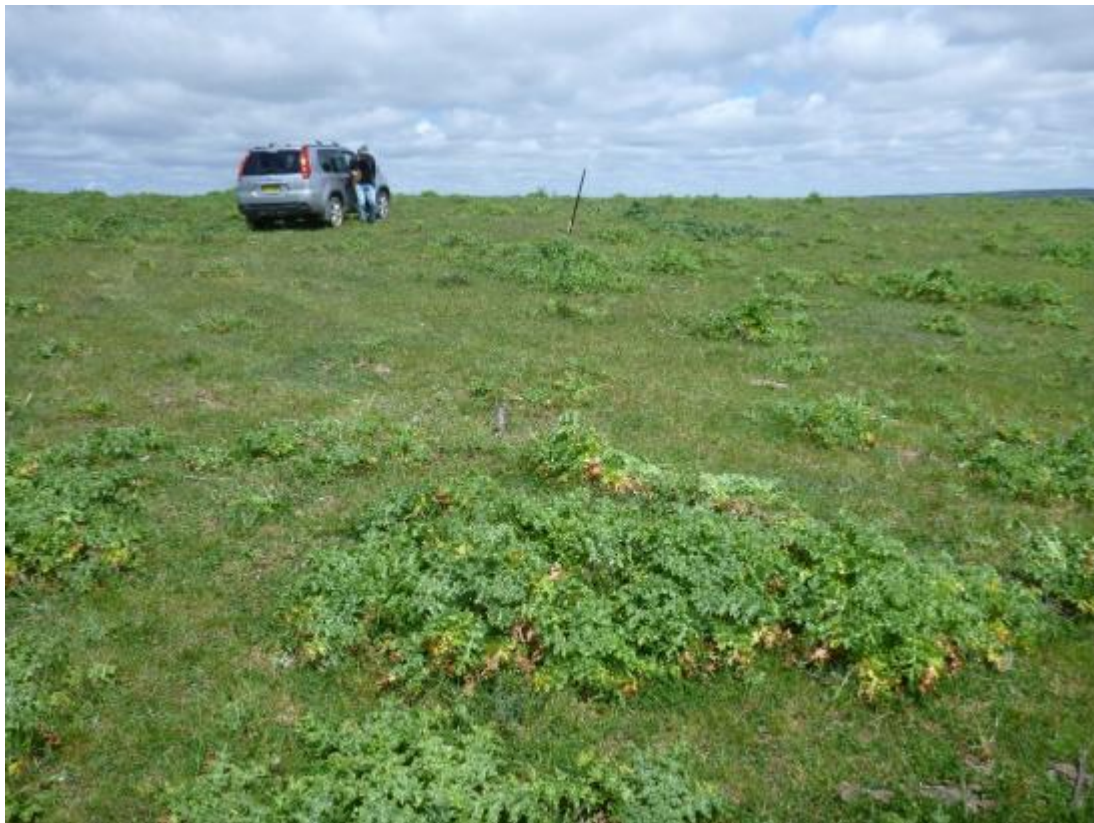
This site is located on a broad, gently undulating ridge landform (Plate 12). This is the site of proposed Turbine #46 which has previously been assessed and approved. The area in which the met-mast is proposed is a ridge crest. The geomorphological context is erosional. It slopes very gently to the northwest and is highly exposed to weather. The site is in a grazed paddock of introduced pasture. The underling geology is basalt, exposed as cobbles. Ground exposure was found to be negligible. No artefacts were recorded in the impact area. Given the landform context and exposed nature of the site, the impact area is assessed to be of low archaeological potential and sensitivity.

Plate 12 Met-mast #MET SC46 at peg; looking 180°.

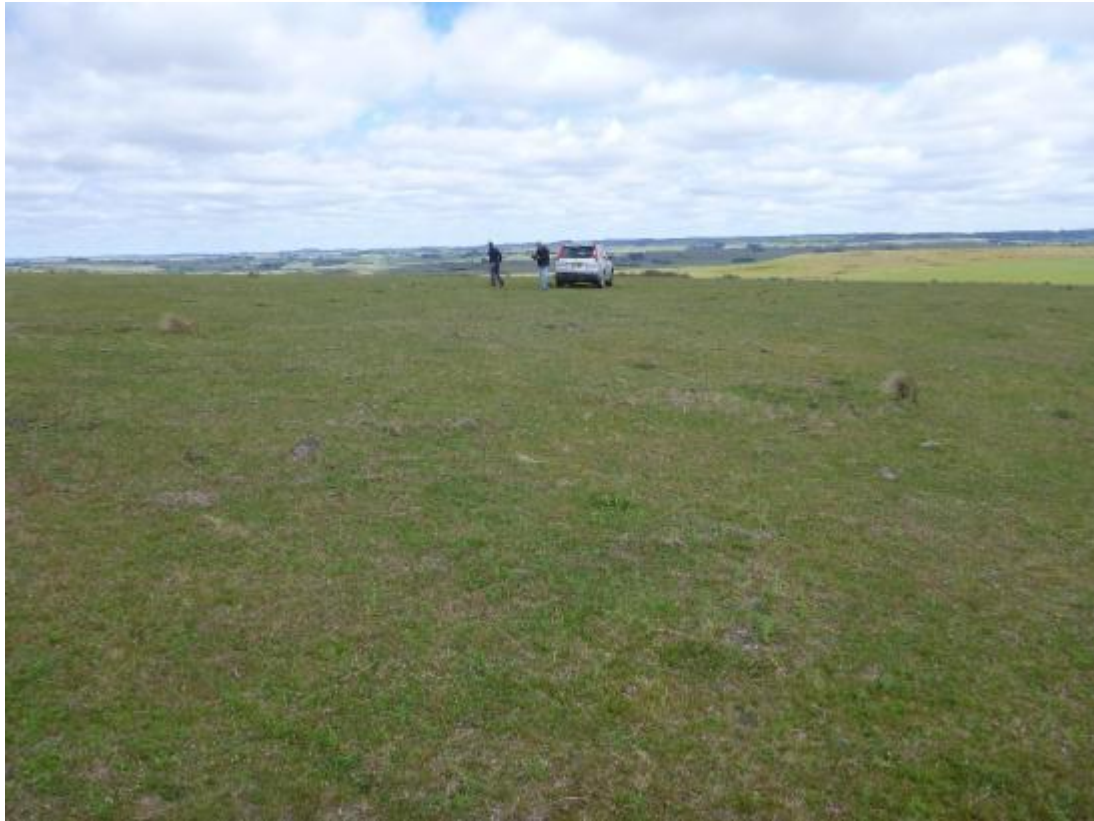
This site is located on a broad, gently undulating ridge landform (Plate 13). The area in which the met-mast is proposed is gently sloping to the west and highly exposed. The geomorphological context is erosional. The trench alignment is along the crest of the gently undulating ridge. The site is in a paddock which was well grazed at the time of the survey. The underling geology is basalt. Ground exposure encountered was negligible. No Aboriginal artefacts were seen in the impact area. Given the landform context and highly exposed nature of the site, the area is assessed to be of generally low archaeological potential and sensitivity.

Plate 13 Met-mast #SD3 at car; looking 190°.

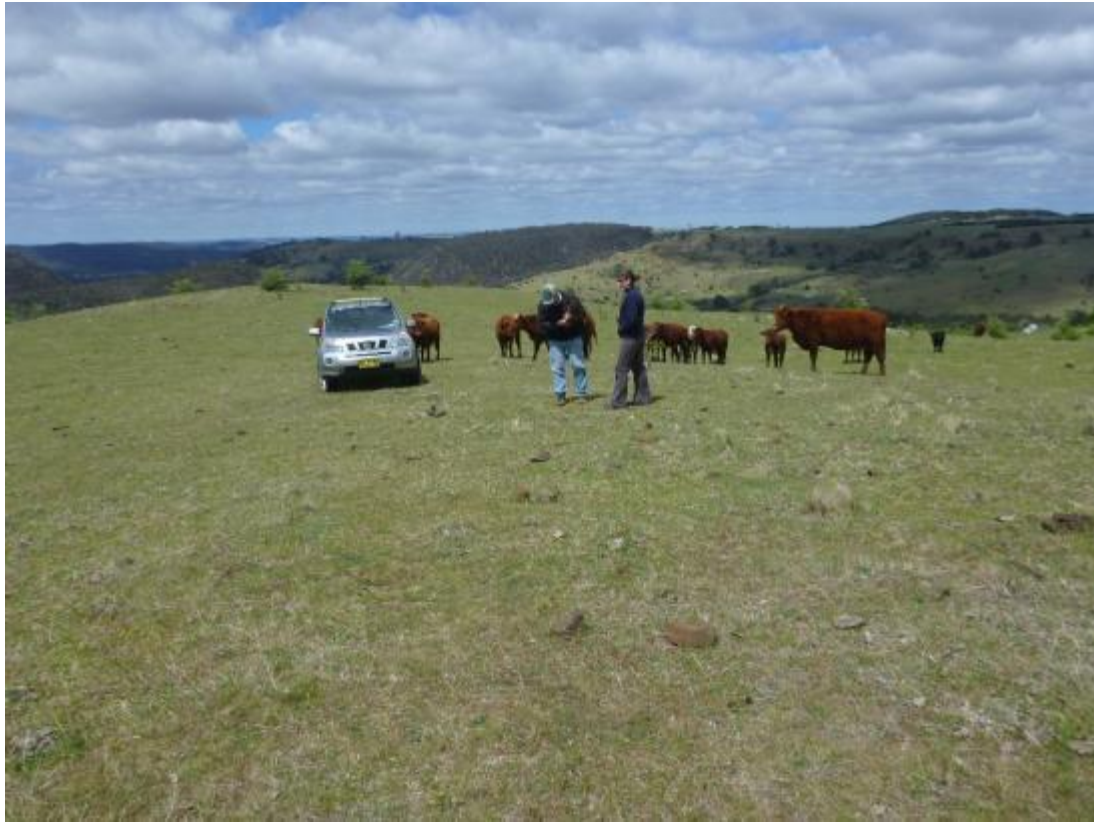
This site is located on a gently undulating ridge landform (Plate 14). The area in which the met-mast is proposed is gently sloping to the east and highly exposed. The geomorphological context is erosional. The trench alignment is along the crest of the gently undulating ridge. The site is in a paddock which was well grazed at the time of the survey. The underling geology is basalt; it is very rocky (technically rockland) with cobbles. Ground exposure encountered is estimated to have been c. 50% with archaeological visibility in that exposure c. 80%. Effective survey coverage was moderate. No Aboriginal artefacts were seen in the impact area. Given the landform context and highly exposed nature of the site, the area is assessed to be of generally low archaeological potential and sensitivity.

Plate 14 Met-mast #SD2 at figures; looking 110°.
