### Heritage Assessment

Ben Churcher  
Senior Archaeologist  
OzArk Environmental & Heritage Management

12 December 2013

**Due diligence inspection of:**

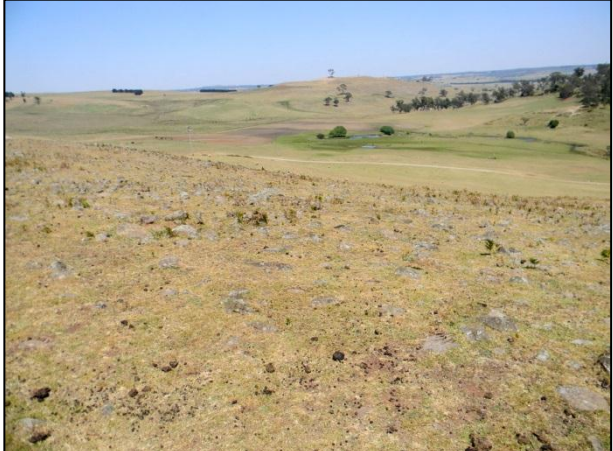
| Location and description | Indicative photo of area |
|---|---|
| <p>West of T52<br/>Northernmost location 'C' in <b>Figure 2</b>.<br/>From T52 the cable route crosses and then descends a steep ridge line that contains a lot of rock outcropping. The route then crosses some flat lowlands that are intensively grazed and cultivated. The route then joins the access track to T58. This view shows the route from T52 looking towards T58.</p> | |

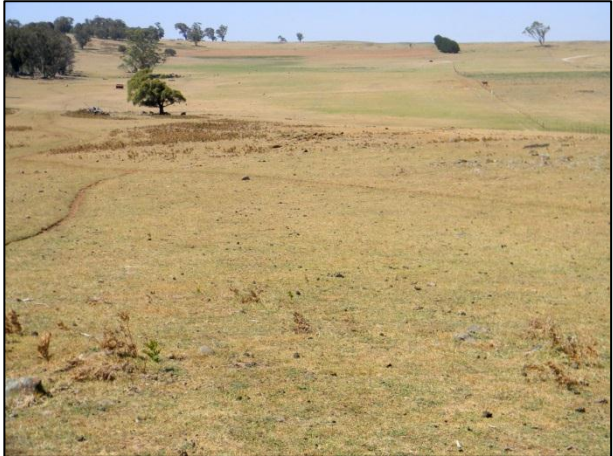
| Location and description | Indicative photo of area |
|---|---|
| <p>South of T52<br/>Northernmost location 'CR' in <b>Figure 2</b>.<br/>Between T52 and T51 the route crosses an elevated, undulating landscape. The route has been fully cleared of tree cover and rock outcroppings are frequent, particularly on the minor ridgelines within the landform. To the east there is a steep drop-off to the nearest water.</p> | |

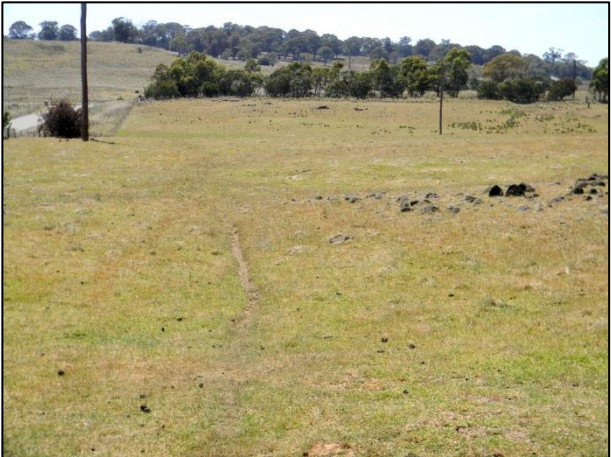
| Location and description | Indicative photo of area |
|---|---|
| <p>Northeast T43<br/>Northeast of T43 in <b>Figure 2</b>.<br/>Between T49 and T43 a small area of cable route required assessment. This route cross a gently sloping cleared paddock in which rock outcropping is frequent. In this view the cable route is shown looking southwest.</p> | |

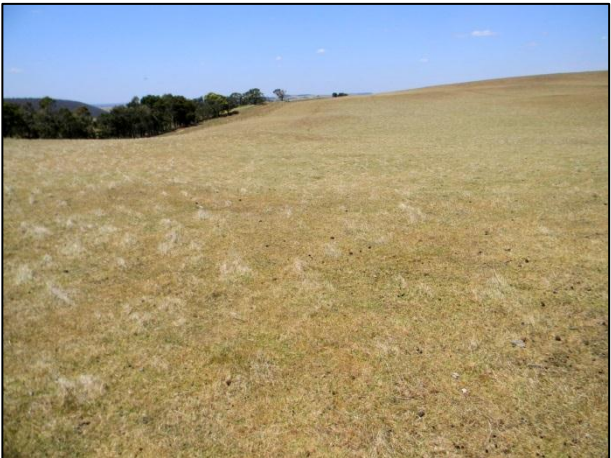
| Location and description | Indicative photo of area |
|---|---|
| <p>South of T41<br/>South of T41 in <b>Figure 2</b>.<br/>The cable route cross an elevated, undulating ridge that has been extensively cleared and used for grazing. All portions of this route are distant to water.</p> | |

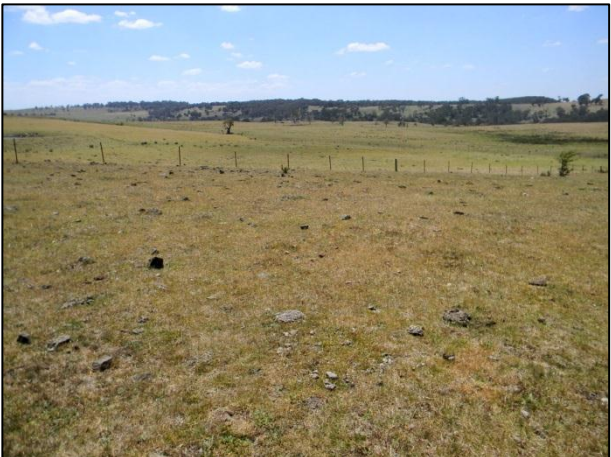
| Location and description | Indicative photo of area |
|---|---|
| <p>Between substation to overhead transmission line<br/>From substation to overhead transmission line in <b>Figure 2</b>.<br/>The landform is elevated and consists entirely of cleared paddocks in which rock outcropping is fairly frequent. This view is from the area of the substation to the northeast.</p> | |

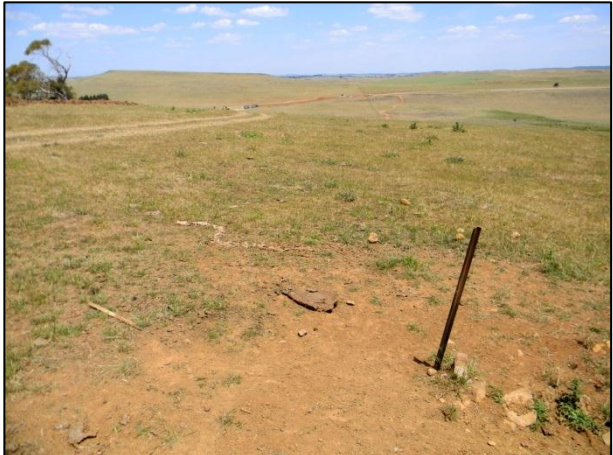
| Location and description | Indicative photo of area |
|---|---|
| <p>South of T44<br/>South of T44 in <b>Figure 2</b>.</p> <p>The cable route begins on a minor ridge before descending to flatter landforms in the vicinity of the site compound. The route is cleared of tree cover and has been used extensively for grazing. Rock outcrops are not frequent although soils on the sloping portion of the landform although they are thicker in the flatter portions. However the soils in the flatter portions tend to waterlog and disturbance from stock trampling into the mud during rain events is evident.</p> | |

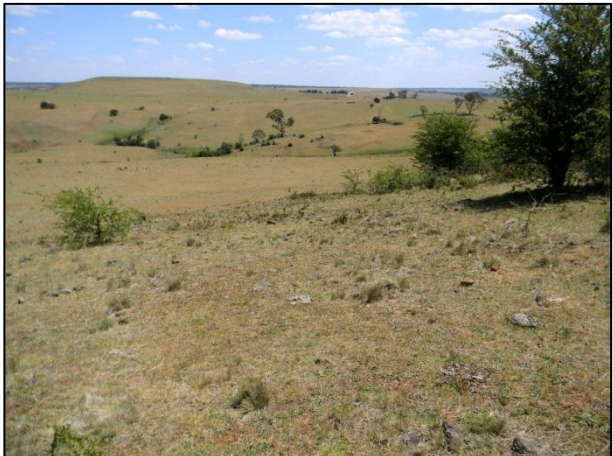
| Location and description | Indicative photo of area |
|---|---|
| <p>Between T32 and T10<br/>Southwestern-most location "CR" in <b>Figure 2</b>.</p> <p>The cable route crosses a shallow valley with a swampy watercourse that is fed, it seems, by a spring to the north. The waterway has defined banks although should be best described as a spring soak rather than a rain fed waterway. The entire route is devoid of tree cover and has been used extensively for grazing. Rock outcrops on the slopes are frequent although soils appear a little deeper in the valley floor. This view is looking from the vicinity of T32 towards T10 to the west.</p> | |

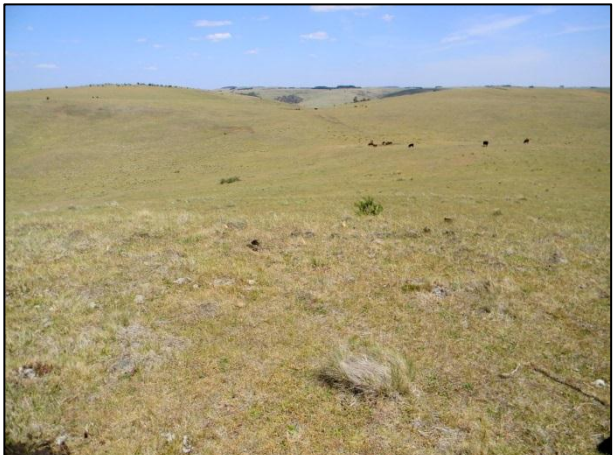
| Location and description | Indicative photo of area |
|---|---|
| <p>North of T8<br/>Southwestern-most and southern central locations 'C' in <b>Figure 2</b>.</p> <p>The landforms to the north of T8 are elevated and undulating devoid of permanent watercourses. Rock outcropping is frequent, particularly on the minor ridges, and generally soil depths appear shallow. The route is cleared of tree cover and has been used extensively for grazing.</p> | |

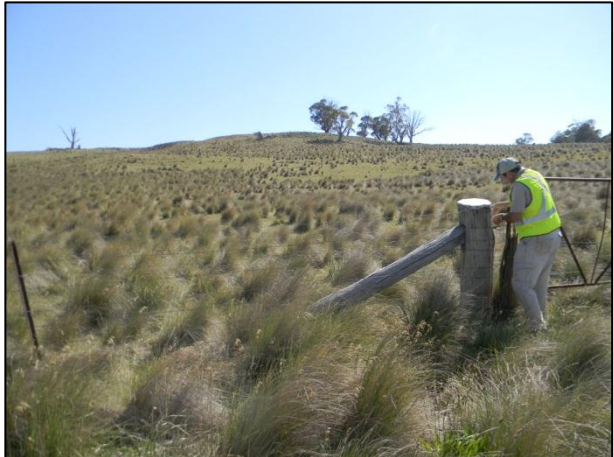
| Location and description | Indicative photo of area |
|---|---|
| <p>Access to T49<br/>South of T49 in <b>Figure 2</b>.<br/>From Bannaby Road the access track rises to a low ridge on which T49 is located. The route is cleared of tree cover and has been extensively used for grazing.<br/>In this view the access track leaves Bannaby Road near this farm gate and traverses the paddocks to the hill in the distance.</p> | |

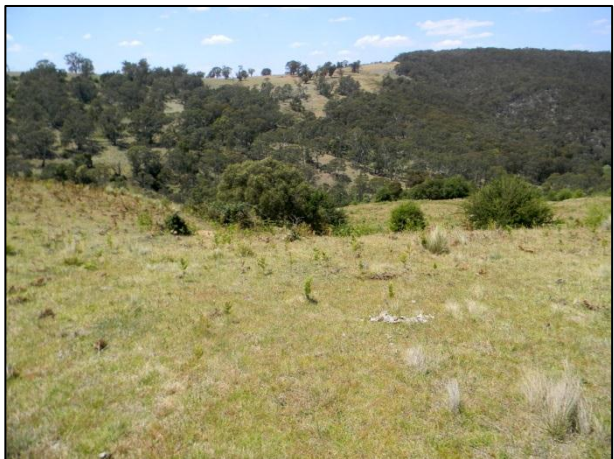
| Location and description | Indicative photo of area |
|---|---|
| <p>Overhead transmission line<br/>Location 'P' in <b>Figure 2</b>. This also includes a small area surrounding the eastern termination of the overhead transmission line marked as the southeastern-most location 'C' in <b>Figure 2</b>.<br/>From the end of the underground cable route the overhead transmission line crosses a steep V-Shaped valley. No poles associated with the line will be placed within 100m of the waterway as this will be spanned. The area to be impacted by pole construction and access for construction is sloping terrain in cleared paddocks. To the west the paddocks remain largely cleared although the eastern portion is within cleared pockets within regenerating woodland. This view is from the west to the east.</p> | |

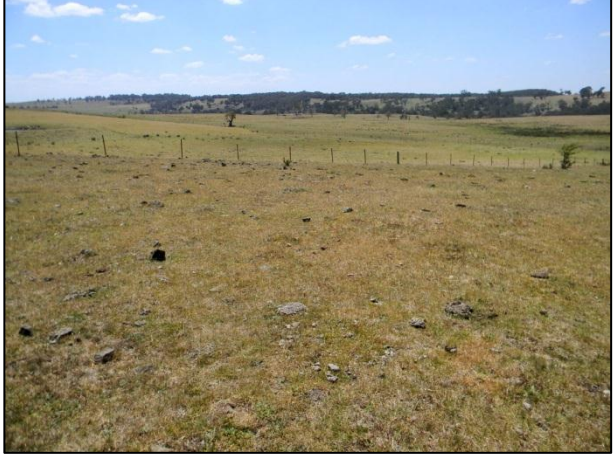
| Location and description | Indicative photo of area |
|---|---|
| <p>An operation and maintenance building<br/>Location 'Q' in <b>Figure 2</b>.</p> <p>This area is located adjacent to the approved substation location and occupies an identical landform: an elevated, gently undulating landform devoid of watercourses. The entire area is without tree cover and has been extensively grazed for many years.</p> | |
