## GINKGO MINERAL SANDS MINE AND CRAYFISH EXPANSION

ANNUAL REVIEW REPORT  
2023

| Ginkgo Minerals Sands Mine and Crayfish Expansion | |

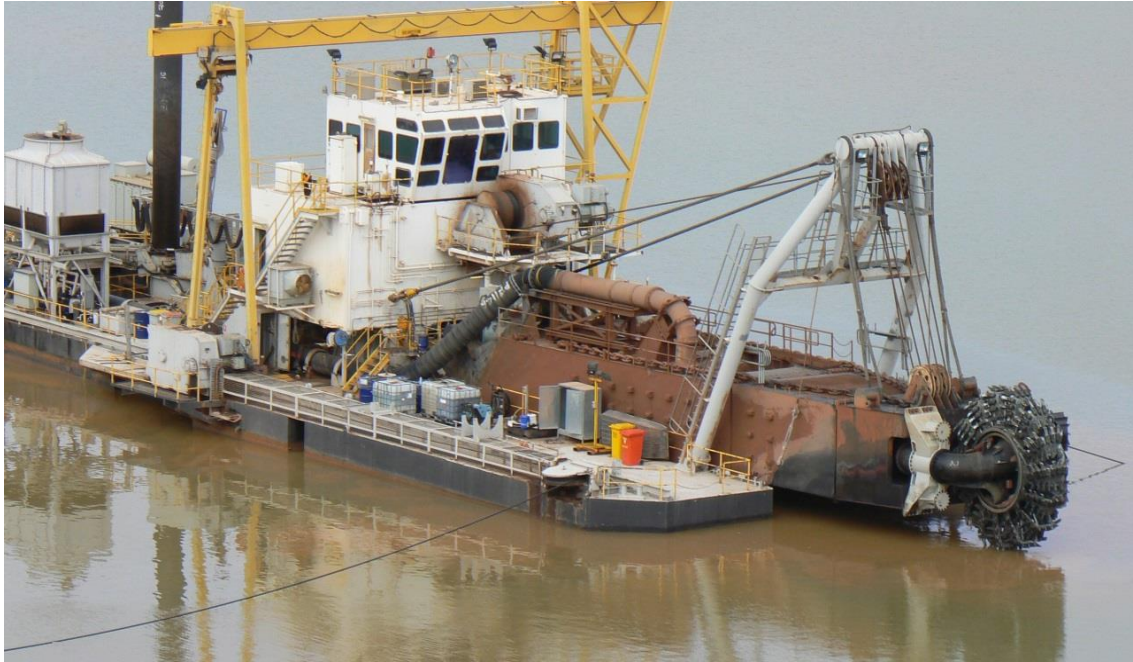
**Figure 3 – Ginkgo Dredge (Amanda II)**

The floating plant is manoeuvred in the pond by four winches, one on each corner of the floating plant pontoon. The winch cables are attached to anchors that will be periodically relocated in accordance with plant advance along the mine path.

The floating plant produces a mineral concentrate comprising approximately 95% valuable heavy minerals. The mineral concentrate will principally contain ilmenite, altered ilmenite, leucoxene, rutile, and zircon. The concentrate is pumped ashore to the mineral concentrate stockpile area and dewatered to approximately 6% water content.

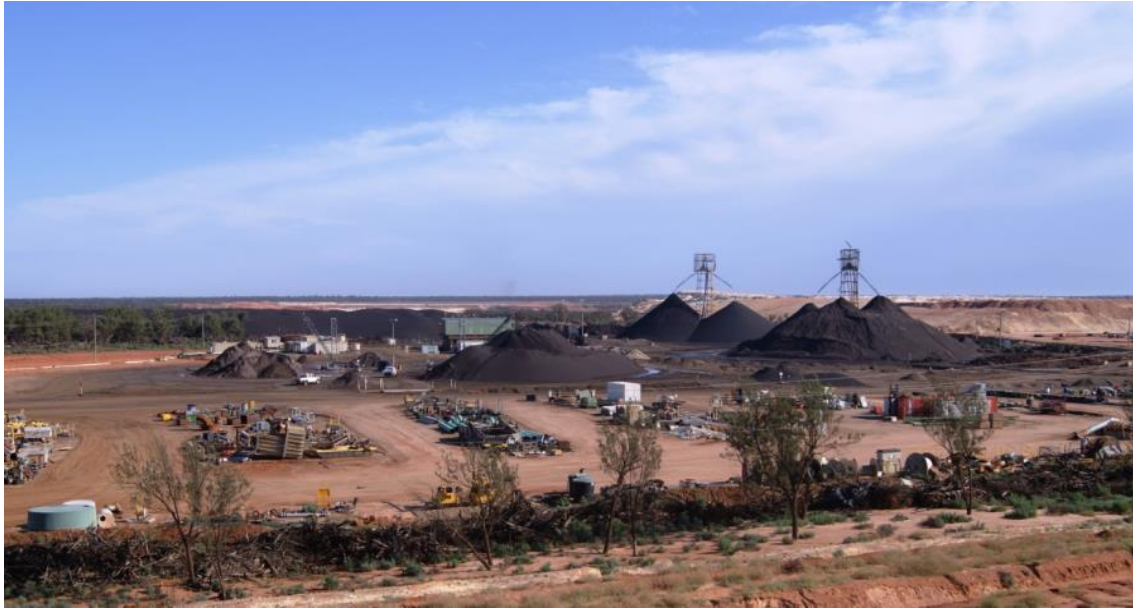
**Figure 4 – Salt Washing Facility and WHIMS Circuit**

Following washing, the mineral concentrate is pumped into the Wet High Intensity Magnetic Separation (WHIMS) circuit. The WHIMS is the preliminary mineral concentrate treatment stage which separates the mineral concentrate into an ilmenite concentrate, a leucoxene concentrate, and non-magnetic concentrate (containing rutile and zircon) utilising the difference in magnetic properties of these minerals. No chemical reagents are used in this process.

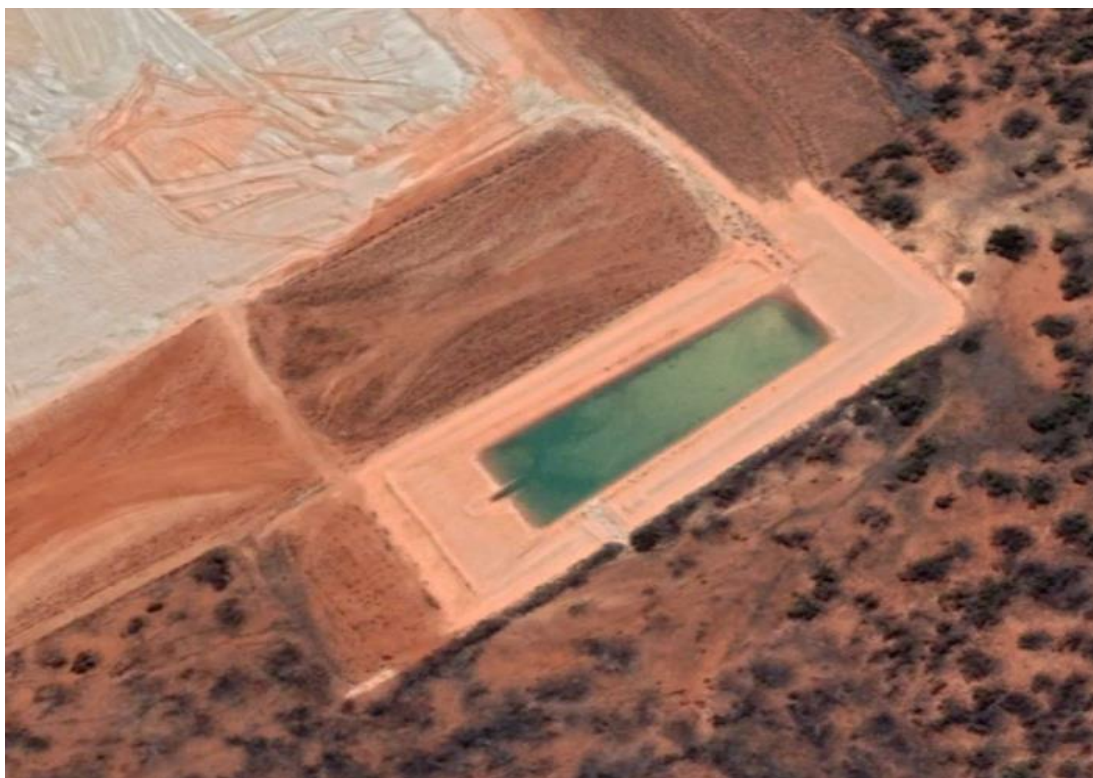
**Figure 11 – Sediment Pond at Crayfish Mine**

Surface water run-off is generated off compacted areas such as the administration block, lay down pad, overburden stockpiles and roads. This run-off is managed via the construction of diversion drains and sediment sumps. These management strategies allow for dirty and potentially contaminated water to be contained on site, and not enter areas of undisturbed land. Conversely, these structures also act to prevent clean runoff from undisturbed land entering the site.

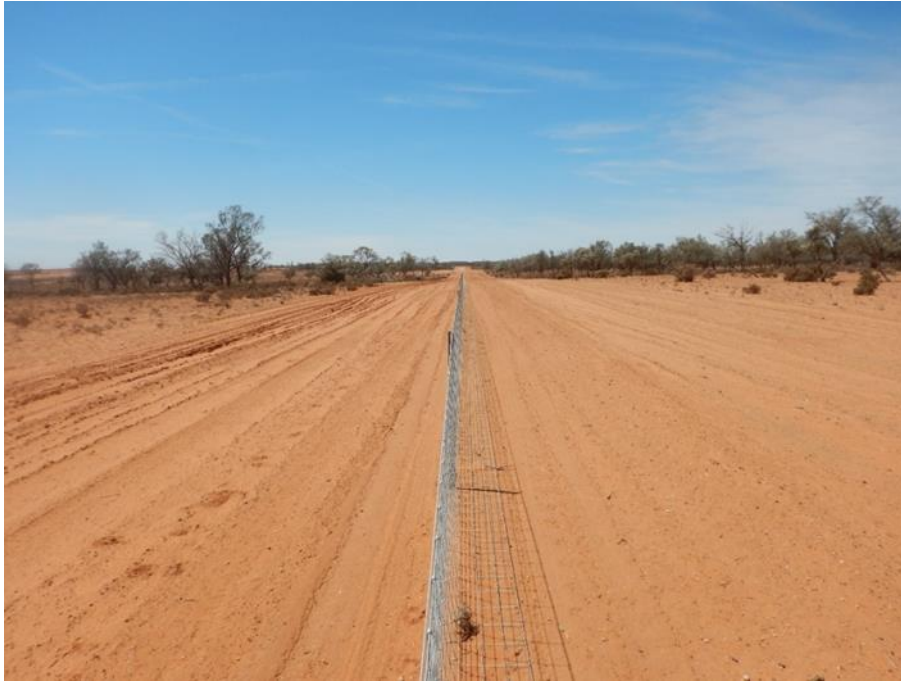
**Figure 24 – Fencing around the Ginkgo Mine Lease boundary**

Monitoring has indicated, that since the installation of fencing, the number of feral goats, kangaroos and livestock in the area have declined. This has resulted in lower grazing pressures and an increase in the natural regeneration of native vegetation species.

Fences are inspected quarterly and are maintained as required.

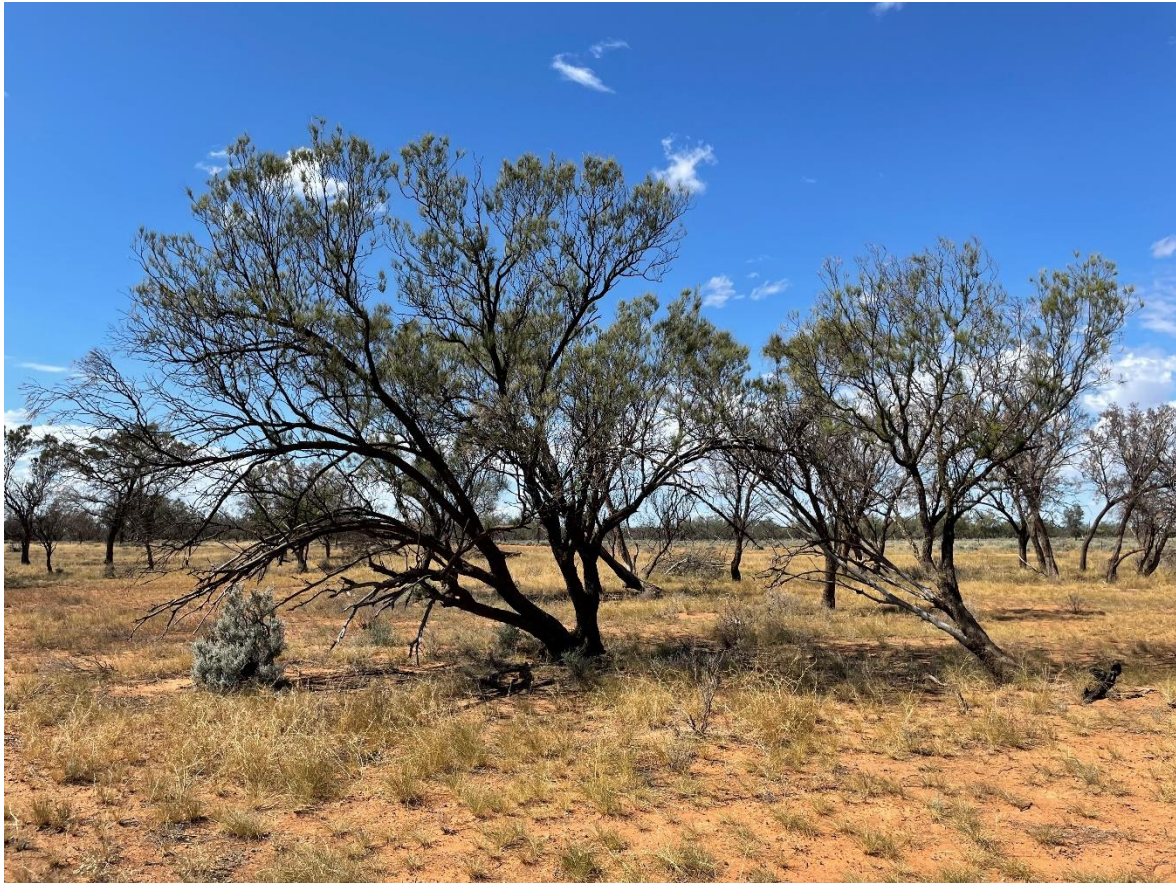
**Figure 26 – Re-established vegetation at Ginkgo Offset 1 bushfire site**

Post-bushfire monitoring was also undertaken quarterly at the 2022 Ginkgo Offset 1 bushfire site. Monitoring focused primarily on the re-establishment of native vegetation, fauna, weed incursions and soil erosion. Native grass and shrub species, such as bluebush, have started to re-establish within the area and mature trees which were defoliated have started to re-sprout, Figure 26. Native fauna, such as kangaroos and reptiles, have also started to return to the area. Minor weed incursions were evident along the graded containment lines and in isolated areas where native vegetation has not yet re-established, Figure 27. No evidence of soil erosion was observed.

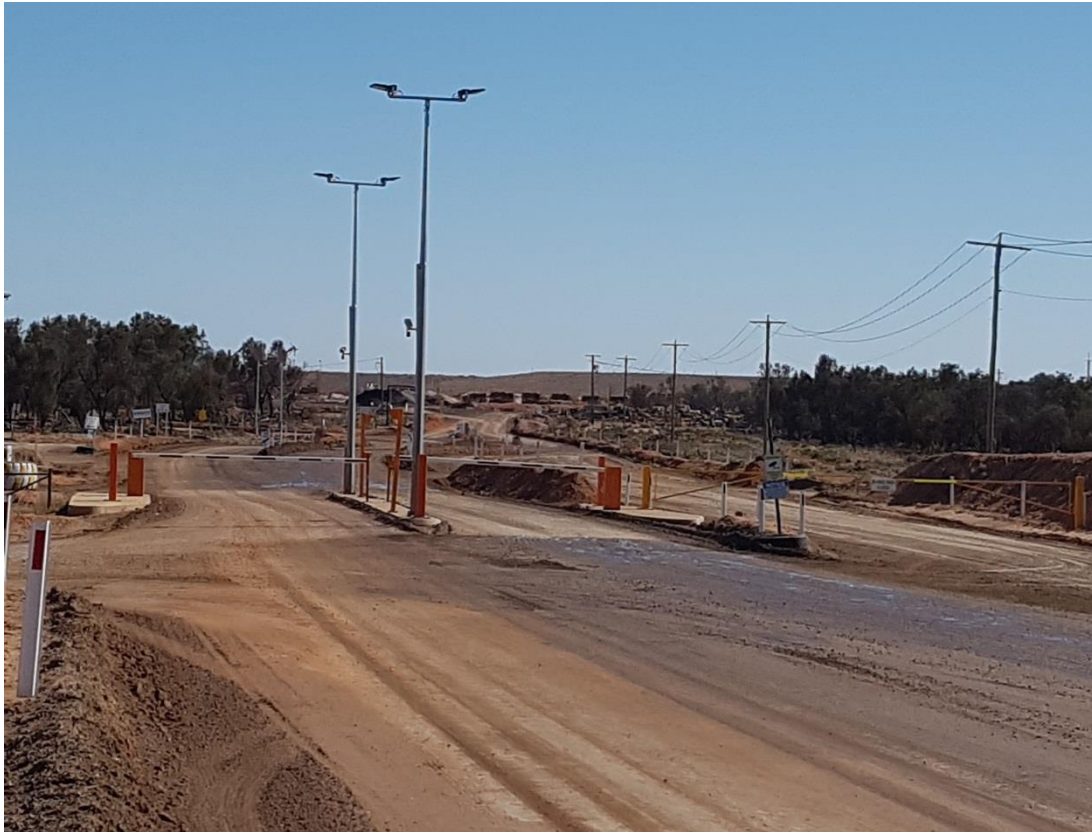
Figure 28 – Ginkgo/Crayfish Mine main entrance security boom gates

The Ginkgo/Crayfish Mine is restricted to authorised personnel only. Employees and contractors are required to complete an online induction prior to arriving on site and a face-to-face induction on arrival. All visitors are to report to the Ginkgo/Crayfish Mine site office on arrival and are accompanied by Tronox personnel whilst on site. Electronic card readers are installed at the main entrance to monitor movements of personnel in and out of the site. The entire mine site is fenced with stock-proof fencing and all access gates are fitted with padlocks. There is also a security boom gate at the main entrance, which is accessed via the Mine Haul Road, Figure 28. Signs, which notify personnel of the active mining area and that unauthorised access is not permitted, have been placed at entrance points and around the perimeter of the mine fence.

No unauthorised access to the Ginkgo/Crayfish Mine occurred during the reporting period.
