**Project 73624.01**  
**17 October 2013**  
**WFY:jlb**

**Preliminary Waste Classification Report**  
**Earthen Mound at Yennora Distribution Centre**  
**Dennistoun Avenue, Yennora**

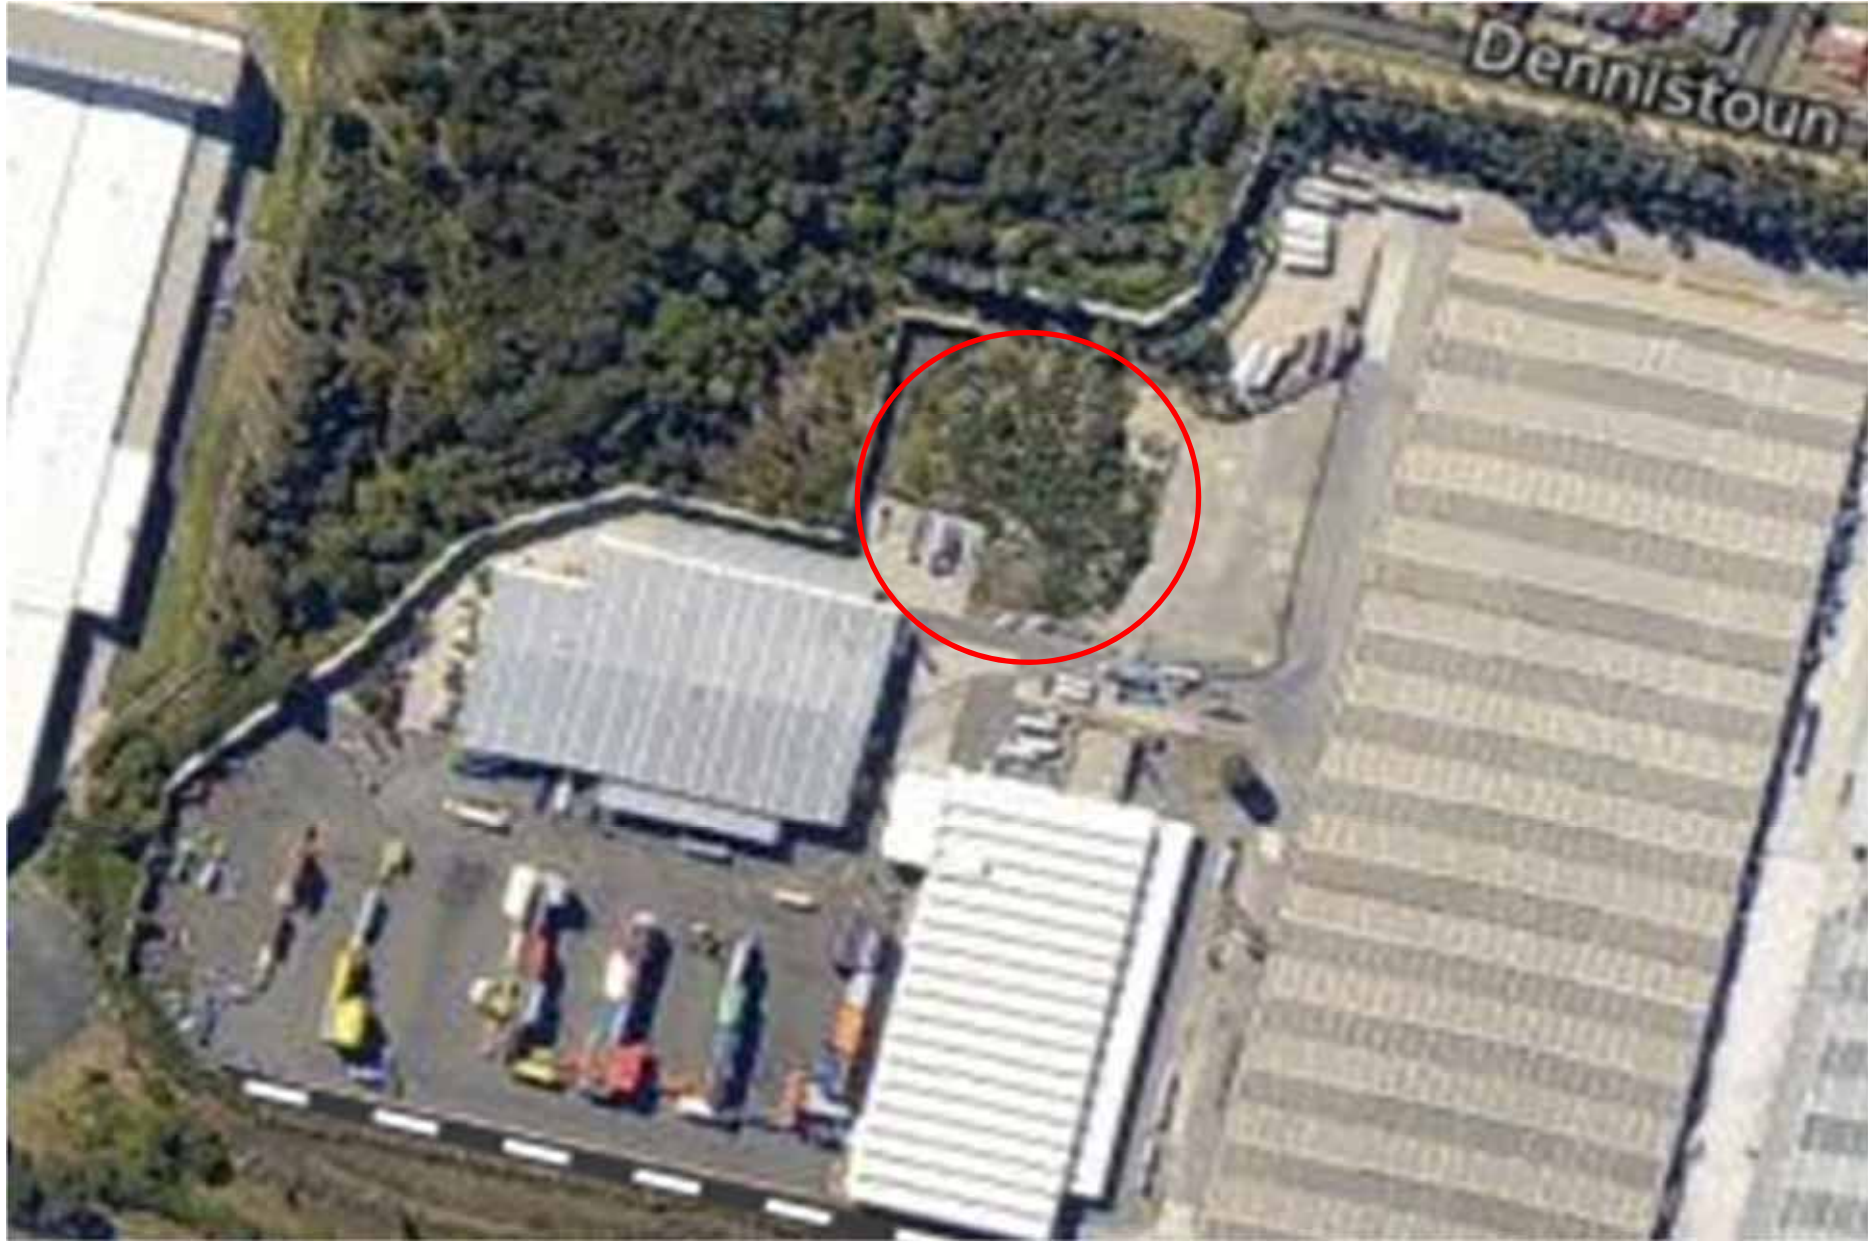
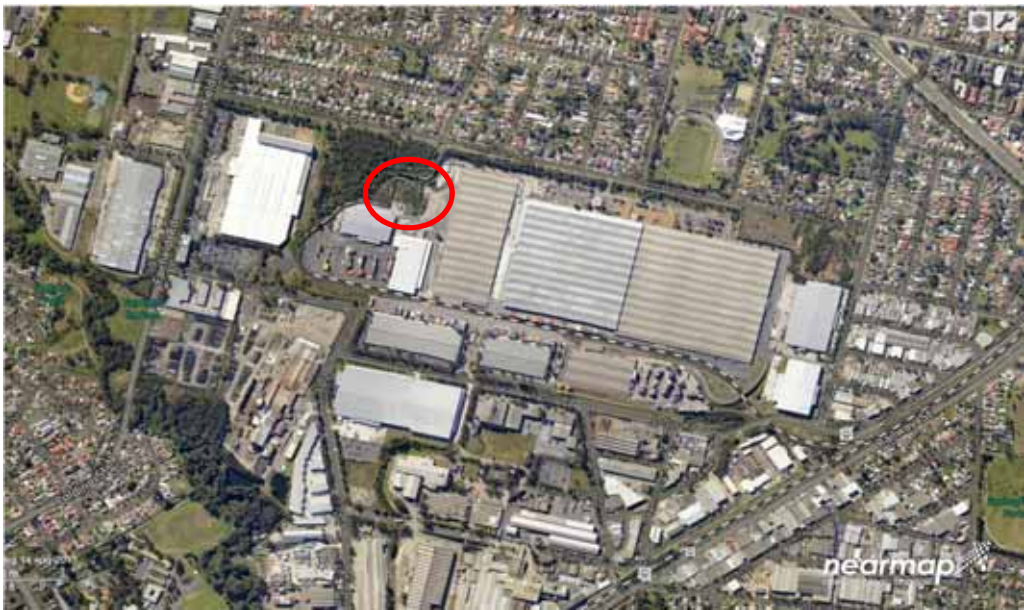
| <b>Douglas Partners</b><br>Geotechnics Environment Groundwater | CLIENT: Stockland Developments Pty Ltd | | TITLE: <b>Locality Map</b><br><b>Waste Classification Assessment</b><br><b>Yennora Distribution Centre, Cnr Dennistoun Ave &amp; Byron Rd, Yennora</b> | PROJECT No: 73624.01 |

This letter report by Douglas Partners Pty Ltd (DP) provides the results of an *ex situ* waste classification conducted for an existing earthen mound located in the north-western portion of Yennora Distribution Centre, Dennistoun Avenue, Yennora. Drawing 1 shows the location of the mound.

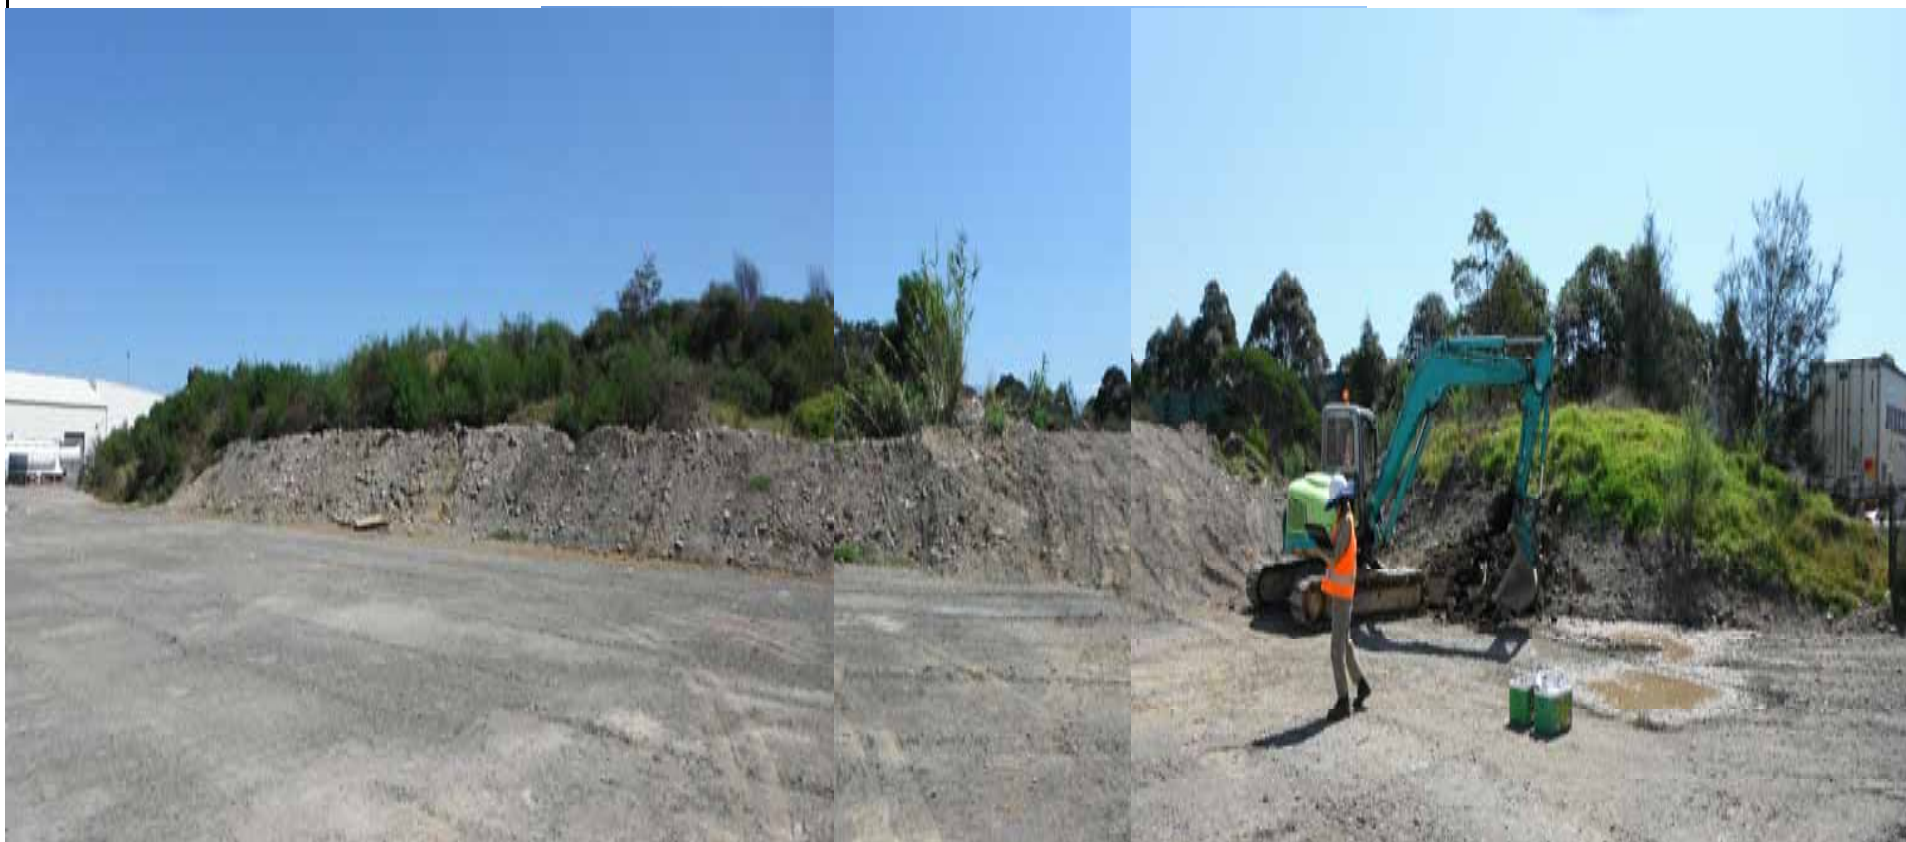
| | OFFICE: Sydney | | Photo no. 1 |

Panoramic view of the existing earthen mound located in the north-western portion of Yennora Distribution Centre site

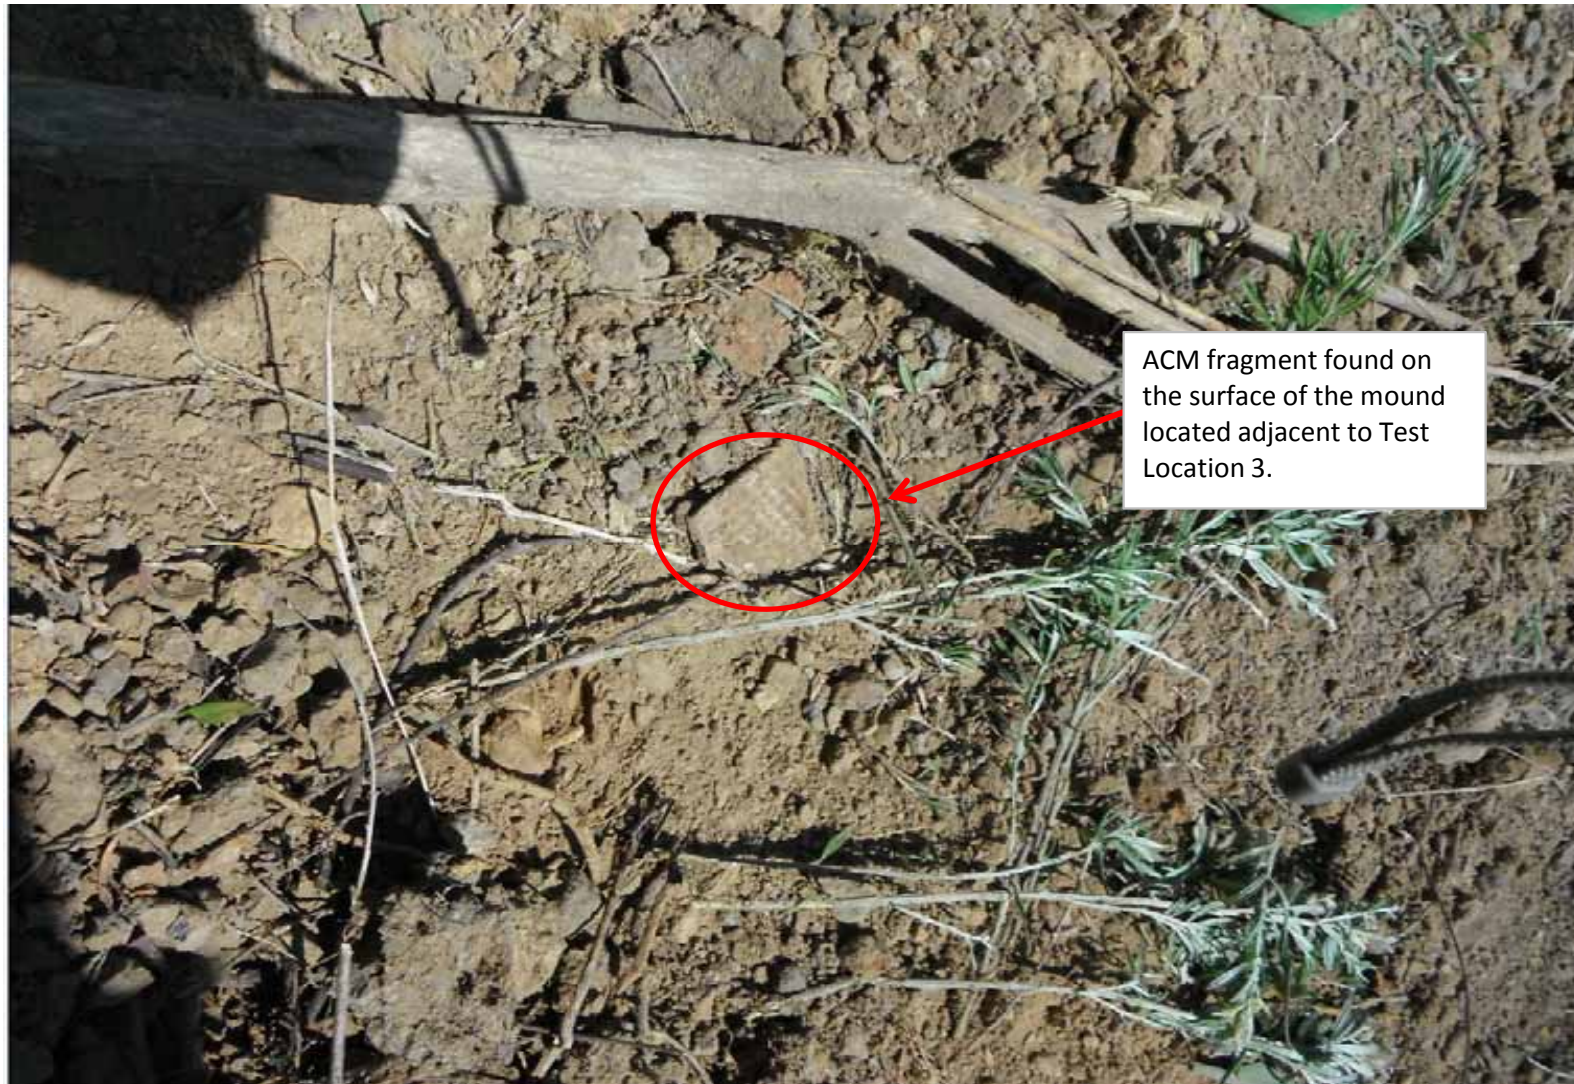
The material observed during excavation generally comprised sandy and/or silty clay filling with some gravel. A fragment of potential asbestos containing material (PACM; Photo 3) was observed adjacent to Test Pit 3. A trace to some construction and demolition (C&D) waste was observed in Test Pits 2

Chrysotile, amosite and crocidolite asbestos were identified embedded in several fragments of fibre cement in the sample collected from Test Pit 12 at 1 m below the surface of the mound. It is estimated that the fibre cement contains up to 15% asbestos fibres and the weight of the asbestos fibres is considered to be greater than the laboratory reporting limit. An asbestos fibre cement fragment was also observed adjacent to Test Pit 3 (not tested).

ACM fragment found on the surface of the mound located adjacent to Test Location 3.

If ACM is found (and no asbestos fibres are detected in the analysed soil samples) segregate the ACM from the soil matrix and, if shown to be successful, dispose of the soil in the portion as GSW (subject to chemical concentrations) and the segregated ACM as Asbestos Waste.

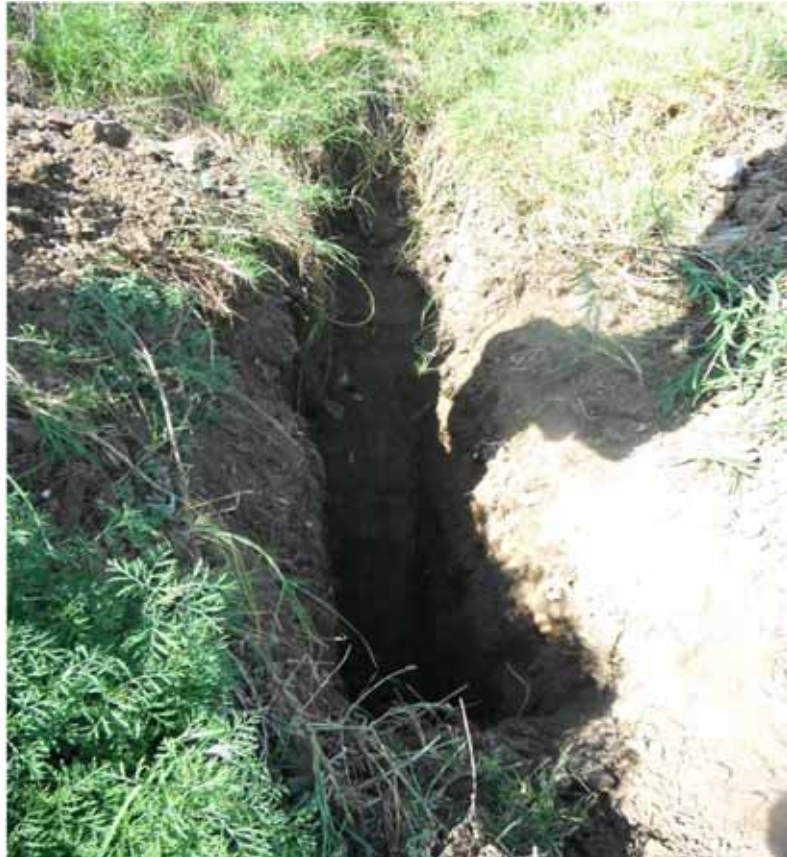
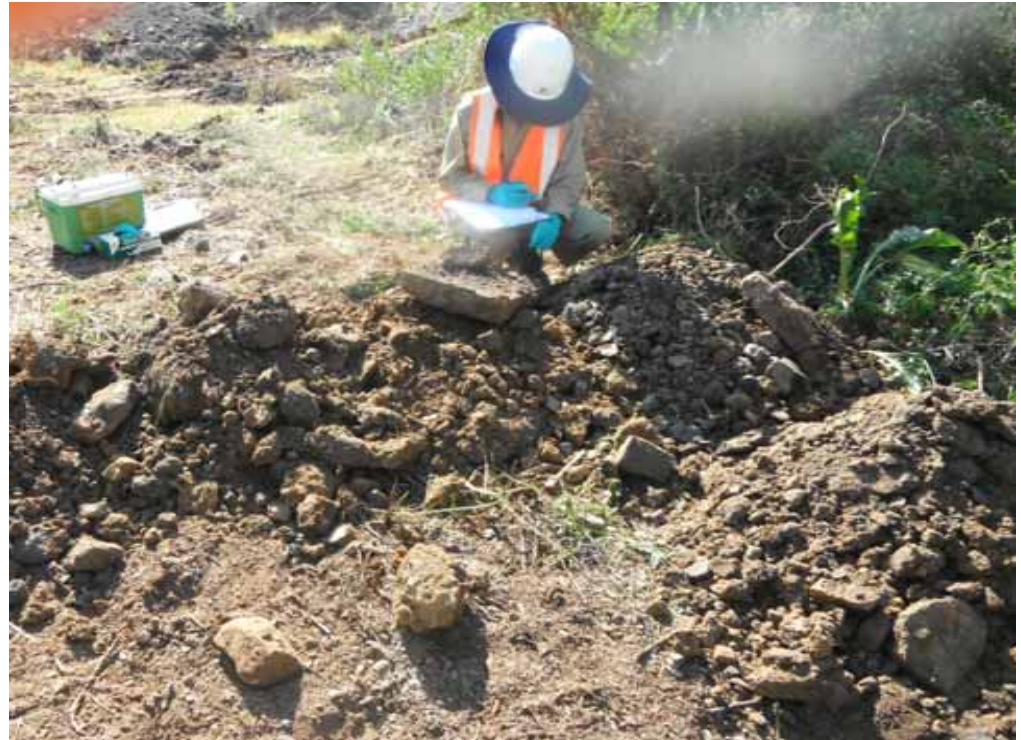
Test Pit 12 - Asbestos identified in soil sample
