**Stockland Developments Pty Ltd**  
**Level 25, 133 Castlereagh Street**  
**Sydney NSW 2000**

**Project 73624.02**  
**4 March 2016**  
**73624.02.R.001.Rev1**  
**KS:mm**

**Preliminary Stockpile Contamination Investigation**  
**Yennora Distribution Centre,**  
**Dennistoun Avenue, Yennora**

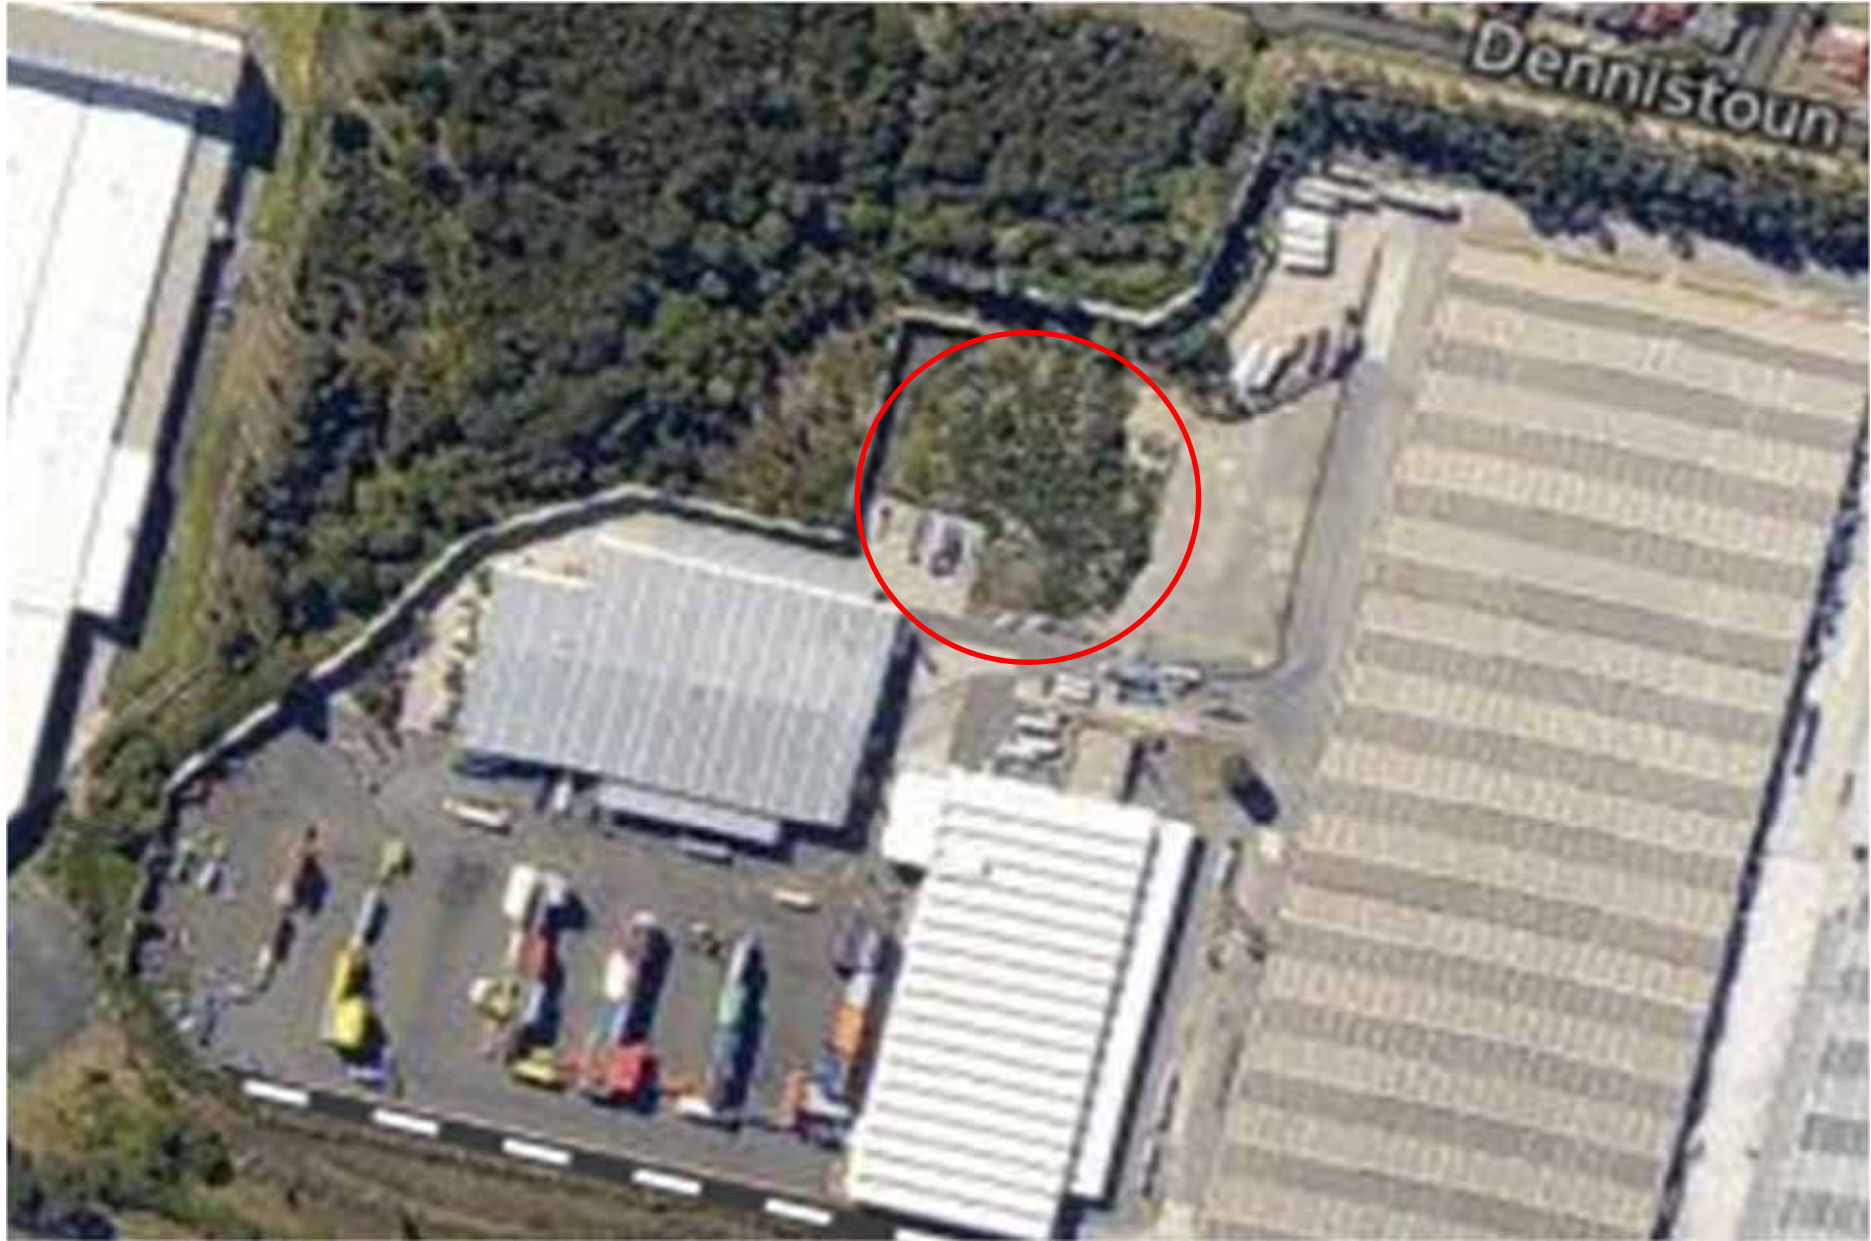
This letter report has been prepared by Douglas Partners Pty Ltd (DP) for the Yennora Distribution Centre, Dennistoun Avenue, Yennora (the 'site') in relation to an existing soil stockpile located at the site, as shown on the attached Drawing 1 (extract from DP, 2013). The investigation was commissioned by Mr Baki Bastepe of Stockland Developments Pty Ltd in support of a development application for a proposed new building (Building 8A at the location of the existing stockpile) and the removal and relocation of the existing stockpiled material as an acoustic mound along the Dennistoun Avenue frontage (near Building 1).

The subject stockpile is located in the north western portion of the Yennora Distribution Centre (the site) and is bounded by Building 2 to the east, Buildings 3 and 8B to the south and west and bushland to the north.

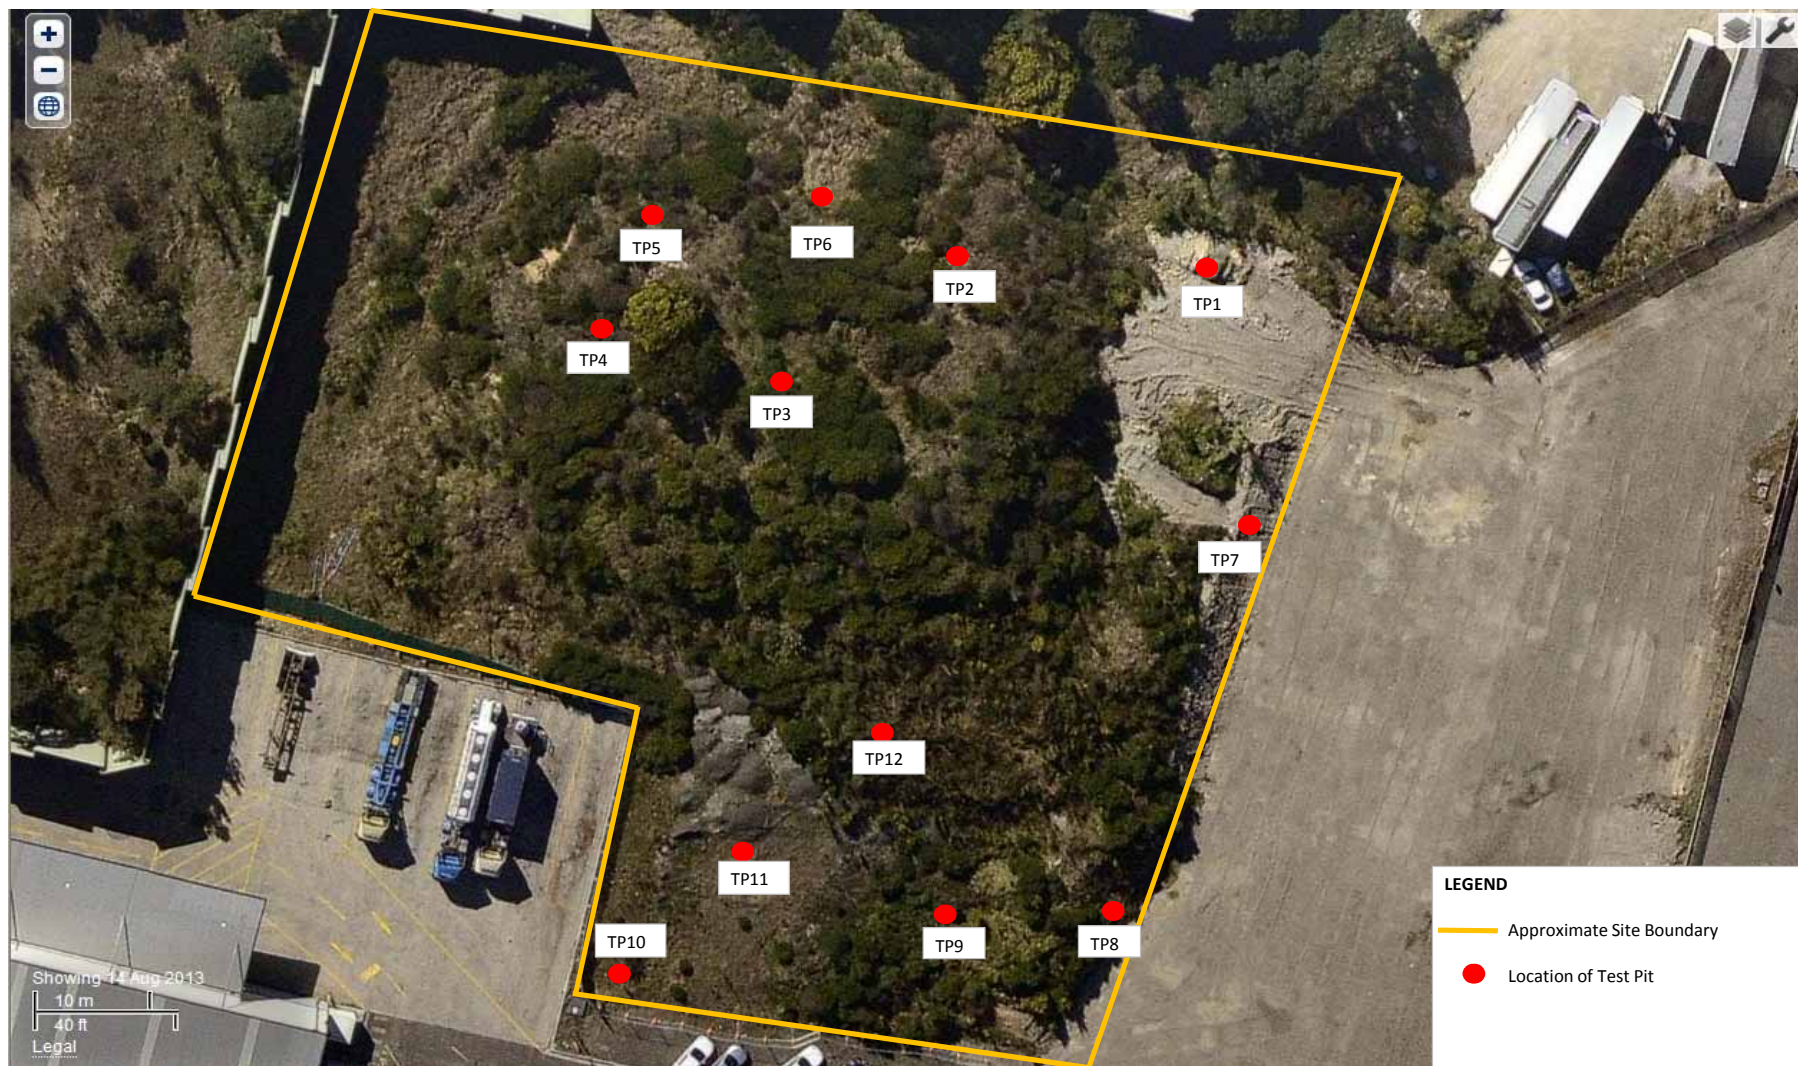
The test pit locations are shown on the attached Drawing 2 (extract from DP, 2013).

- Soil excavated generally comprised sandy and/or silty clay fill with some gravel;
- Potential asbestos containing material (ACM) was observed in Test Pit 3;
- Construction and demolition waste were observed in Test Pits 1, 2, 7, 8 and 12; and
- Ash and slag were observed in Test Pits 3, 6, 9, 10 and 12.

All analytical results were within the adopted SAC with the exception of asbestos detected in sample TP12/1 m.

Based on the data collected in 2013, the stockpile is considered to be suitable to remain on site subject to the following:

- Conduct additional sampling in accordance with NEPC (2013) and the NSW EPA sampling design guidelines, including further more detailed assessment of asbestos in accordance with the

procedure outlined in NEPC (2013) and the WA Department of Health *Guidelines for the Assessment, Remediation and Management of Asbestos-Contaminated Sites in Western Australia*, 2009. The supplementary sampling and testing will take place during the construction phase;
