# PROPOSED MODIFICATION NO.5 SPRING FARM QUARRY CONSENT (DA 75/256)

## ENVIRONMENTAL ASSESSMENT

### APPENDIX M

# LANDSCAPE REHABILITATION AND BUSH REGENERATION REPORT

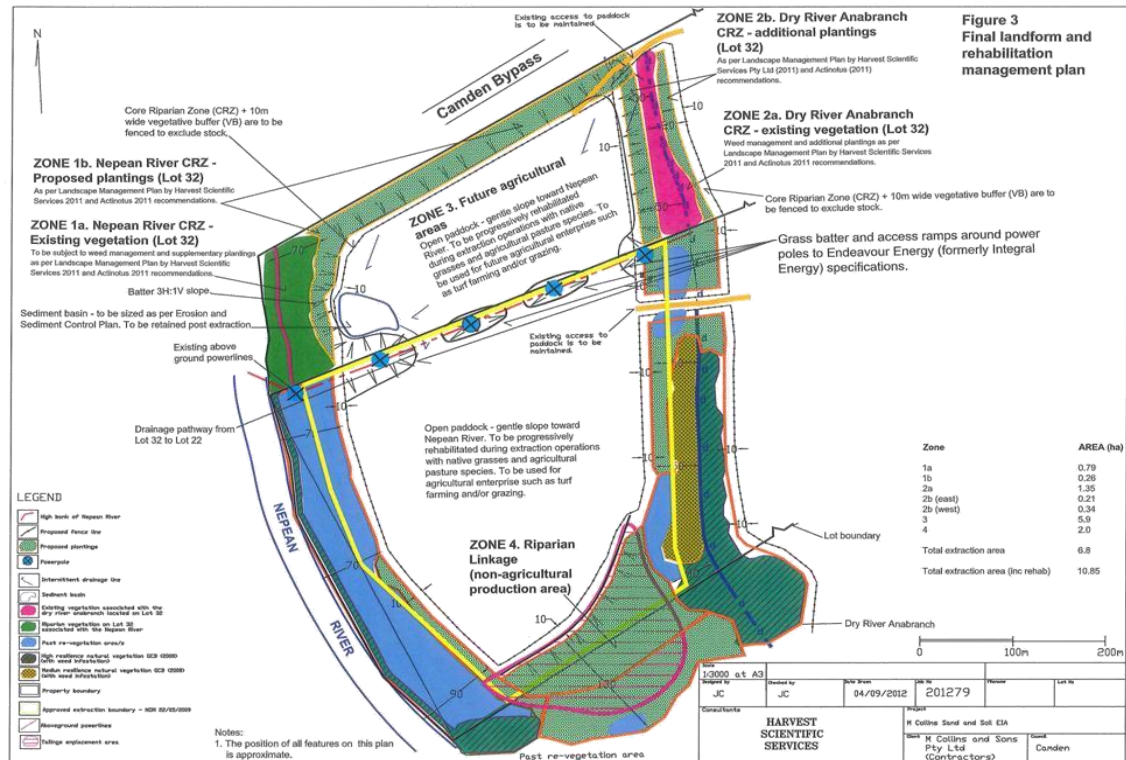
**Figure 3. Final Landform and rehabilitation management plan**

The Report is structured to address the following landscape “zones”:

- Zone 1(a) – Nepean River – Core Riparian Zone existing vegetation on riverside bank extending to river edge at lot 32
- Zone 1(b) – Northern Quarry Batter – Establishment of natural vegetation post extraction on Lot32
- Zone 2 (a) – Dry River Anabranh – Core Riparian Zone additional plantings on the western bank on Lot32
- Zone 2 (b) – Dry River Anabranh – Core Riparian Zone existing vegetation on the eastern bank on Lot 32
- Zone 3 – Agriculture Production Lands – Post extractive land use return to Agriculture on Lot 32
- Zone 4- Non-Agricultural Land on Lot 22- Provides a permanent elevated linkage between the Nepean River and the Dry Anabranh
- Zone 7 - Dry River Anabranh on Lot 1 – Comprising Core Riparian zone along the western bank

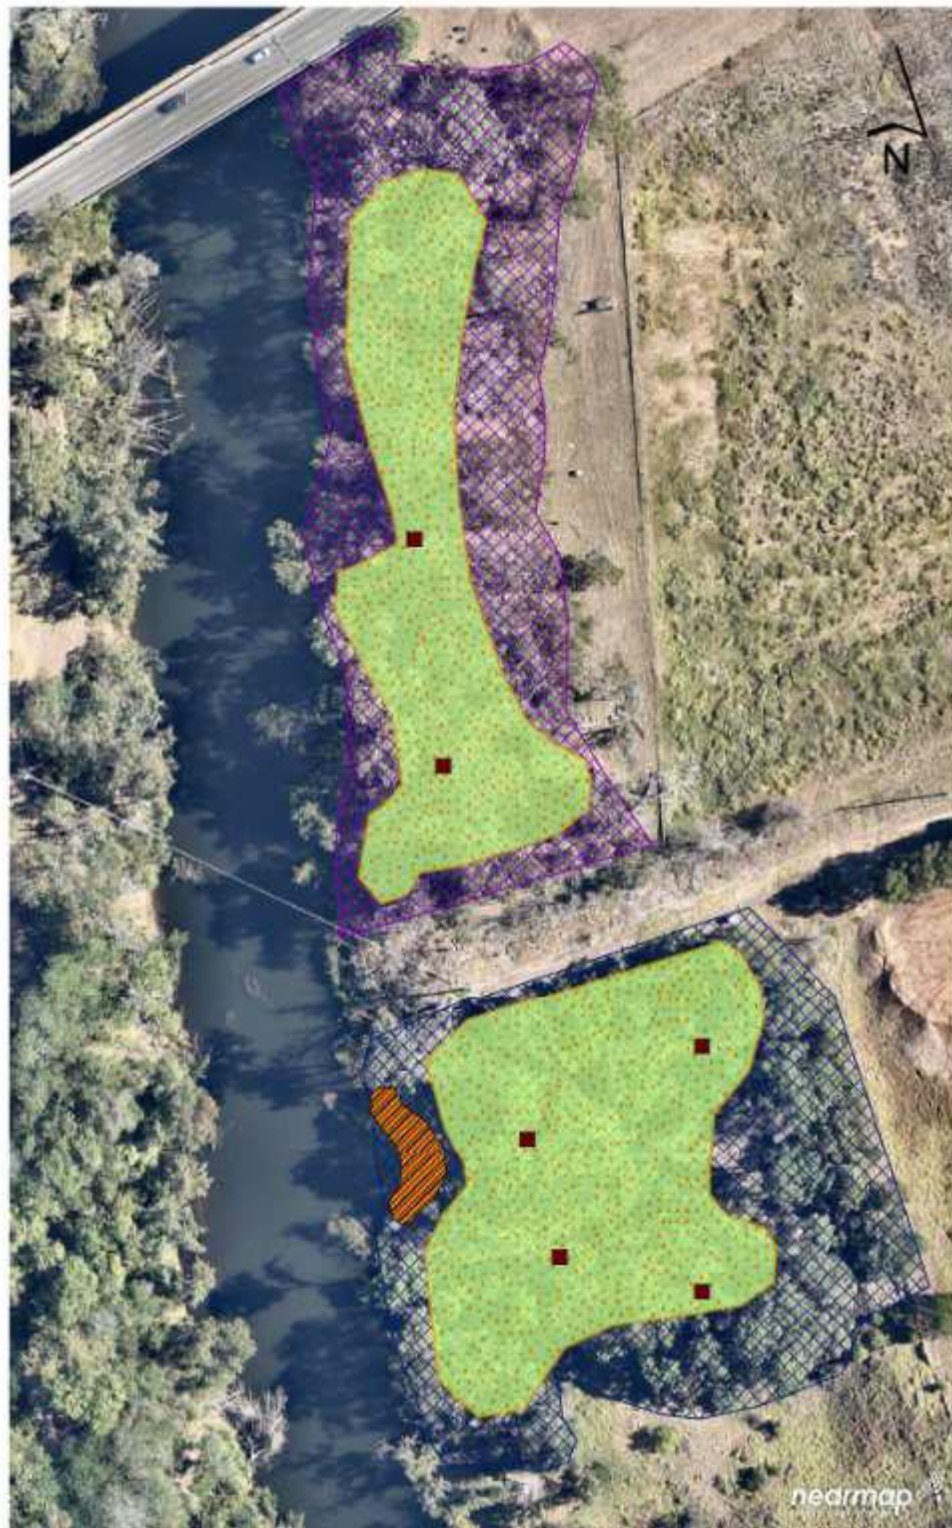
Zone 1a. & Zone 5. Riparian Forest Restoration works.

- Nesting Boxes
- Revegetation Zone
- Bank Stabilisation
- Secondary Weed Control
- Primary Weed Control

*Note: This map is for visual representation, the position of all features on this plan is approximate.*

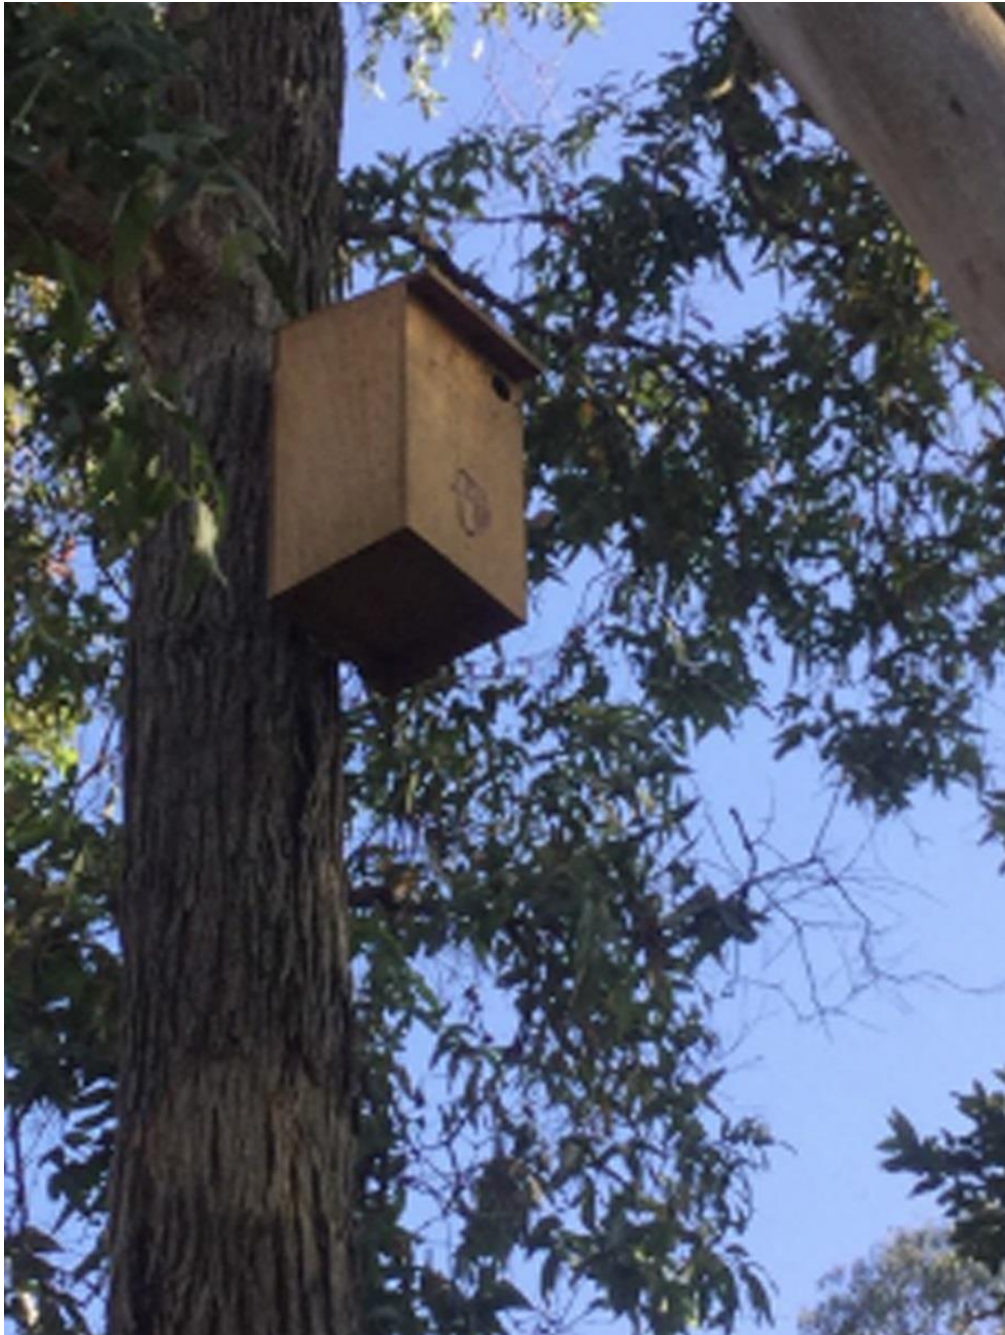
Typical nesting box installed

There have been four habitat nest boxes installed within the bushland areas

Installation of ten nesting boxes targeting arboreal marsupials has been completed. Brush tail possums are active in the area with sufficient existing habitats however the following nesting boxes were installed to enhance the existing habitat:
