MOUNT PLEASANT OPERATION

2019 ANNUAL REVIEW & ANNUAL REHABILITATION REPORT

Document ID:	20200120		
Company:	MACH Energy Australia Pty Ltd		
Effective Date:	-	Status:	Issued for Approval
Approved By:	Richard Bailey	Revision Number:	00

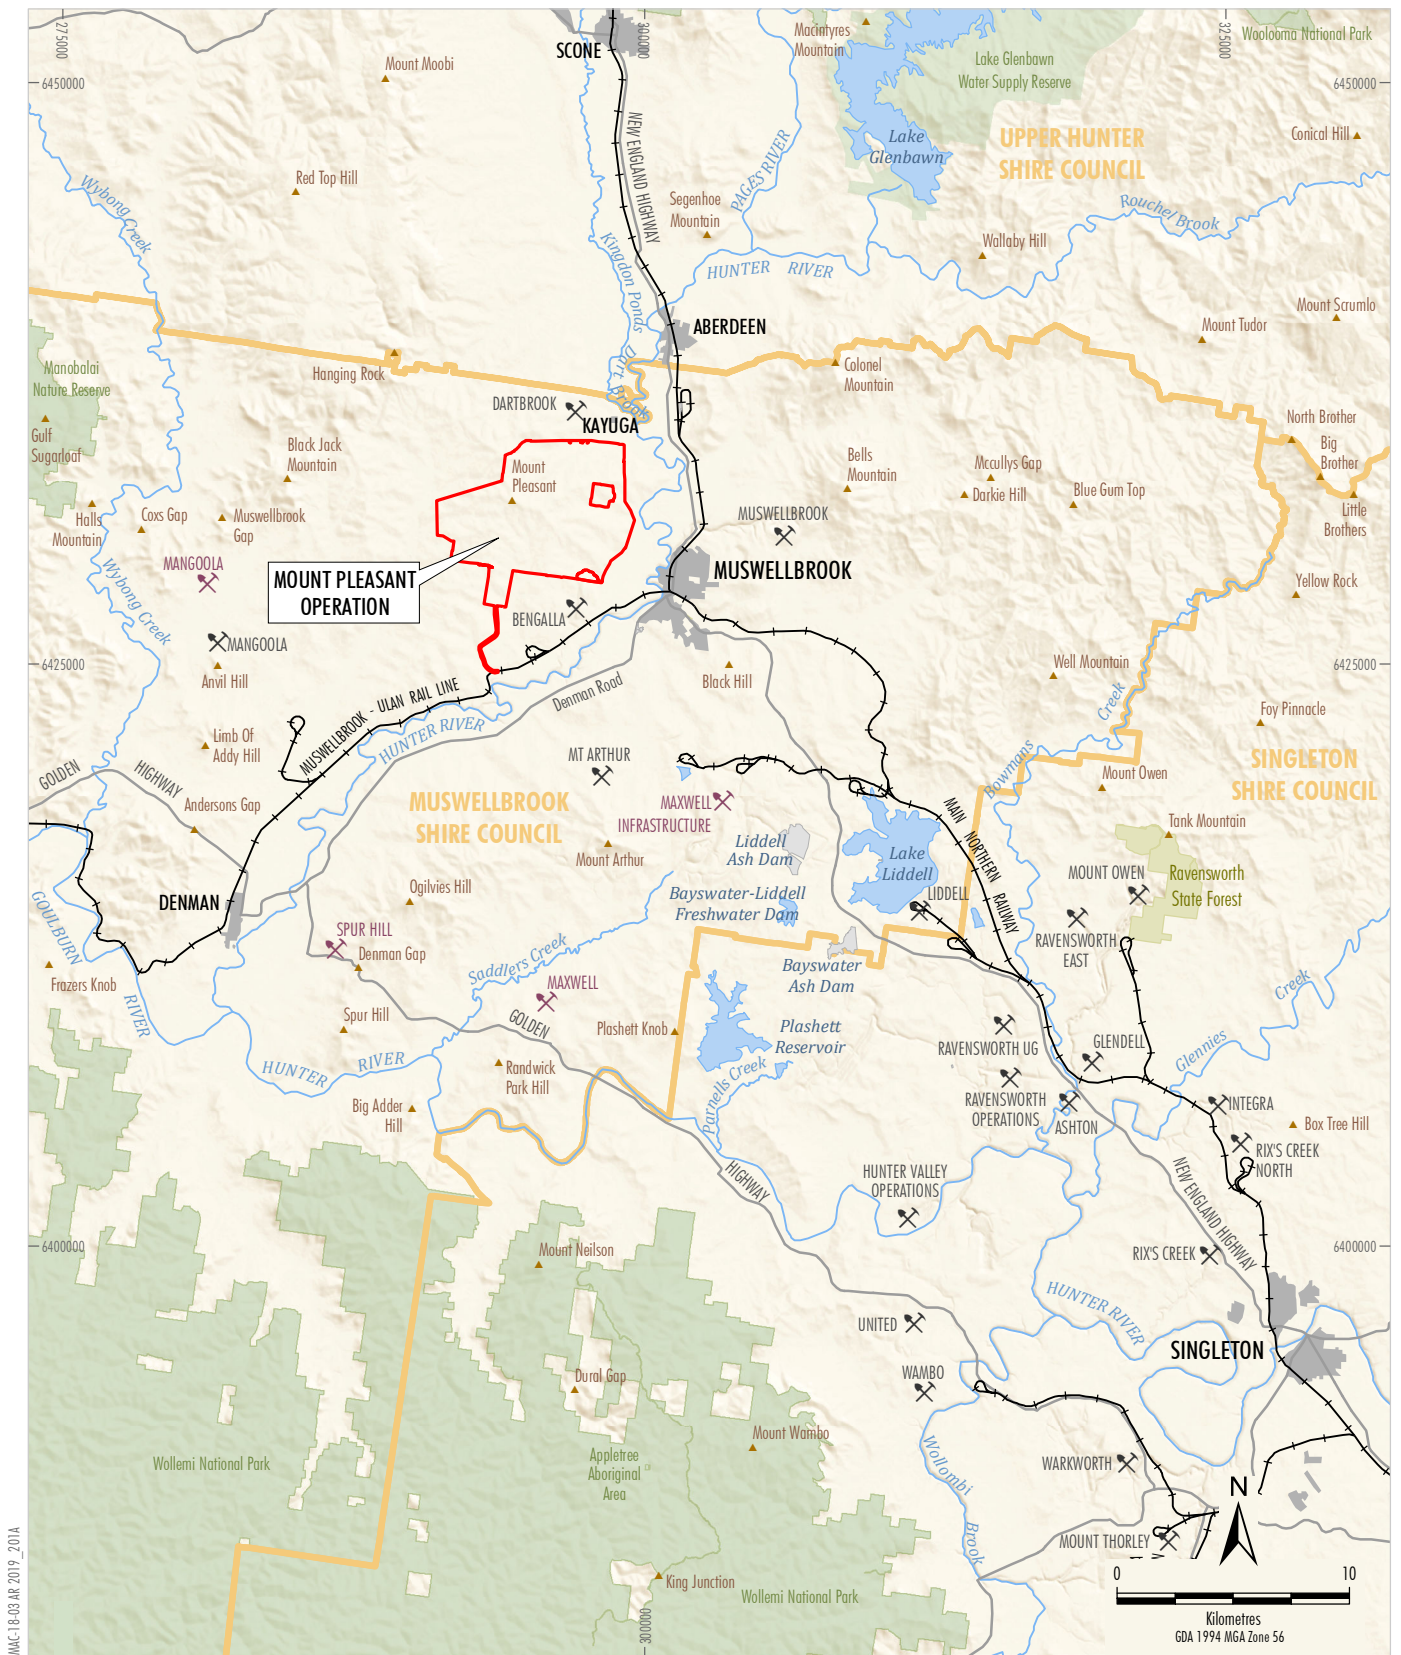
Figure 2 shows the general arrangement of the MPO, as well as the extent of disturbance and rehabilitation at the end of 2019 and the forecasted additional disturbance proposed in 2020.

Figure 2 shows the extent of active disturbance and rehabilitated areas at the end of the reporting period, as well as the forecast disturbance areas proposed in 2020.

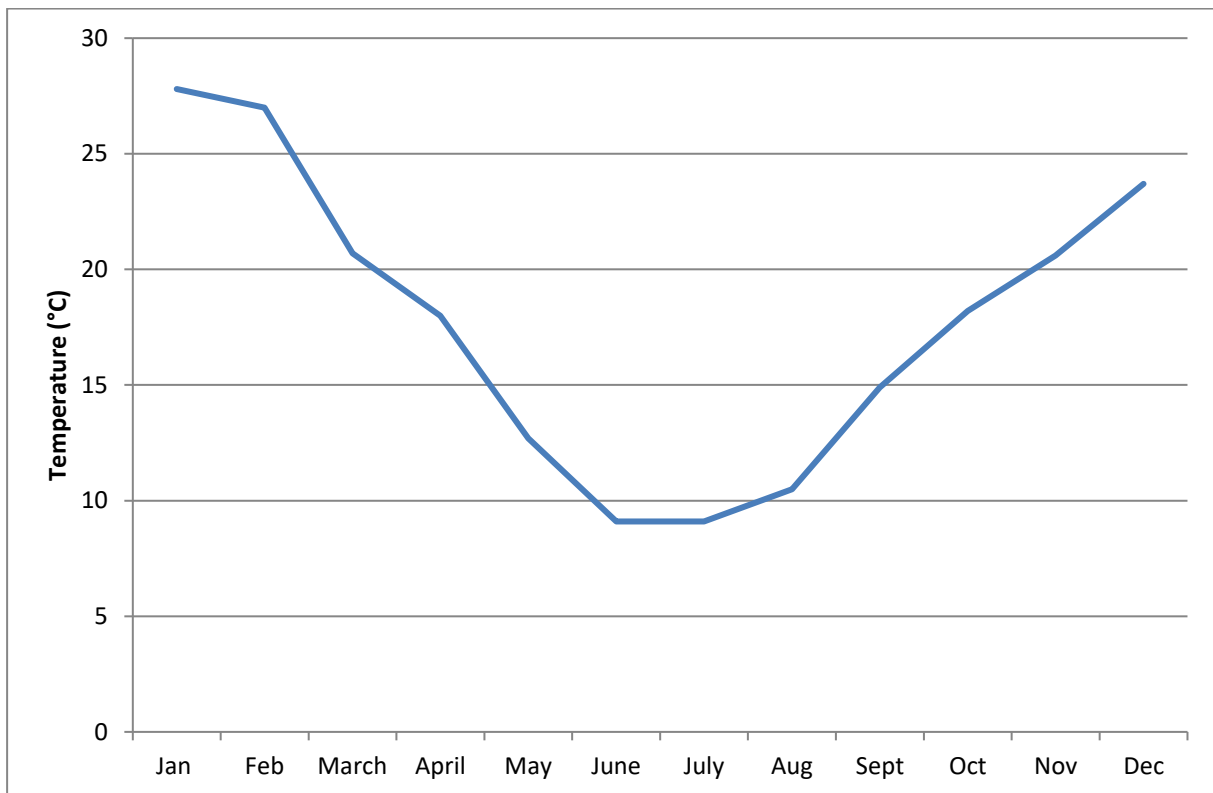
Chart 2: MPO Monthly Mean Temperature 2019

* and ** Indicates temperature data taken from the Muswellbrook NW: Upper Hunter Air Quality Monitoring Network Monitor and Bureau of Meteorology (Scone Airport), respectively, due to technical issues with M-WS4.

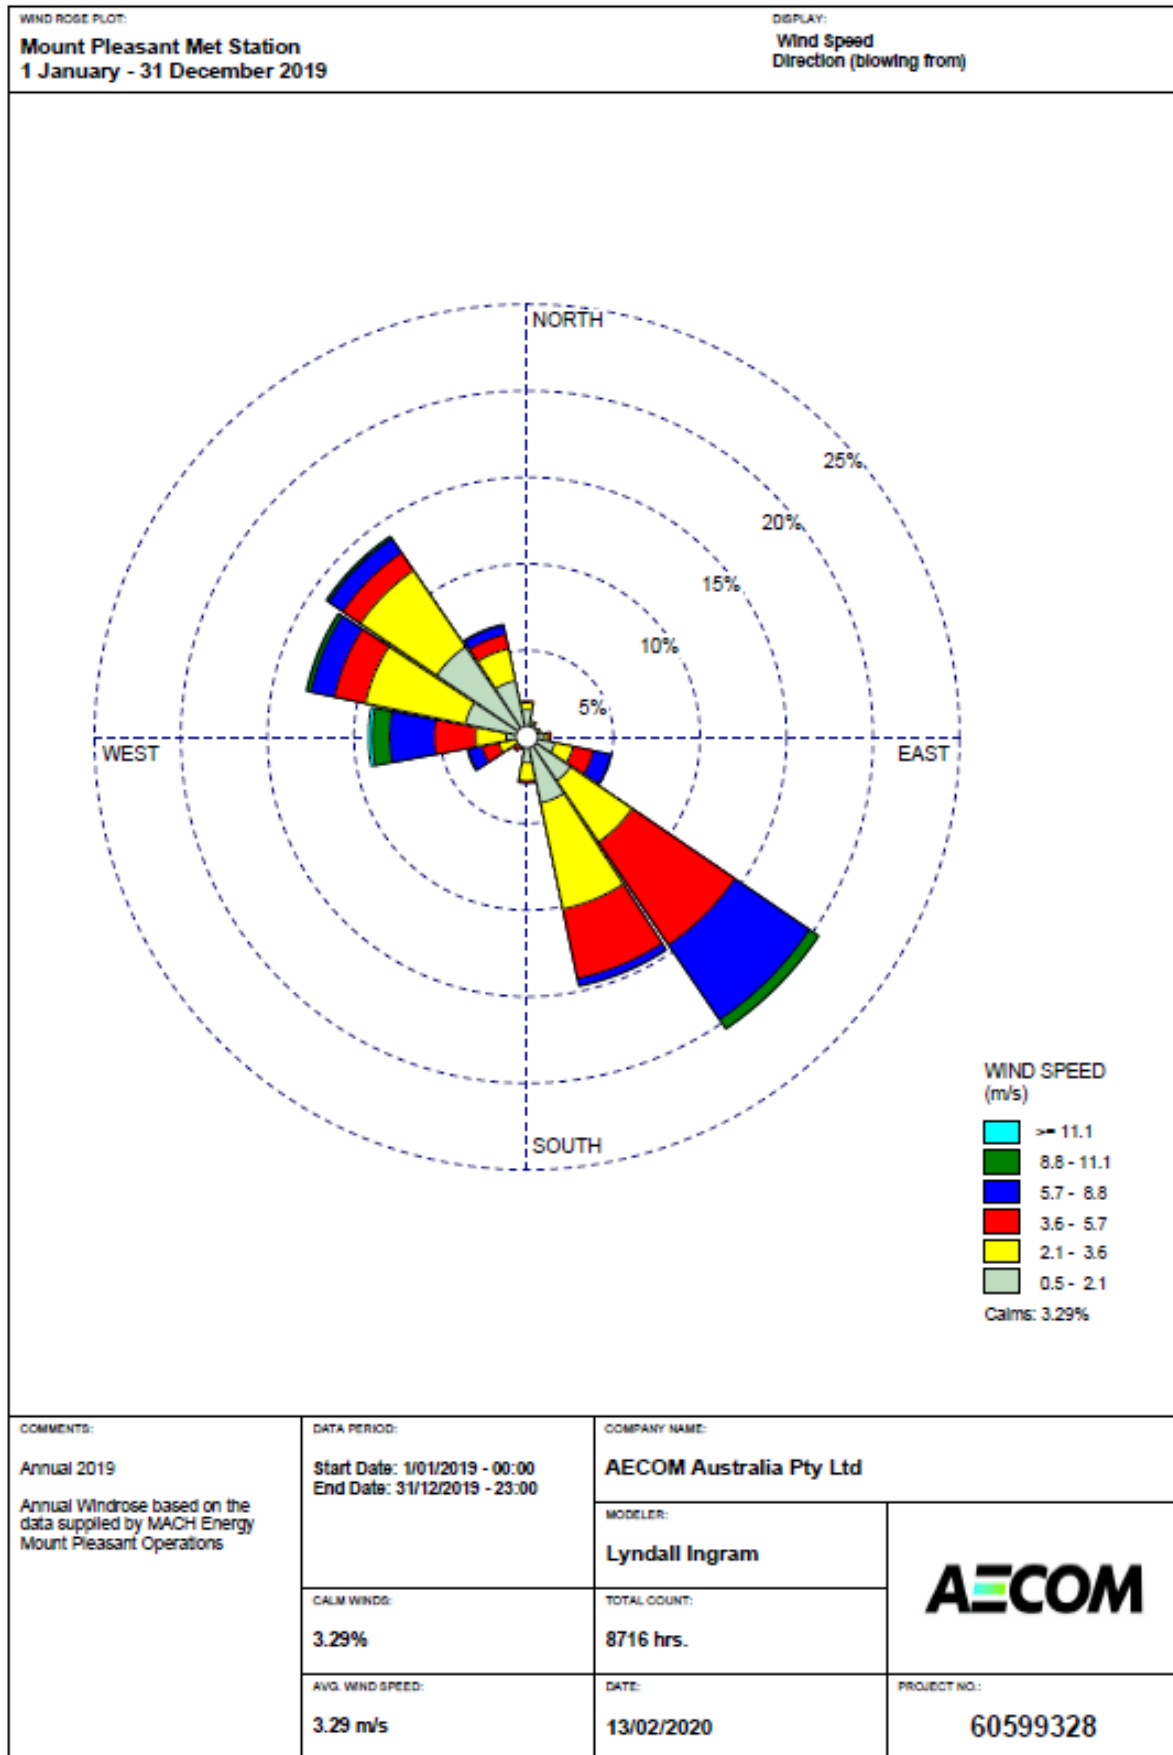
Chart 3: MPO Annual Wind Rose 2019

During the reporting period, the majority of prevailing winds were from the south-southeast and north-west. Only a very minor percentage of winds were generated from the south-west and almost none were generated from the north-east. This is consistent with trends observed in previous Annual Reviews (Coal & Allied, 2014, 2015 and 2016; MACH Energy, 2017b; MACH Energy, 2018b; and MACH Energy, 2019). An annual wind rose is presented in Chart 3.

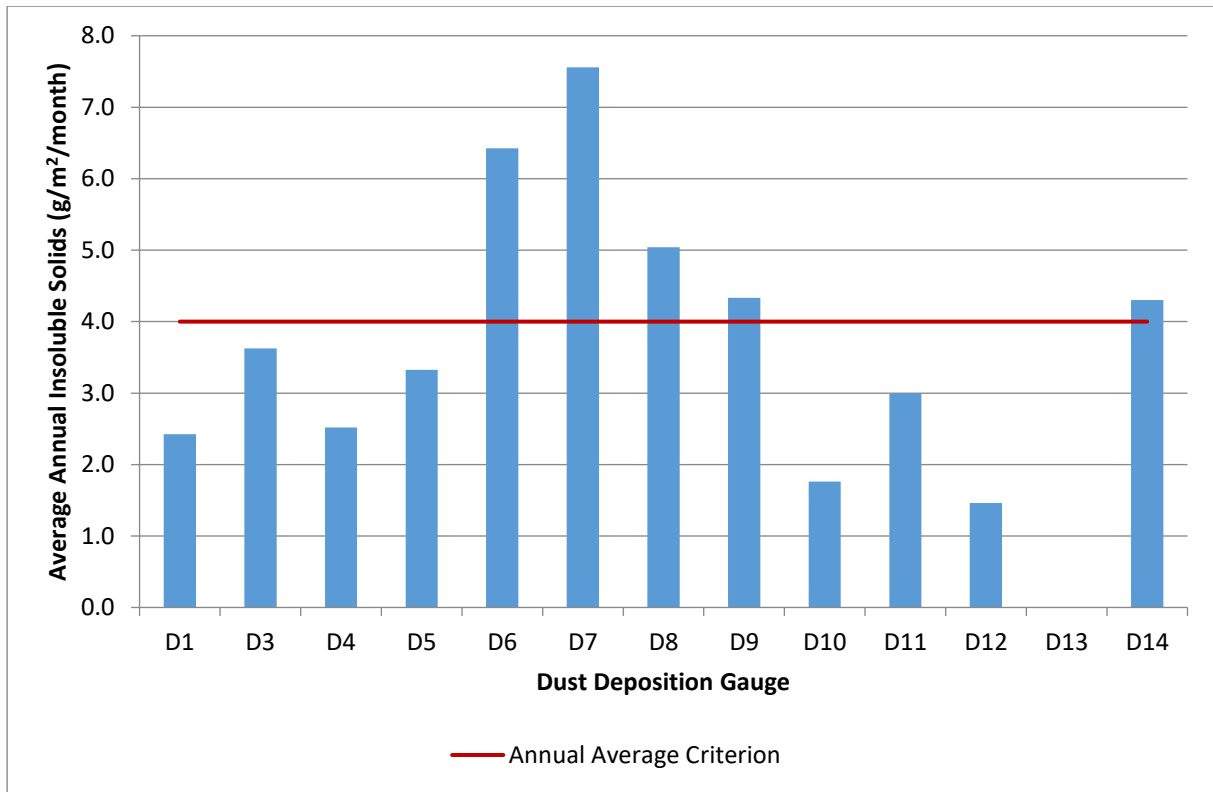
Chart 4: 2019 Annual Average Insoluble Solids

Annual average levels of insoluble solids (i.e. dust deposition) are presented in Chart 4. Chart 5 provides a comparison between annual average dust deposition levels at each of the monitoring sites from 2014 to 2019.

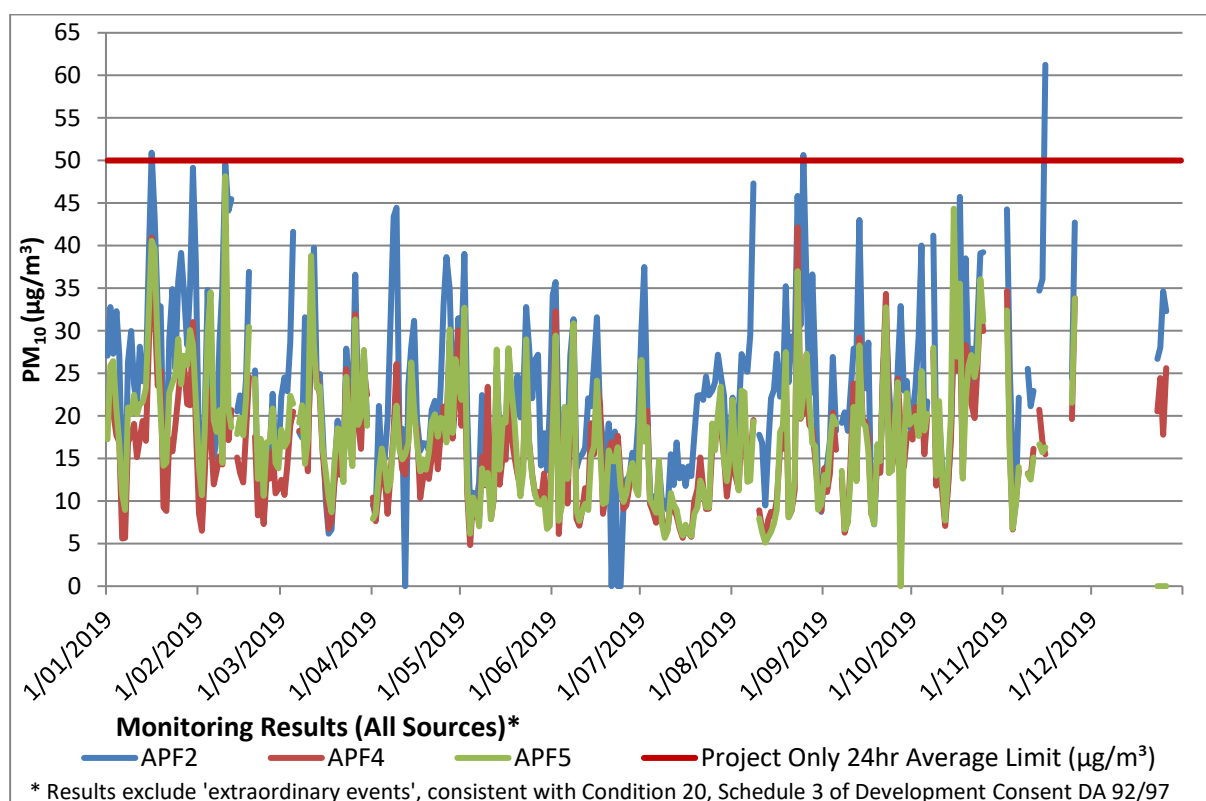
Chart 6: 24 hour Average PM₁₀ Levels

The data presented excludes 'extraordinary events', consistent with Condition 20, Schedule 3 of Development Consent DA 92/97. A total of 57 'extraordinary event' days in 2019 were advised by the DPIE, with the majority associated with bushfire activity and some dust storms/regional dust events. MACH notes that air quality levels in the vicinity of the MPO may have been materially affected by regional dust or bushfire events that occurred on other days. For example, the *Air Quality Monitoring Network Upper Hunter Summer 2018-19 seasonal newsletter* (OEH, 2019) indicates bushfire smoke led to exceedances of the 24 hour average PM₁₀ benchmark in Muswellbrook on 16 and 17 January 2019, however these days were not included in the 'extraordinary event' days advised by DPIE. Notwithstanding, MACH has conservatively adopted only the 'extraordinary event' days advised by the DPIE when presenting monitoring data in this Annual Review. Results inclusive of 'extraordinary events' are provided in Appendix C for completeness.

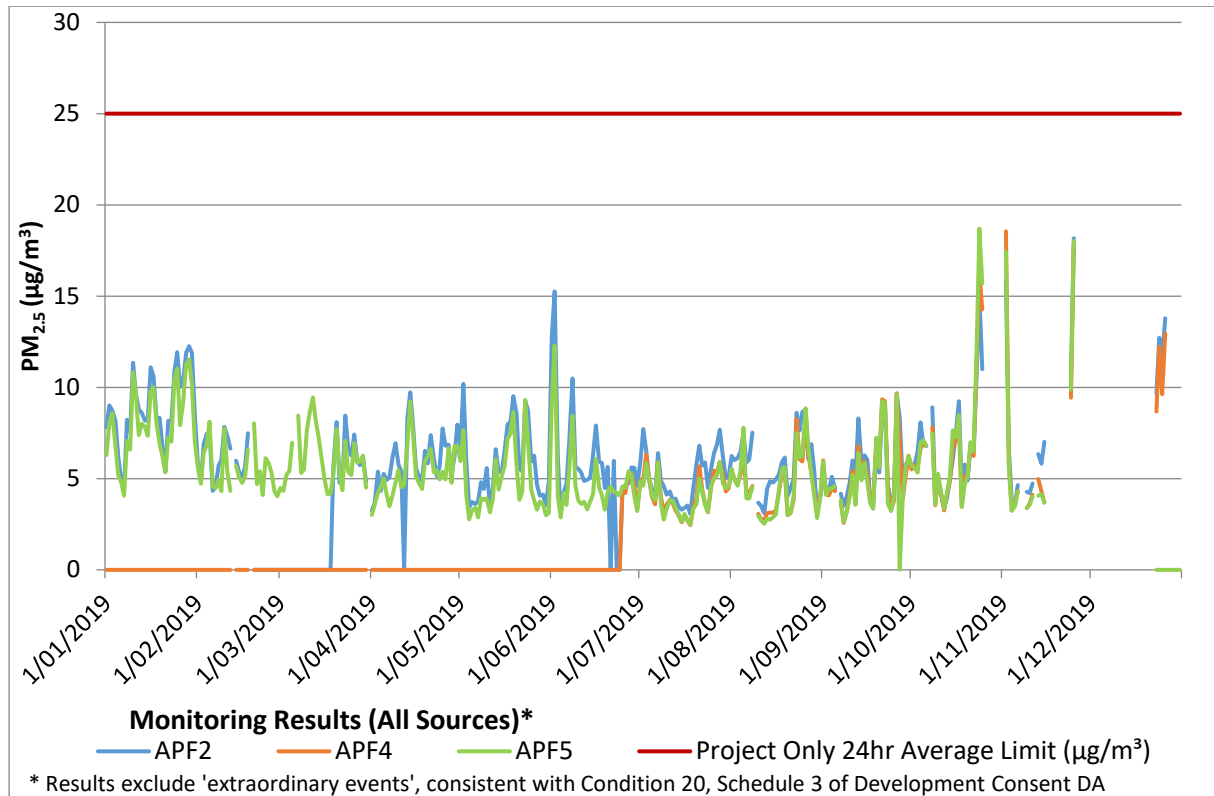
Chart 7: 24 hour Average $\text{PM}_{2.5}$ Levels

During the reporting period, it was identified that PM_{2.5} monitoring results were consistently higher than would be expected. An investigation (with co-located TEOM monitoring) determined that the calibration factor being applied to the raw PM_{2.5} and PM₁₀ measurements was incorrect (i.e. was overstating particulate levels). A letter describing the investigation and outcomes is provided in Appendix D. The data presented in this document therefore applies the new calibration factors determined for PM_{2.5} and PM₁₀. Consistent with advice from the technical specialist who conducted the investigation, the new calibration factors have also been applied to data from previous years (including the 2018 data presented in this Annual Review).

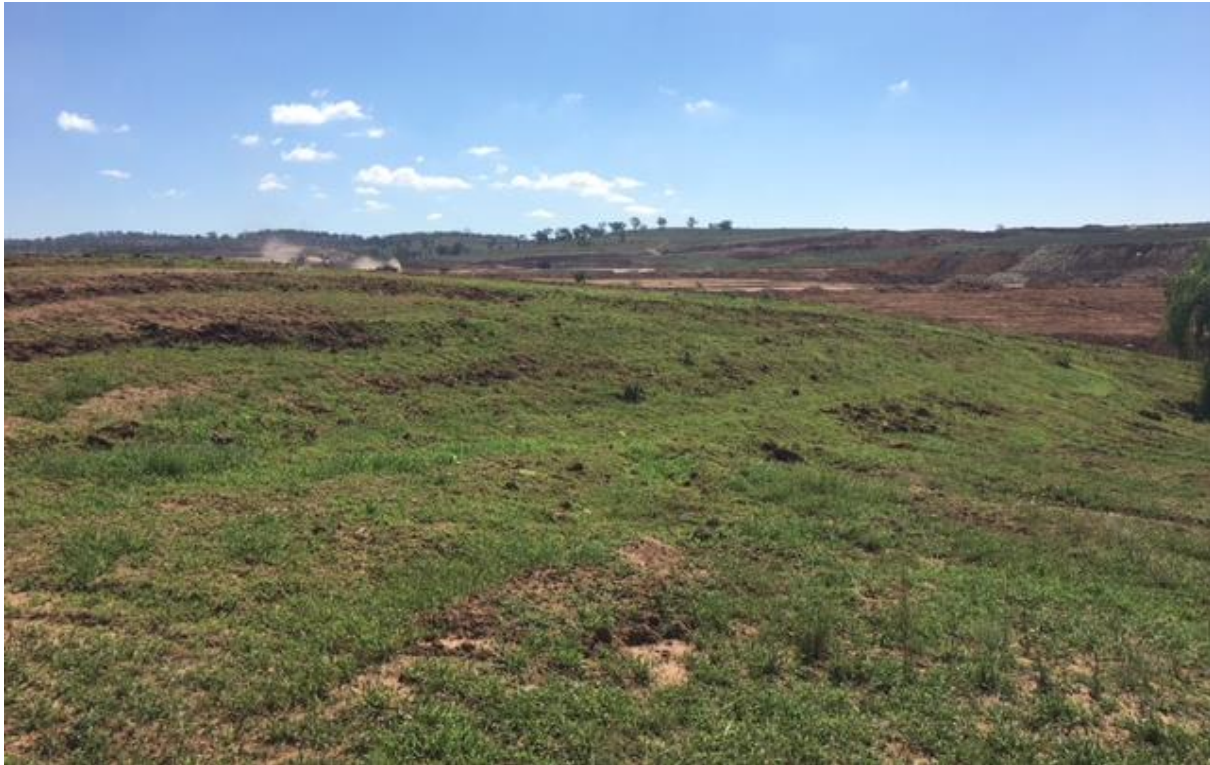
Plate 2: Example Topsoil Stockpile

Plate 2 provides an example topsoil stockpile at the MPO. Further descriptions of topsoil stockpile management options are outlined in the approved MOP/RMP.

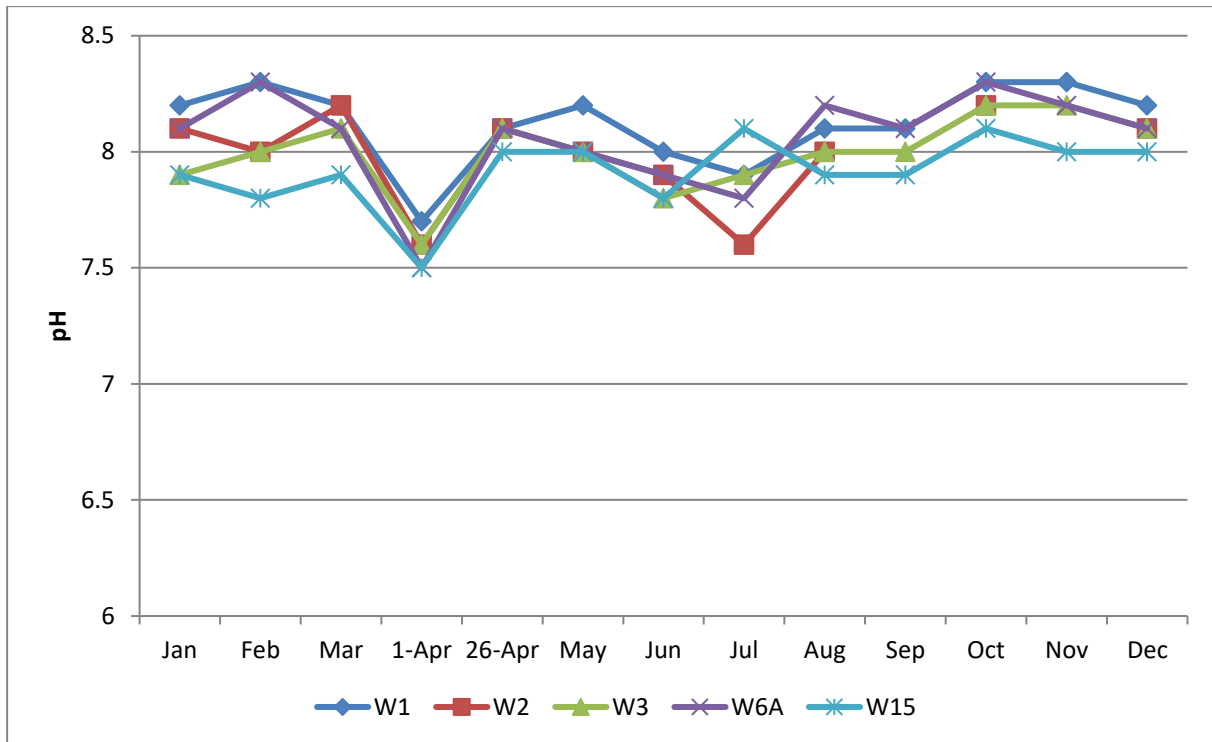
Chart 11: Hunter River pH Levels 2019

Monitored pH values for the Hunter River monitoring sites during the reporting period are shown in Chart 11. Additionally, a comparison between 2017, 2018 and 2019 pH values is provided in Chart 12.

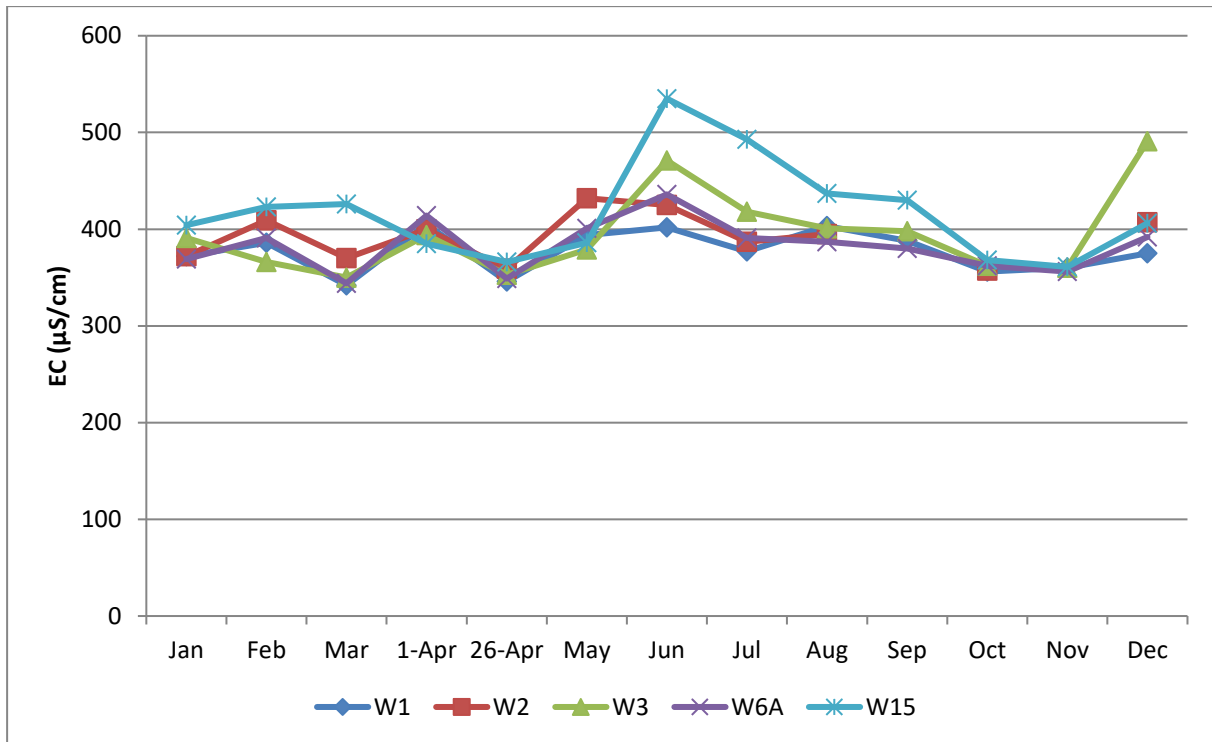
Chart 13: Hunter River EC Levels 2019

EC values for the 2019 monitoring period are shown in Chart 13. Additionally, a comparison between 2017, 2018 and 2019 EC values is provided in Chart 14.

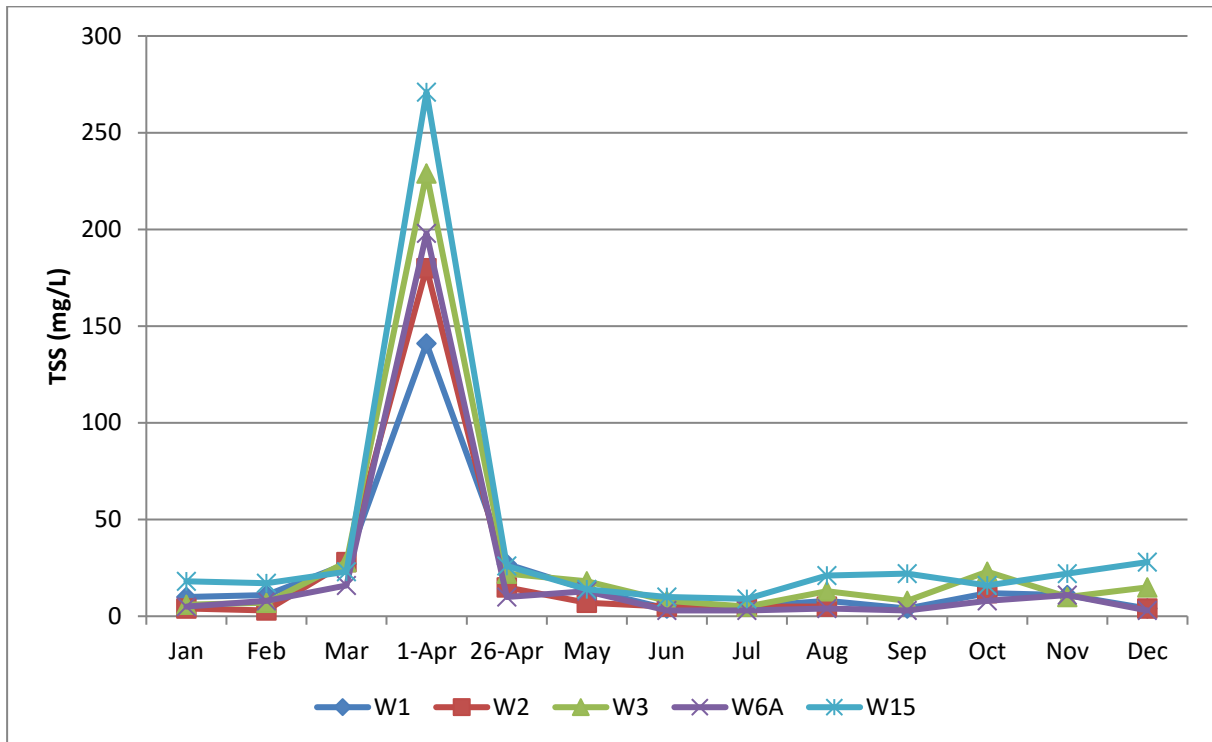
Chart 15: Hunter River TSS Levels 2019

TSS values for the 2019 monitoring period are shown in Chart 15. Additionally, a comparison between 2017, 2018 and 2019 TSS values is provided in Chart 16.

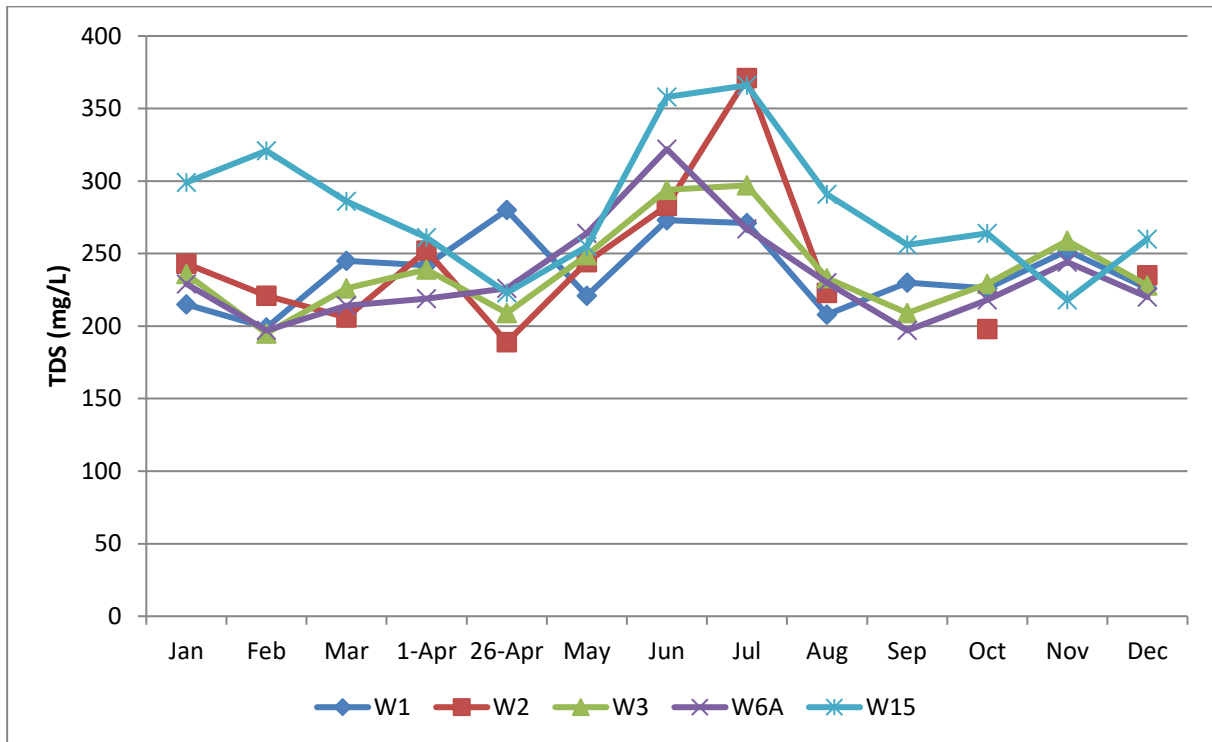
Chart 17: Hunter River TDS Levels 2019

TDS values for the 2019 monitoring period are shown in Chart 17. Additionally, a comparison between 2017, 2018 and 2019 TDS values is provided in Chart 18.

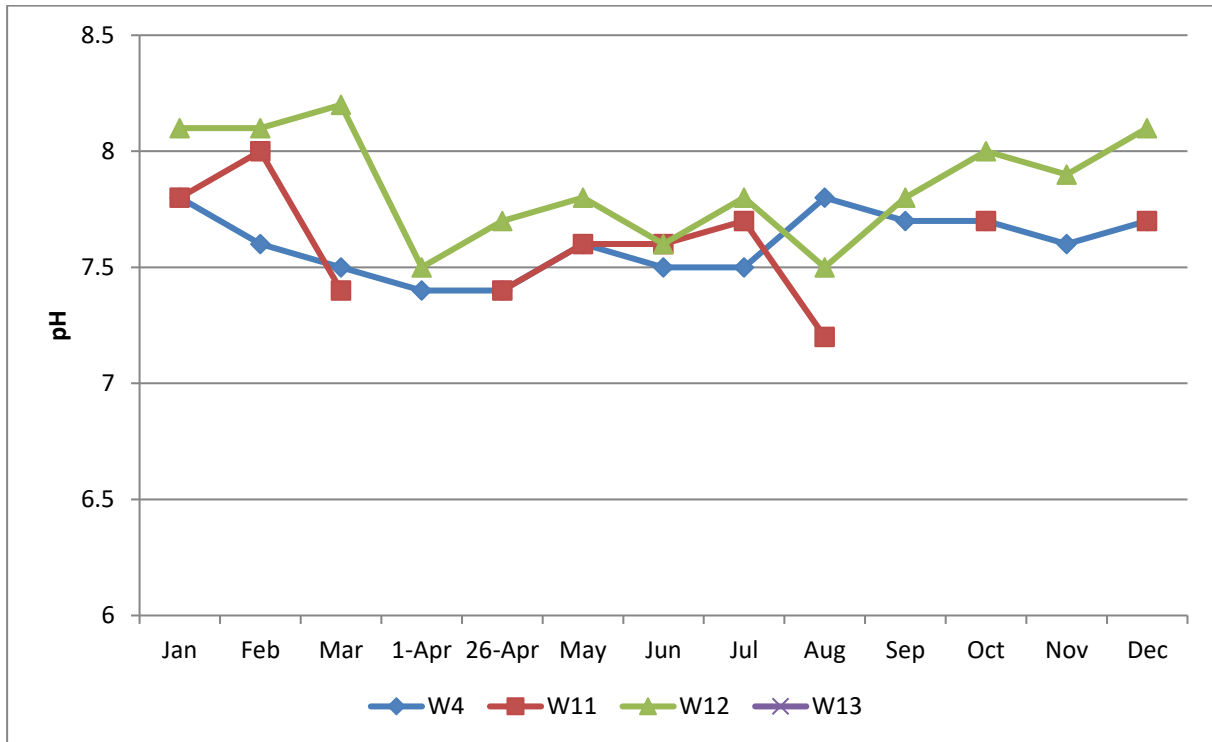
Chart 19: Sandy, Muscle and Rosebrook Creeks pH Levels 2019

Monitored pH values for the Sandy, Muscle and Rosebrook Creek monitoring sites during the reporting period are shown in Chart 19. Additionally, a comparison between 2017, 2018 and 2019 pH values is provided in Chart 20.

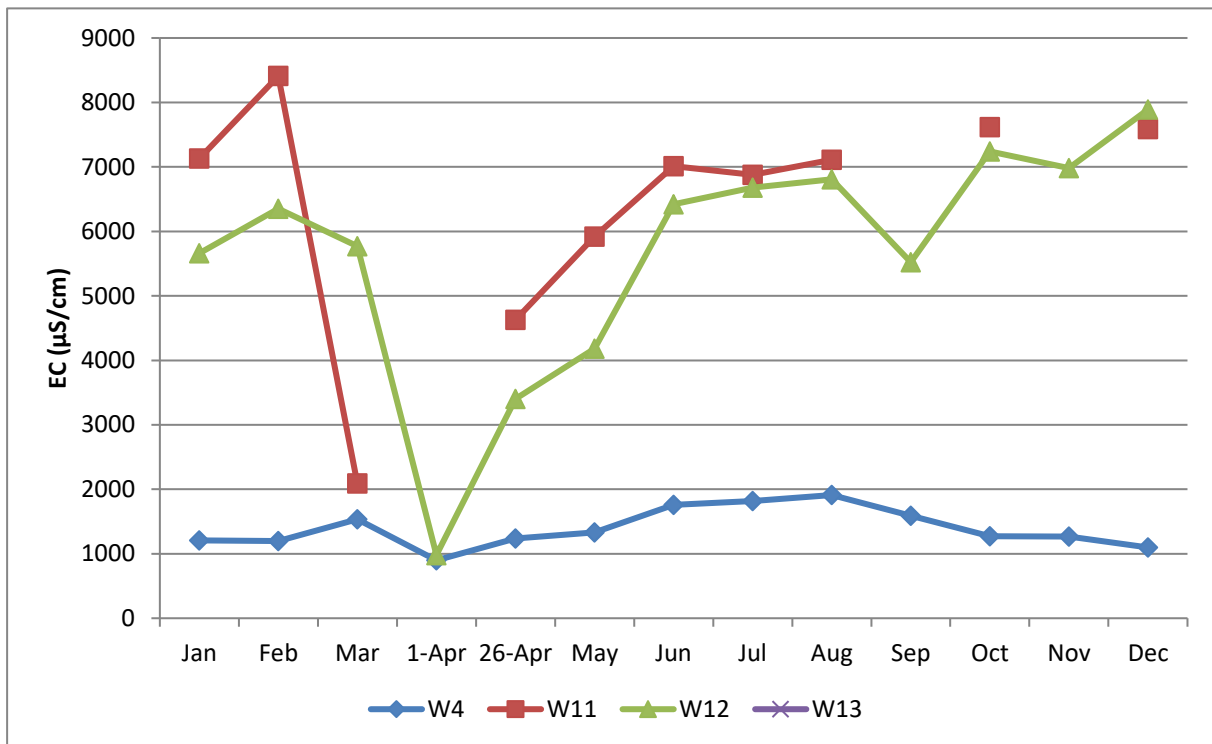
Chart 21: Sandy, Muscle and Rosebrook Creeks EC Levels 2019

EC values for the 2019 monitoring period are shown in Chart 21. Additionally, a comparison between 2017, 2018 and 2019 EC values is provided in Chart 22.

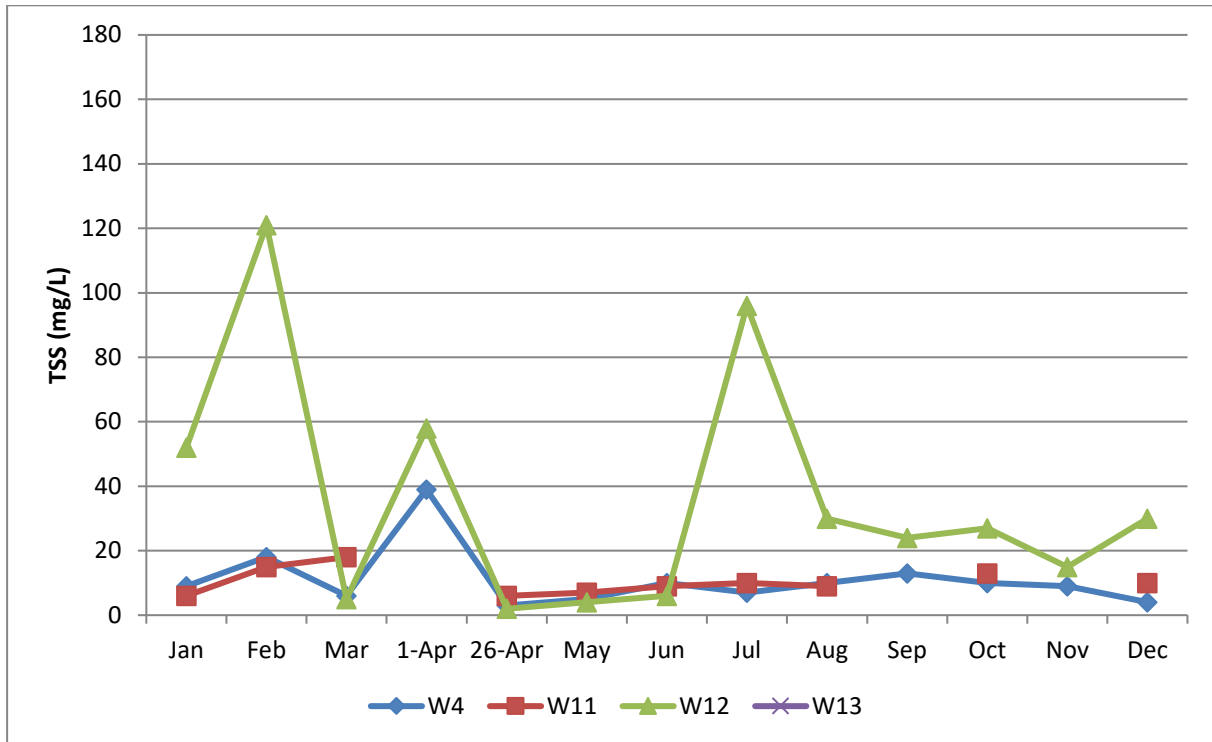
Chart 23: Sandy, Muscle and Rosebrook Creeks TSS Levels 2019

TSS values for the 2019 monitoring period are shown in Chart 23. Additionally, a comparison between 2017, 2018 and 2019 TSS values is provided in Chart 24.

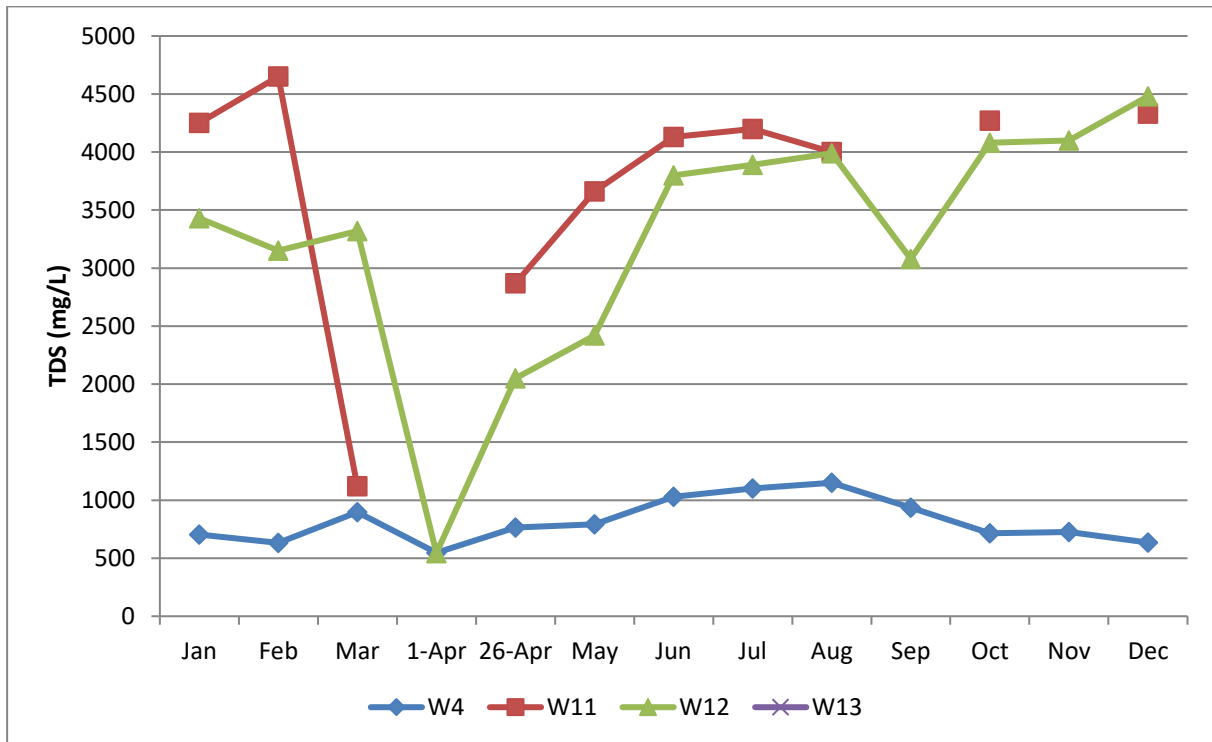
Chart 25: Sandy, Muscle and Rosebrook Creeks TDS Levels 2019

Recorded TDS values for the 2019 monitoring period are shown in Chart 25. Additionally, a comparison between 2017, 2018 and 2019 TDS values is provided in Chart 26.

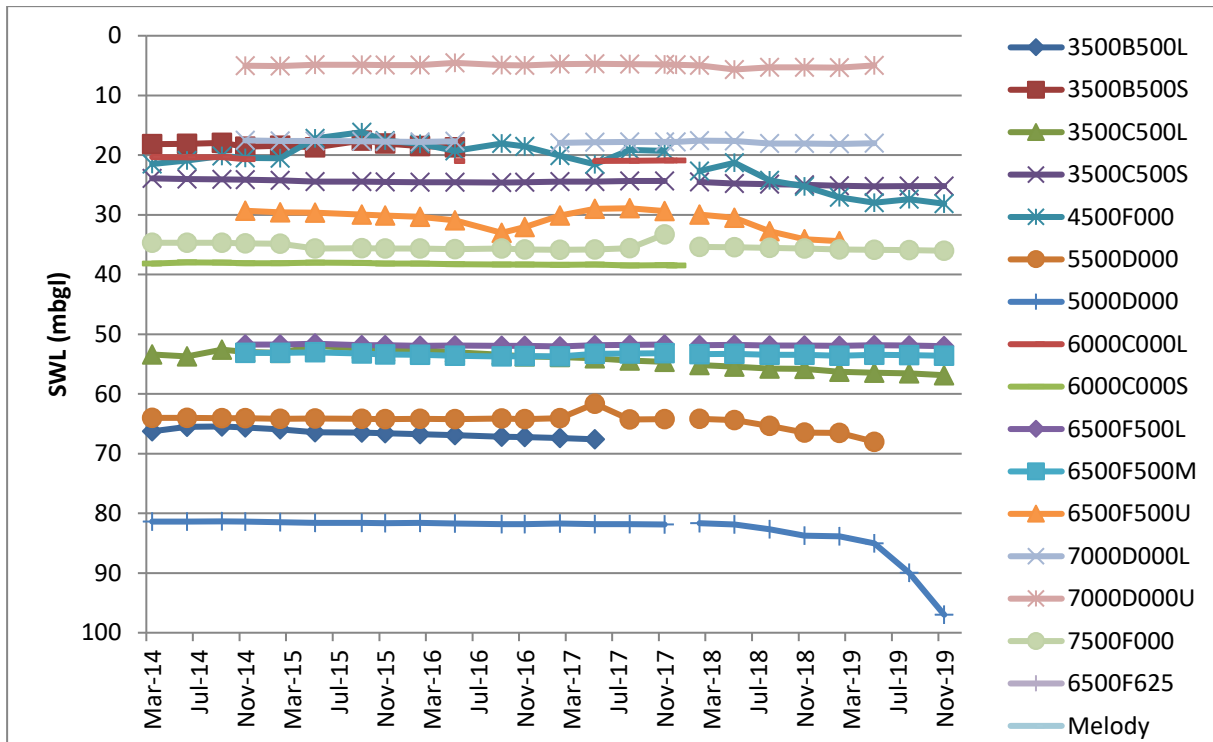
Chart 27: Groundwater Central Bores SWL 2014 – 2019

The results of monitoring SWL (measured in metres below ground level [mbgl]), EC and pH from 2014 to 2019 for the groundwater central bores are shown in Charts 27, 28 and 29 respectively.

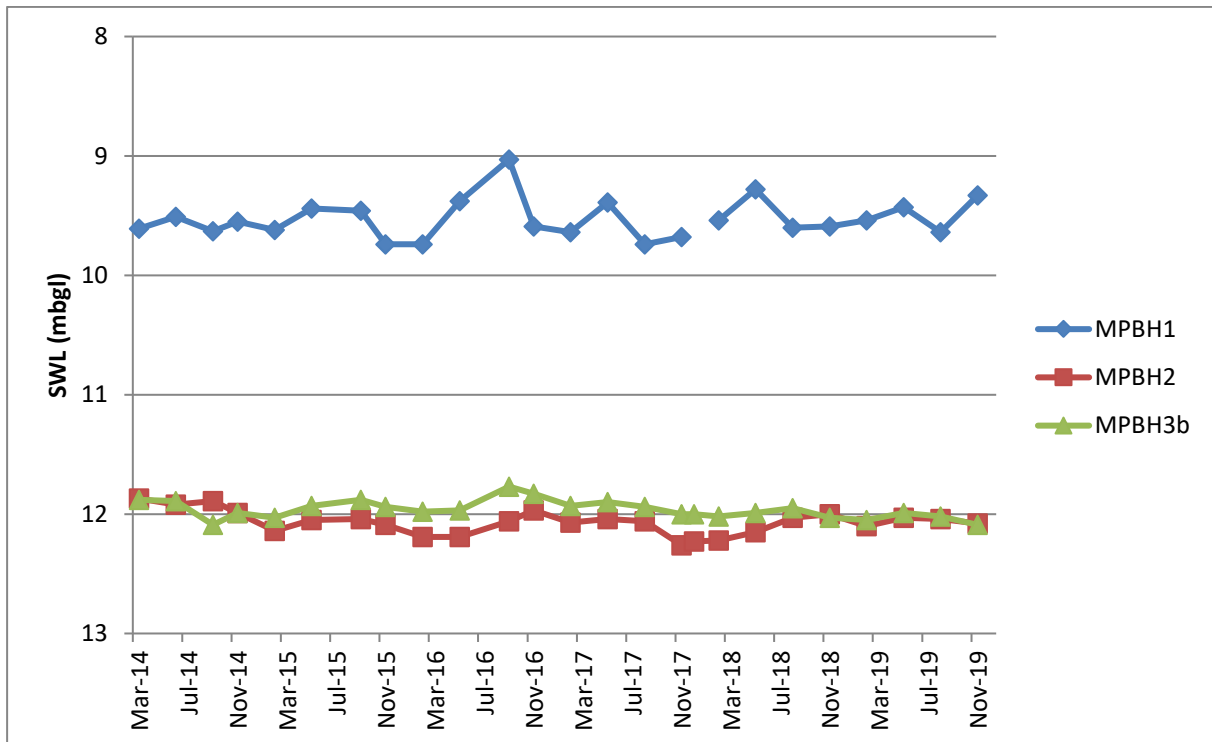
Chart 30: Groundwater Eastern Bores SWL 2014 - 2019

The results of monitoring SWL, EC and pH from 2014 to 2019 for the groundwater eastern bores are shown in Charts 30, 31 and 32 respectively.

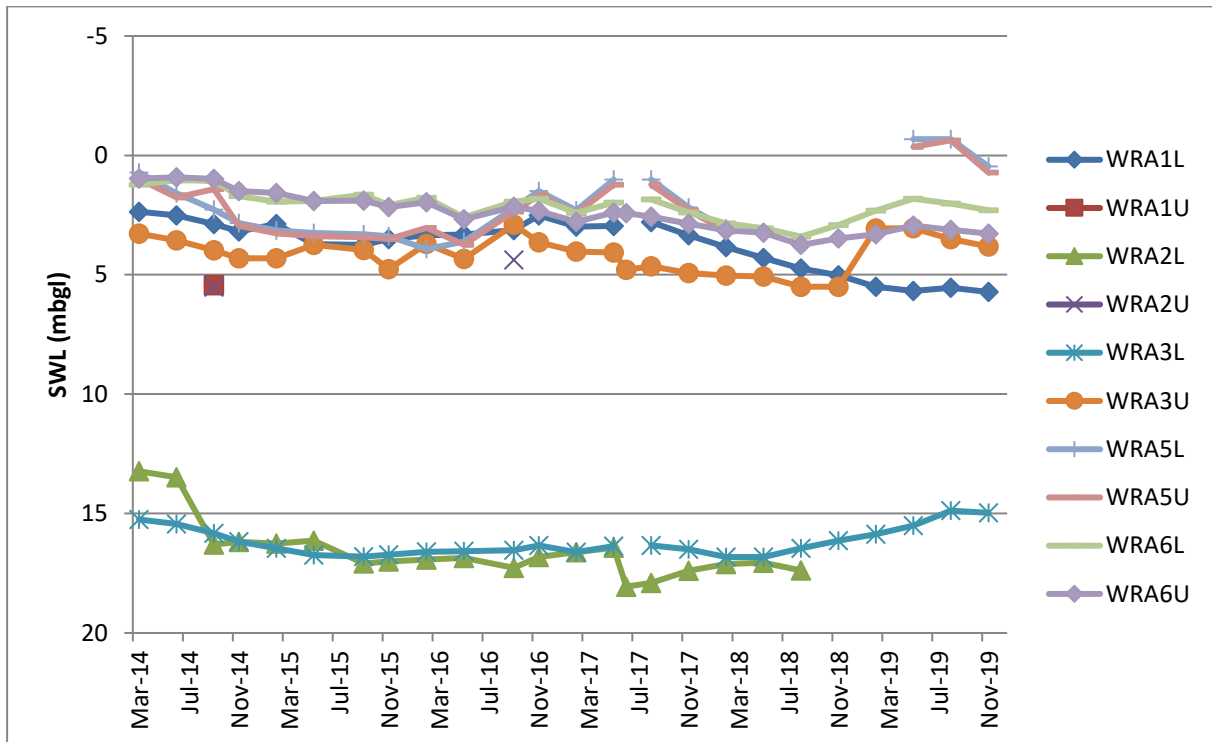
Chart 33: Groundwater Western Bores SWL 2014 - 2019

The results of monitoring SWL, EC and pH from 2014 to 2019 for the groundwater western bores are shown in Charts 33, 34 and 35 respectively.

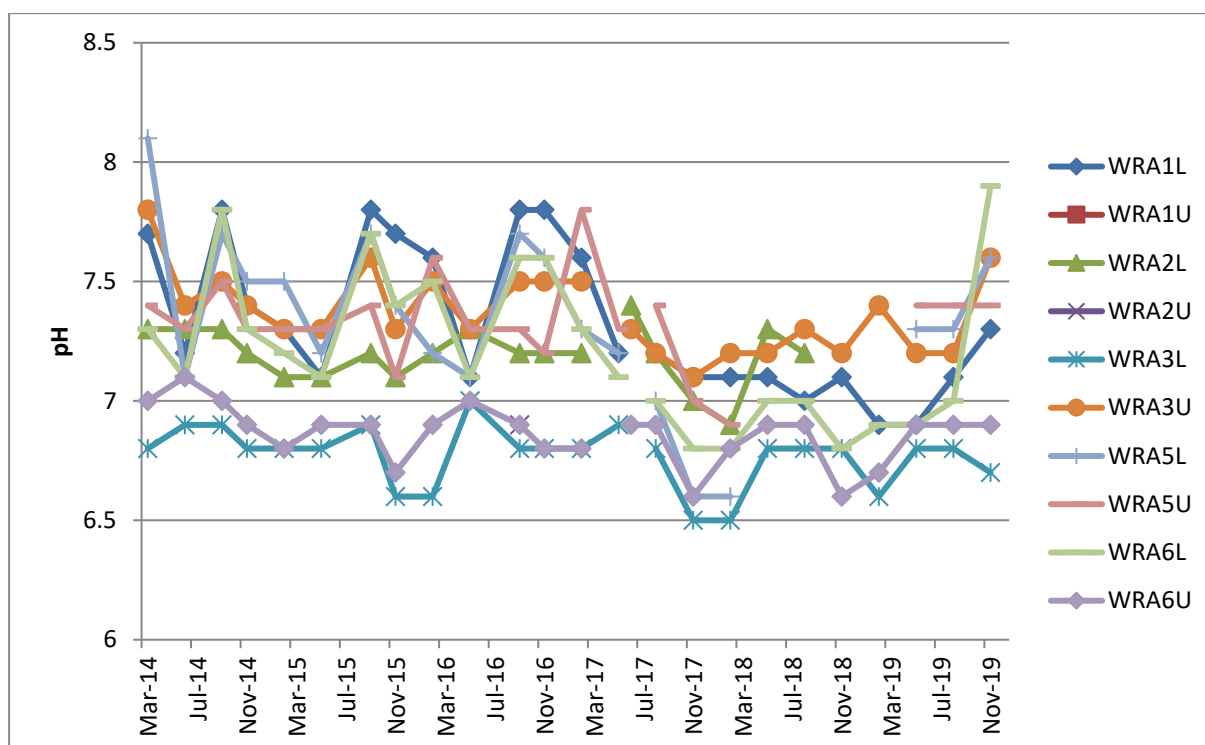
Chart 35: Groundwater Western Bores pH 2014 – 2019

During the reporting period, sites 3500B500L and 3500B500S continued to be blocked on all monitoring rounds. Monitoring was also not undertaken at 6000C000L due to insufficient water levels, and at 6000C000S, due to disturbance. Limited samples were taken in site 6500F500U and no samples were taken in site WRA1U during the reporting period due to dry conditions. Additionally, site 5500D000 was decommissioned before August 2019.

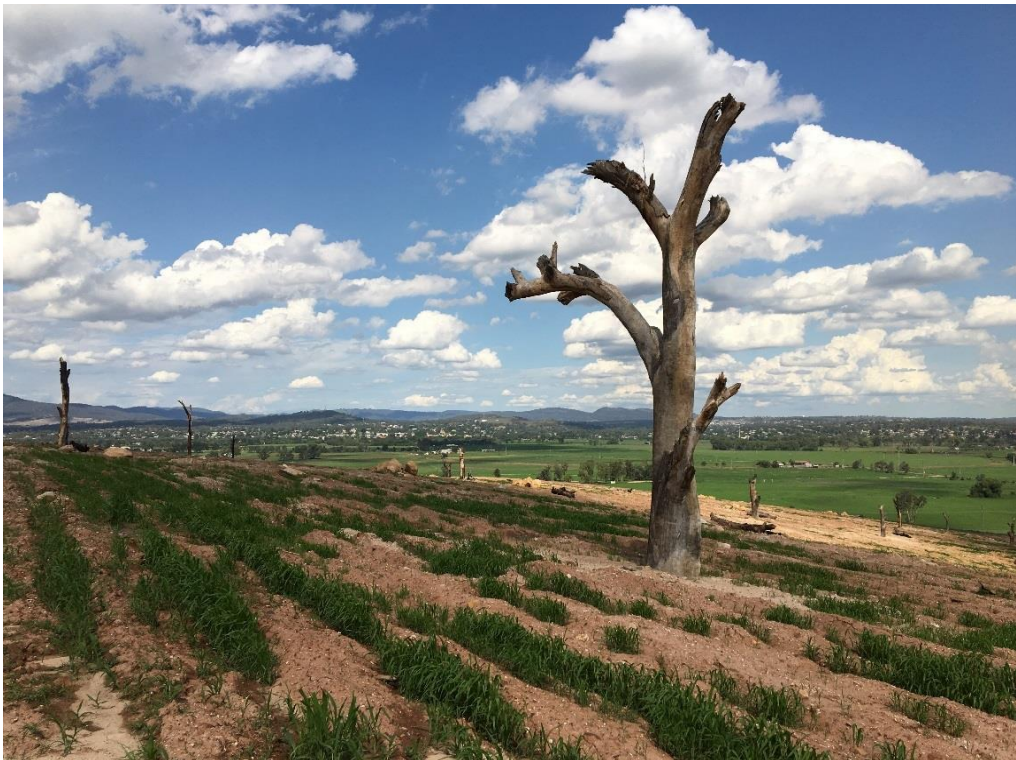
Plate 3: Eastern Out of Pit Emplacement Rehabilitation

- bulk and detailed re-shaping of overburden material to final landform;
- installation of habitat features such as stag trees and rock piles;
- topsoil spreading to a minimum depth of 100 mm;
- gypsum application at a rate of 10 tonnes per hectare (t/ha);
- deep ripping/tining along the contour of the final landform;
- direct/hand seeding of EEC tree/shrub/grass indicative species plus an additional grass cover crop; and
- planting of approximately 1,000 native trees per hectare.
