MOUNT PLEASANT OPERATION

2019 ANNUAL REVIEW & ANNUAL REHABILITATION REPORT

Document ID:	20200120		
Company:	MACH Energy Australia Pty Ltd		
Effective Date:	-	Status:	Issued for Approval
Approved By:	Richard Bailey	Revision Number:	00

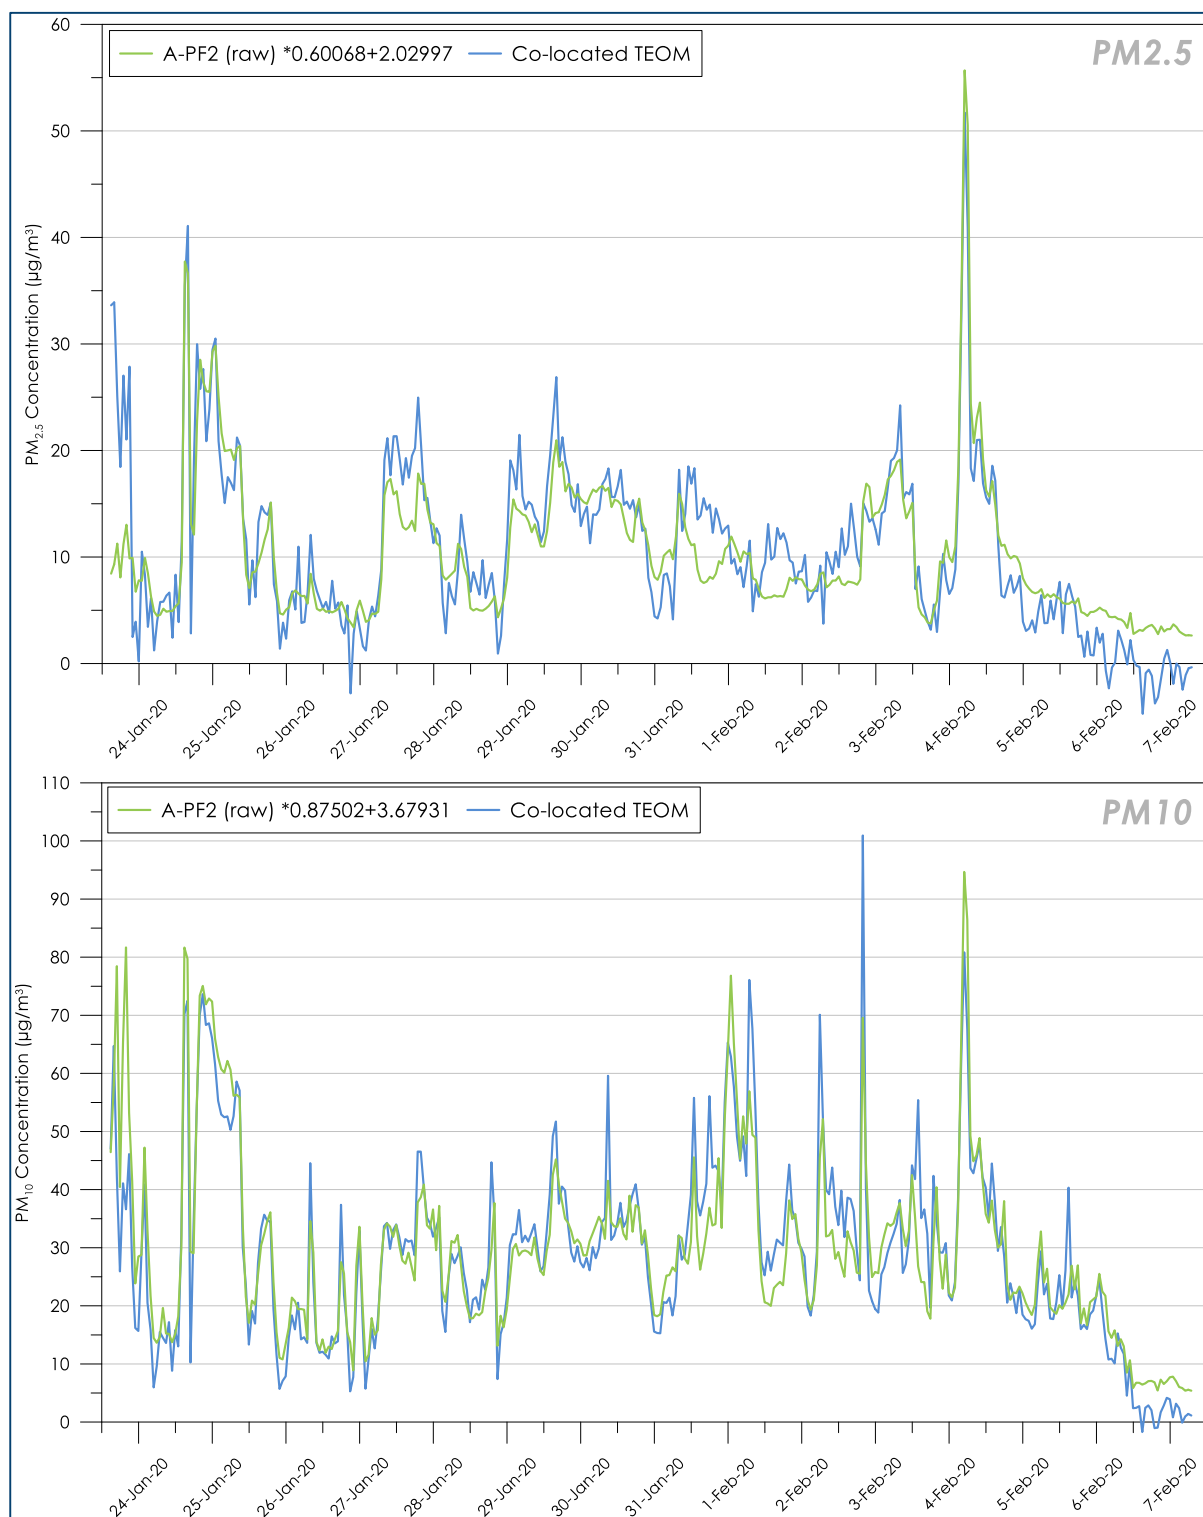
Figure 2: A-PF2 (k-factors applied) and co-located TEOM data

The data show that with the calibration factors applied, the A-PF2 data more closely match the TEOM data for both PM_{2.5} and PM₁₀.
