**Stage 3 - Proposed Residential Development**

**30-46 Auburn Road, Regents Park NSW 2143**

**Groundwater Impact Assessment (GIA)**

Project number: IRP-01500-V3

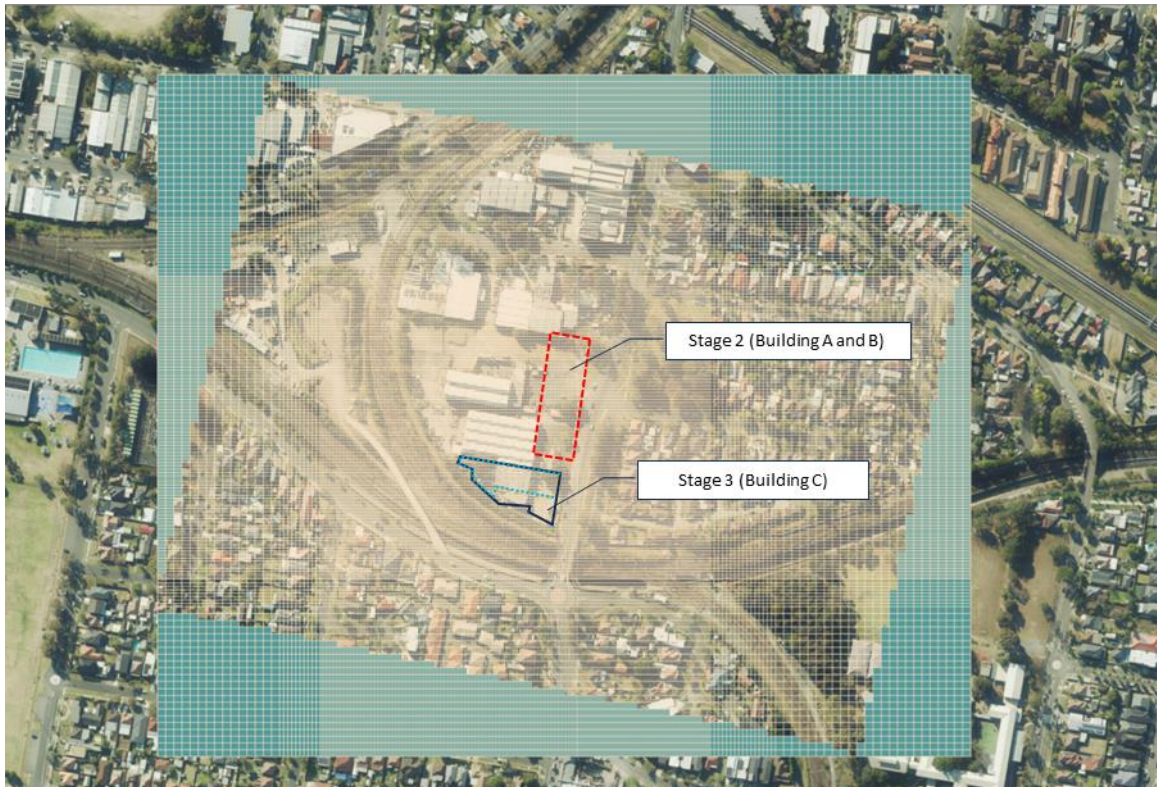
**Figure 1 Model Scenario Stage 3, Building C**

As part of the proposed Stage 3 construction plan, the construction of Building C was simulated in this report. During some of the model simulations, an excavation wall was simulated (as a groundwater inflow control) by applying a horizontal flow barrier (HFB) to the cells around the proposed Building C basement excavation. Modelled scenarios include soldier pile wall to lowest basement C3 with bulk excavation level (BEL) between 22.5 mRL with no shotcrete infill to 0.5 m below the BEL. Groundwater modelling results are included in the Appendix E. The Figure 1 below illustrates the Model Scenario: Soldier pile wall with shotcrete infill around the basement excavation for Stage 2 and Stage 3 basement construction.

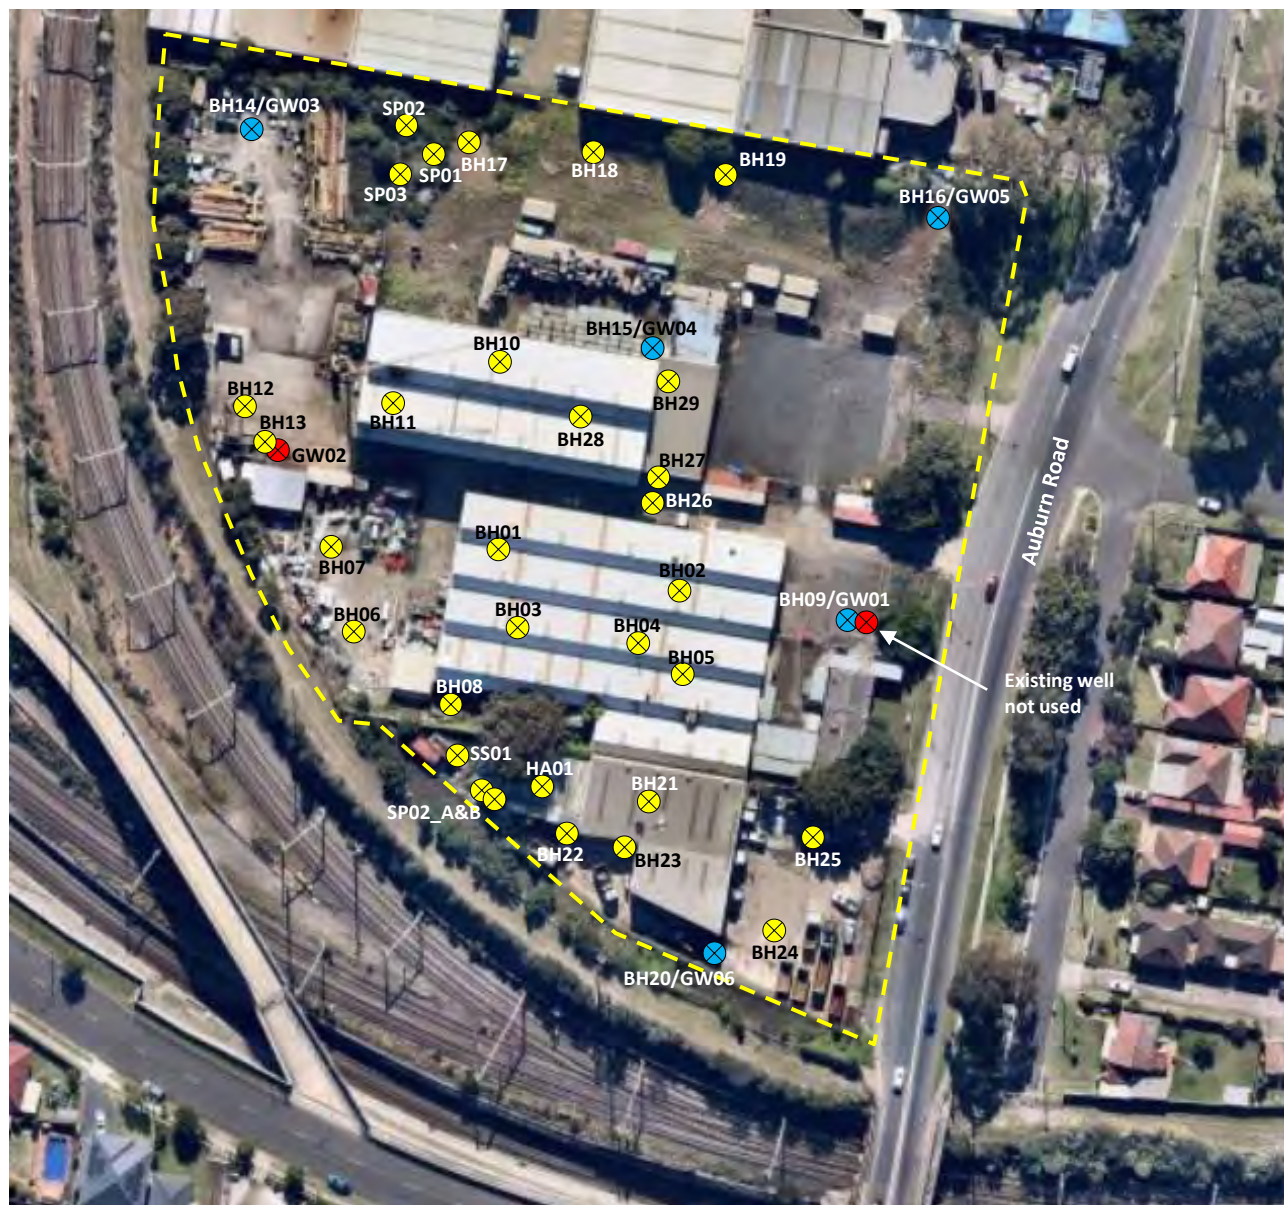
- Site boundary
- X New groundwater monitoring well
- X Existing groundwater monitoring well
- X Soil sample location

Added locations are approximate  
 Not to scale      Date: 17/06/2021  
 Source: Nearmaps™ 2021

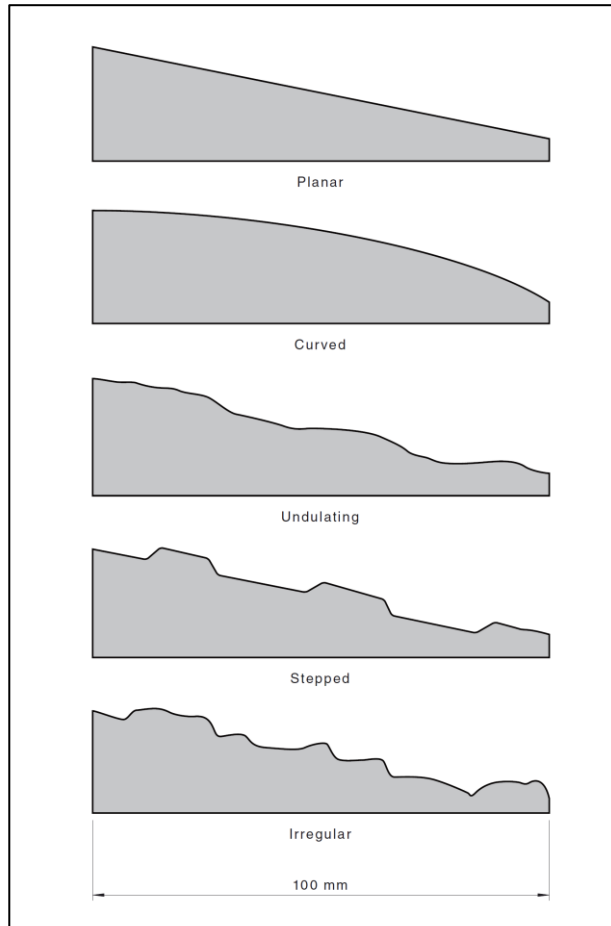
**Surface Shape** – At the medium scale of observation, description of the roughness of the surface shall be enhanced by description of the shape of the defect surface using the following terms, as illustrated below:

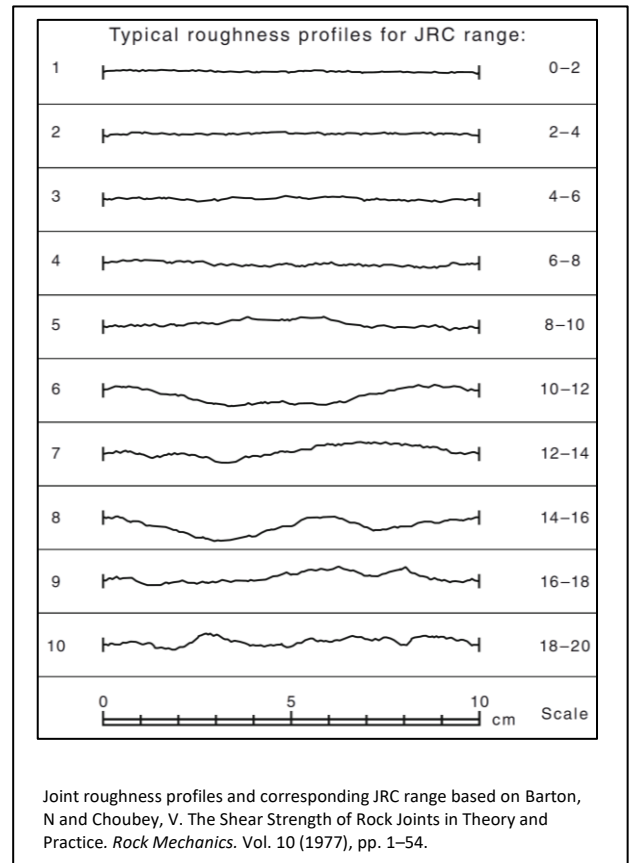
Where applicable Joint Roughness Range (JRC) is provided as follows:
