M^CLAREN TRAFFIC ENGINEERING

15 December 2025

Reference: 251075.01DA

LETTER OF ADVICE RELATED TO THE WALKING DISTANCE ASSESSMENT AT 11 - 23 RANGERS AVENUE, MOSMAN

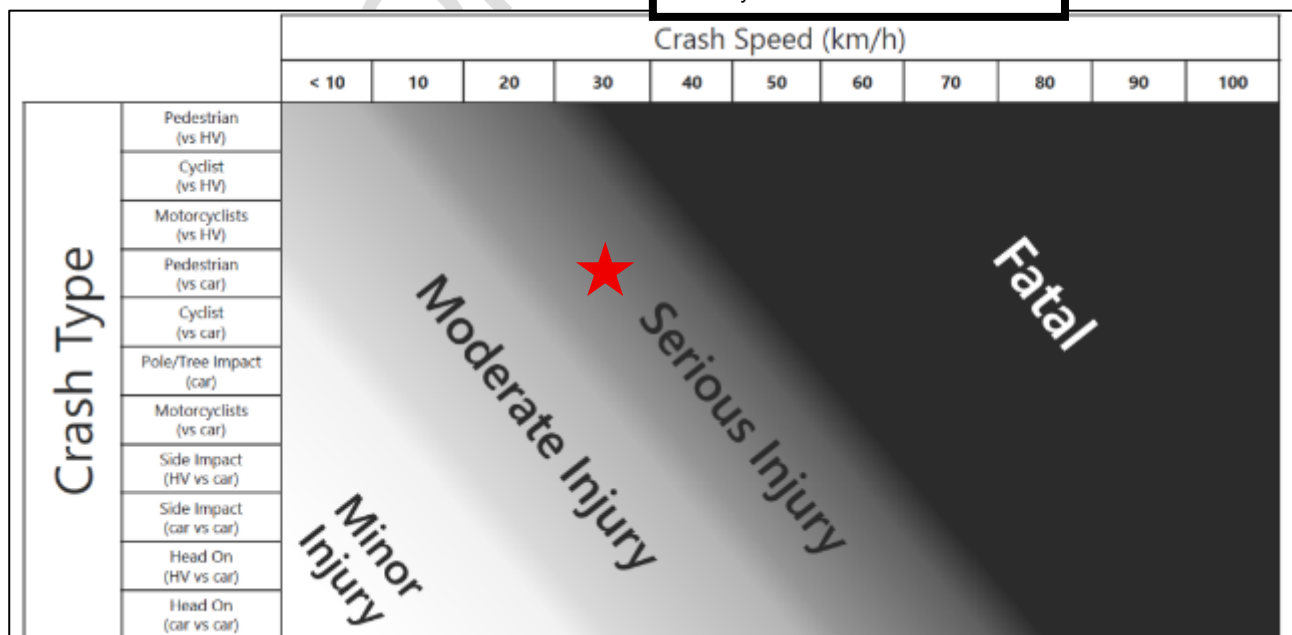
FIGURE 2: SEVERITY GUIDANCE SHEET – AUSTRROADS

Safe System crash outcome threshold

A vehicle would likely decelerate in anticipation of a pedestrian strike. It is reasonable to assume that at the point of impact, a vehicle would be traveling approximately 30km/h. As shown, an incident involving a pedestrian and a car at speeds between 30km/h can cause serious injuries. Although the incident may be rare, serious injuries indicate a **medium** risk level and exceeds the Safe System crash outcome threshold.

There is a risk of a pedestrian strike where a pedestrian accepts an unsafe gap to cross the road. Given the gaps available, it is possible that the pedestrian does not give a vehicle enough time to stop before hitting the pedestrian. The severity of a pedestrian strike is based on the guidance sheet as provided in the *Austrroads Guide to Road Safety Part 6*, which is reproduced as **Figure 2**.

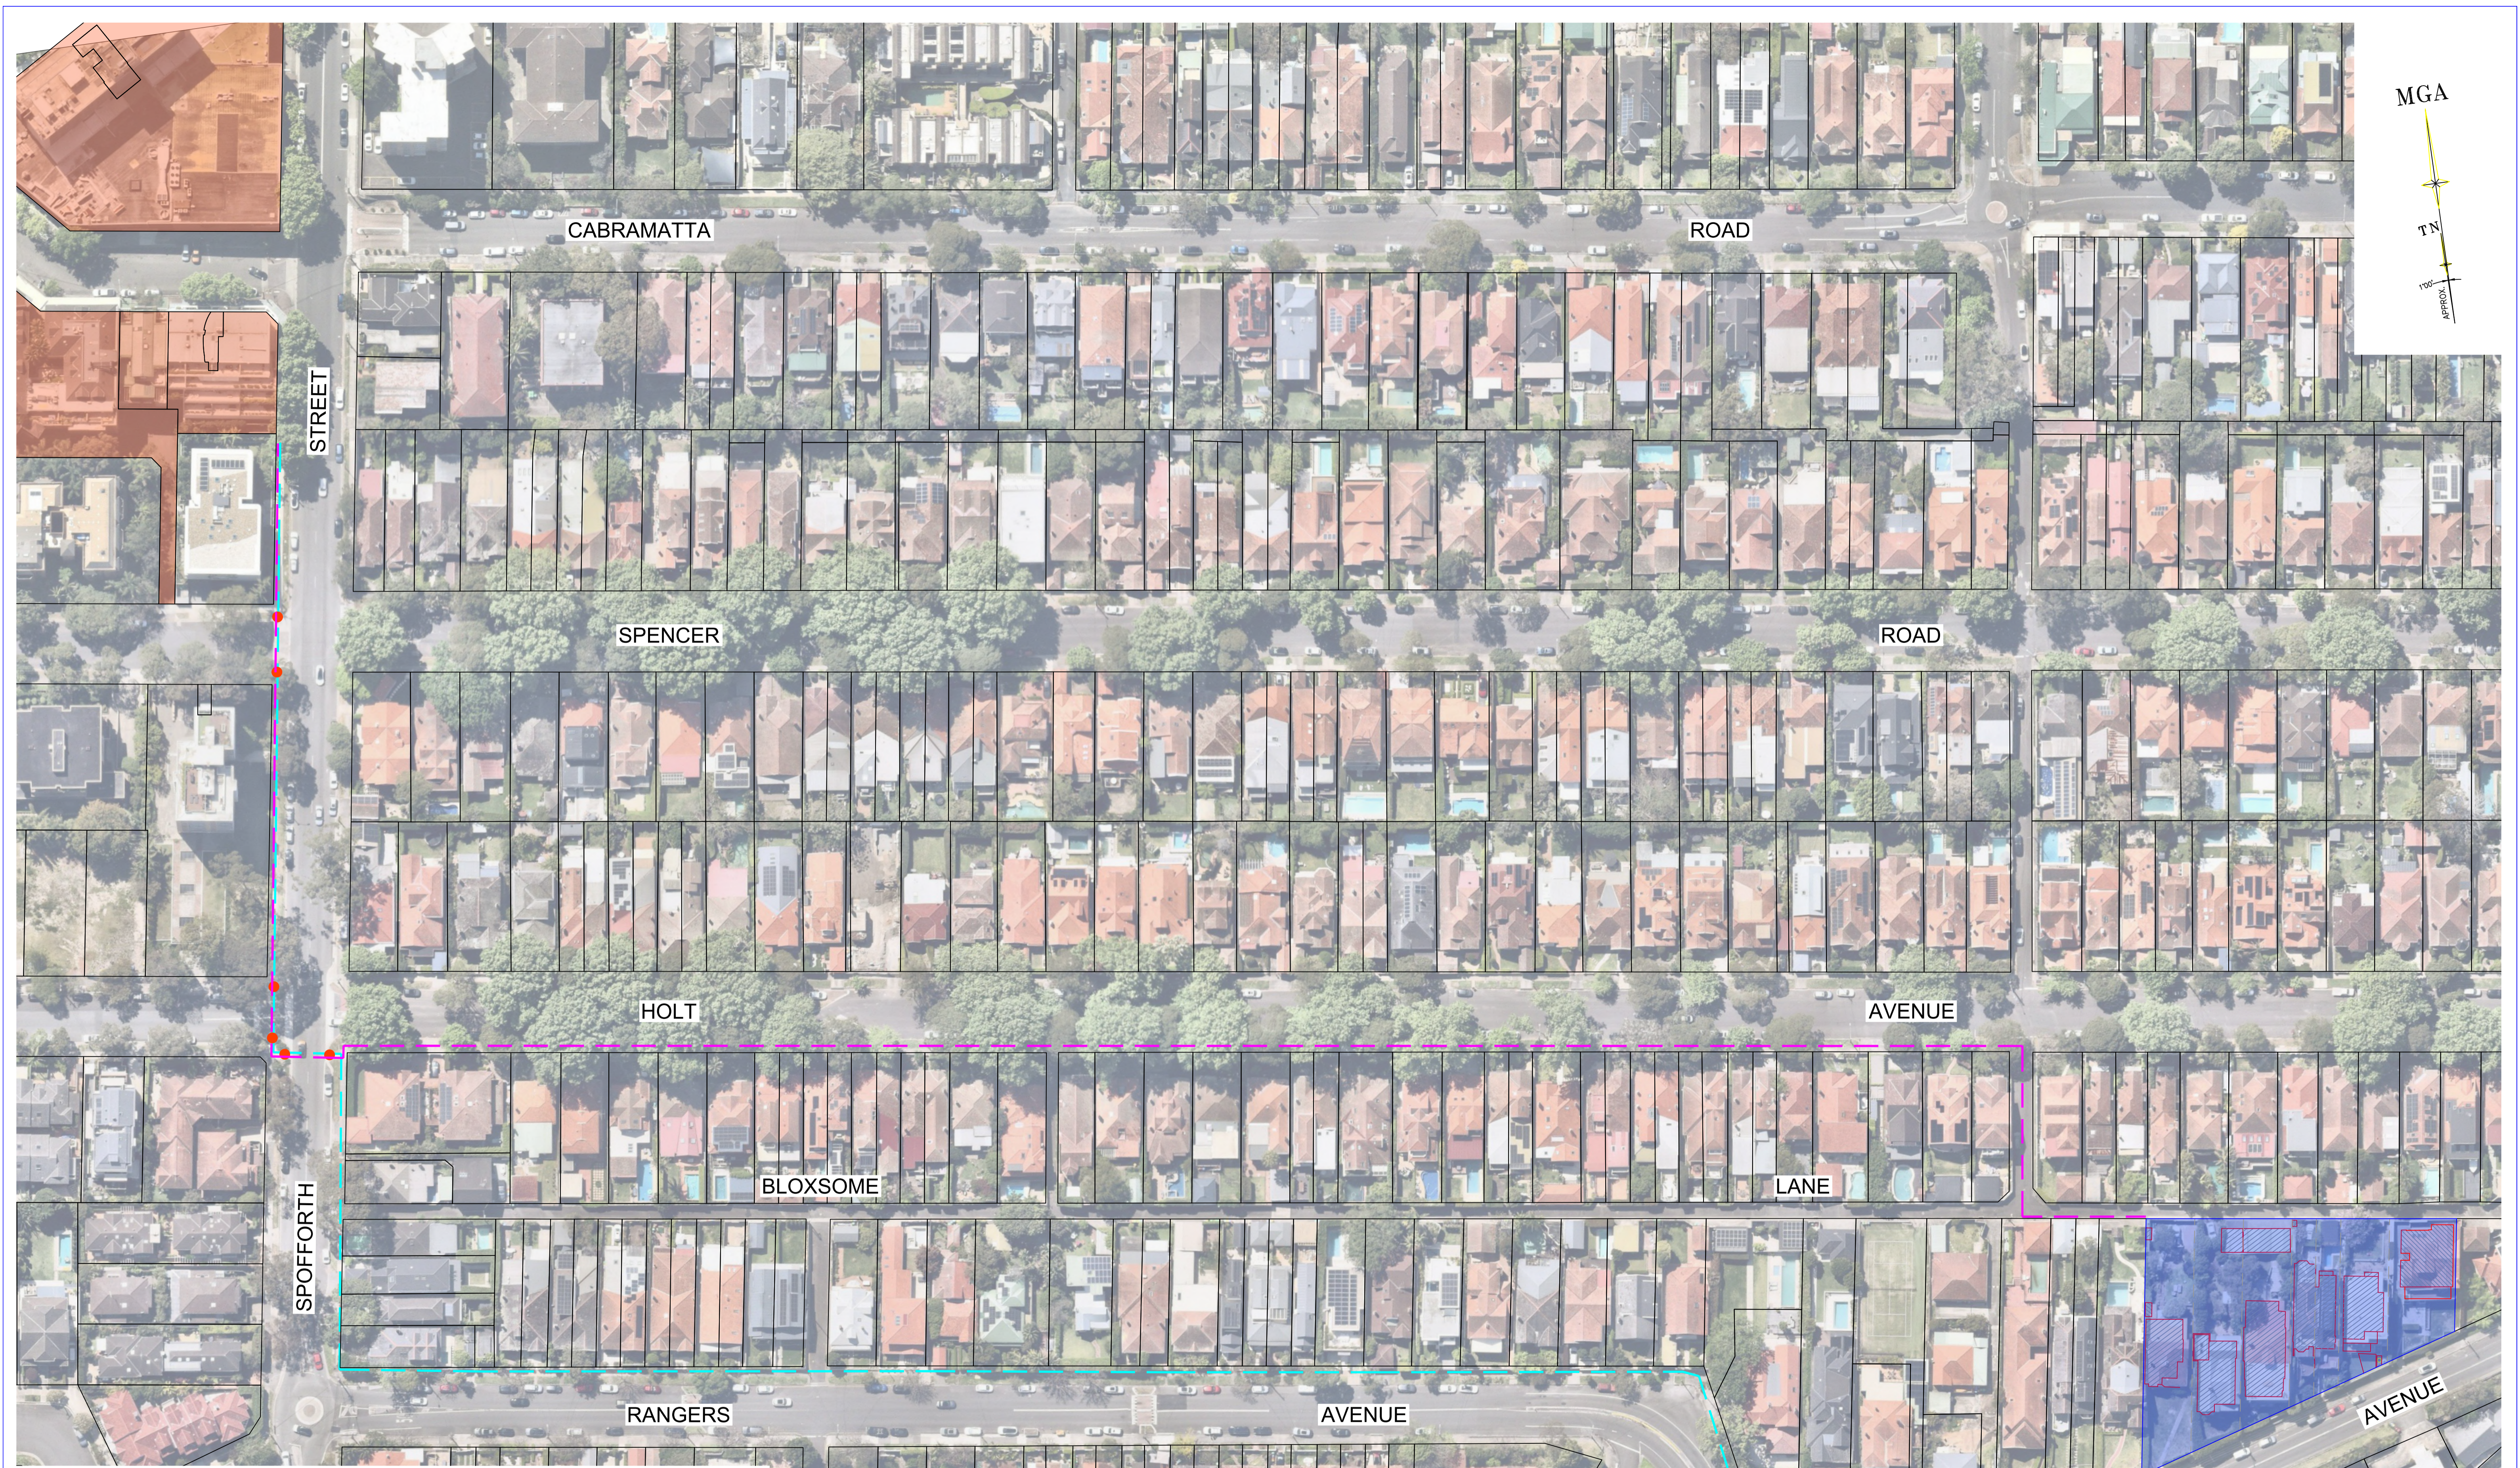
**ANNEXURE A: WALKING ROUTES
(1 SHEET)**

LENGTH
 WALKING ROUTE 1 : 742m
 WALKING ROUTE 2 : 668m

Client: GRAND NOBLE PROJECT 1 PTY LTD
 Drawing title: PLAN SHOWING WALKING DISTANCE TO TOWN CENTRE FROM LOTS 1 & 2 IN DP 748842 AND LOTS 37, 38, 39 & 41 & 42 SEC A DP 2509 KNOWN AS NO.11-23 RANGERS AVENUE, MOSMAN

LTS Surveyors undertook a survey on 11 November 2025 using high-accuracy GPS surveying equipment and physically verified on foot two (2) walking routes to determine the walking distance between the site and the Cremorne Town Centre (provided in **Annexure A**). The definition of "walking distance" under the SEPP Housing 2021 is below.

Both survey routes require pedestrians to cross Spofforth Street at the intersection of Holt Avenue, which the letter accompanying the survey describes as *residential streets with adequate pedestrian safety*. The Walking Route 1 is a distance of 742m, whilst the Walking Route 2 is 668m, which does not use footpaths for the entire length.

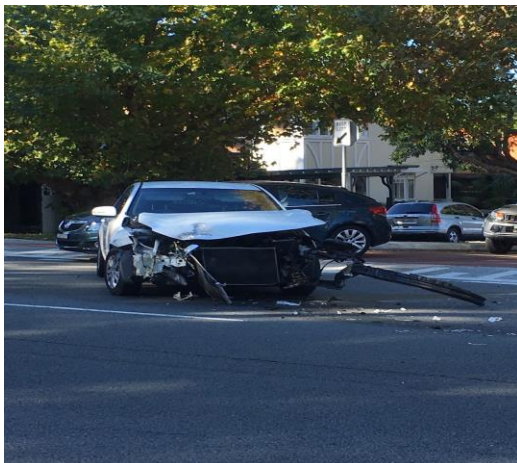
21.2.19	850pm	2 vehicle crash	
6.5.19	2pm	Head-on crash 2 vehicles

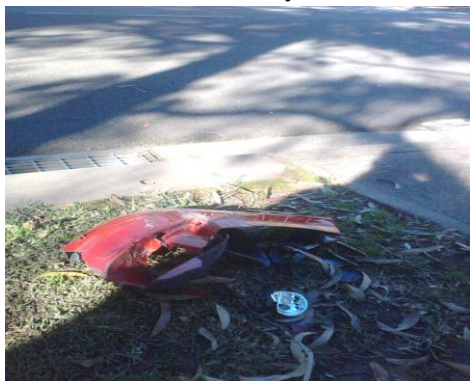
11.7.19 10am 2 car accident - car was attempting to traverse across Spofforth from Holt to Holt. Tow away

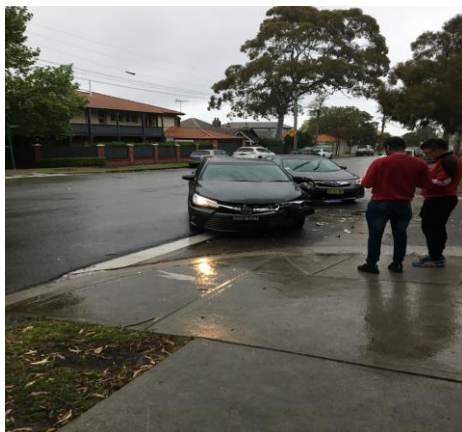
5.10.19 7.30am 2 car accident cnr Holt Ave & Spofforth St

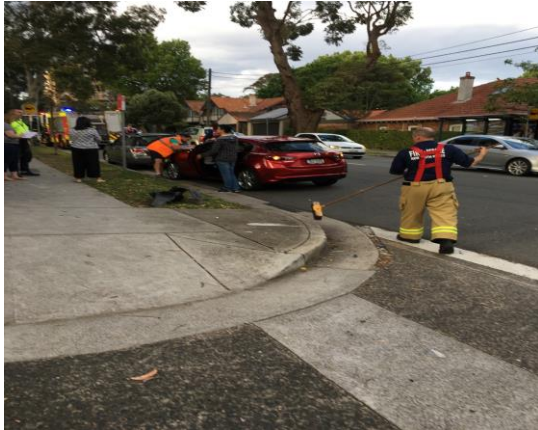
19.10.19 530pm 2 vehicles Holt & Spofforth - **Police, Fire Brigade**

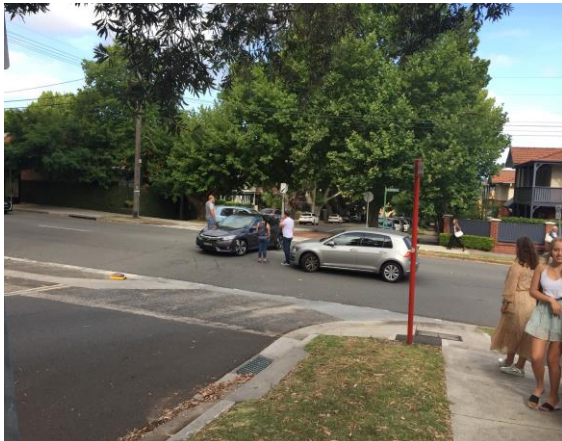
16.11.19 345pm - T-bone 2 vehicles

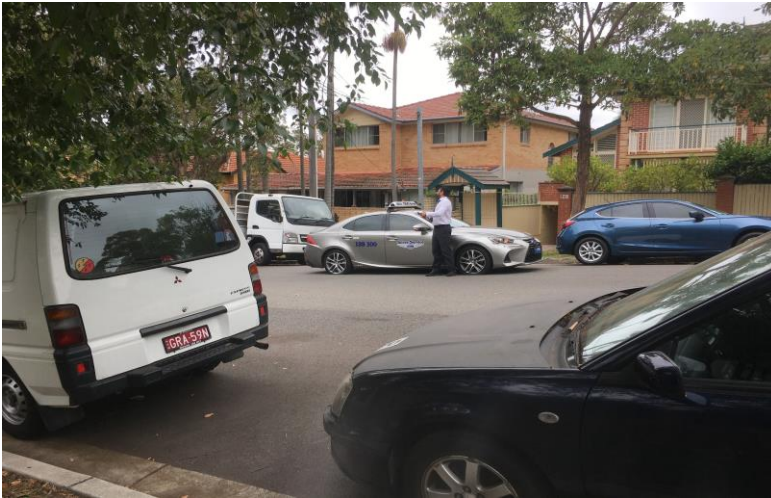
23.1.20 Taxi with flat tyres - caused by hitting "silent cop" (now removed) at center of Holt Ave intersection.

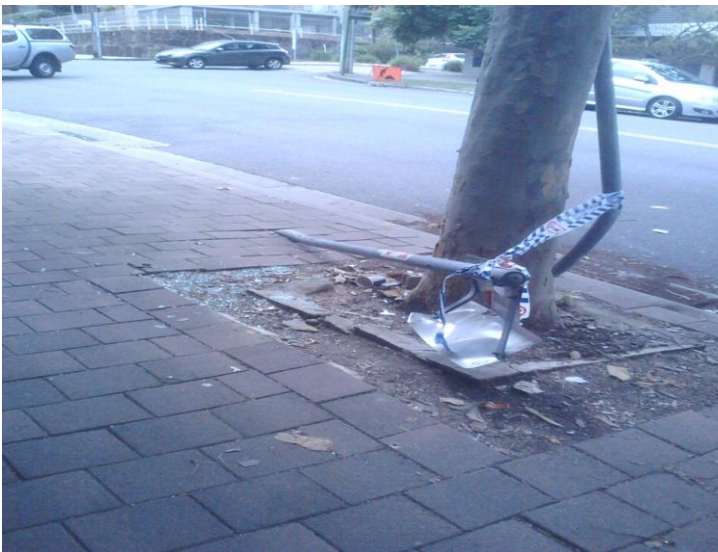
27.2.20 **Accident cnr Cabramatta Road & Spofforth** - vehicle lost control, mounted footpath, hit a pole and tree at the corner of Cabramatta Road

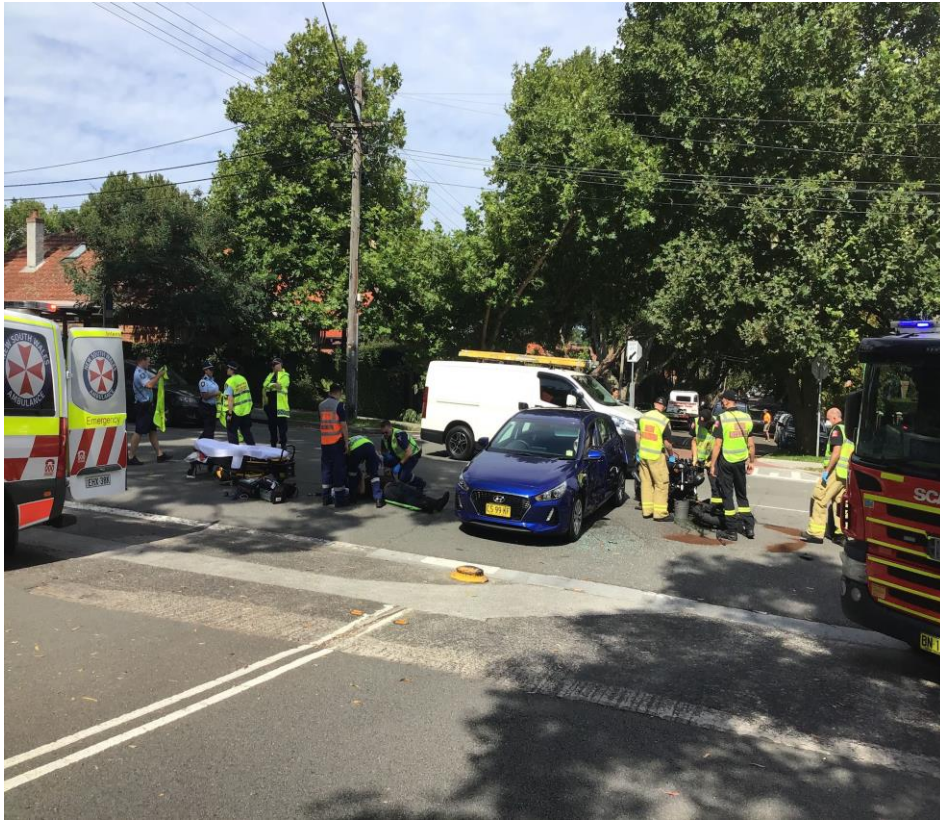
15.1.21

Motorcyclist and car - T-bone crash Spofforth/Holt
Ambulance, police in attendance

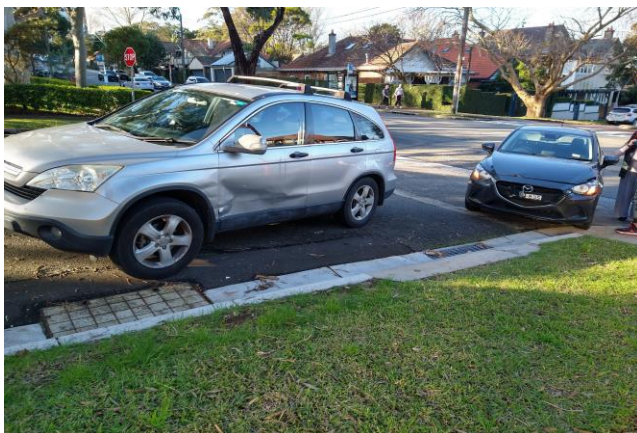
24.7.22: 2 vehicle crash - T-bone crash. Extensive damage to both vehicles

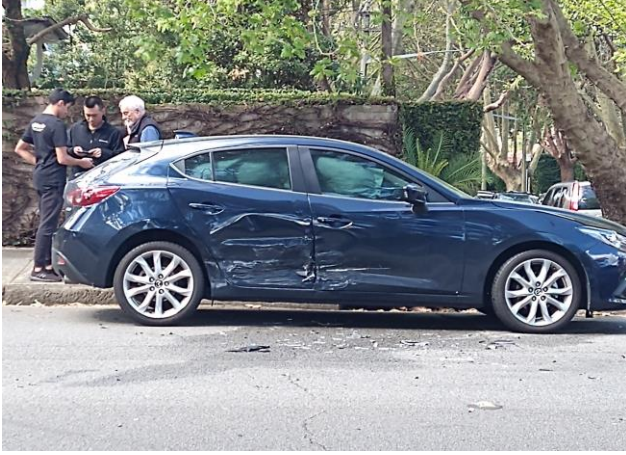
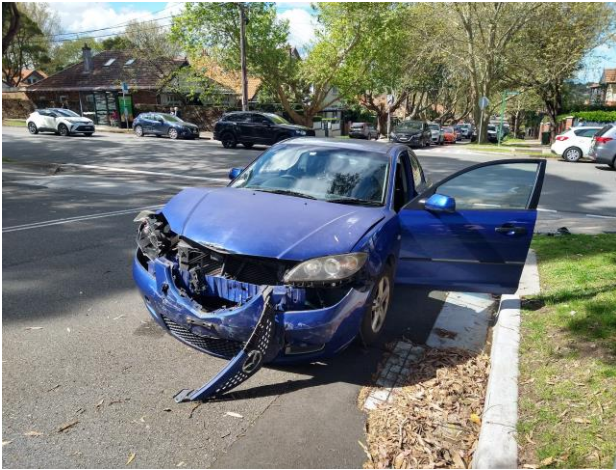
10.9.22: 3 vehicle incident Sat 10.9.22 - 130pm

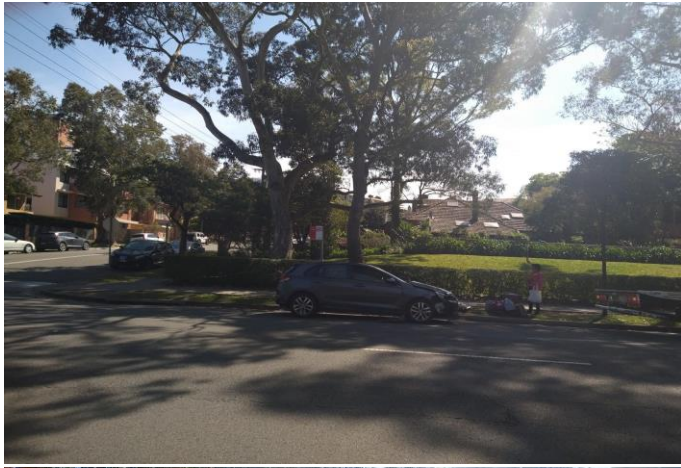
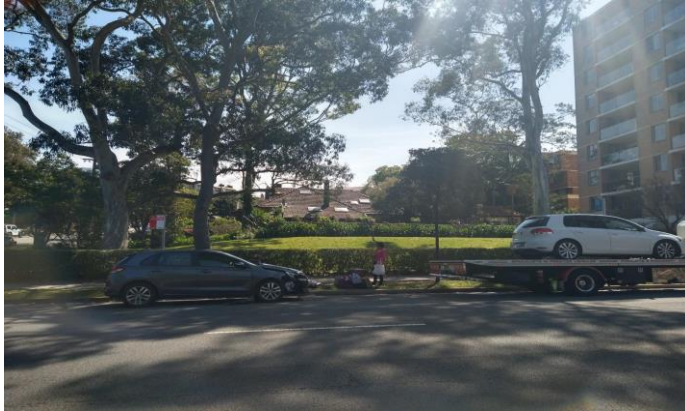
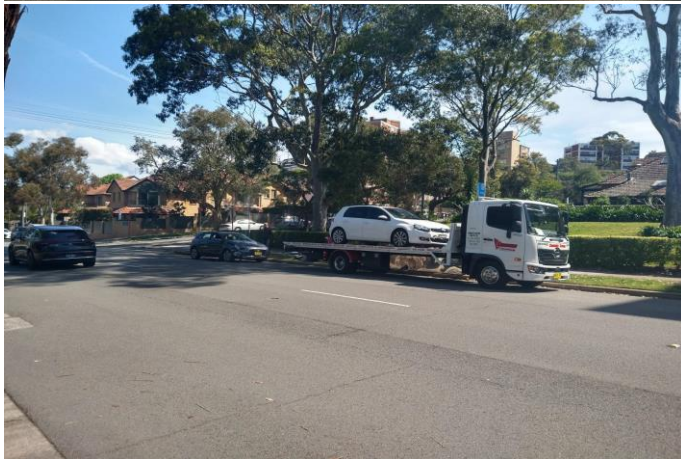
Mon, 3 Oct 2022, 14:33
2 car collision

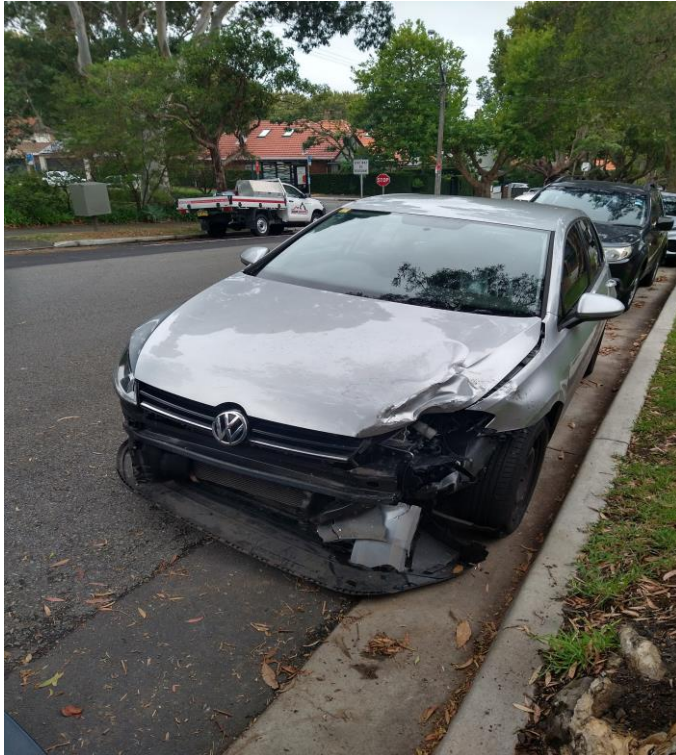
6 February 2024

3 car accident at 9 am at Holt ave intersection of Spofforth.

Victim stated she was hit whilst turning right out of Holt on the Mosman side - the car was seriously damaged. Police in attendance.

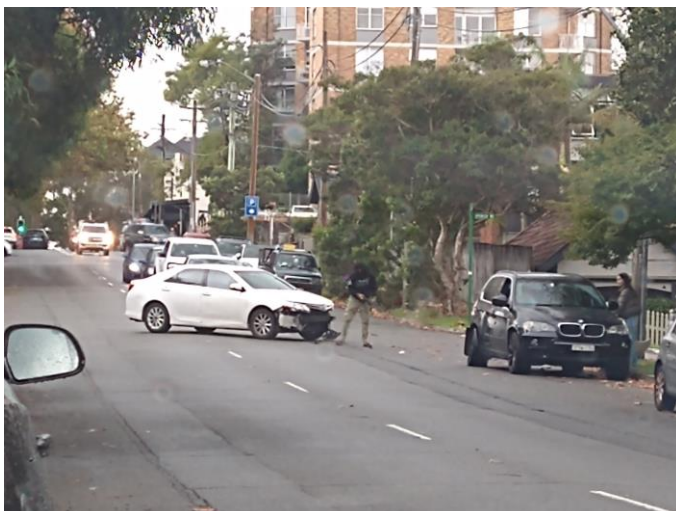
Fri, 24 May 2024

2 vehicle crash

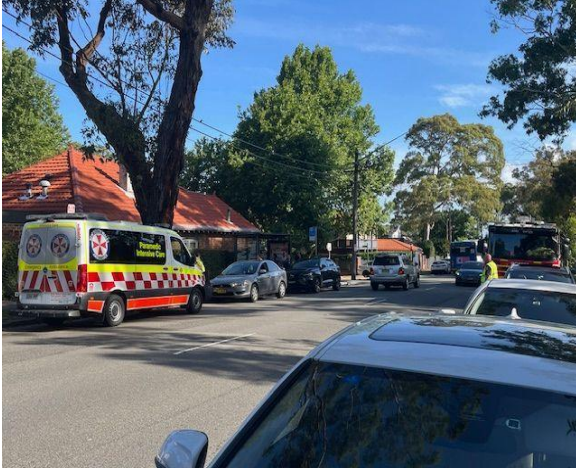
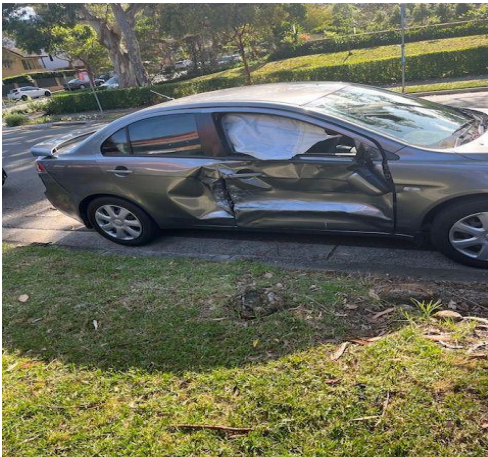
9.11.24

A serious accident occurred at 4.30pm on Saturday 9th November at the intersection of Holt Avenue and Spofforth Street. Ambulance, Fire Brigade and Police were in attendance. See Minutes of Nov 2024

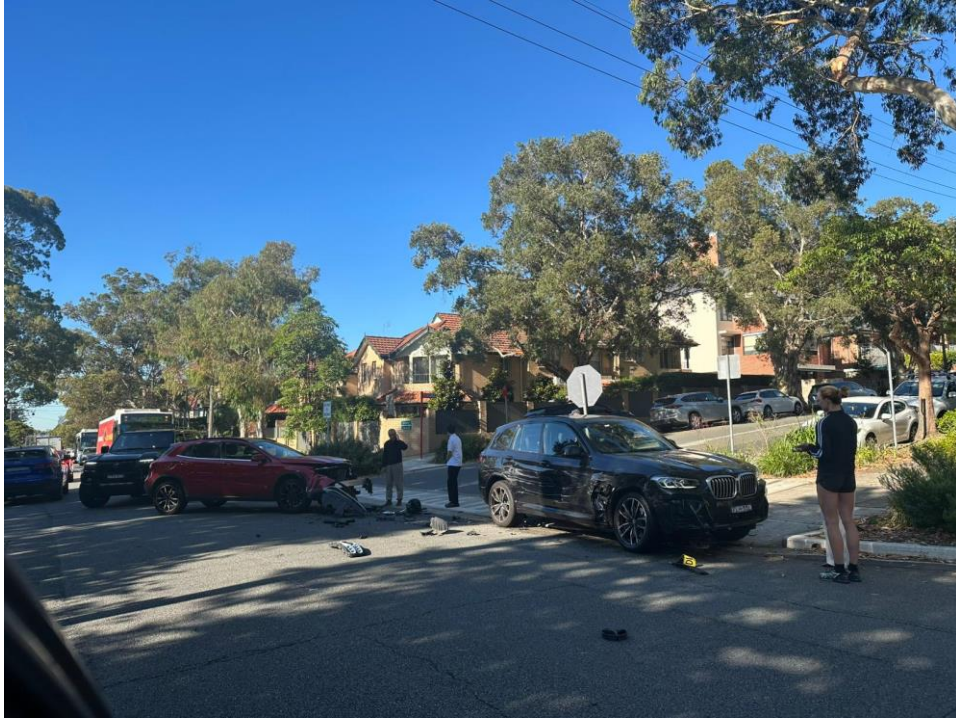
Wednesday, 19 November 8:20am

2 cars involved

Extensive damage to both vehicles including a BMW SUV

No police were in attendance, no one was physically injured as far as we are aware.
